INVESTIGATION OF BRIDGE PIN FAILURES

FINAL REPORT  
to  
Missouri Highway and Transportation Commission  
on  
INVESTIGATION OF BRIDGE PIN FAILURES

Department of Metallurgical Engineering  
University of Missouri-Rolla

November 15, 1987

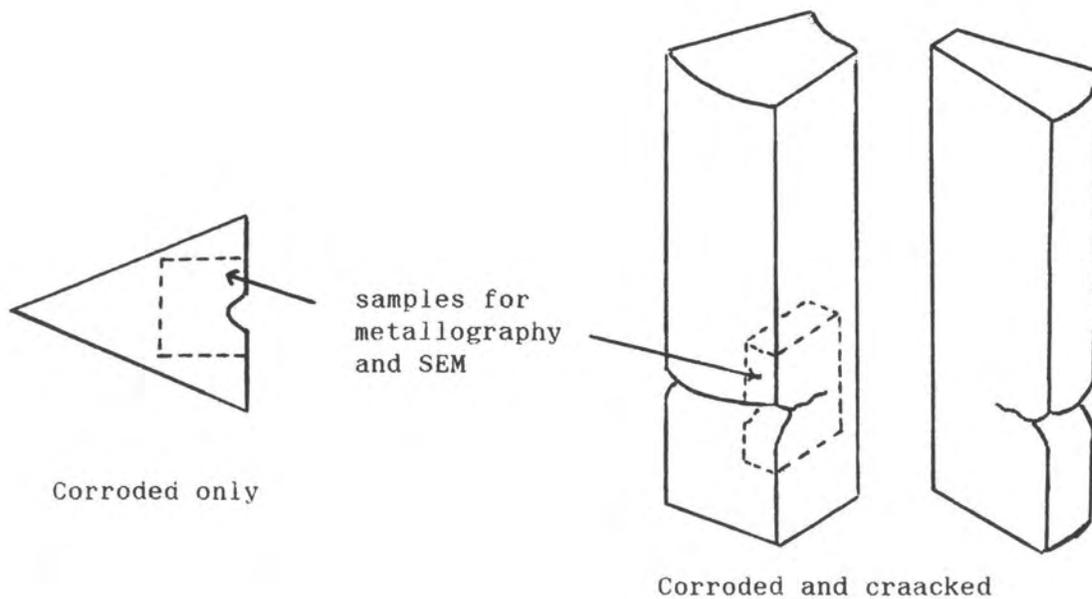
Item #1: The full pin from the I-55 bridge contained two circumferential regions of damage -- one area consisted of a shallow corrosion pit or groove with no visible indication of crack nucleation while the second area consisted of a deeper corrosion pit or groove from whose base a crack had formed. Sections were removed from this pin using a band saw. Figure 3 illustrates some of the cuts that were made. Samples were prepared for metallographic and SEM examination from locations that were only corroded and locations that were both corroded and cracked. In addition, a section was removed in such a manner that the section still contained the crack, Figure 4. This section was trimmed to a suitable size, then fractured; the final surface contained both the crack surface as well as a fresh fracture surface. The surface of the fractured specimen was examined with the SEM.

Figure 3: The full pin from the I-55 bridge after sectioning. The pin was first cut into two halves. Additional slices were then obtained from the two halves to provide samples for metallographic and SEM inspection. One of the longitudinal slices was fractured so that the actual crack surface could be observed, shown in greater detail in Figure 4.

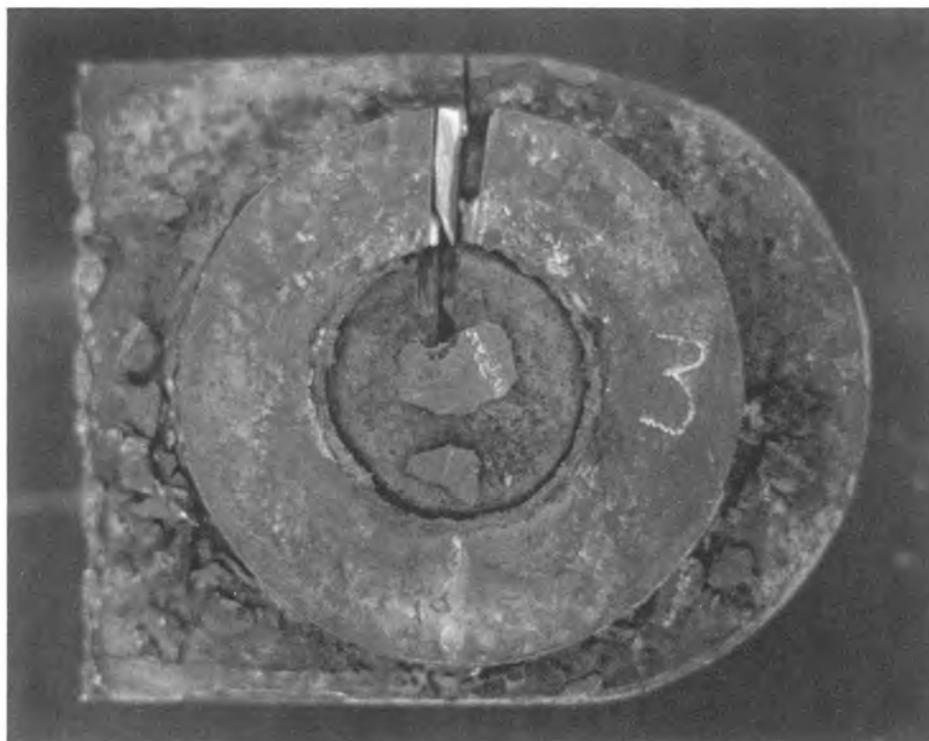
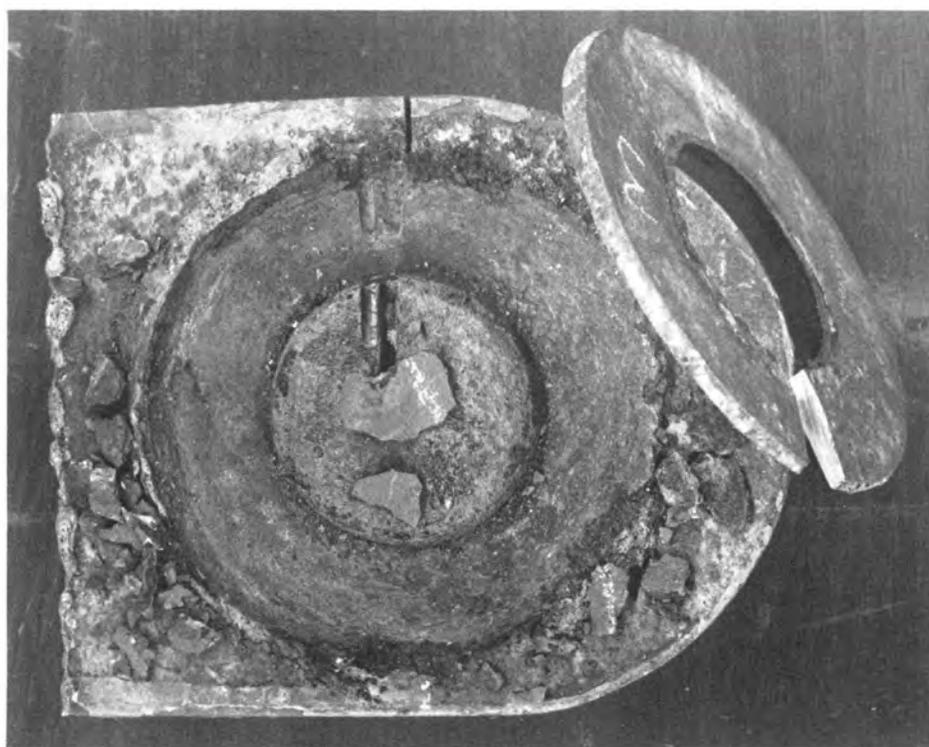
Item #3: This item included a hanger strap-pin-washer junction from the I-55 bridge. This particular pin had actually fractured completely while in place in the bridge; the hanger strap had previously been cut by the Highway Department during their repair. The bronze washer, which was on the opposite side of the strap from the nut, was about flush with the fracture surface of the pin and was still firmly attached to the strap and pin. Initial attempts to cut the strap section containing the bronze washer with a band saw were unsuccessful because of the hardness of the bronze washer. Instead, a power saw with an abrasive wheel was used to cut through the washer. As this was being done, a layer of corrosion product (about 1/16 inch thick) popped off the fracture surface of the pin. Figures 5a and 5b show the section after the cut with the abrasive wheel -- the two fragments on the pin surface are a portion of the remains of the

oxide that popped off during cutting; originally the entire fracture surface of the pin was covered with this material. In addition, at this time the washer separated from the strap.

Figure 5: Photographs of the pin-strap piece containing the bronze washer. (a) The piece after the bronze washer was cut with an abrasive wheel. (b) The piece with the washer removed, showing the thick layer of corrosion product between the washer and the strap, two pieces of corrosion product originally on the pin fracture surface, and the start of the band saw cut.

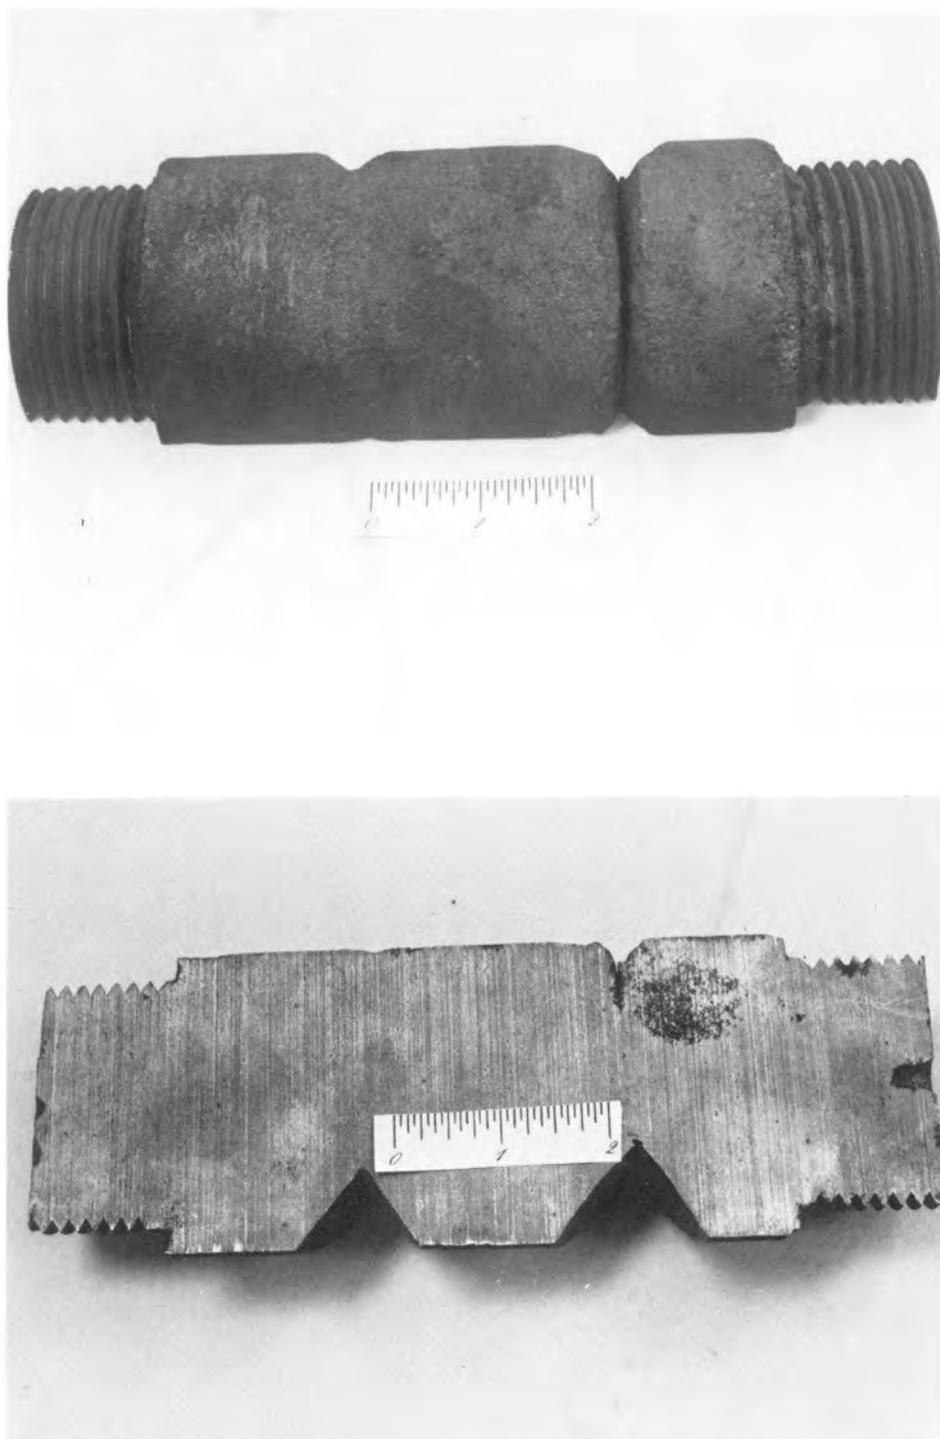
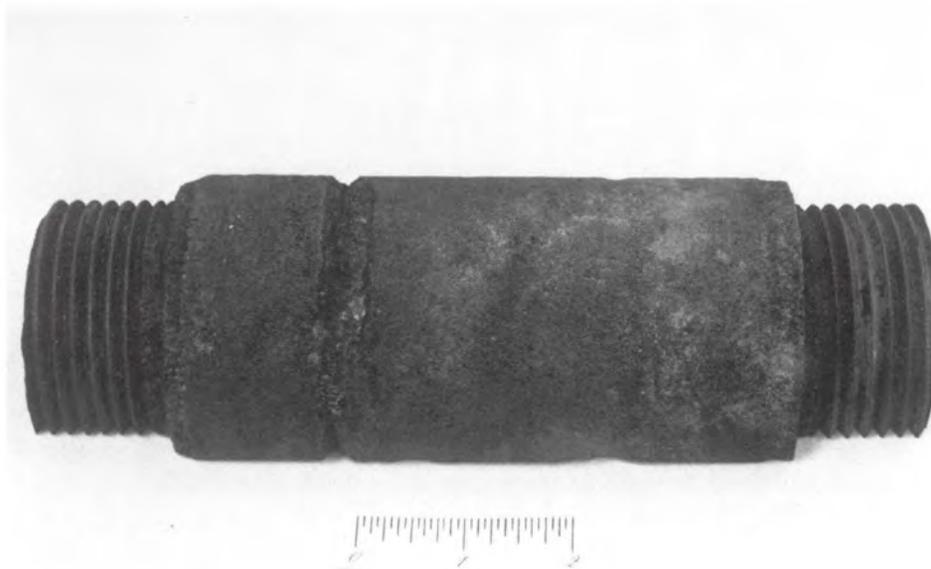
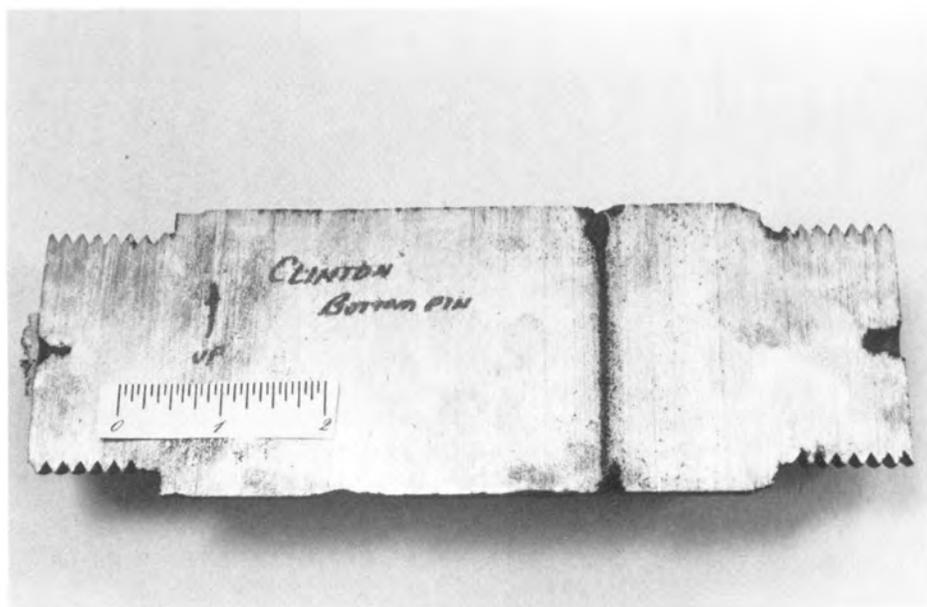
Item #5: As in the I-55 bridge pins, both of the Clinton pins contained two areas of circumferential corrosion. One area contained corrosion only while the second area contained both corrosion and deep cracks. Using the band saw, both the top and bottom pins were cut longitudinally. Figure 7 shows the outside surface as well as the cross-sections of these pins. Two samples were removed from the top pin -- one from the corroded area and one from the corroded and cracked area. These samples were also examined microscopically and with the SEM. Although the bottom pin was also cut longitudinally, no additional samples were removed.

Figure 7: Photographs of the Clinton pins. Note that only mild corrosion occurred at one pin-strap-web junction but deep corrosion and cracking occurred at the second junction on each of the pins. Cracks were about 1/2 inch deep, with combined corrosion plus crack extending about 3/4 inch beneath the original pin surface.

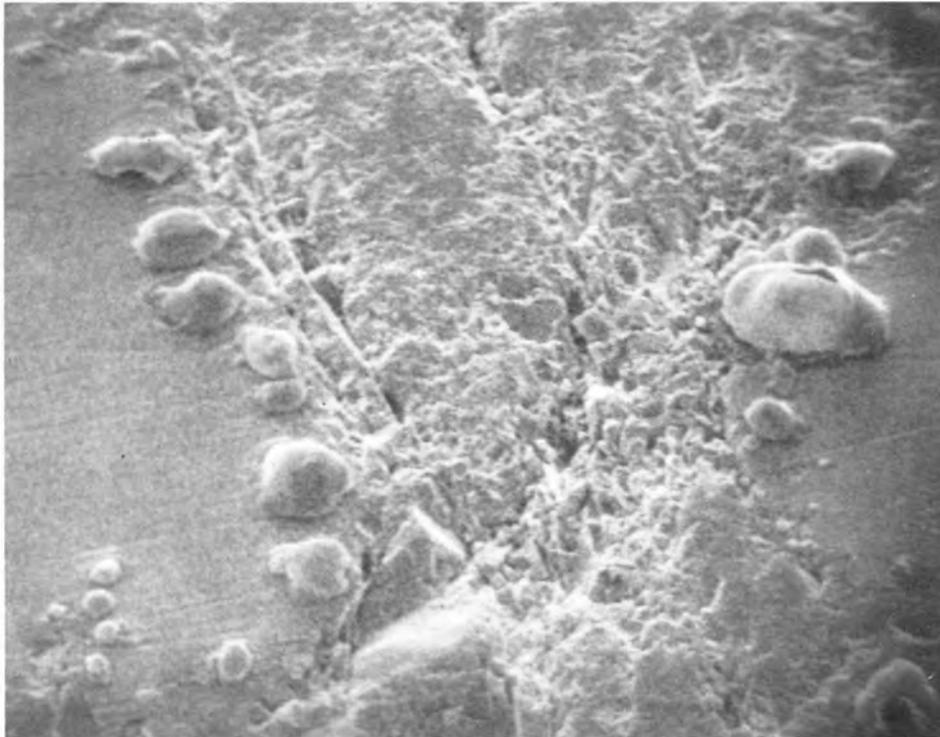
In an area near the surface, Figure 15a, small crystals were present which had apparently oozed out between the residue and the steel on both sides of the crack during the vacuum desiccation that preceded insertion of the specimen into the SEM. The residue itself contained only iron and manganese. Figure 16 shows the typical energy spectrum from the crystals. The crystals contained about 40 wt% (52 at%) chlorine. During preparation of the samples, moisture used to lubricate the sample during polishing apparently dissolved the salt in the residue. The salt solution was then drawn from the residue prior to examination, allowing the crystals to form.

Figure 15b shows an area of the crack lying deeper into the pin, somewhat to the upper left of Figure 15a, where the crack had branched. This area also contains a residue plus small crystals. Figure 17 is the energy spectrum from the residue, which contained 14 wt% (20 at%) chlorine.

Figure 15: Scanning electron microscope photographs of the crack shown in Figure 14. Note the small globules or crystals at the edges of the crack residue. (a) Near the start of the crack. (b) Near the end of the crack. x720.

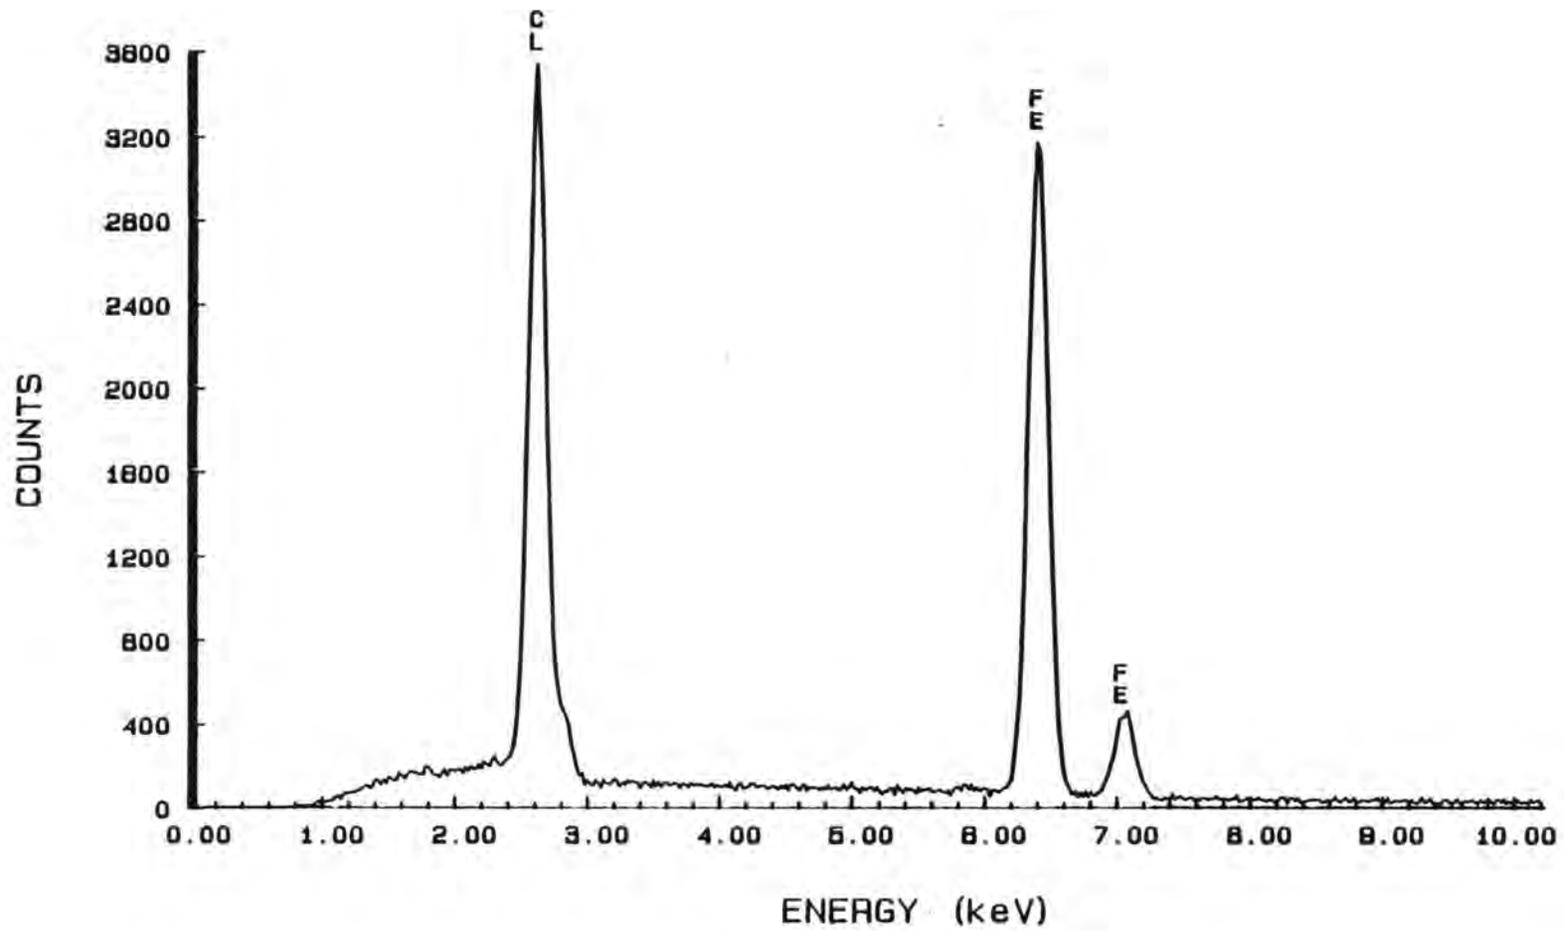
Only chlorine is present in the energy spectrum; sodium, which almost surely is present in the crystals, does not have a high enough atomic number to be detected.

Figure 16: Energy spectrum of X rays emitted from a crystal at the crack residue boundary in Figure 15a. Note the large quantity of chlorine present in the crystal.

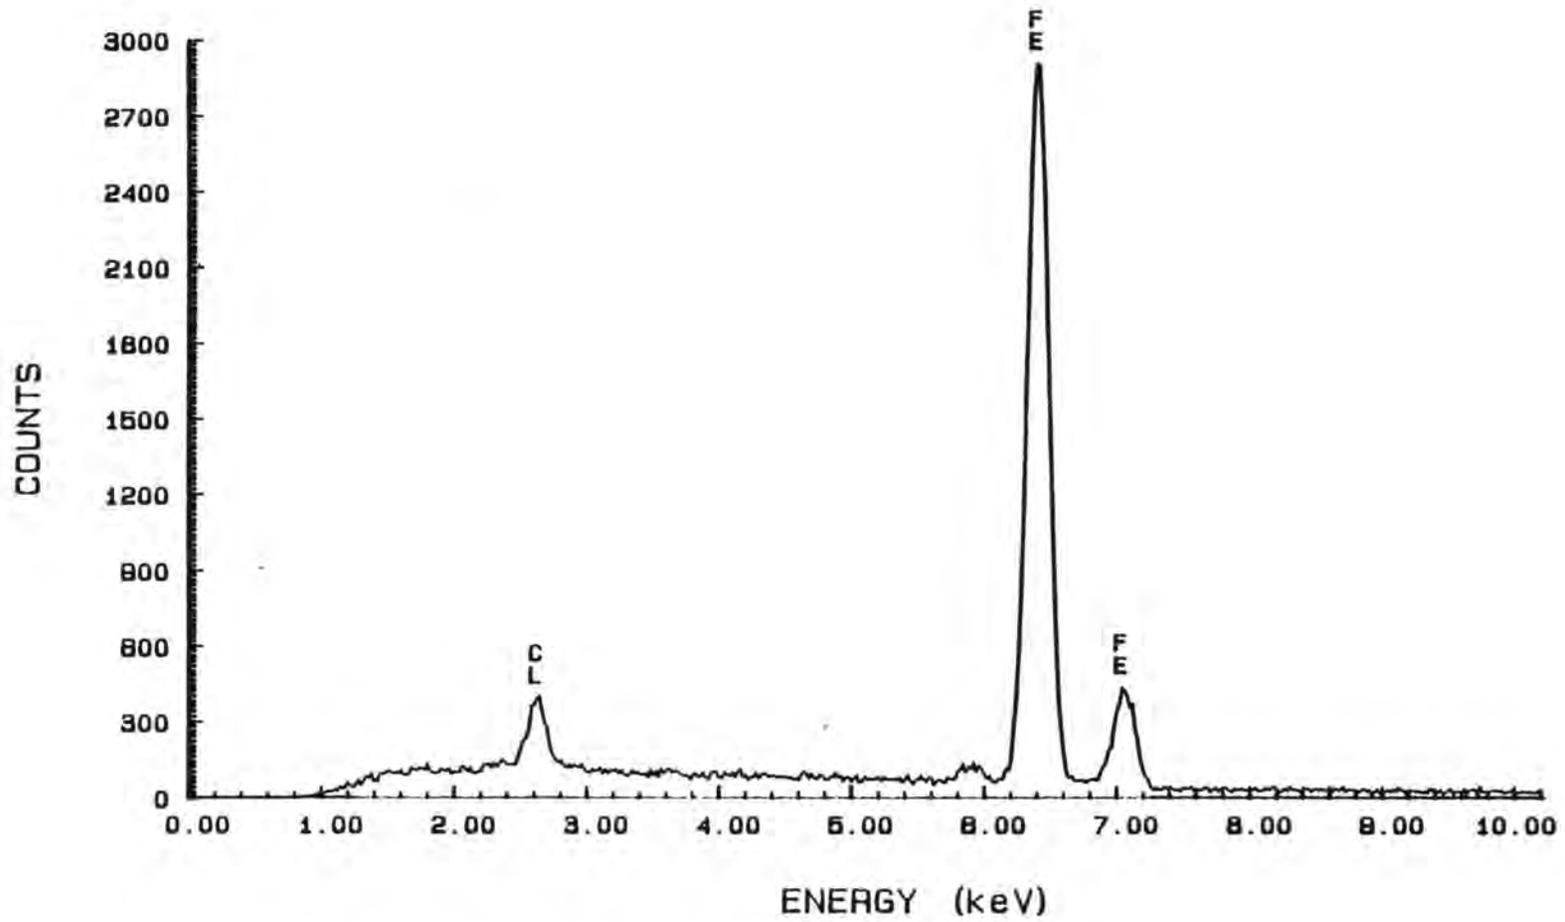
Point B lies on the corrosion crack surface just below the rounded portion of the pit; Figure 20 shows that a smaller amount of chlorine, about 16 wt% (24 at%), is present.

Figure 20: Energy spectrum of X rays emitted from the crack surface just beneath the curved corrosion pit. A smaller amount of chlorine is located here than deeper in the crack.

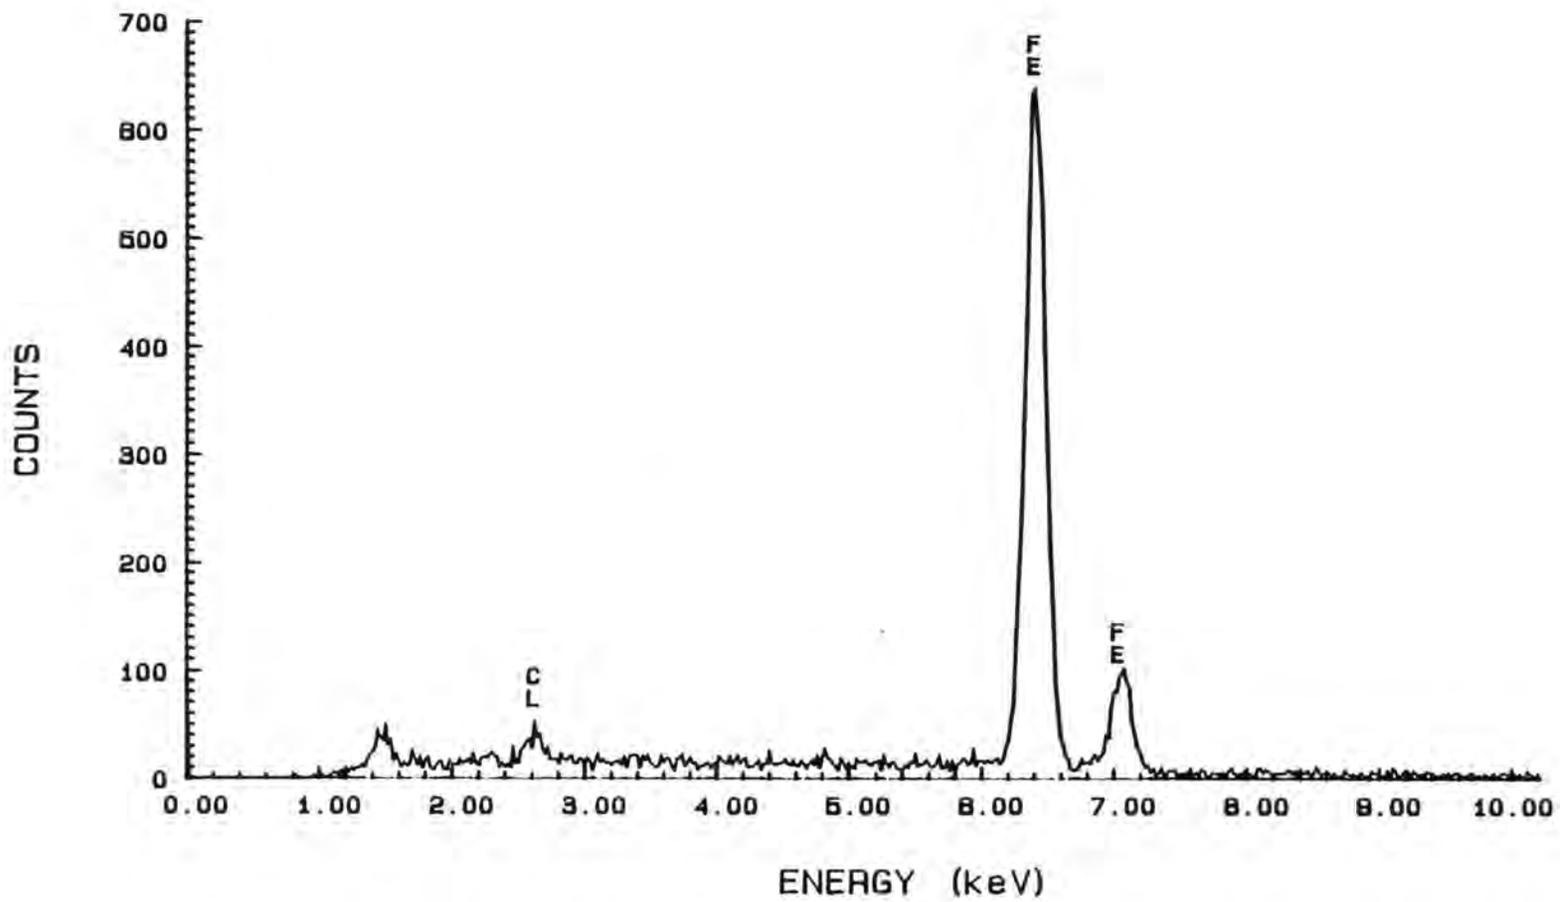
The surface of the rounded pit, point C, contains relatively little chlorine, as shown in Figure 21. Analysis indicates 9.5 wt% (14 at%) chlorine at this point; perhaps most of the chlorine in this area had been washed away by rainfall.

Figure 21: Energy spectrum of X rays emitted from the surface of the curved corrosion pit. Note that the chlorine level is quite small compared to that observed in the actual crack.
