Missouri
Department
of Transportation

Fiber-Reinforced PCC Unbonded Overlay

I-29 Atchison County – Performance Update

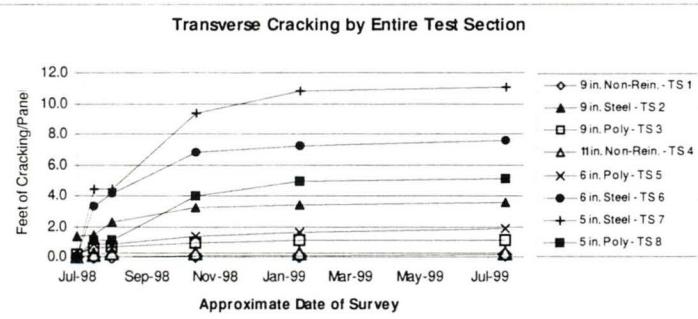
Figure 1 shows the amount of transverse cracking for all test sections. This figure represents the relative amount of cracking in each section. Detailed analysis of the cracking is present in the full report, "Evaluation of Fiber-Reinforced Unbonded PCCP Overlay". Some trends with regard to transverse cracking are apparent. Thinner sections exhibited more cracking than thicker sections; longer panels exhibited more cracking than shorter panels and the steel fiber-reinforced sections exhibited more cracking than the polyolefin fiber-reinforced sections.
