**MoDOT**

RDT 04-018

# Evaluation of Cutco Sawing and Sealing Method

RI 00-030

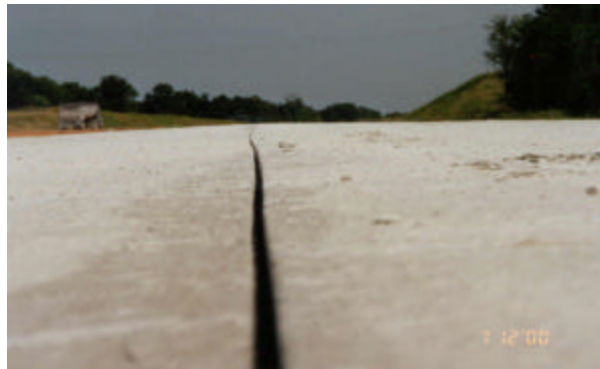
Figure 8. Uneven Longitudinal Sawed Joint Due to Uneven Roadway Edge

The only problems on the saw joints were on longitudinal joints, where the saw machine used the edge of the new roadway as a guide. If the paving screed left the edge of the roadway uneven, then the saw had to follow the uneven edge, which transmitted an uneven looking longitudinal joint (See Figure 8 below).

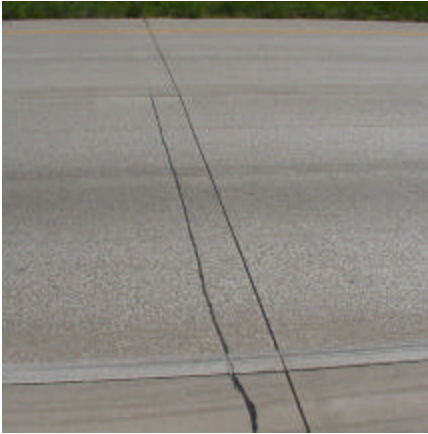
Figure 11. Crack at Mile Marker 94, RT 44

Station 150+00 to 160+00: Station 160 is at the east end of the section. There is one repaired area at mile marker 94 (see Figure 11 below.) Repaired crack is parallel to and about ten inches from the joint. The cause of this cracking is unknown. All of the joints look good.

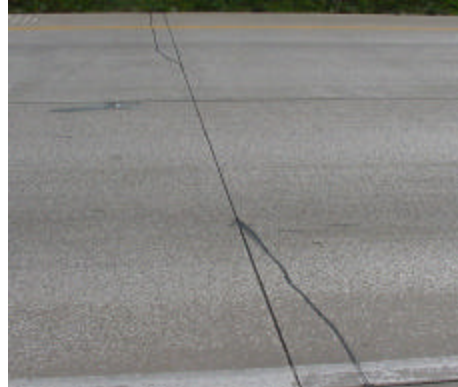
Figure 12. Cracks at Station 74 + 00, RT 44

Station 70+00 to 80+00: Test area is between mile Marker 92 and 93. All of the joints in the section look good with the following exceptions. One joint has two cracks emanating from it (see Figure 12 above). The joint with the two cracks is located just east of station 74 + 00 across from the cell phone tower. Another joint, (one joint west of station 72 + 00), has damage at one corner where the longitudinal joint meets the transverse joint (see Figure 13 below).

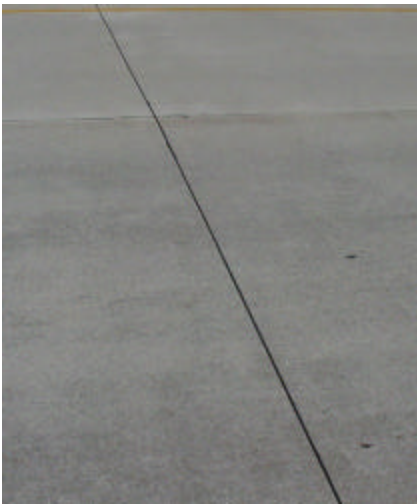
Figure 14. Cutco Joint Seal Method, RT 71

SB 63 + 00 to 53 + 00, SB 828 + 00 to 836 + 00: Both the test sections look like new, with only a weed or two between the rubber and the concrete at a few joints. Condition is

as good or better than the conventional joints on the northbound lanes. The Cutco joints do look nicer and more uniform.

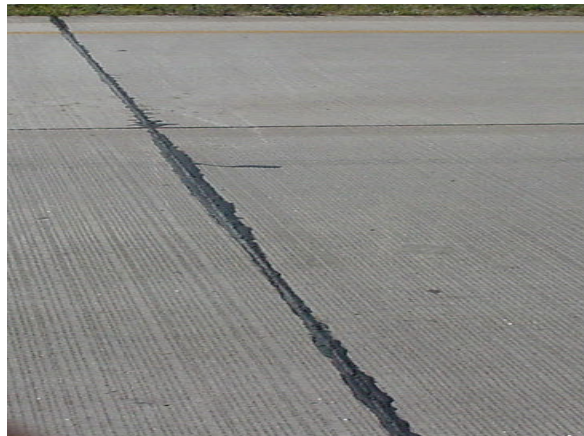
Figure 15. Conventional Joint Seal Method, RT 71

The conventional type joints in northbound lanes are also in excellent condition, with only occasional weed growth between concrete and seal material at the edges of the roadway. Since this is a normal occurrence, and both types of joint exhibit a similar amount of plant growth, it appears that the sealing quality of the two types of joint seal is of equal worth. While the Cutco joint sealing method is more aesthetically pleasing due to its clean appearance (see Figure 13 below), the conventional method seems to perform as well. A conventional joint is generally wider and the sealing material applied in a less clean appearing manner (see joints on Figure 15, 16 and 17). Observing the following joint photographs you can tell the aesthetic difference between the two styles of joint seal.
