# Investigations of Failures of Epoxy Polymer Overlays in Missouri

Prepared by  
Missouri Department  
of Transportation

RI06-020

**November 2007**

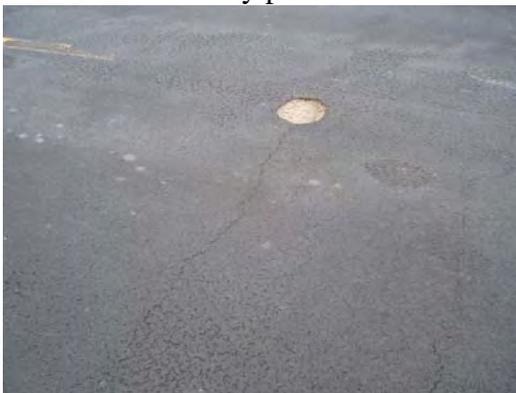
Cracking

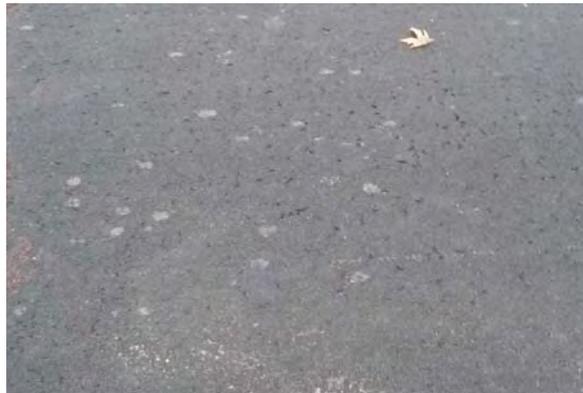
An unexpected observation during the study was the presence of pitting on a majority of the bridge decks. Sixty-two out of ninety eight bridges had pitting of some degree. (The epoxy polymer overlay on two of the bridge decks had completely worn off.) One source of pitting is the presence of air bubbles in the epoxy component of the overlay. In discussions with epoxy suppliers it was noted that the use of certain types of paddles for mixing can lead to air bubbles within the epoxy. The proper type of paddle to be used is called a “jiffy paddle” or a “Sika paddle.”

Pitting

- Make sure the proper type of paddle is used to mix the epoxy and that the speed of the paddle meets the product recommendations. During hot weather extra care should be given to working out any air bubbles in the epoxy.

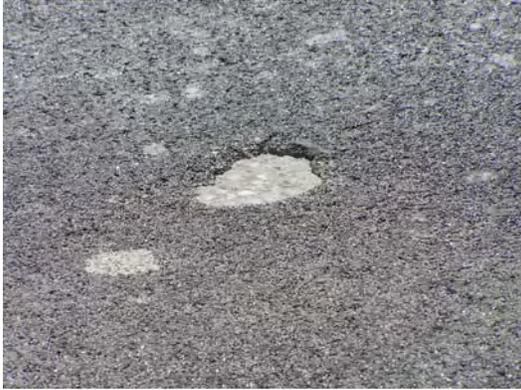
Delamination

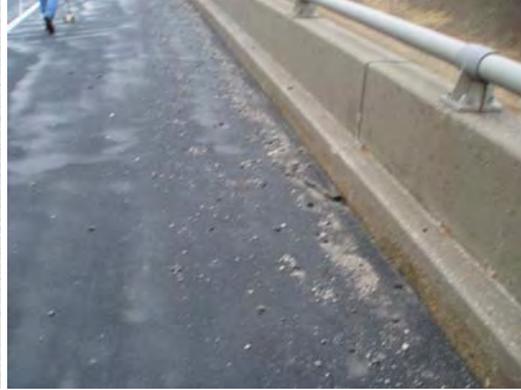
Peeling

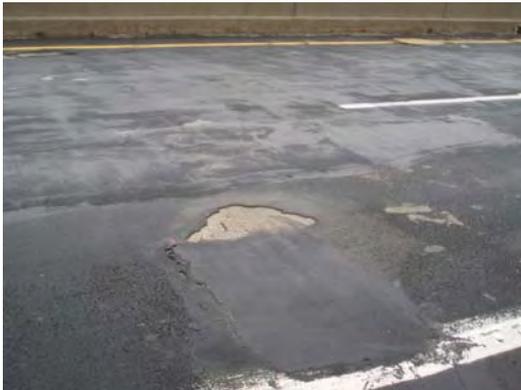
Missing areas of epoxy

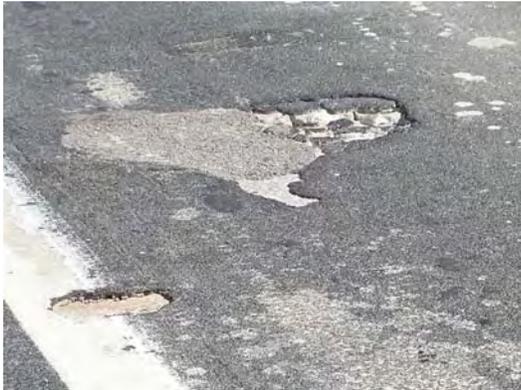
Sunken/cracked areas

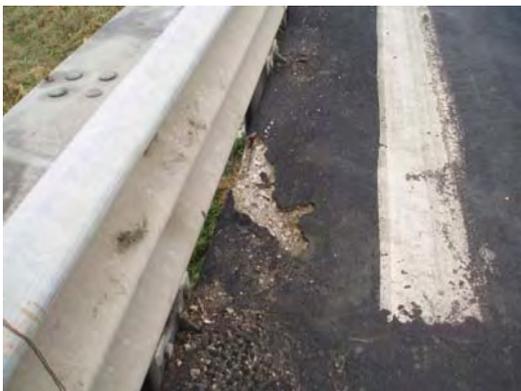
Spalling/loose areas

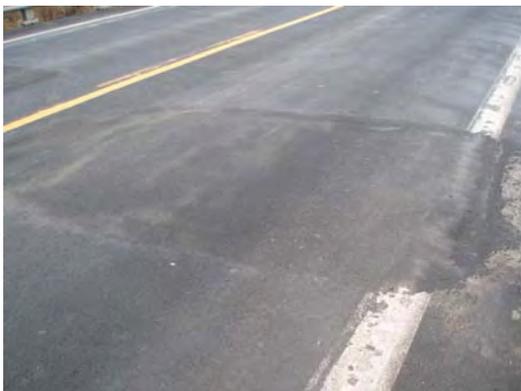
Post overlay Patches

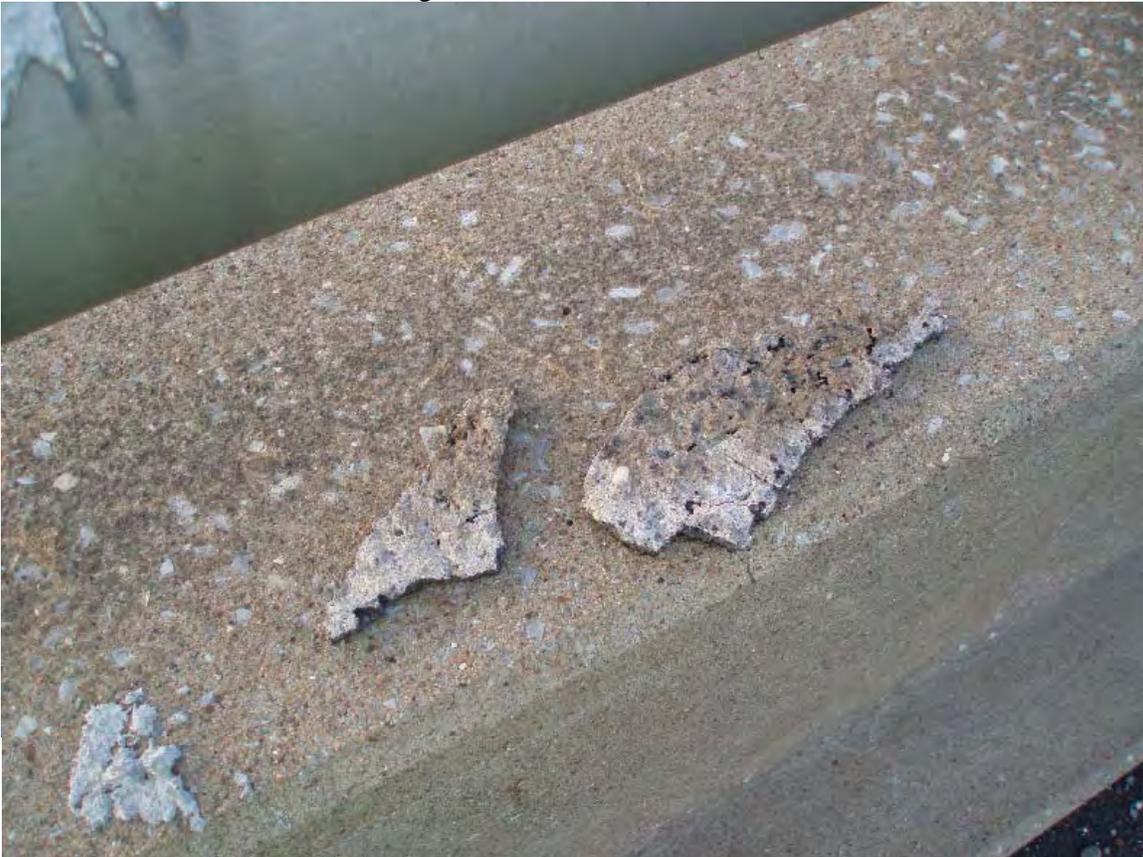
Epoxy polymer overlays are not a “repair” for bridge decks. They are only a means of protecting a deck that is in fairly good condition but is at risk for chloride and water penetration. Once a bridge deck has defects over a significant surface area, an EPO will not provide long lasting protection for the bridge deck and can even hamper repair efforts in the future. MoDOT’s Bridge Division generally recommends placing EPOs on bridge decks that are rated a 7 or higher and have less than 5% of the deck requiring repairs. Information gathered during the investigation indicated that many of the bridges that received overlays had significantly more than 5% defects. Many of the failures observed in the site visits appeared to be a failure of the top surface of the deck as opposed to a failure of the epoxy. Where possible, epoxy that had separated from the deck was examined. In most cases there was a layer of concrete paste on the bottom surface of the epoxy indicating that the epoxy had not debonded from the deck, but that the top surface of deck had delaminated. See Figure 1.

Figure 1. Epoxy Polymer Overlay that has concrete paste attached to the bottom

- While deck rating can be used as a screening tool, a deck evaluation should be performed on each deck prior to placing an epoxy polymer overlay. An EPO should not be placed if more than 5% of the deck requires repairs. It is also recommended to do a pull-off test on the bare deck along with chloride testing and checking for delaminations to ensure that the epoxy will not pull off the top layer of deck.

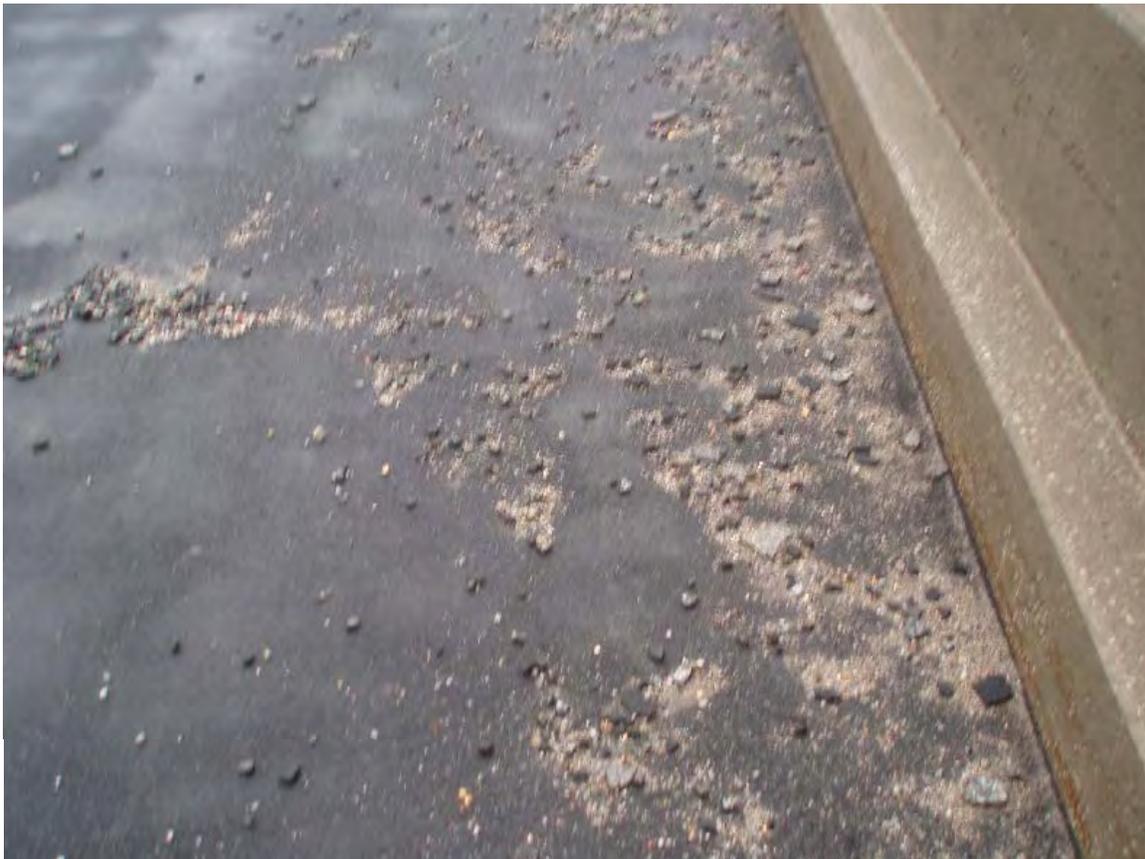
EPOs are initially hydrophobic and should not be exposed to water until they have fully cured. MoDOT’s specs require that the deck is dry and that rain is not in the forecast for 24 hours after placement. However there are some misconceptions about this requirement. Field logs have shown that some contractors consider the deck satisfactory as long as there is not standing water on the deck. One of the approved products is Sikadur 22, Lo-Mod. On the data sheet for the product it refers to a damp deck as being acceptable. However further in the data sheet, the limitations state that for “porous substrates” i.e., concrete bridge decks, the surface must be free of moisture. Inspectors must be aware that the deck must be free of moisture in order to get a good bond between the epoxy and the bridge deck. The Michigan DOT requires a moisture test, ASTM D 4263 “Standard Test Method for Indicating Moisture in Concrete by the Plastic Sheet Method.” This test is simple to perform. It involves taping a polyethylene sheet to the bridge deck for a period of time and then visually inspecting the underside of the sheet and the concrete surface for the presence of water. The ASTM standard requires leaving the plastic sheet in place for 16 hours, however Michigan specs require a minimum of two hours. It is highly recommended that this test be included in the MoDOT specifications to verify that the deck is completely dry. The presence of water in the deck will prevent an adequate bond between the concrete and EPO. This could be behind some of the failures on I-29 in District 1. Unlike many of the failures observed, in this area the epoxy appeared to “flake” off the bridge deck. See Figure 2.

Figure 2. Epoxy “flaking” off the bridge deck

- Require that a moisture test be performed on a deck before placement. The “Standard Test Method for Indicating Moisture in Concrete by the Plastic Sheet Method” is a simple test that would ensure that the deck is dry and the epoxy will bond to the deck.
