Organizational Results Research Report

November 2007
OR08.010

Investigations of Failures of Epoxy Polymer Overlays in Missouri

RI06-020

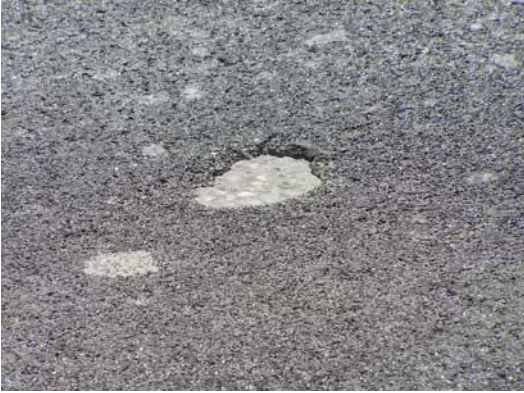
Delamination

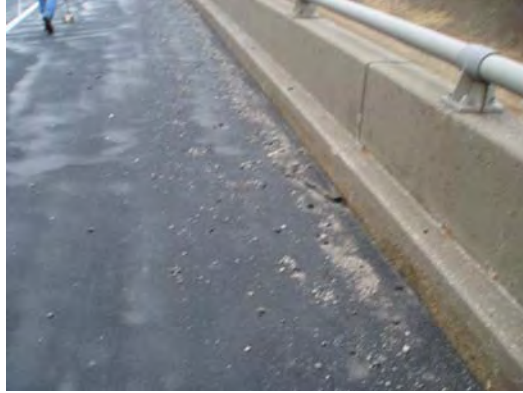
Peeling

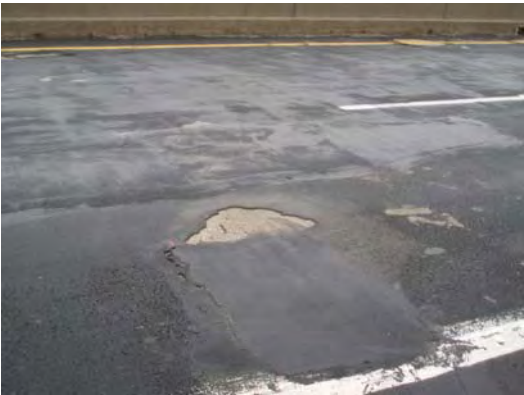
Missing areas of epoxy

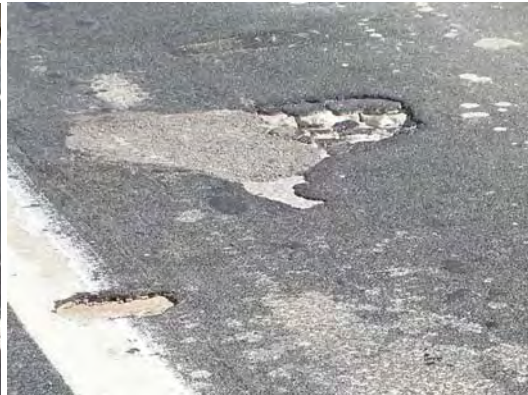
Sunken/cracked areas

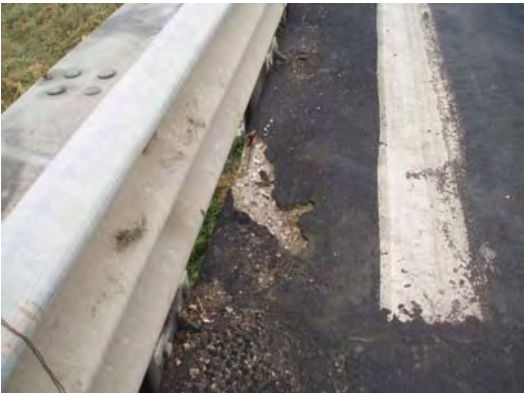
Spalling/loose areas

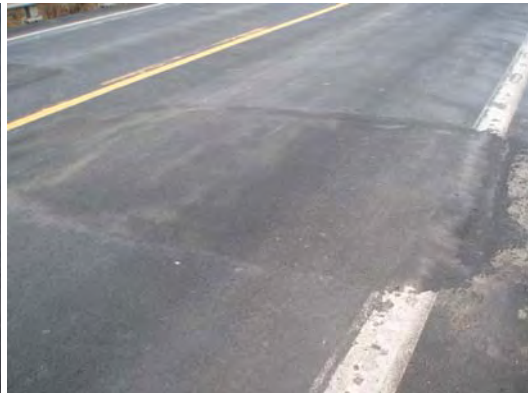
Post overlay Patches
