# Preservation of Missouri Transportation Infrastructures: Validation of FRP Composite Technology

Volume 2 of 5

Life-Cycle Inspection and Monitoring Using  
Near-Field Microwave Nondestructive  
Testing Methods

Prepared by Missouri S&T  
and Missouri Department of  
Transportation

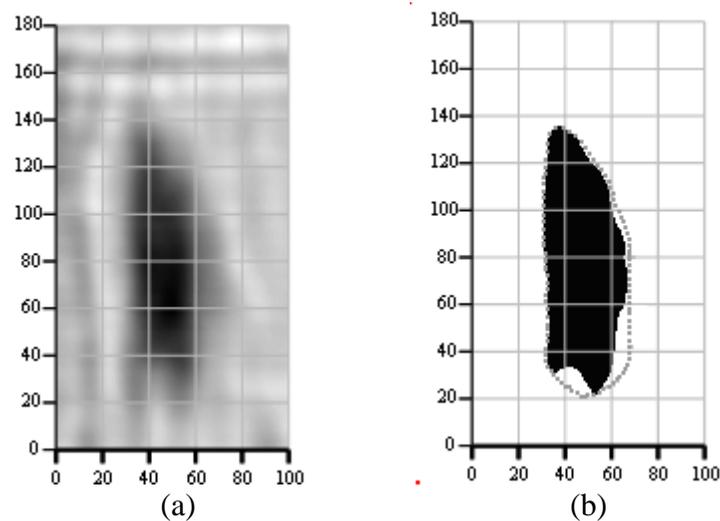
larly-polarized image. It must also be noted that the dimensions of the disbonded region associated with its image in Figure 13d corresponded well with its actual dimensions. This is one of the more important attributes of near-field microwave imaging [17]. To further illustrate this capability the following experiment was performed. Using this reflectometer, images of several disbonds with different sizes and shapes were produced and the disbond boundaries indicated by the respective compensated images were compared with the results of tap testing which can closely indicate the boundaries of a disbond. The compensated image of one of the disbonds in sample #2 is shown in Figure 14a. The results show that the shape of this disbond is complex while its exact boundary is not clear. Figure 14b shows the boundaries of this disbond corresponding to the 3-dB intensity level of the image and from tap testing (dash line). The results clearly indicate that compensated images of disbonds can provide close estimate of their boundaries. This is an important feature when considering repair of disbonded areas which is commonly accomplished by injecting epoxy into the disbonded region [14].

Figure 14 - (a) Microwave compensated image of the disbond generated using the dual-polarized reflectometer and (b) boundary of the disbond at the 3-dB level (dashed line shows the boundary of the disbond obtained by tapping method, (dimensions in mm)).

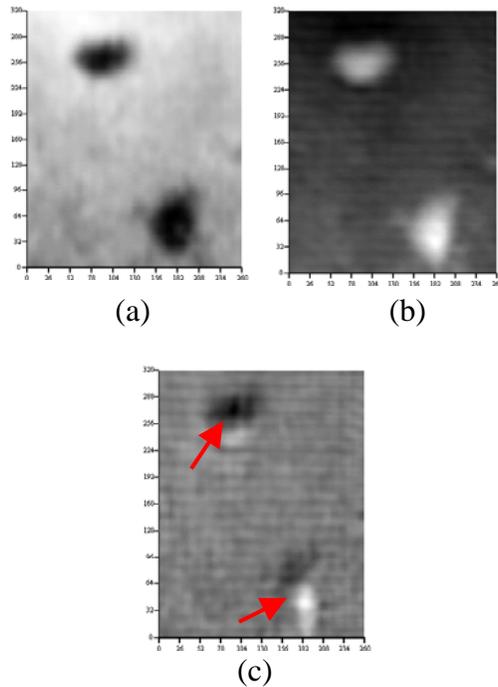
The dark indications in the perpendicular polarization image in Figure 16a represent two different disbonds. The indications of the slight surface bulging due to the presence of air between CFRP and concrete are also clearly visible in the image for parallel polarization (bright indications in Fig. 16b). The compensated image shown in Figure 16c clearly indicates the disbonds as well as the local non-uniformity associated with them. The locations and sizes of the detected disbonds, indicated by these compensated images, agreed well with their locations and sizes on the bonded CFRP patches and were corroborated by tap testing. These results clearly show the effectiveness of this novel reflectometer and inspection method for detecting and evaluating disbonds in CFRP-strengthened structural members.

Figure 16 - Microwave images of a CFRP patch at the abutment (dimensions in mm): (a) at perpendicular polarization, (b) at parallel polarization, and (c) compensated image (detected disbands are marked by red arrows).

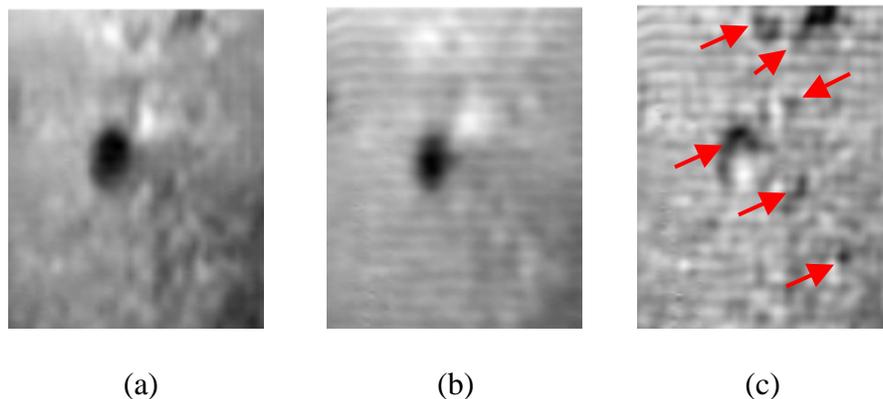
Close-up views of these images are shown in Figure 19. The dark and bright indications in the perpendicular polarization image in Figure 19a represent different disbonds and influence of surface roughness and any bulging that may be present as a result of air injection. The indications of the slight surface bulging and depressing due to the presence of air between CFRP and concrete and the surface roughness are also clearly visible in the image for parallel polarization (Figure 19b). The compensated image (shown in Figure 19c) was produced (in real-time) by removing the effect of bulging and standoff distance variation using the information from Figure 19b and removing it from the data in

Figure 19 - Microwave images of the portion (270 mm by 330 mm) of the CFRP patch at: (a) perpendicular polarization, (b) parallel polarization, and (c) compensated image (detected disbands are marked by red arrows).

Figure 19a. Figure 19c clearly shows the disbands as well as the local non-uniformity associated with them. The locations and sizes of the detected disbands (indicated by this compensated image) in all of the investigated cases agreed well with their actual locations and sizes on the bonded CFRP patch and the results were further corroborated by tap testing.

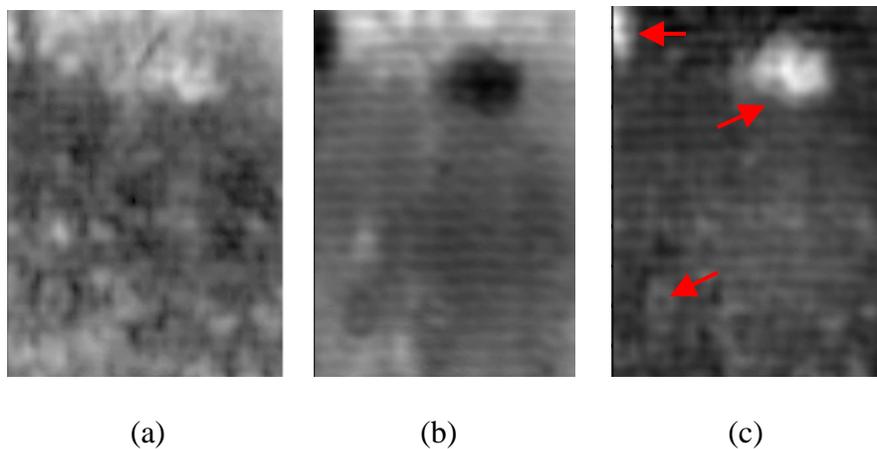
Figure 21 - Microwave images of a CFRP patch at the bent: (a) at perpendicular polarization, (b) at parallel polarization, and (c) compensated image (detected disbonds are marked by red arrows).

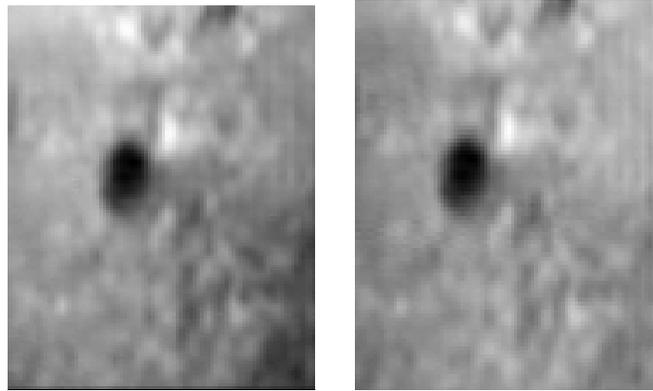
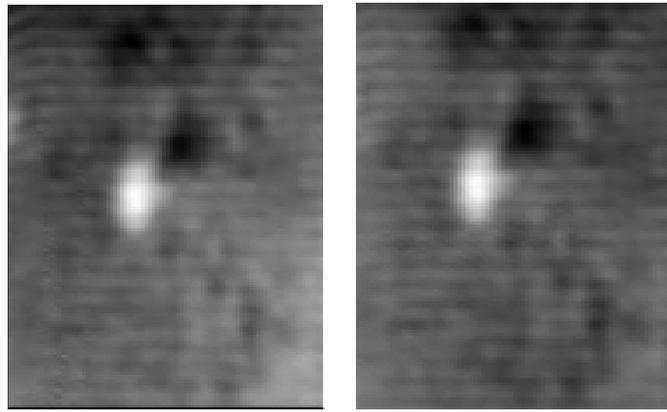
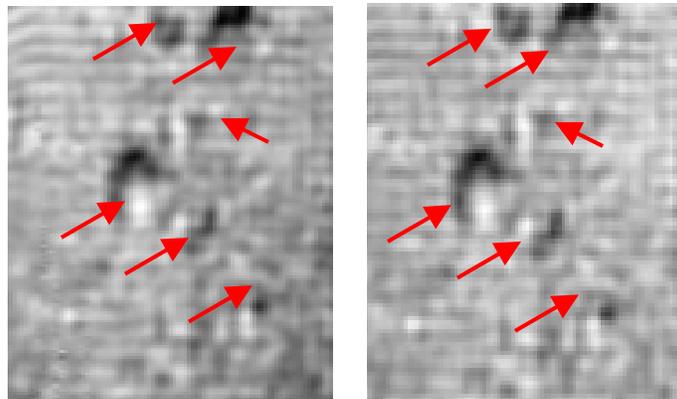
Figures 22 - 23 show the microwave images of CFRP patch #1 and patch #2, respectively, at the bent at perpendicular and parallel polarizations, and compensated image obtained in 2005 (October 14) and in 2006 (May 26). Scanned areas were 270 mm by 330 mm and 250 mm by 300 mm for patch #1 and #2, respectively, and standoff distance was 8 mm for both patches. It can be seen from Figures 22 - 23 that all corresponding images for each patch are very similar.

Figure 22 - Microwave images of a CFRP patch #1 at the bent: (a) at perpendicular polarization, (b) at parallel polarization, and (c) compensated image obtained in (left column) October 14, 2005 and (right column) May 26, 2006. Red arrows show disbonds.
