Research, Development and Technology

University of Missouri-Columbia

RDT 01-007

# Instrumentation and Monitoring of High Performance Concrete Prestressed Bridge Girders

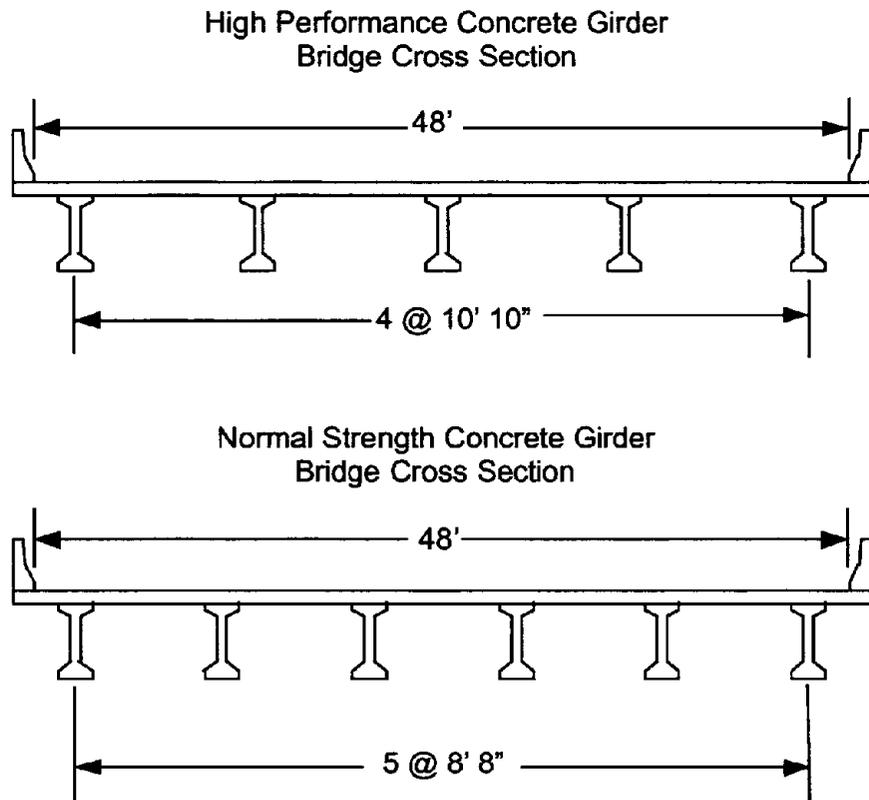
**Figure 1.2 Cross-sectional view of Bridge A5529 (High Performance Concrete) and sister Normal Strength Concrete bridge**

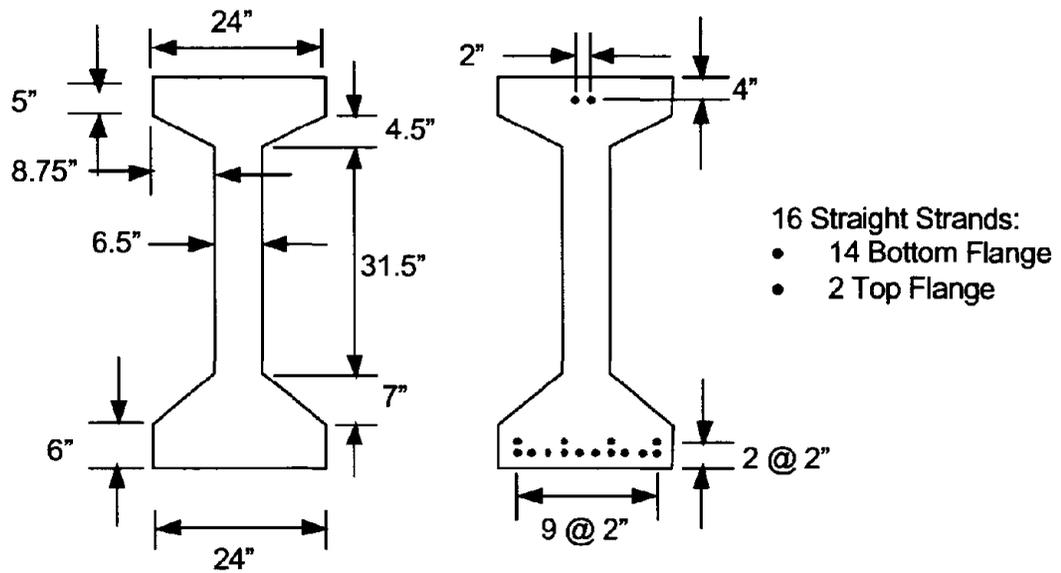
**Figure 1.4 Cross-sectional dimensions of MoDOT Type VI girders and strand arrangement for girders in Span 1-2**

All of the instrumentation used in the project described in this report was used in Span 1-2 and Span 2-3. For this reason the strand arrangements of Span 1-2 and Span 2-3 are detailed in Figure 1.4 and Figure 1.5. Span 1-2 used only straight strands while the other three spans all used a combination of straight and draped strands. The strands are  $\frac{1}{2}$ , seven wire, low relaxation, Grade 270 prestressing strands with an initial prestress force of 31 kips each. This adds up to 496 kips total prestress force for Span 1-2 girders and 868 kips for Span 2-3.

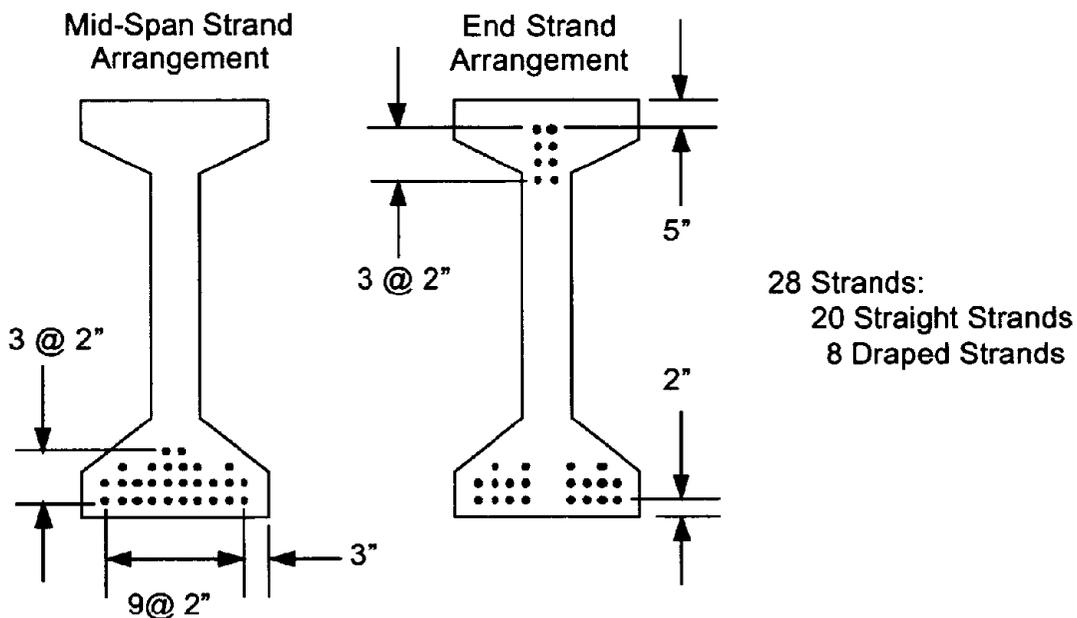
**Figure 1.5 Strand arrangement for Span 2-3**

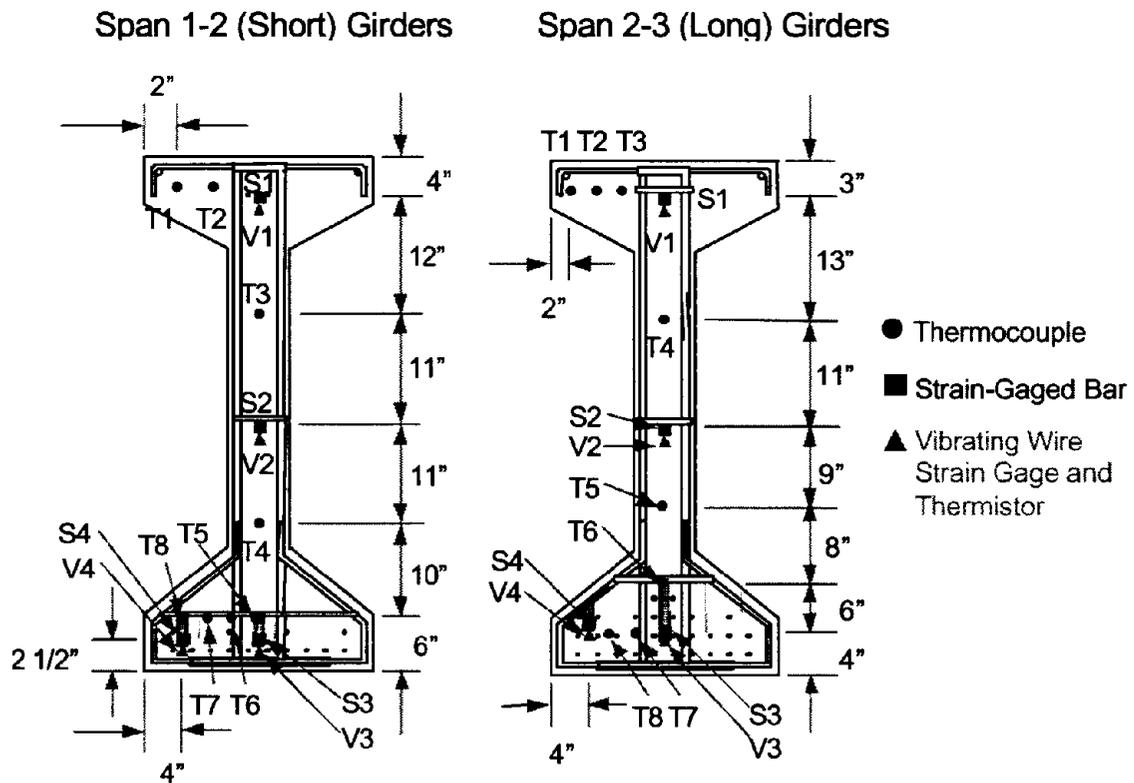
Figure 2.2 Instrumented cross-sections showing location of gages

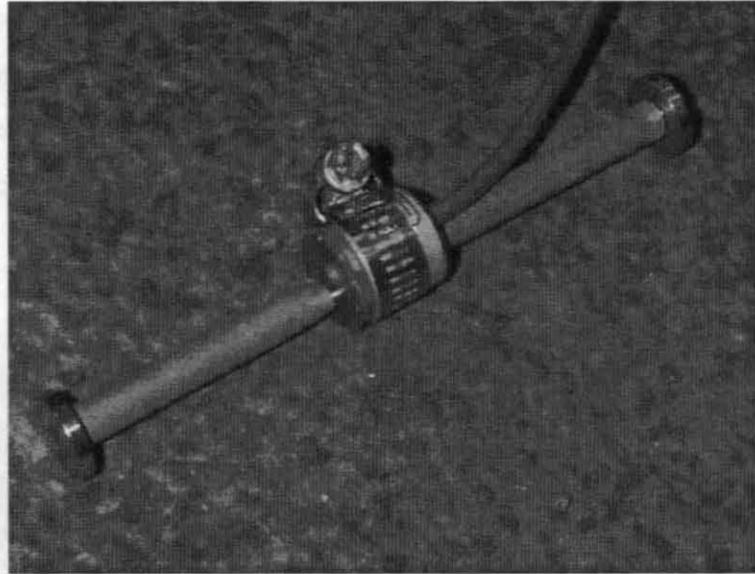
**Figure 2.6 Vibrating wire gage**

The vibrating wire strain gage involves a wire that is stretched between two flange plates. Displacement of one flange relative to the other causes the tension in the wire to change. The change in wire tension is then measured as a change in the resonant frequency of the wire. Electromagnetic coils, which are housed in a plastic block, are positioned around the center part of the gage. By sending an alternating current through the coils at a range of frequencies, the taut wire is excited. After sweeping the range of frequencies the wire continues to vibrate at its resonant frequency. The electromagnetic coils then pick up the signal as an alternating current induced by the wire vibrations. The frequency of the alternating current is measured and correlated to strain. The strain in the gage is directly proportional to the square of the resonant frequency.

The length of the wire, however, also changes with temperature and as a result the tension, natural frequency, and strain measurement are dependent on temperature. A correction for this effect is provided by the manufacturer, which uses the coefficient of linear thermal expansion of steel (wire material).

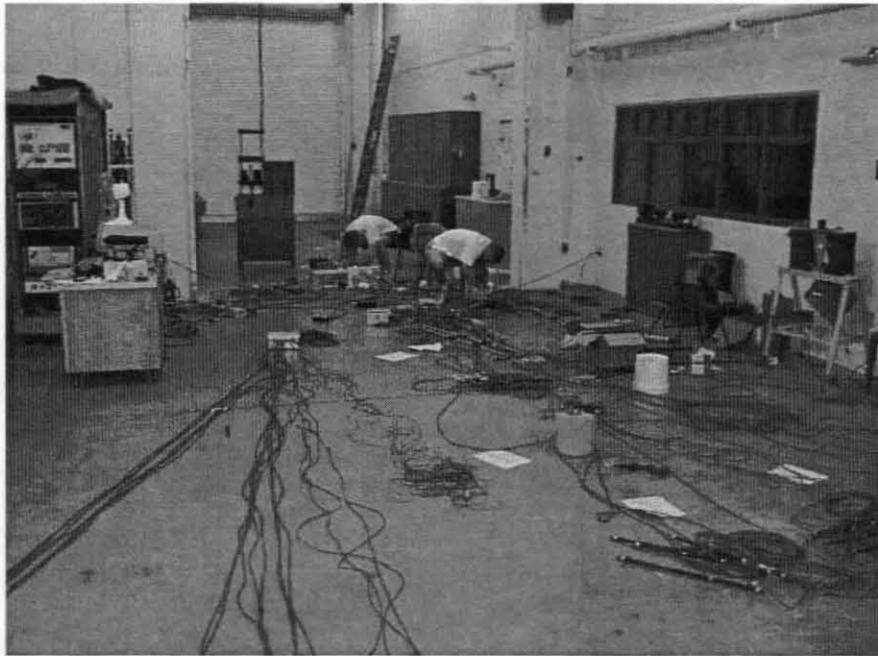
**Figure 2.10** Instrumentation and associated wires being readied for placement in the girder molds at the precasting site

The instrumentation clusters were laid out on the lab floor and grouped according to the cross-section for which they were intended. All gages were checked to ensure that they were operating properly. Figure 2.10 highlights the scope of the instrumentation program. The wire length for every gage was individually estimated such that there would not be slack in the wires when installed.

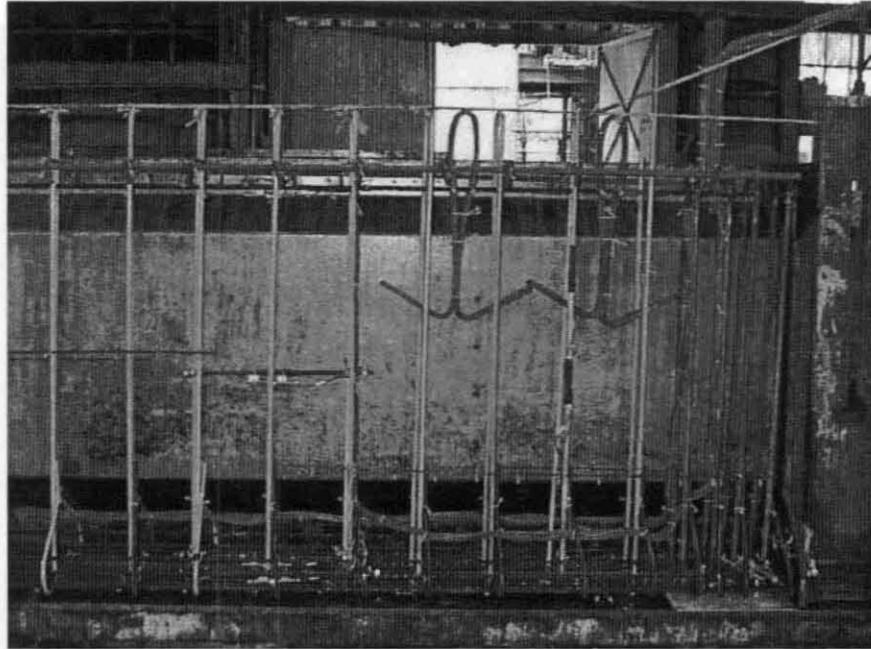
**Figure 2.14** Photograph of the girder showing the end cross-section instrumentation, instrumented stirrup, and wire bundles

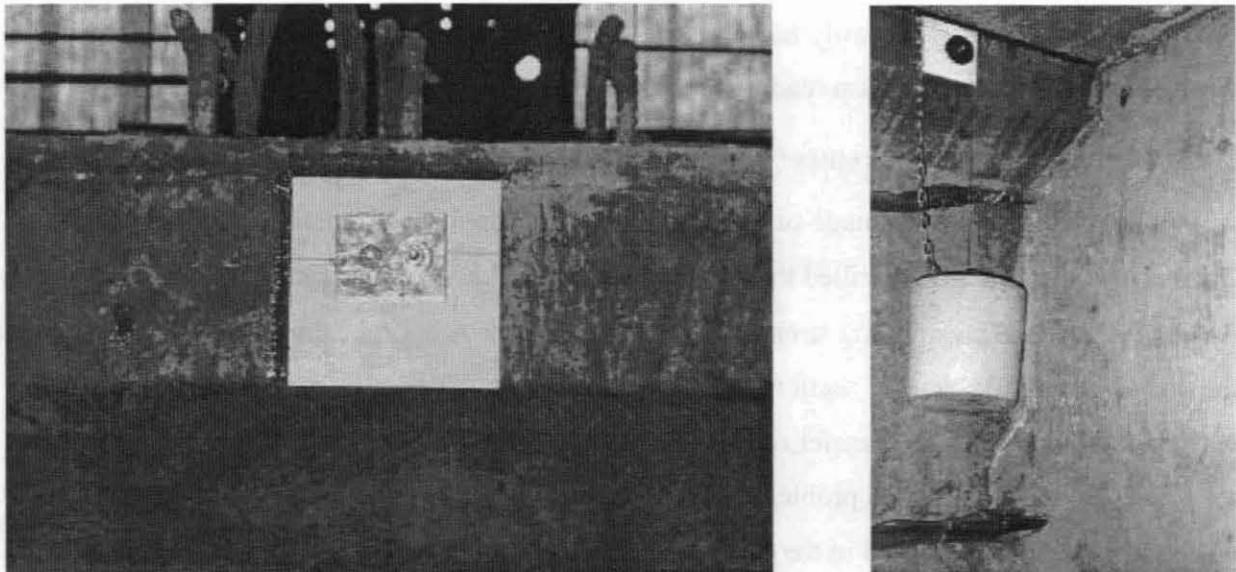
**Figure 2.20** Taut-wire deflection device showing the passive (left) and active (right) ends

The live-end of the deflection system used a similar 5" x 5" x  $\frac{1}{8}$ " plate epoxied to the top flange of the girder approximately two feet from the end. The live-end plate holds a 2" diameter pulley around which the piano wire was wrapped once before hanging down, attached to a weight. The weight is a block of concrete that weighs approximately 50 pounds. The purpose of the weight and pulley assembly is to maintain a constant tension in the piano wire so that relaxation or temperature change cannot cause a change in the deflected shape of the wire.

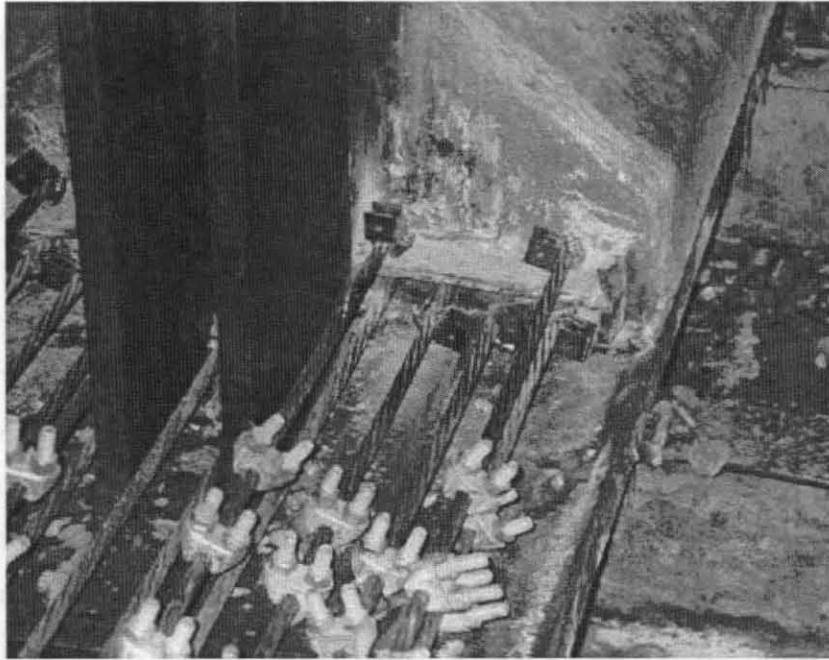
**Figure 2.22** Arrangement for measurement of end-slip

to reduce the amount of movement of the end slip channel sections. This approach still did not work as well as anticipated. The strands, channel sections, and cable clamps are shown in Figure 2.22. The end slip measurement made after transfer is shown in Figure 2.23.

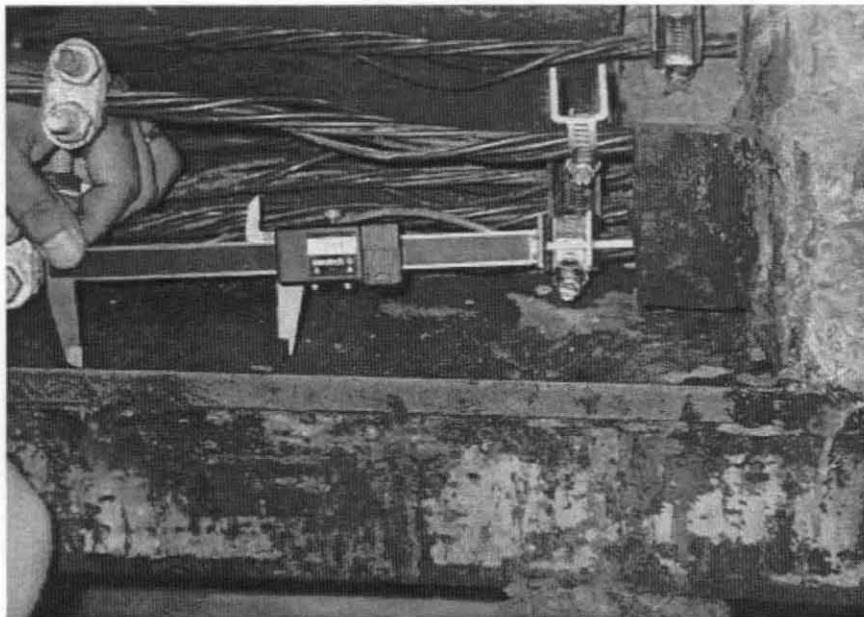
**Figure 2.23** Digital calipers used to make end-slip measurements

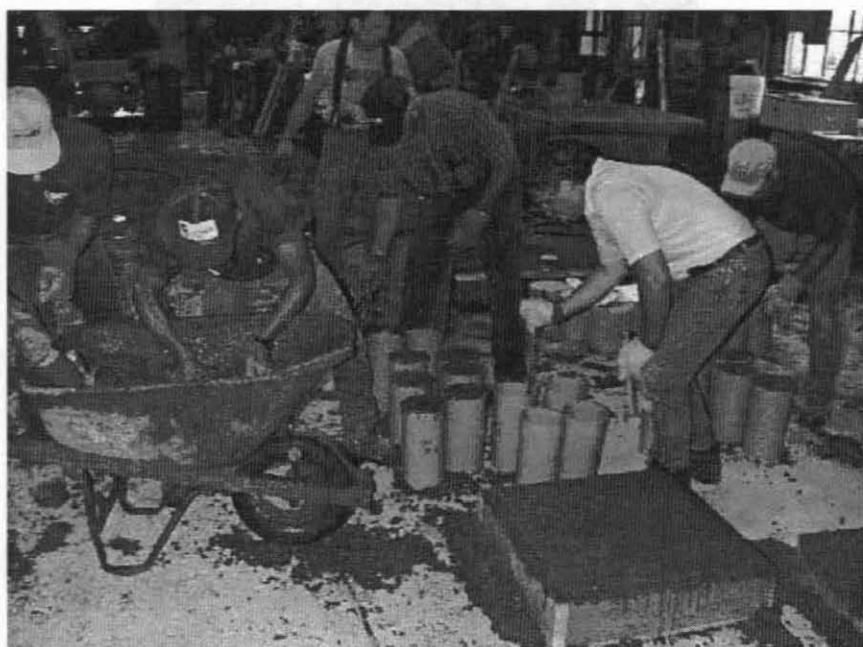
**Figure 2.26 Casting of the cylinders and slabs used for the laboratory tests**

The specimens for all laboratory tests carried out at the University of Missouri – Columbia were cast from the first load of concrete used to cast the Span 2-3 (long girders) girders. Figure 2.26 shows the casting of the cylinders, beams, and slabs used in the laboratory tests. Twenty 6” cylinders, six shrinkage test beams, and two 24” x 24” x 6” slabs were cast. The slabs were used for sawing notched beam specimens for fracture properties and for coring 3” compression cylinders.

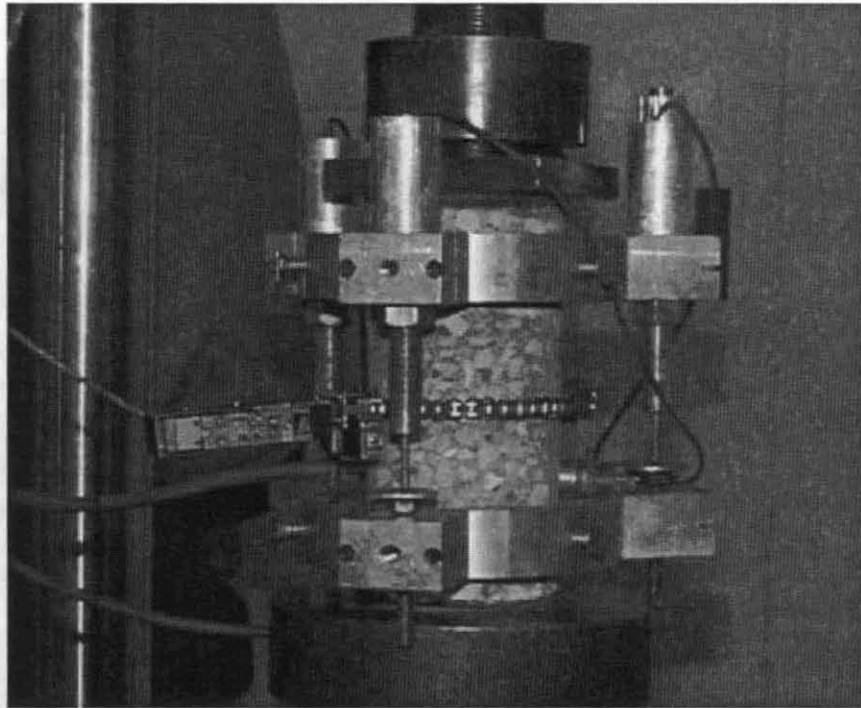
**Figure 2.28** Compression test on 3" diameter cored cylinders conducted using circumferential strain control

These compression tests were conducted using closed loop control and circumferential strain as the feedback control parameter. This ensures stable fracture and allows post-peak response to be recorded. Load was measured using a 100-kip capacity load cell. Ram displacement was measured using an LVDT. The 3" cylinder compression test set-up is shown in Figure 2.28.

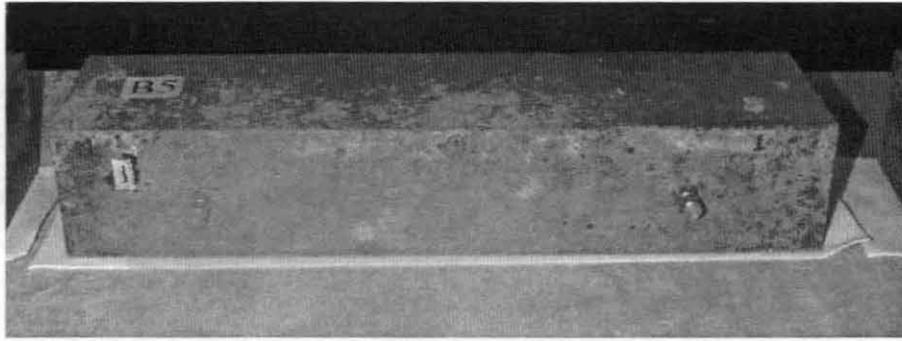
**Figure 2.31** Beam shrinkage specimens showing Demec points used for strain measurements

The beam shrinkage specimens are  $3 \frac{1}{2} \times 4 \frac{1}{2} \times 16$ " prismatic specimens. The beams were demolded and half of them waxed at the same time as the other specimens. Preparation of the beam specimens was similar to the cylinders. The difference in preparation was that brass studs were attached to two sides ( $4 \frac{1}{2}$  dimension) of the beam. The beams were set on Teflon sheets to reduce the amount of friction between the concrete and the surface on which it rested. Measurement of beam specimen deformation was carried out using the Whitmore gage using a 10" gage length as described in the section on creep measurement. A beam shrinkage specimen is shown in Figure 2.31.

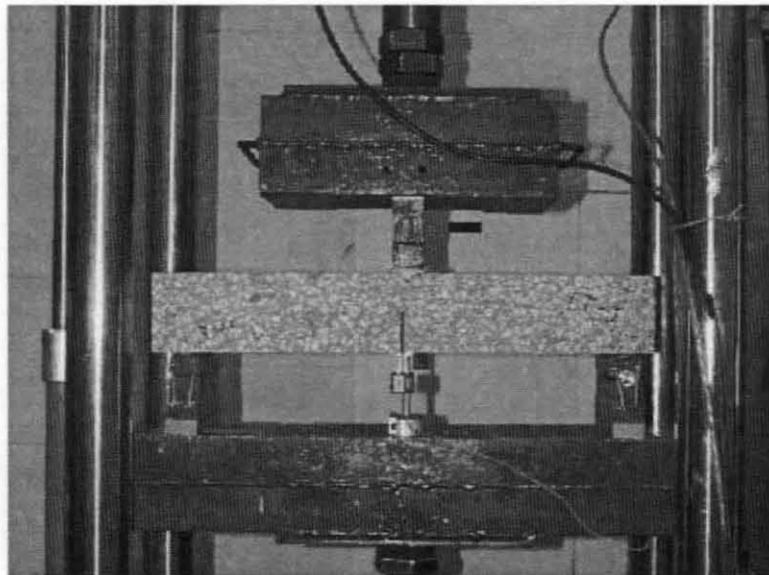
**Figure 2.32** Test set-up showing CMOD controlled notched beam

Fracture parameters that were found from the data include  $K_{IC}^S$ ,  $CTOD_C$ , and  $G_f$ . Recommendations in the RILEM draft standards were followed for the fracture test.

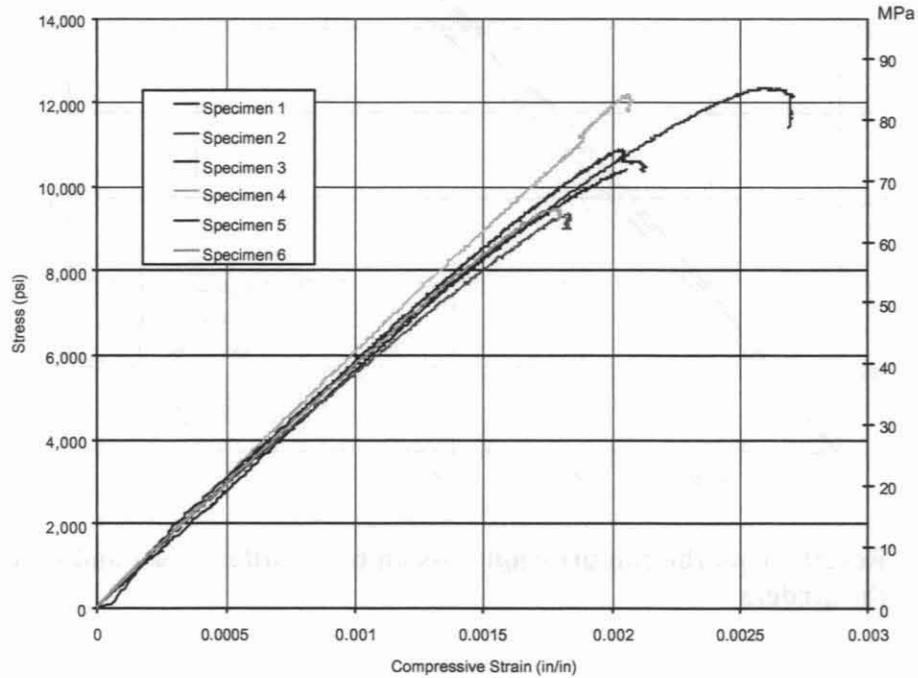
**Figure 3.1 Results from the compression tests on 3” cored cylinders**

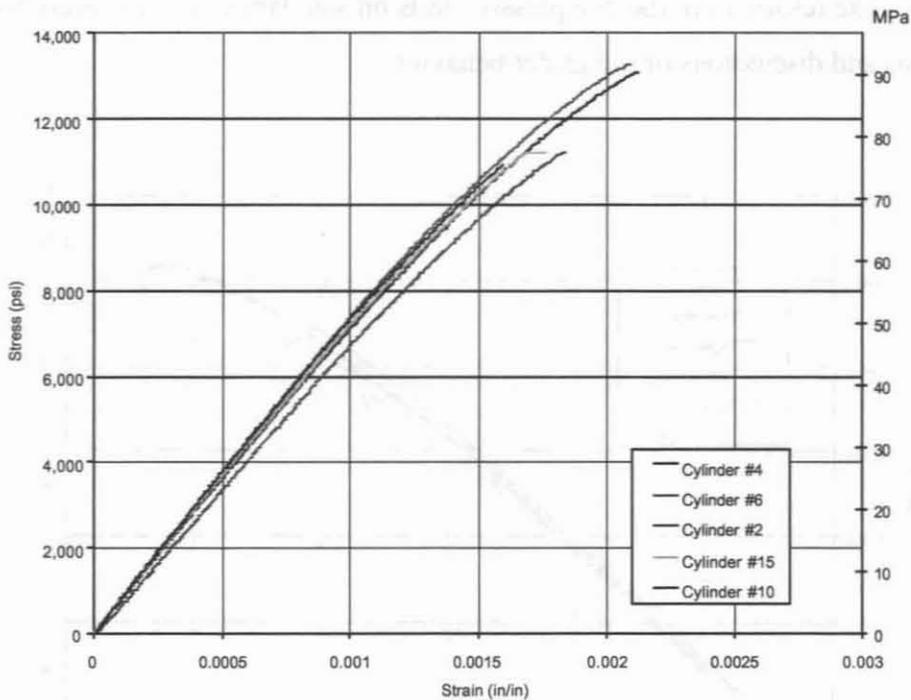
**Figure 3.2 Results from the compression tests on 6” cylinders (cast and cured along with the girders)**

7,250,000 psi. The results from the compressive tests on standard 6” cylinders are used in further analysis and discussions of the girder behavior.

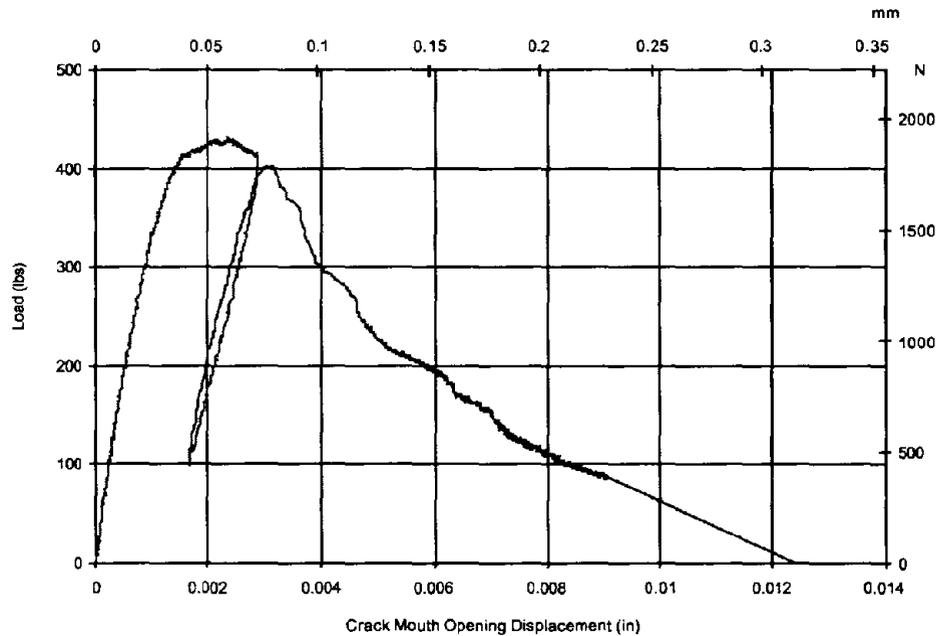
**Figure 3.3 Typical load – CMOD response of a notched HPC beam**

are tabulated in Table 3.4. There was a significant amount of variation in the measured  $CTOD_C$ . Less variation was noted in the  $K_{IC}^S$  values. The average measured values for  $G_F$ ,  $K_{IC}^S$ , and  $CTOD_C$  were  $0.619 \text{ lb-in/in}^2$  ( $108 \text{ N-m/m}^2$ ),  $1044 \text{ psi-in}^{1/2}$  ( $1147 \text{ kN-m}^{-3/2}$ ) and  $0.000413 \text{ in}$  ( $0.0105 \text{ mm}$ ) respectively.

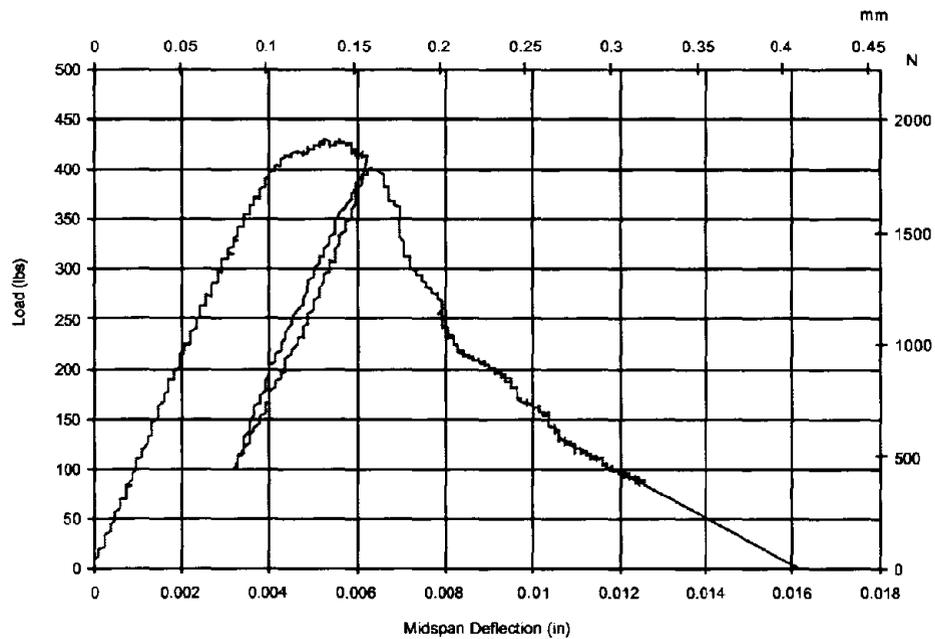
**Figure 3.4 Typical load – deflection response of a notched HPC beam**

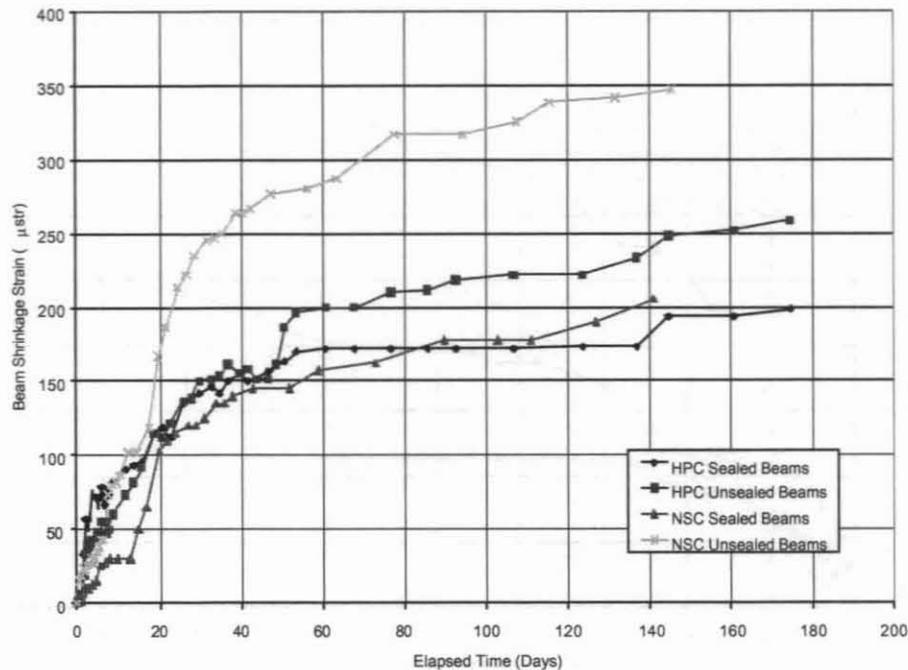
shrinkage specimens. These trends are identical with only small increases in additional strains after one year of measurements.

**Figure 3.5 Beam shrinkage as a function of time**

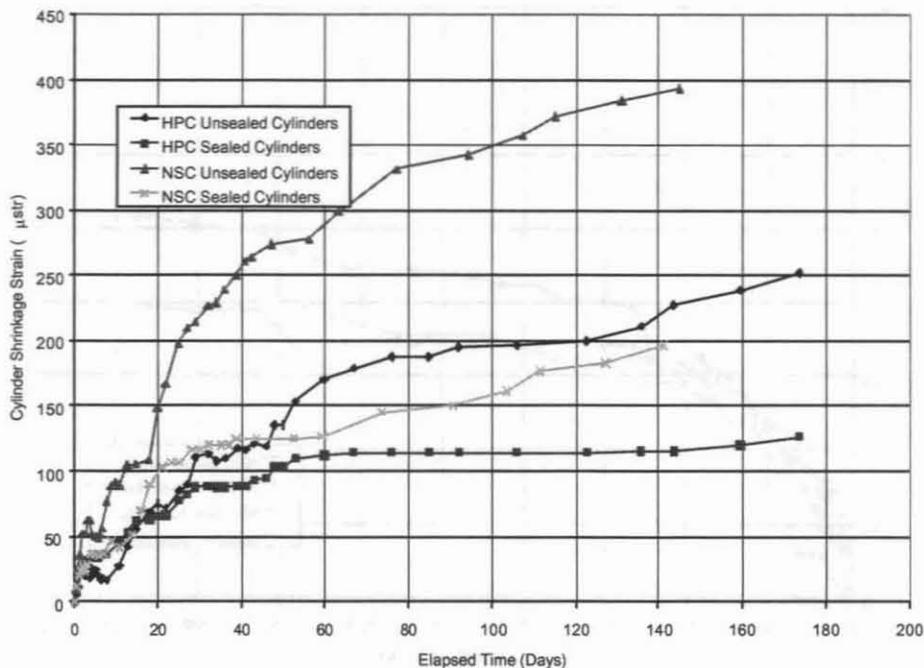
cylinders reached 115  $\mu\text{str}$  after 140 days while the sealed NSC cylinders reached 197  $\mu\text{str}$ . These trends are identical with only small increases in additional strains after one year of measurements.

**Figure 3.6 Cylinder shrinkage as a function of time**

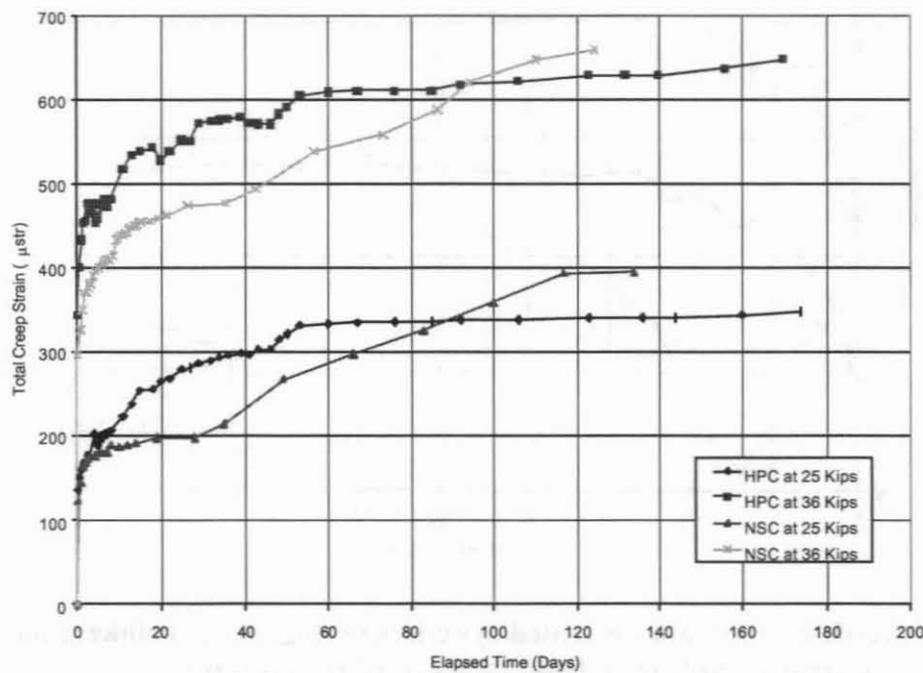
After 120 days the HPC specimens at 25 kips load level exhibited 4.5% less strain than the NSC specimens at the same load level. After 120 days the HPC specimens at 36 kips load level exhibited 13.5% less strain than the NSC specimens at the same load level. If the initial elastic shortening of the cylinders is removed, these differences become 21% and 24% respectively.

**Figure 3.7 Total creep strain for sealed cylinders (including elastic shortening and autogenous shrinkage) versus time**

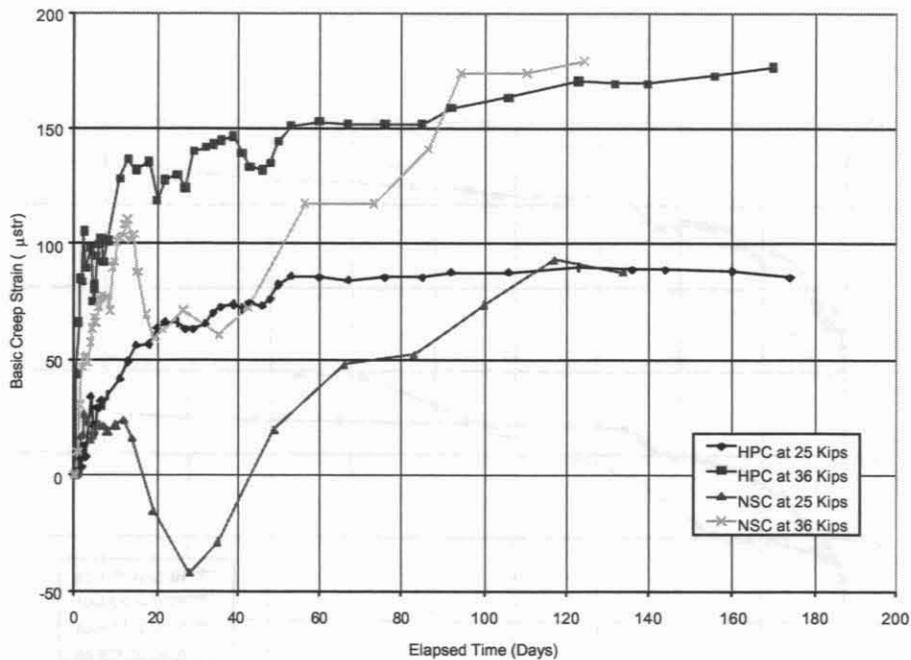
Regardless of erratic results, after 120 days of measurement the basic creep for the HPC and NSC cylinders are comparable at both levels of sustained loads.

**Figure 3.8 Basic creep strain for sealed cylinders (autogenous shrinkage and elastic shortening subtracted from total creep) versus time**

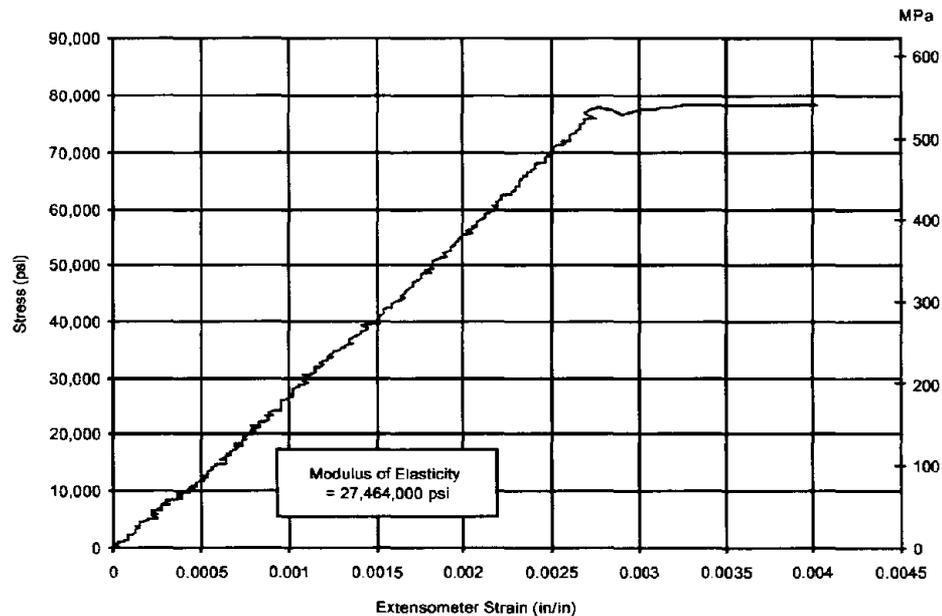
Tension loading was applied until failure. The extensometer was removed shortly after the specimen was loaded into the plastic region, so as to prevent damage to the extensometer. Figure 3.9 shows a graph of the results of the tension test. The yield strength determined was higher than expected for the Grade 60 rebar. The modulus of elasticity of the steel used for the strain-gaged bars was determined to be  $27.5 \times 10^6$  psi.

Figure 3.9 Stress-strain response of the reinforcing bar used for the strain-gaged bars

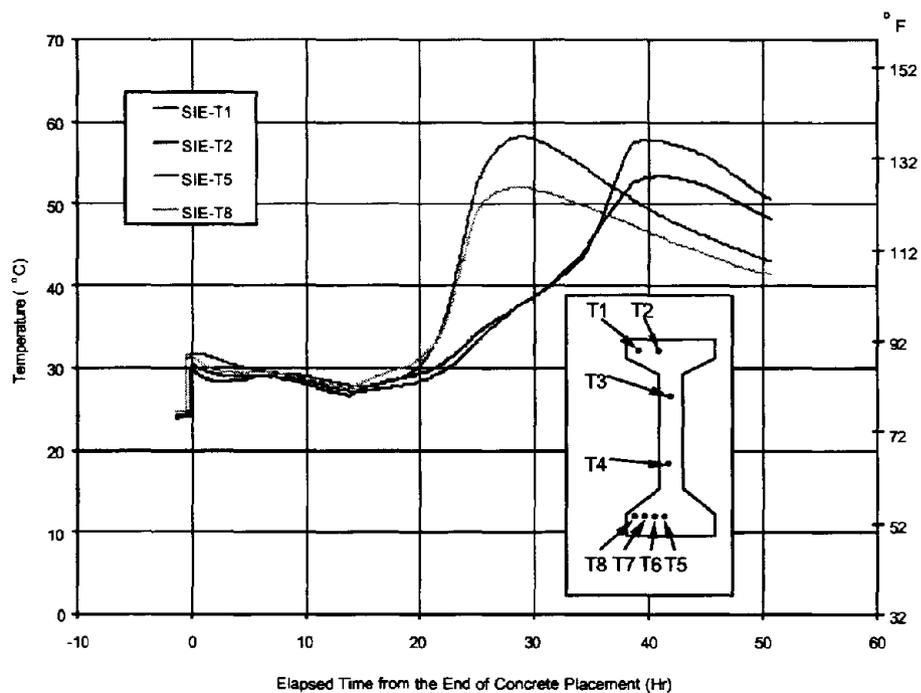
Figure 4.5 shows the curing temperatures as measured by the thermocouples in cross-section SIE. This figure shows the most extreme case of differential curing and temperature gradient of any of the cross-sections examined. It is very likely that this extreme case was caused by conditions that are not common practices that Egyptian Concrete usually follows. The thermographic survey was carried out on the short girders. To allow easy access to the girders a light tarp was used to cover one side of the girders from the midpoint of girder SI to the midpoint of girder SX. Usually Egyptian Concrete uses a heavy, insulated tarp to cover the girders during curing. The end cross-sections were both together in the middle of the section using the light tarp. These light tarps were also raised once every hour to undertake the infrared scans. Although cross-section SXE did not exhibit such drastic differential curing as SIE, it is very clear that the temperature history of cross-section SIE is not typical of the data obtained from the other cross-sections.

**Figure 4.5 Development of temperatures in cross-section SIE**

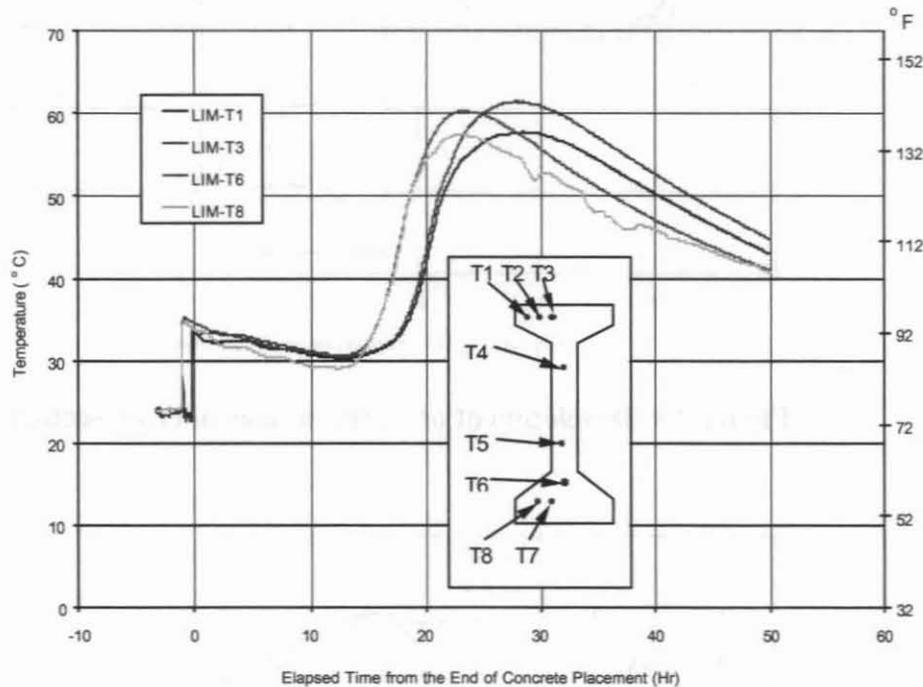
Figure 4.8, which shows temperature development in cross-section LIM, gives an example of differential curing more common than cross-section SIE. The difference between the maximum and minimum temperatures in the cross-section reached a peak of 17° C at 19 hours after concrete placement. The bottom flange reaches a maximum temperature at 23 hours after concrete placement, and the top flange reaches maximum at 28 hours after concrete placement. These times to peak temperature are more common than the 29 hours for the bottom flange and 40 hours for the top flange that was shown in cross-section SIE.

**Figure 4.8 Development of temperatures in cross-section LIM**

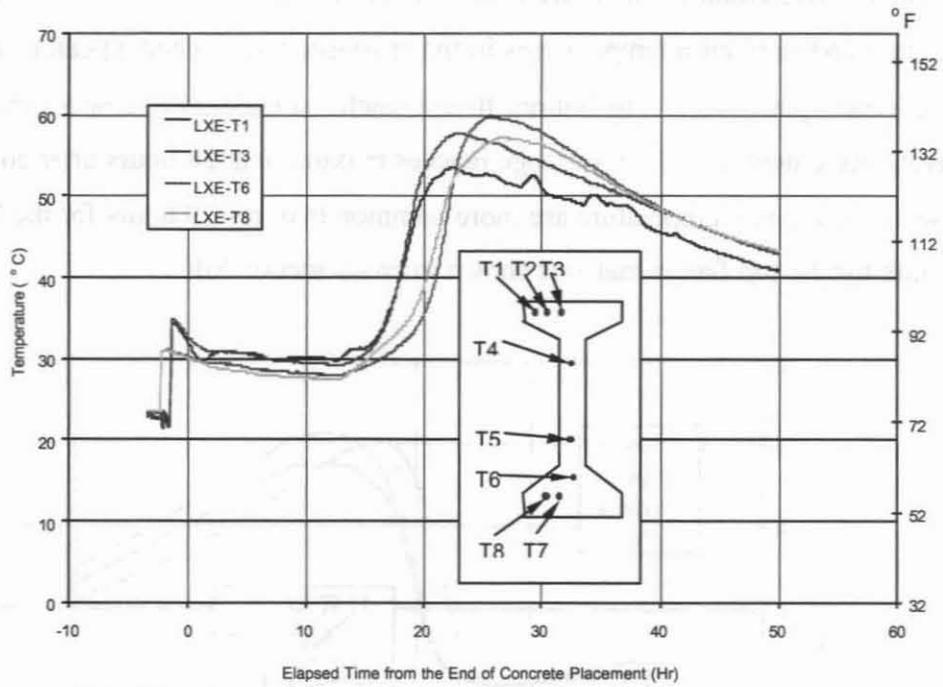
Figure 4.9 shows the only exception to what was typically observed (typically bottom flange temperatures peaking earlier than the top flange temperature). Cross-section LXE shows the top flange reaching maximum temperatures before the bottom flange. Temperature gradients of almost 19° C were recorded at 20 hours after concrete placement. Figure 4.10 shows the curing temperatures in cross-section LXE as measured by the thermistors, which closely matched those measured using thermocouples. Gage LXE-V1t is positioned in the middle of the top flange unlike LXE-T3 that is offset about 2 inches from the center. Gage LXE-V1t shows a higher temperature and reaches a maximum higher than any of the other gages in the cross-section.

**Figure 4.9 Development of temperatures in cross-section LXE**

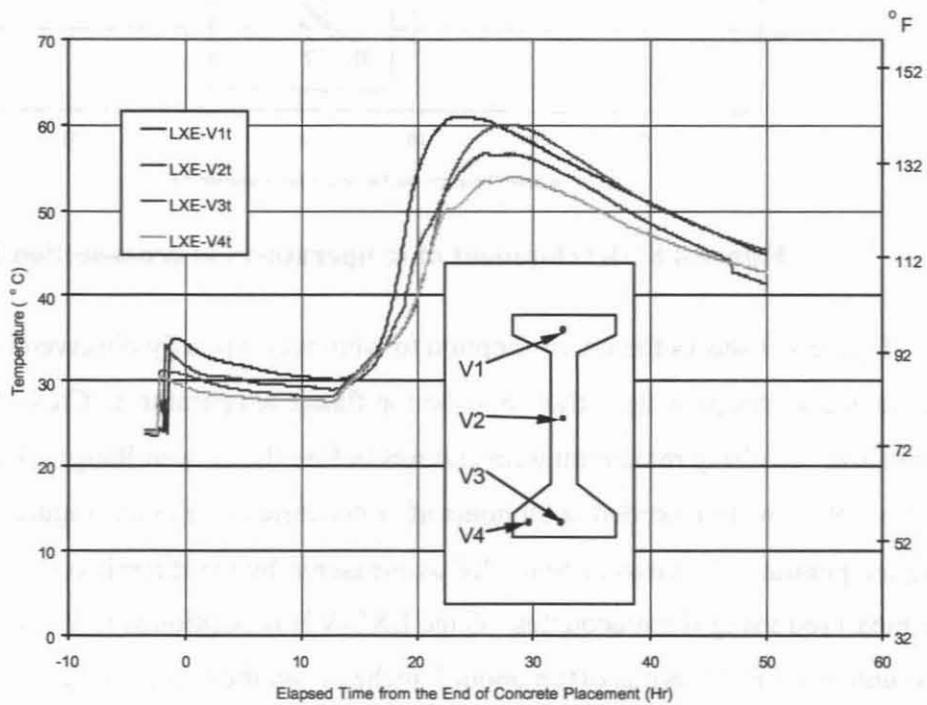
**Figure 4.10 Thermistor temperatures in cross-section LXE**

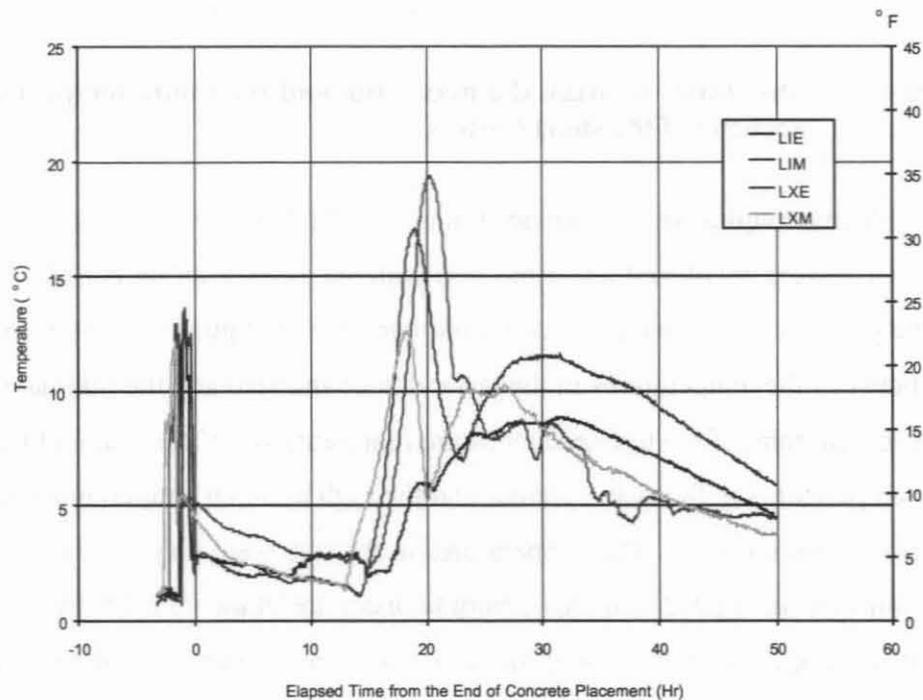
Figure 4.11 and Figure 4.12 show the difference between the maximum and minimum recorded temperatures in the cross-section. This measure of the temperature gradient shows when the maximum gradients occurred. The cross-sections that did not exhibit noticeable differential curing also show the least amount of temperature gradient. This is because the maximum temperature gradients occur when the temperature in one flange is increasing rapidly while the other flange is not heating as quickly. The maximum gradient generally occurs between 19 and 22 hours after concrete placement.

**Figure 4.11** Difference between the maximum and minimum temperatures in the cross-sections of the long girders

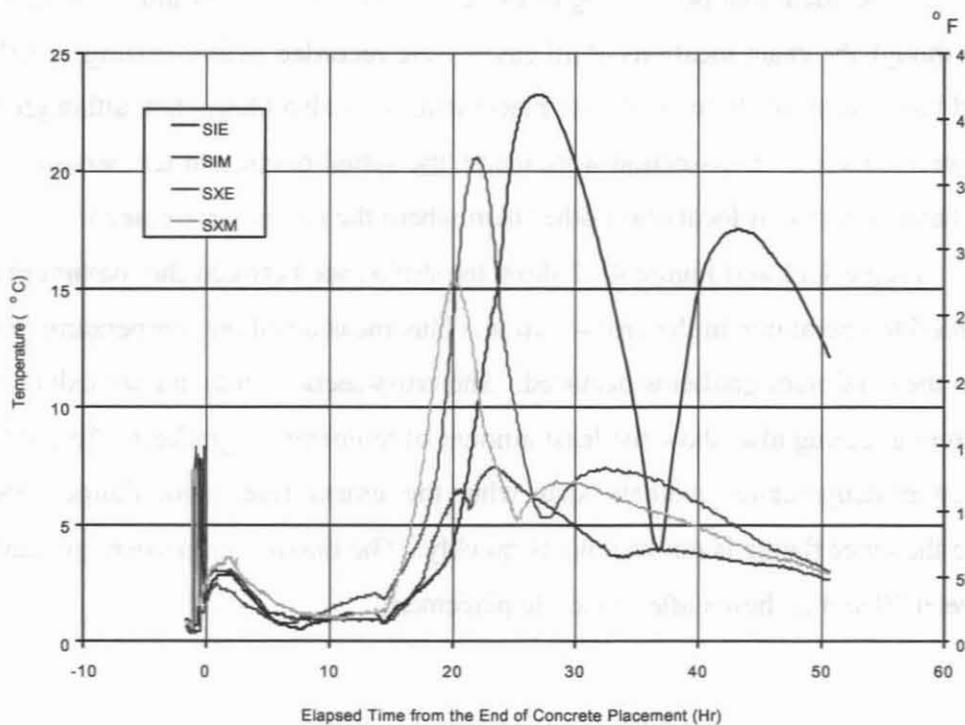
**Figure 4.12 Difference between the maximum and minimum temperatures in the cross-sections of the short girders**

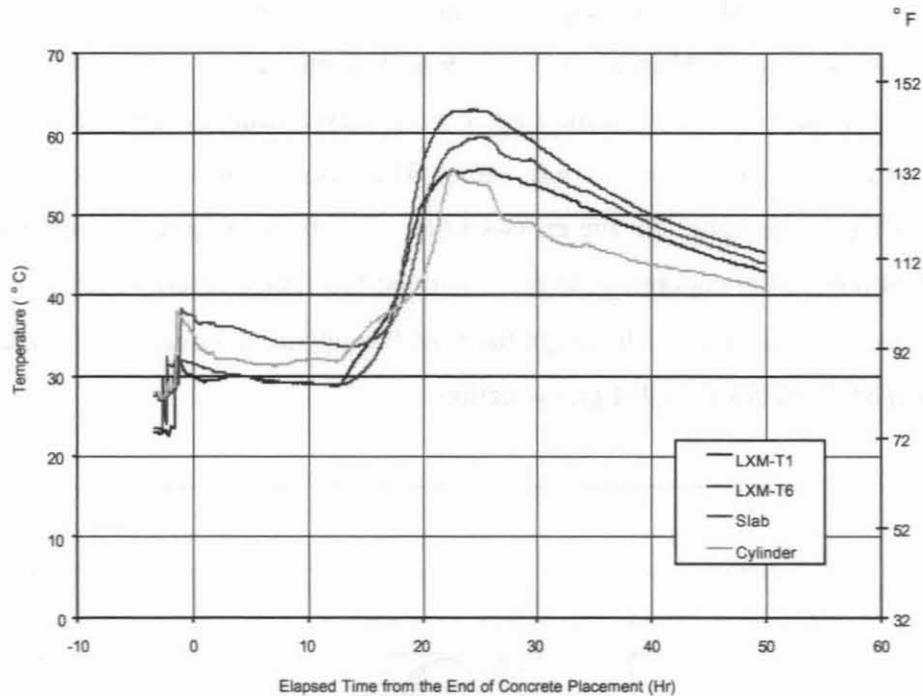
Thermocouples were also placed in one of the 2' x 2' x 6" slabs and one standard 6" cylinder that were positioned under the tarp with the girders during curing. Storing test cylinders with the girders during curing is a common practice at Egyptian Concrete. A comparison was made between the temperatures in the test cylinder and slab and the internal temperatures of the girders to determine if the test specimens are representative of the material in the girder. A graph of the temperatures in the slab, cylinder and the high and low temperatures in cross-section LXM are shown in Figure 4.13. The temperatures in the slab were very representative of the temperatures in the girder. The maximum temperature in the cylinder was comparable to the lower peak temperatures in some girder cross-sections. Figure 4.13 shows that it may not be necessary to specially match cure cylinders to reproduce heat development history in the girders. It is possible to achieve comparable temperature histories simply by curing the cylinders in the same environment as the girders.

**Figure 4.13 Test slab and cylinder temperatures compared to girder temperatures**

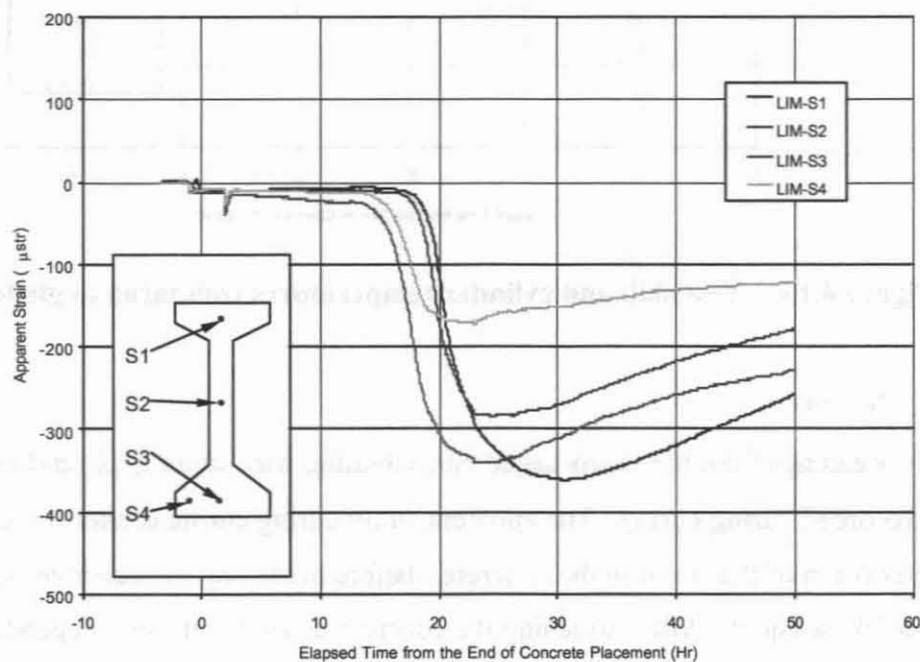
**Figure 4.14 Apparent strain from strain-gaged bars in cross-section LIM**
