Research, Development and Technology

University of Missouri-Columbia

RDT 01-007

# Instrumentation and Monitoring of High Performance Concrete Prestressed Bridge Girders

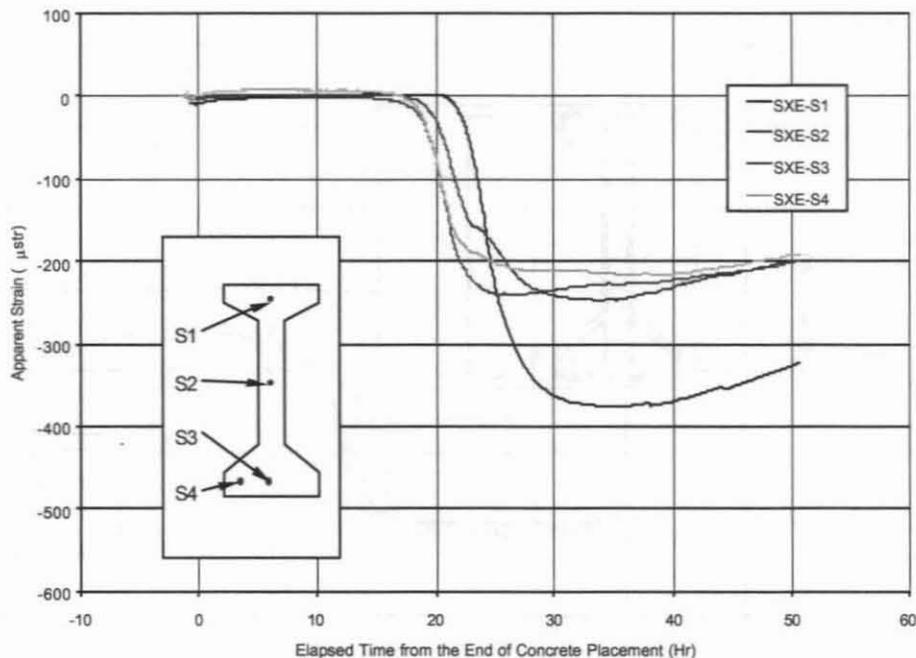
**Figure 4.15** Apparent strain from strain-gaged bars in cross-section SXE

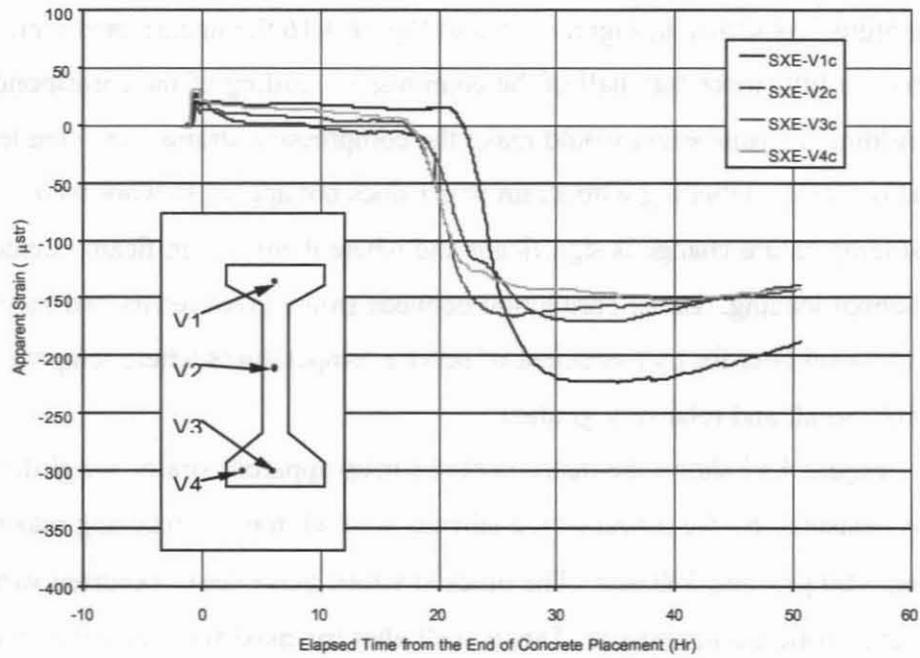
**Figure 4.16** Apparent strain from vibrating wire strain gages in cross-section SXE

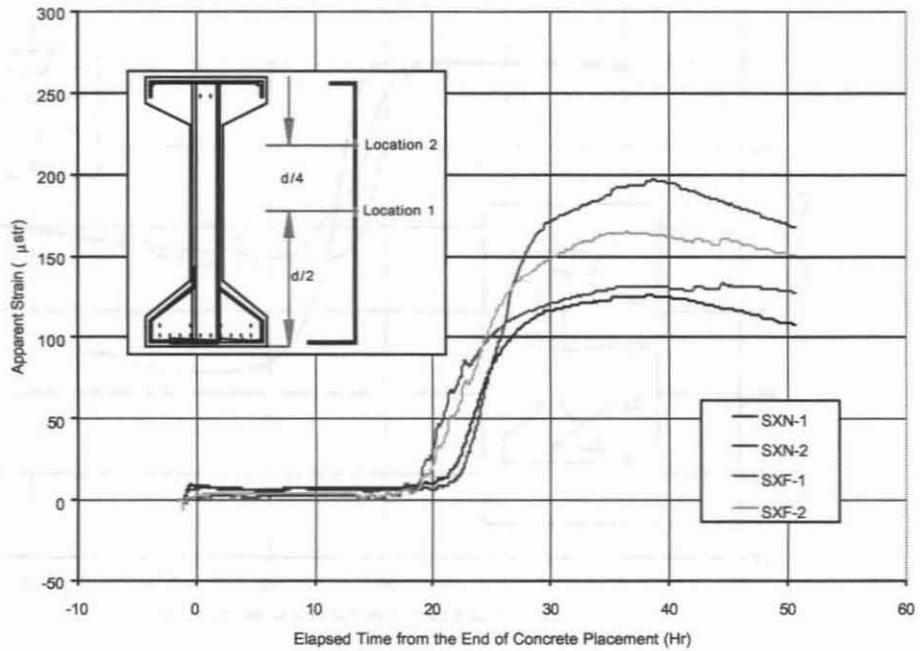
**Figure 4.17** Apparent strains in stirrups used in girder SX

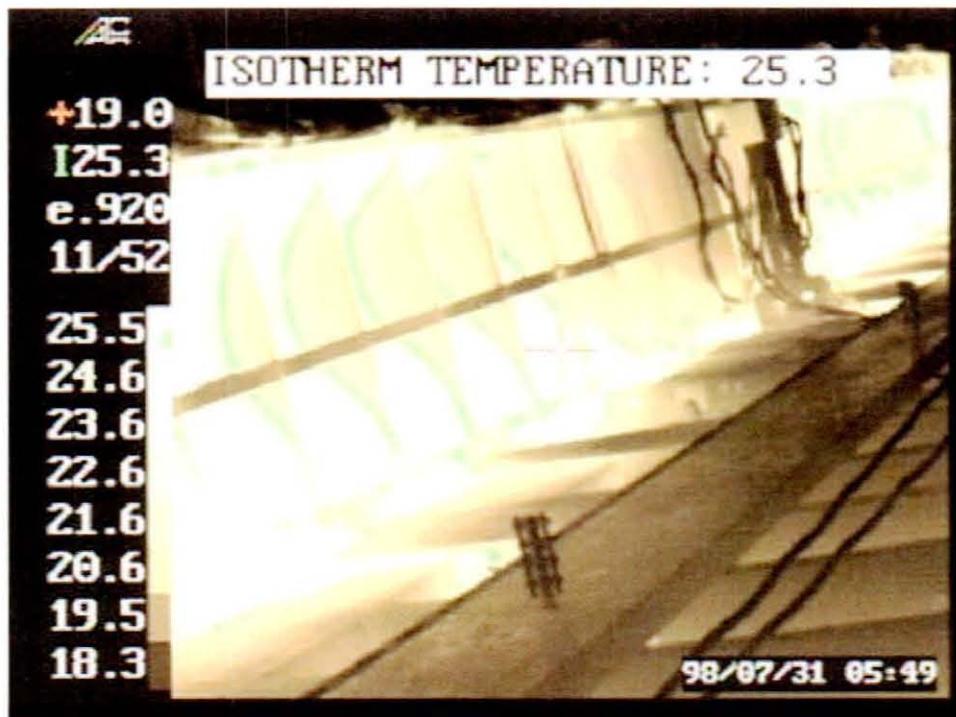
Figure 4.18 Infrared photograph showing the side of girders SI and SX

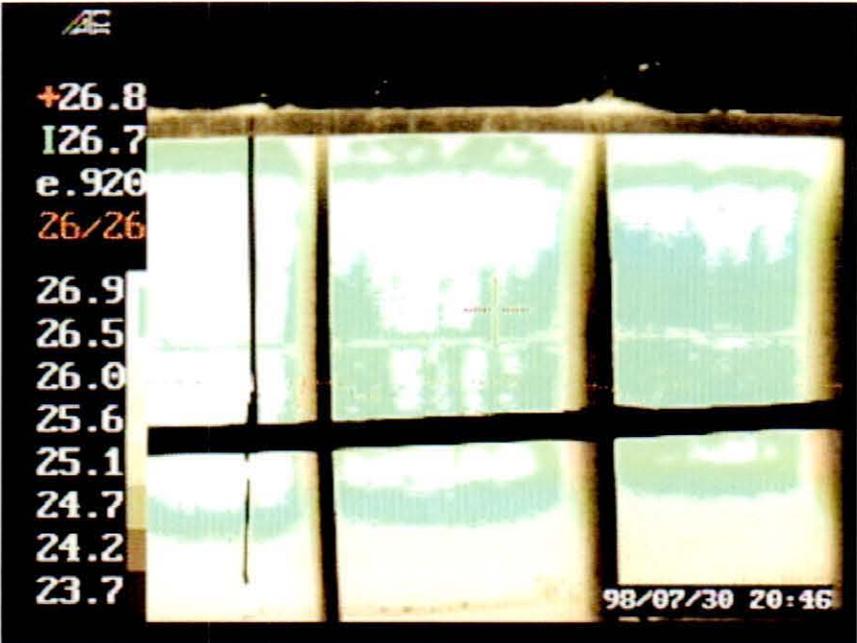
Figure 4.19 Infrared photograph of girder after approximately 13.5 hours of curing

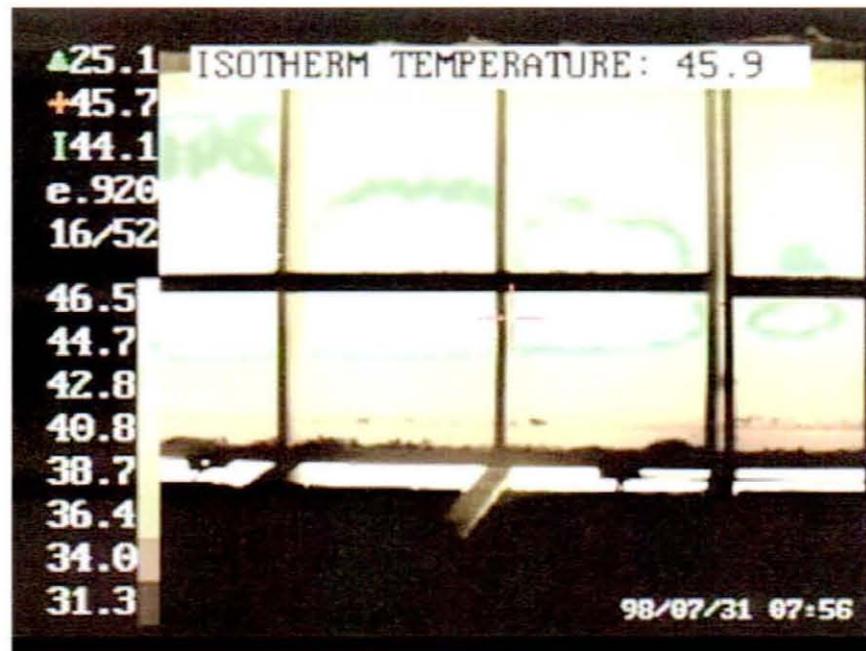
**Figure 4.21 Infrared photograph of girder after approximately 22.5 hours of curing**

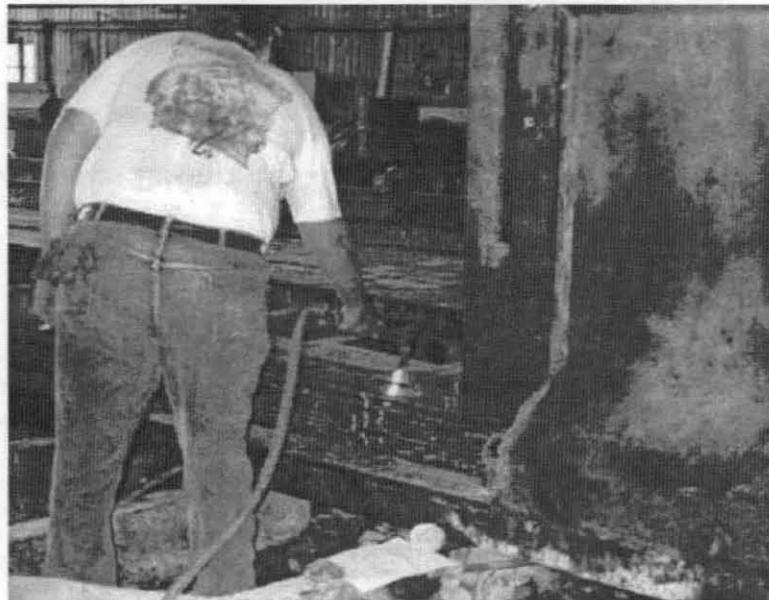
**Figure 5.1** Transfer of the prestress force

The strands were cut using torches. The process of stress transfer is illustrated in Figures 5.1 and 5.2.

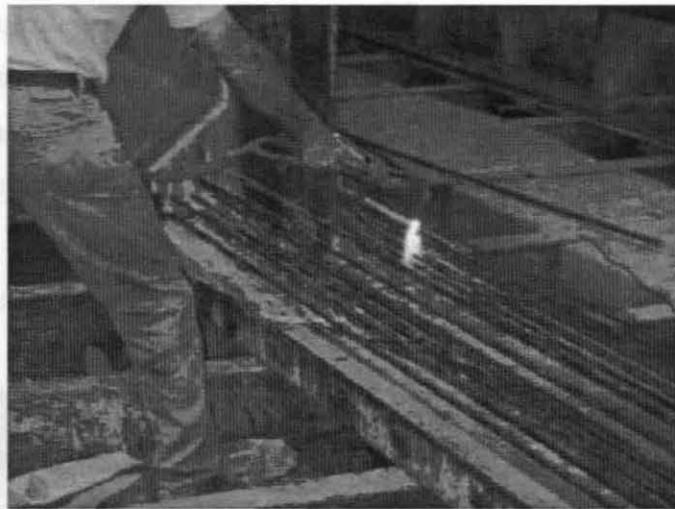
**Figure 5.2** Close-up of the process of cutting prestressing strands with a torch

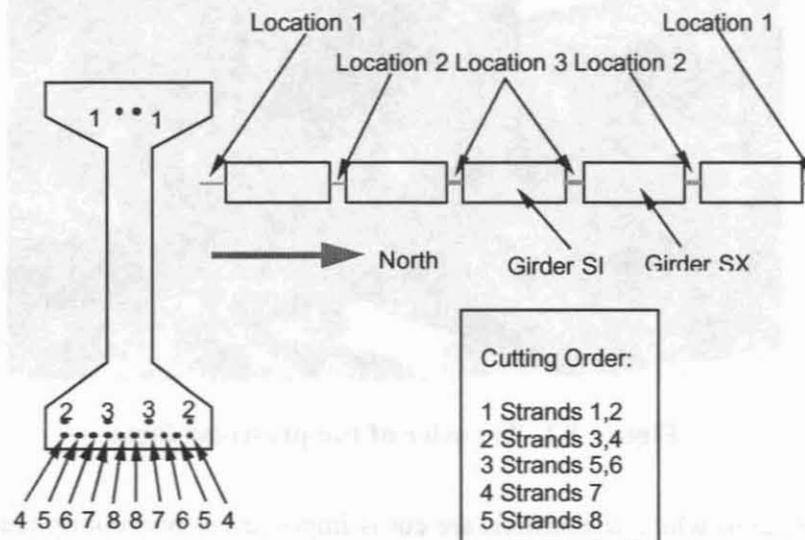
**Figure 5.3** Strand cutting sequence for short girders

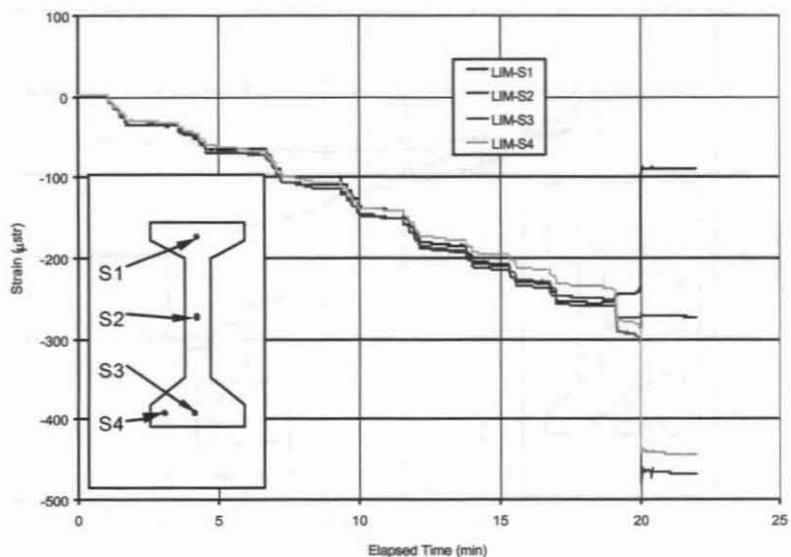
**Figure 5.8** Strains during transfer of prestressing force for cross-section LIM

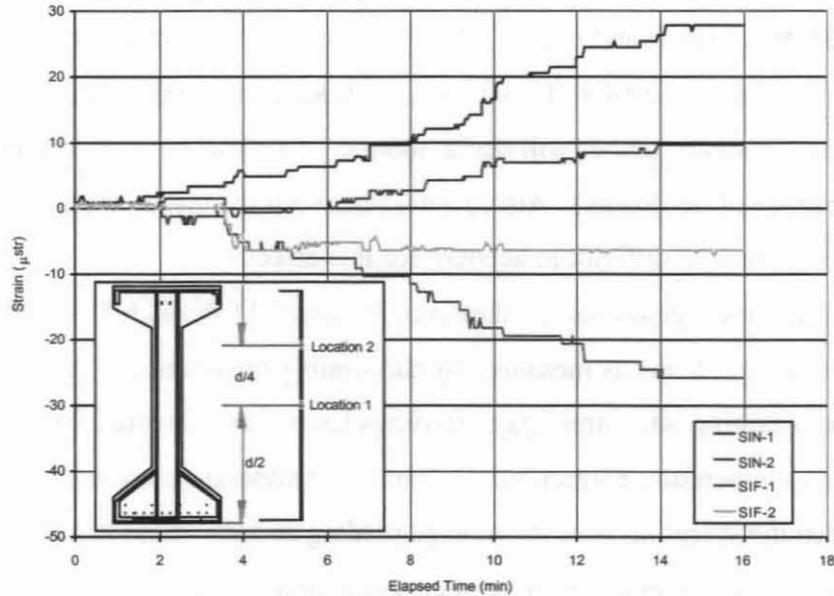
**Figure 5.9** Stirrup strains during transfer of prestressing force for girder SI

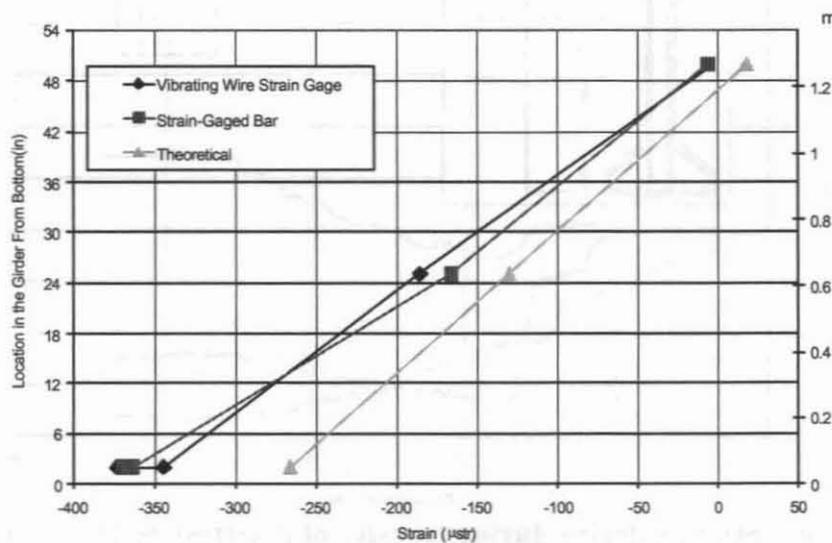
Figure 5.11 Strain distribution and gradient after transfer for cross-section SIE

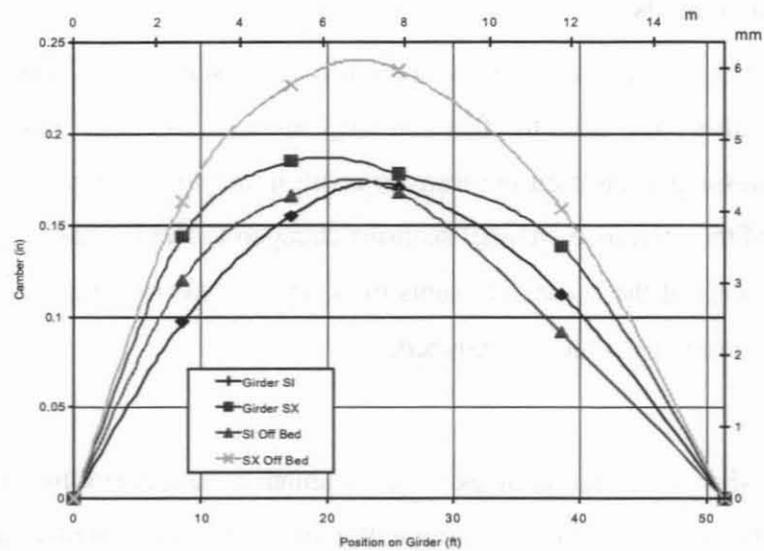
**Figure 5.15** Camber profiles after prestress transfer for the short girders

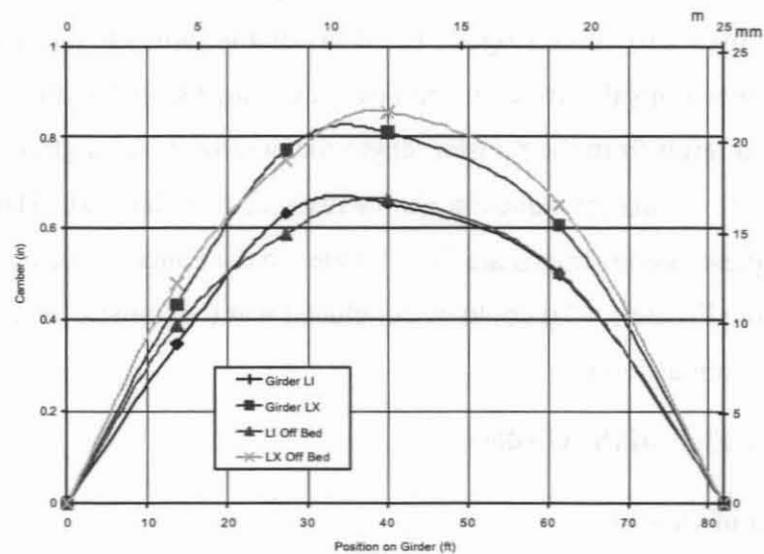
**Figure 5.16** Camber profiles after prestress transfer for the long girders

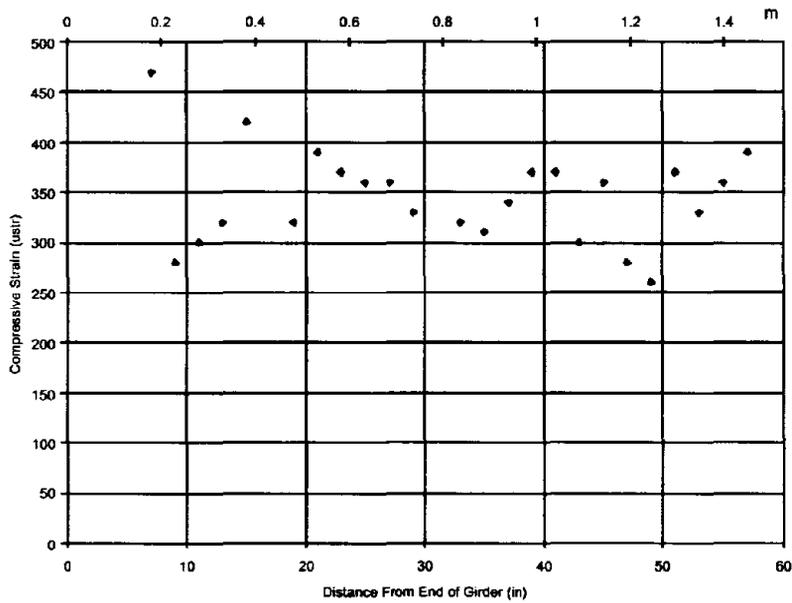
**Figure 5.17 Transfer length measurement results**

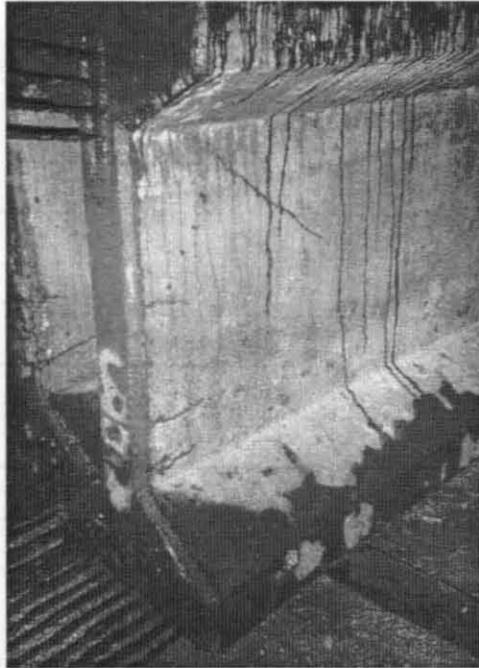
**Figure 5.18** Photograph of girder end cracking

It has been concluded from the study that cracking at girder ends could result from a combination of residual stress due to differential thermal loading from curing/hydration and stresses due to prestress transfer. Improved curing procedures and potential design modifications can minimize this potential for cracking.

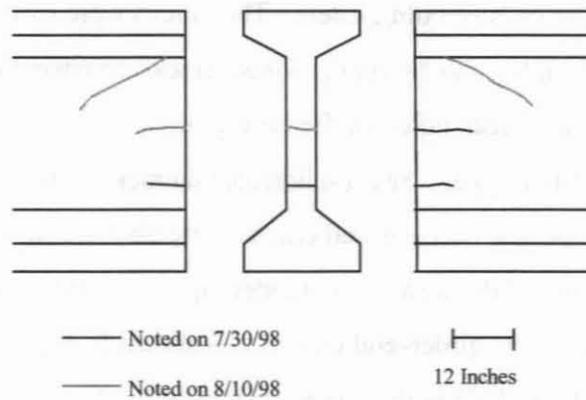
**Figure 5.19** Sketches of girder-end cracks for the “marked end” of girder LI

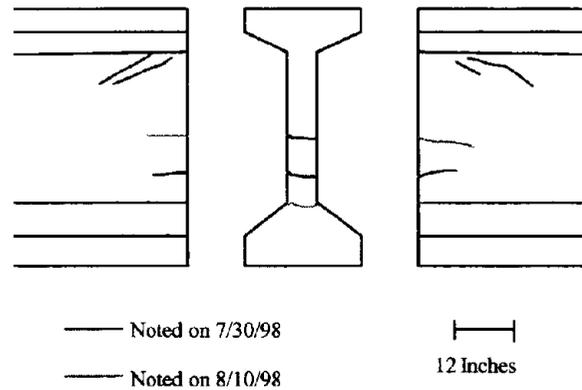
**Figure 5.20 Sketches of girder-end cracks for the “marked end” of girder LX**

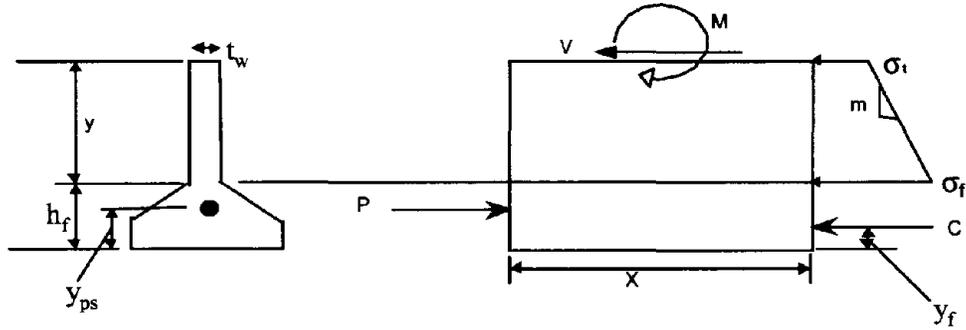
**Figure 5.21 Modified Gergely – Sozen model (Earney, 2000)**

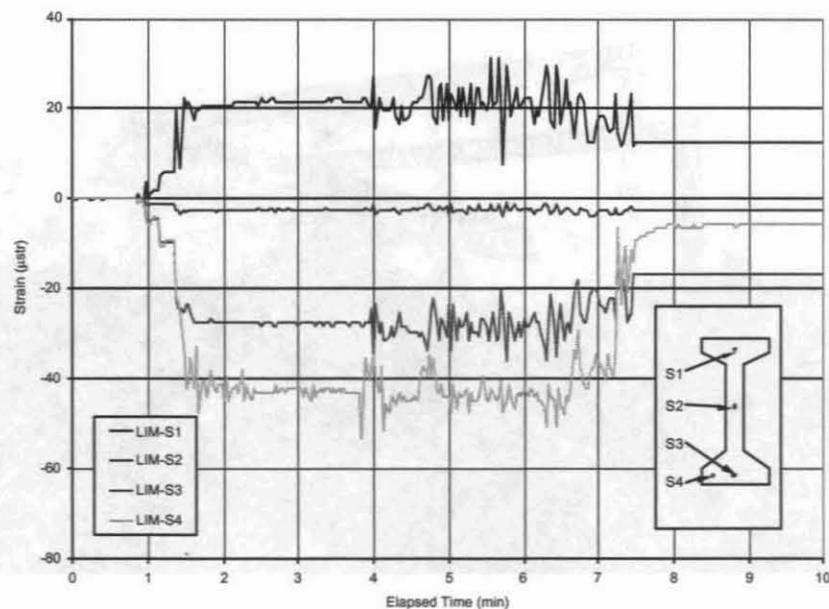
**Figure 6.2 Strains in girder LI while the girder is being moved from the precasting bed**

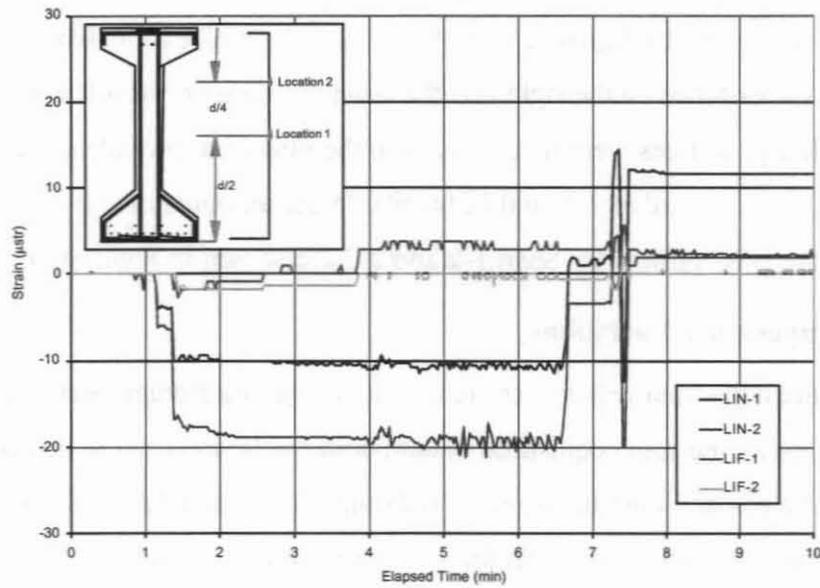
**Figure 6.3** Stirrup strains while girder LI is moved from the precasting bed

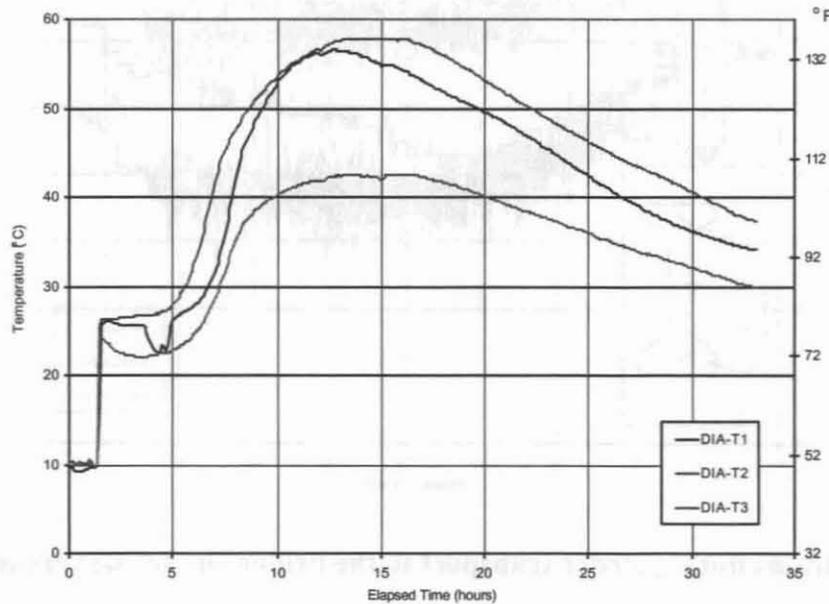
**Figure 6.16 Diaphragm temperatures during diaphragm and slab hydration**

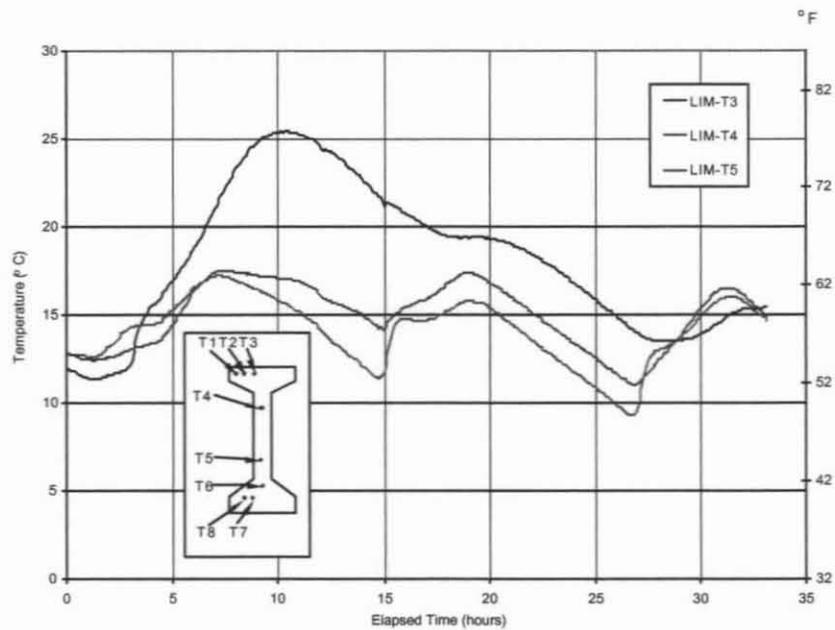
**Figure 6.17 Girder temperatures (LXM) during diaphragm and slab hydration**

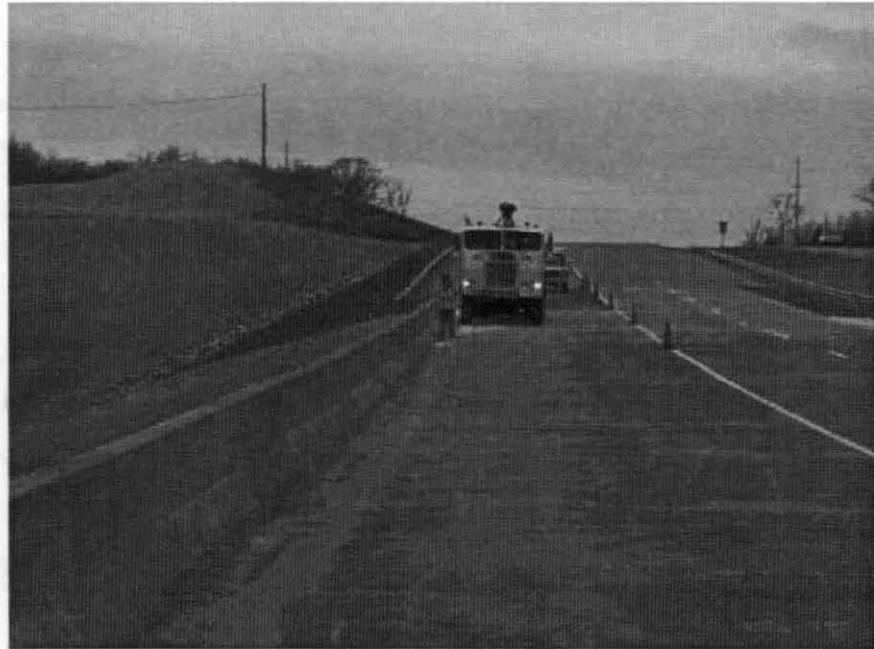
**Figure 7.1** Load truck and markings on the bridge for the load test

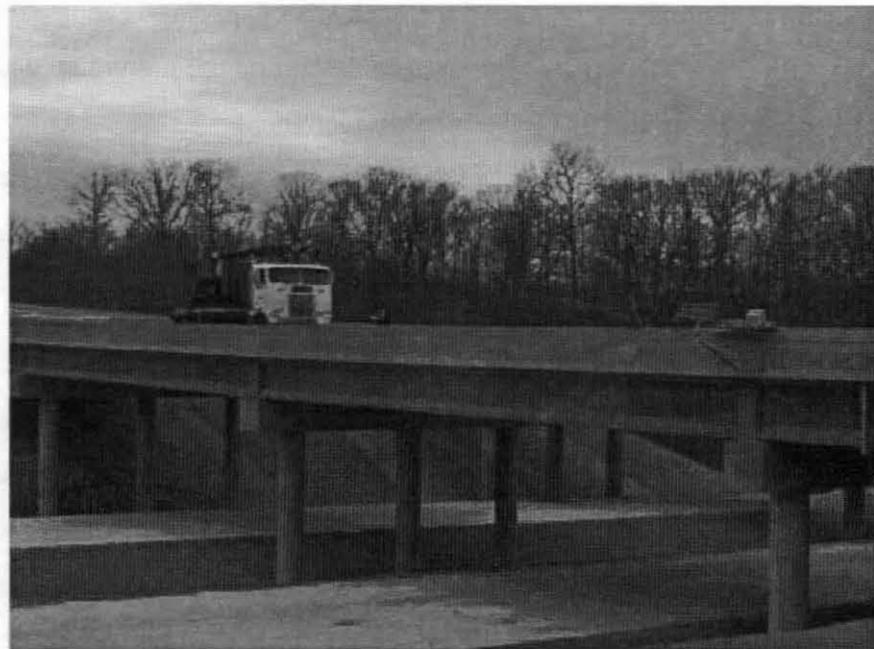
**Figure 7.2** Load test in progress

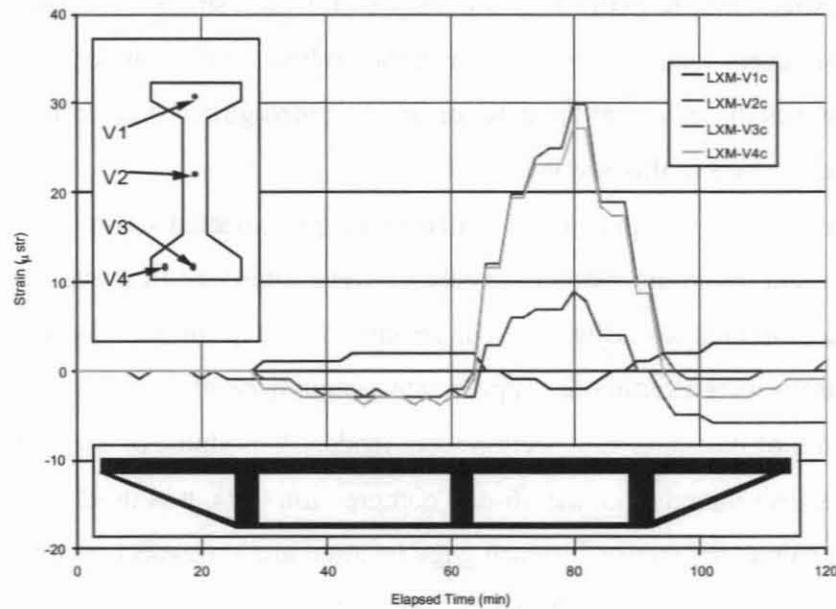
**Figure 7.3** Strains from the load test in cross-section LXM measured by vibrating gages

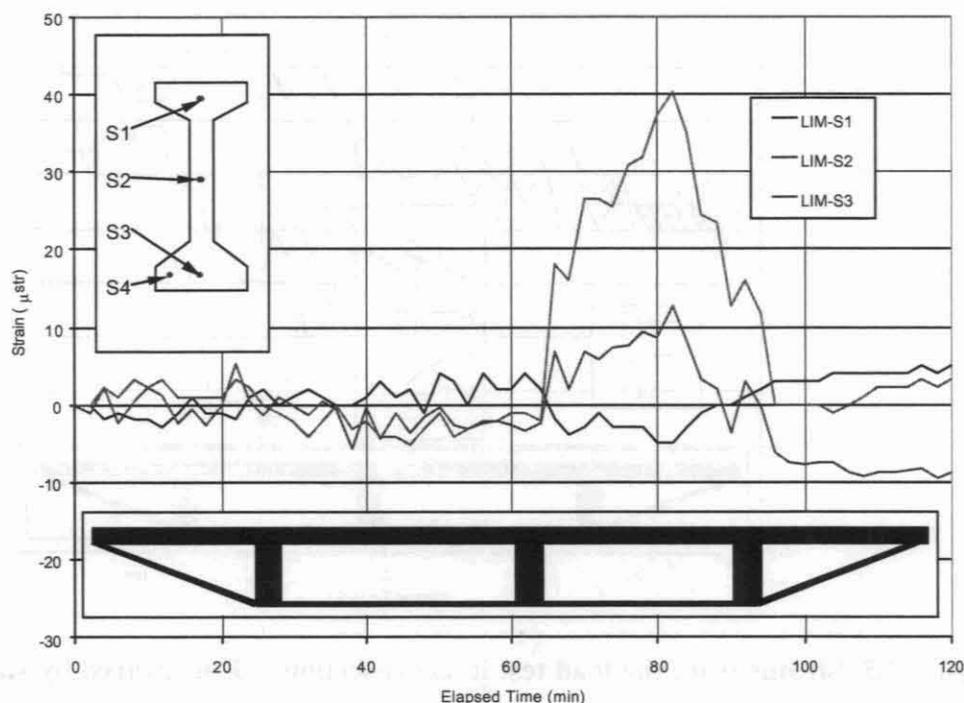
**Figure 7.4** Strains from the load test in cross-section LIM measured by strain-gaged bars

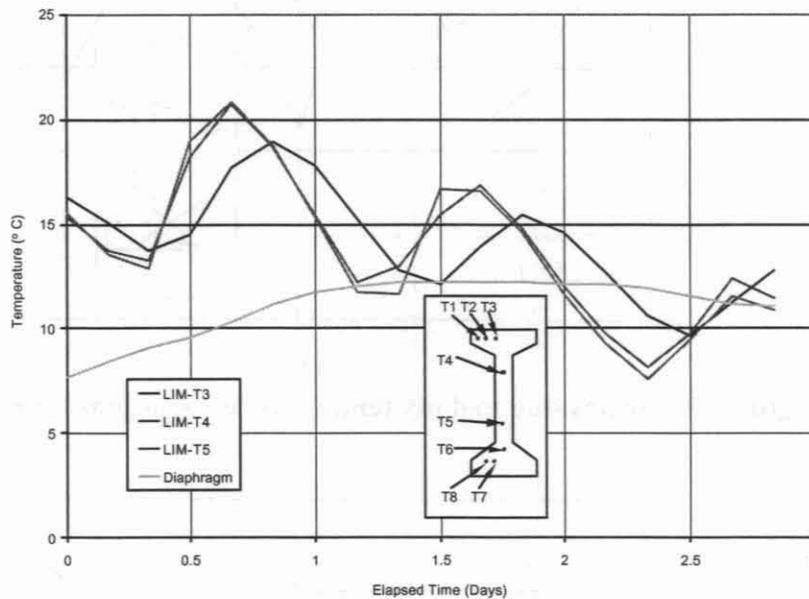
**Figure 7.7 Daily temperature variations in the girder and the diaphragm**

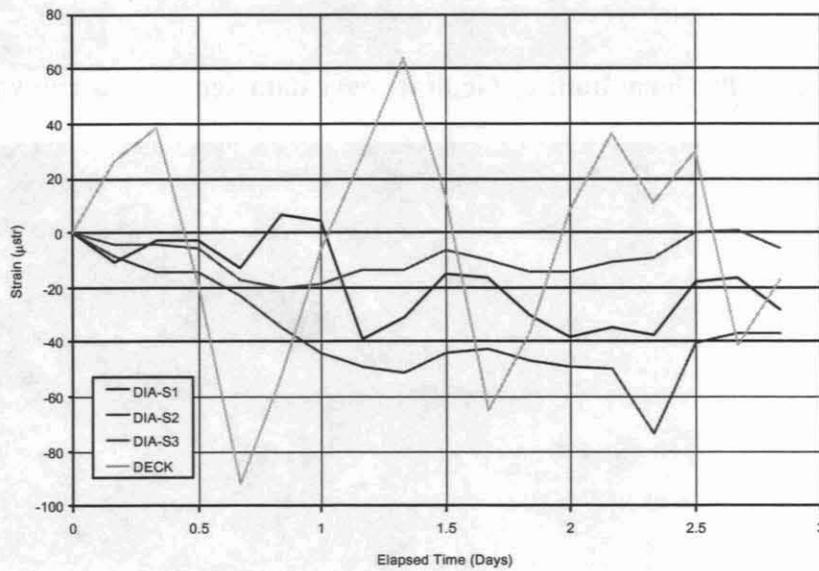
**Figure 7.13** Diaphragm strains due to daily temperature variations

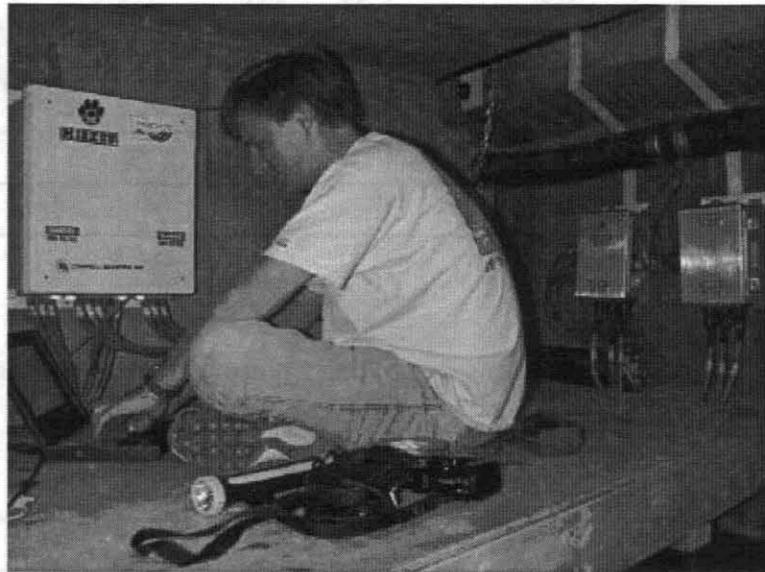
**Figure 7.14** Platform built to facilitate easy data acquisition and wiring reconfigurations

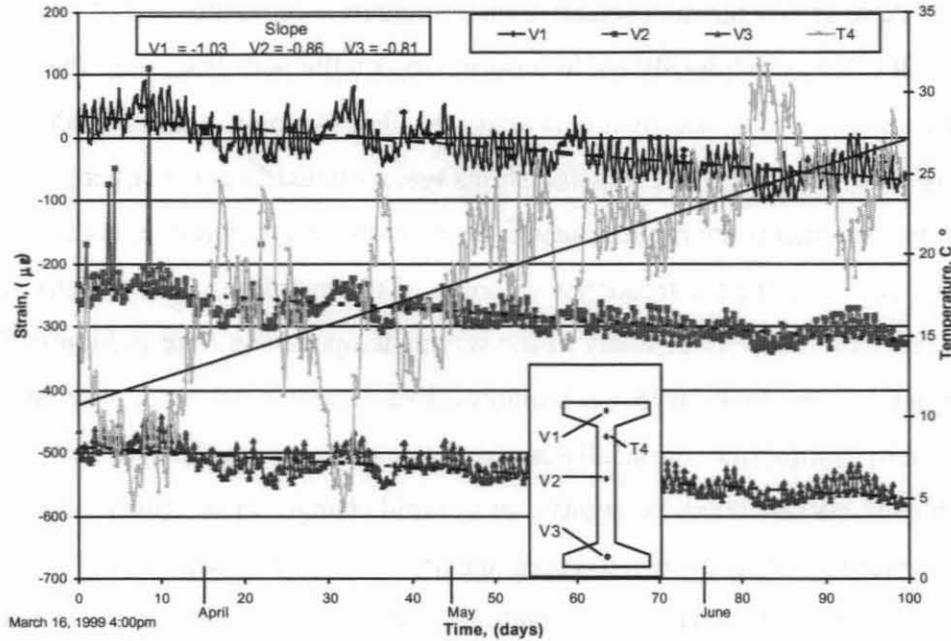
**Figure 7.16** Strains due to service temperatures during a period of increasing temperature in cross-section SIE

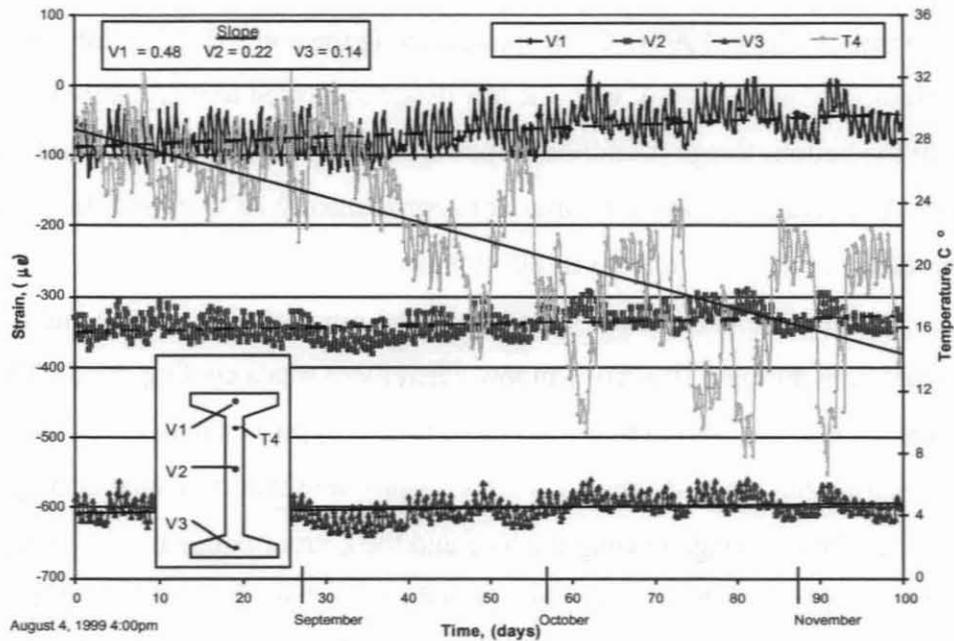
**Figure 7.17** Strains due to service temperatures during a period of decreasing temperature in cross-section SIE

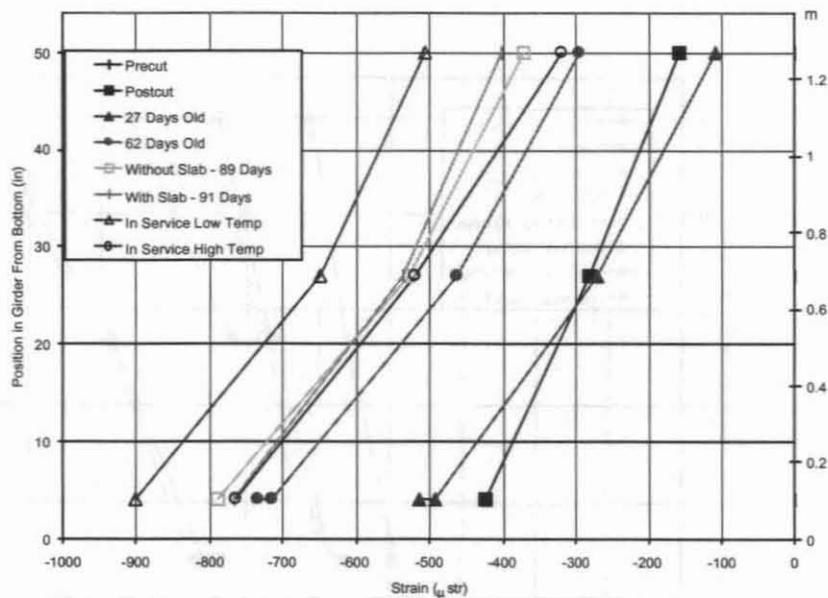
**Figure 7.20 Measured strain gradients at selected times for cross-section LIE**

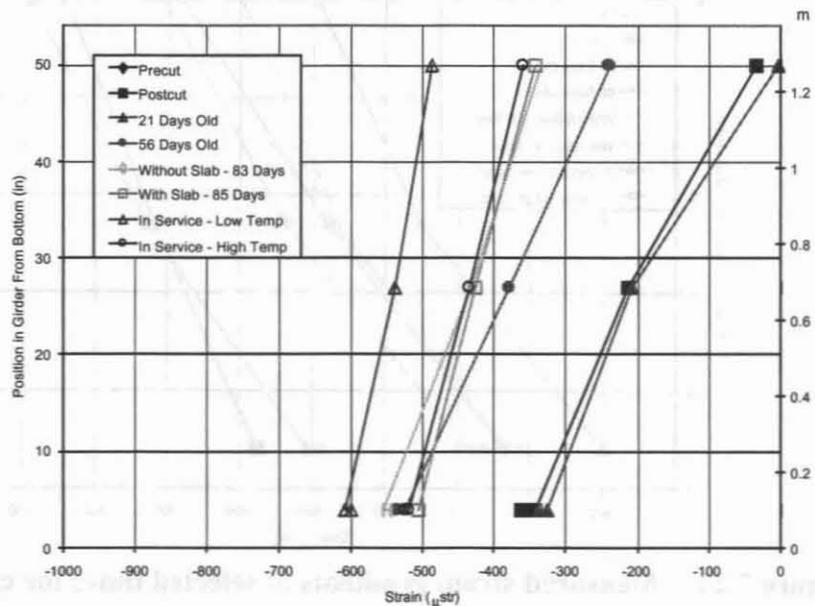
**Figure 7.22 Measured strain gradients at selected times for cross-section SIM**

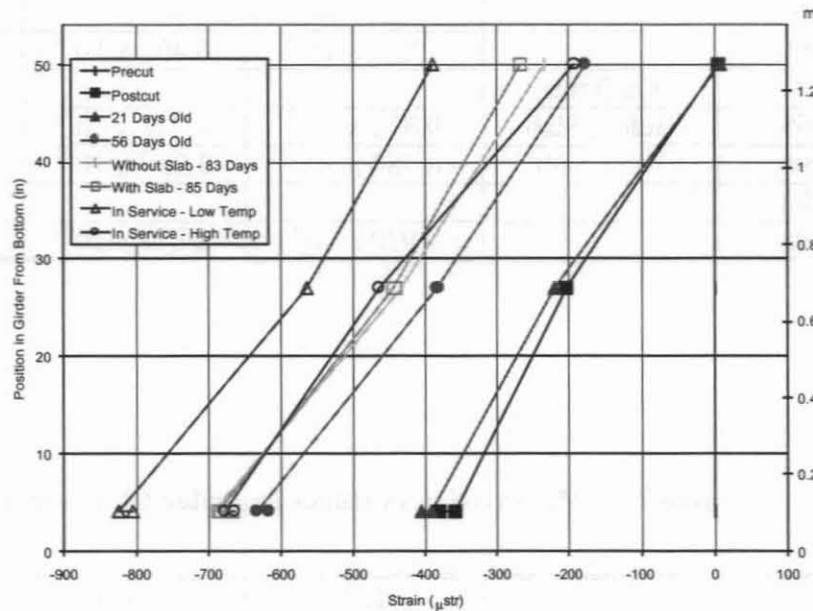
Figure 7.23 Measured strain gradients at selected times for cross-section SXE
