# Missouri Guide for Pavement Rehabilitation

RI 00-008

November, 2002

MISSOURI GUIDE FOR PAVEMENT REHABILITATION

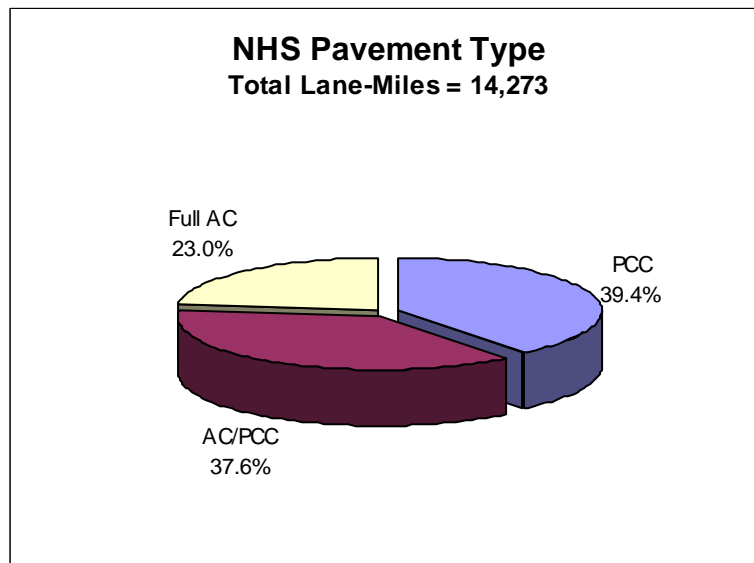
The pie chart below reveals that Missouri's NHS is primarily Portland cement concrete (PCC) or PCC overlaid with asphalt concrete (AC). The percentage of AC/PCC may actually be higher and full-depth AC lower because of uncertainty about the historical records for some full-depth AC pavements. The entire Interstate system was originally paved with PCC, except for a few short stretches on I-44.

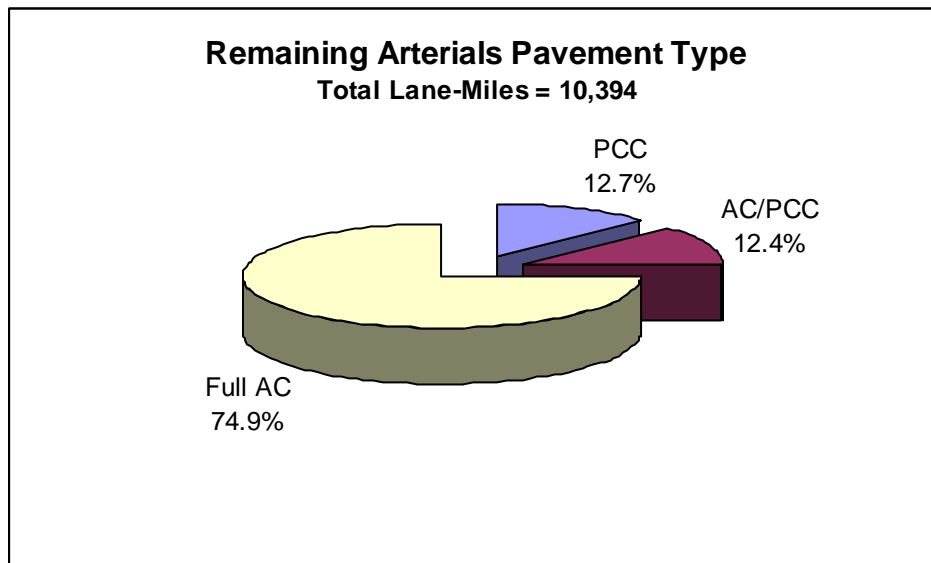
The pie chart below reveals that nearly 75 percent of the lane-miles in this category are full-depth AC. The rest is evenly split between bare and overlaid PCC. The percentage of AC/PCC may actually be higher and full-depth AC lower because of uncertainty about the historical records for some full-depth AC pavements.

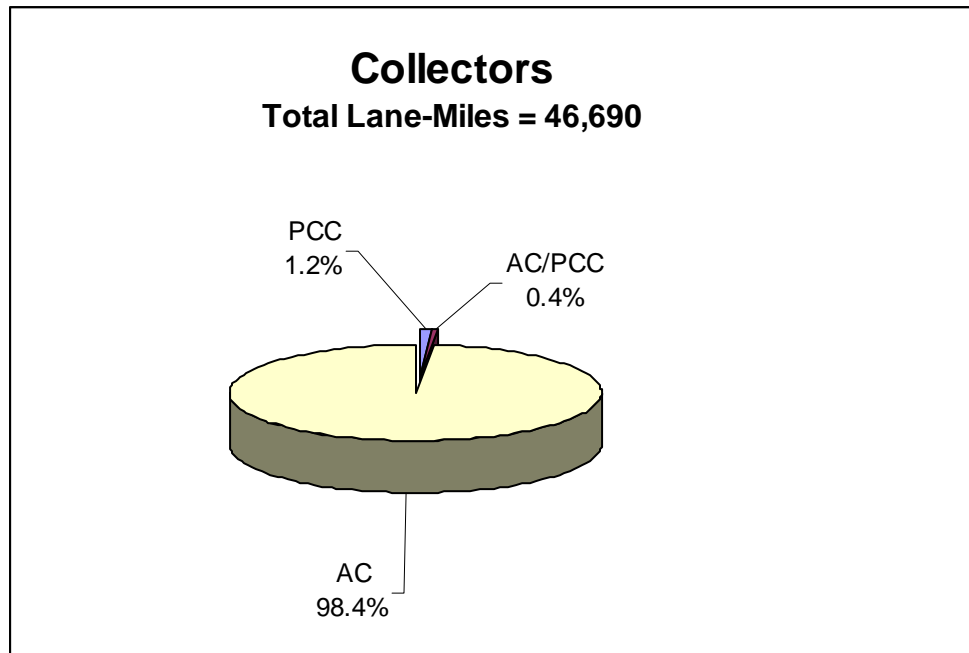
The following pie chart indicates that these routes are predominantly AC.

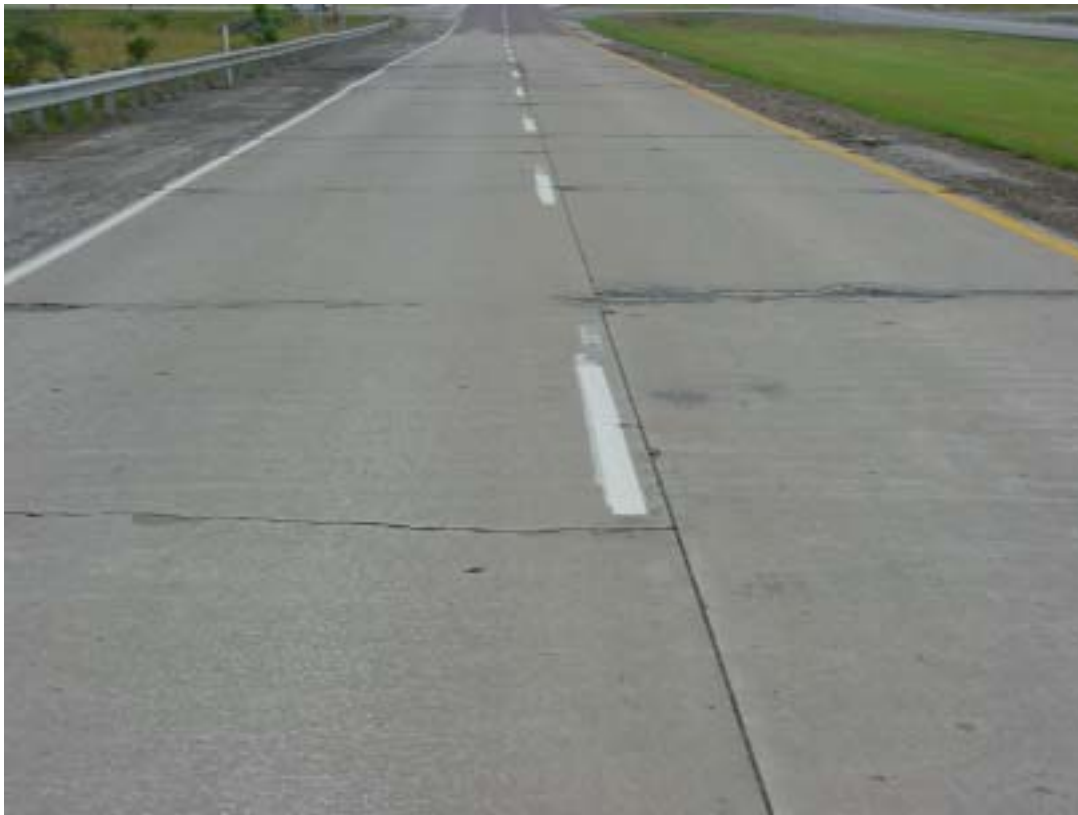
JRCP on NB US 54 in Callaway County

Until 1993 JRCP was the standard design in Missouri. Design thickness ranged from 8 – 11 inches. Joint spacing was 61.5 feet. JRCP performance was often marred by faulting, spalling and general deterioration at joints and sometimes at working third point panel cracks. D-cracking in the northwestern part of the State often accelerated these failures. Outside of these problems, the PCC slabs remained intact for a long time. The biggest concern over this type of design, assuming proper base support, drainage and good quality coarse aggregate are present to keep it structurally sound, is the effect of temperature and moisture-induced slab curvature on ride.

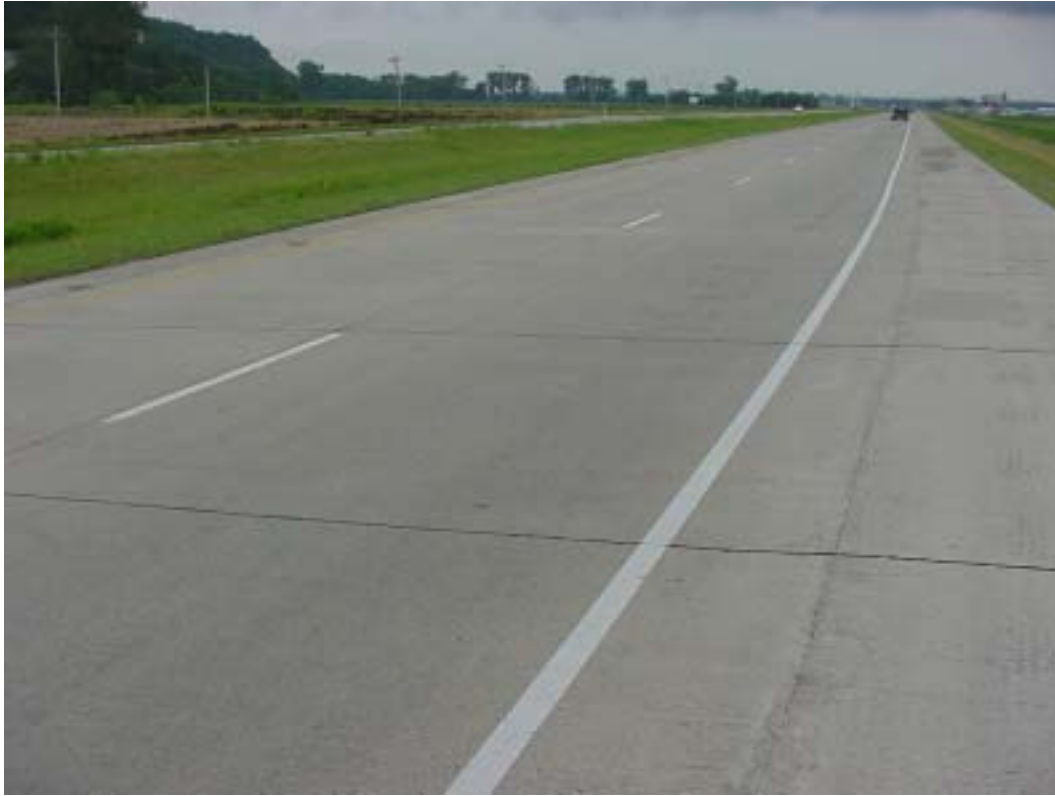
JPCP on SB US 63 in Boone County

Prior to 1994 Missouri had occasionally built some 30-foot JPCPs. These pavements tended to form mid-panel cracks. Since 1994 all PCC pavements in Missouri have been built with the JPCP style. Driving lane slabs are paved 14-feet wide or 2 feet beyond the edge line. Joint spacing is 15 feet, which has virtually eliminated natural mid-panel cracking. Joints are doweled. Slab thickness is 11-14 inches on NHS and other arterial roads, much greater than the older JRCP design. The preferred base type is a 2-foot, daylighted rock base, which provides a stiff platform as well what is currently believed to be a very drainable layer. Performance to date has been excellent.

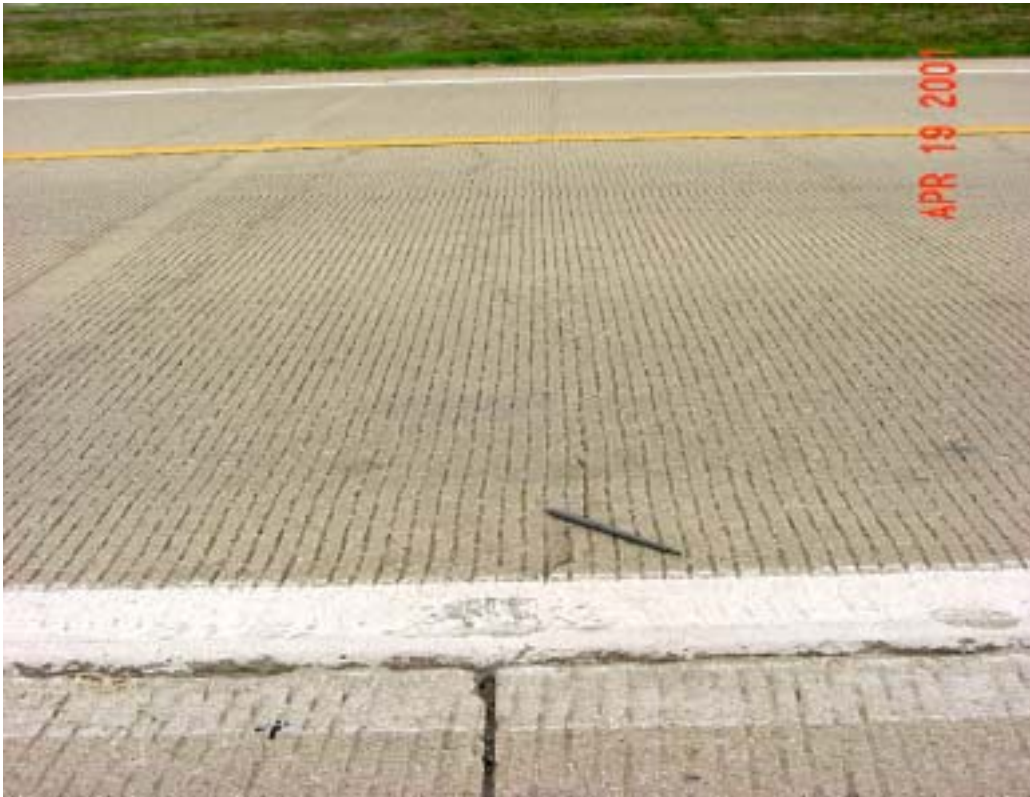
Illinois CRCP

Continuously reinforced concrete pavement (CRCP) has continuous wire mesh or tied longitudinal rebar across its entire area. The reinforcement is usually placed slightly above slab mid-depth. There are no joints. The slab cracks naturally from shrinkage in 4-5-foot transverse spacing. The cracks are held tight by the steel. The picture below illustrates ideal crack spacings and openings for a CRCP.

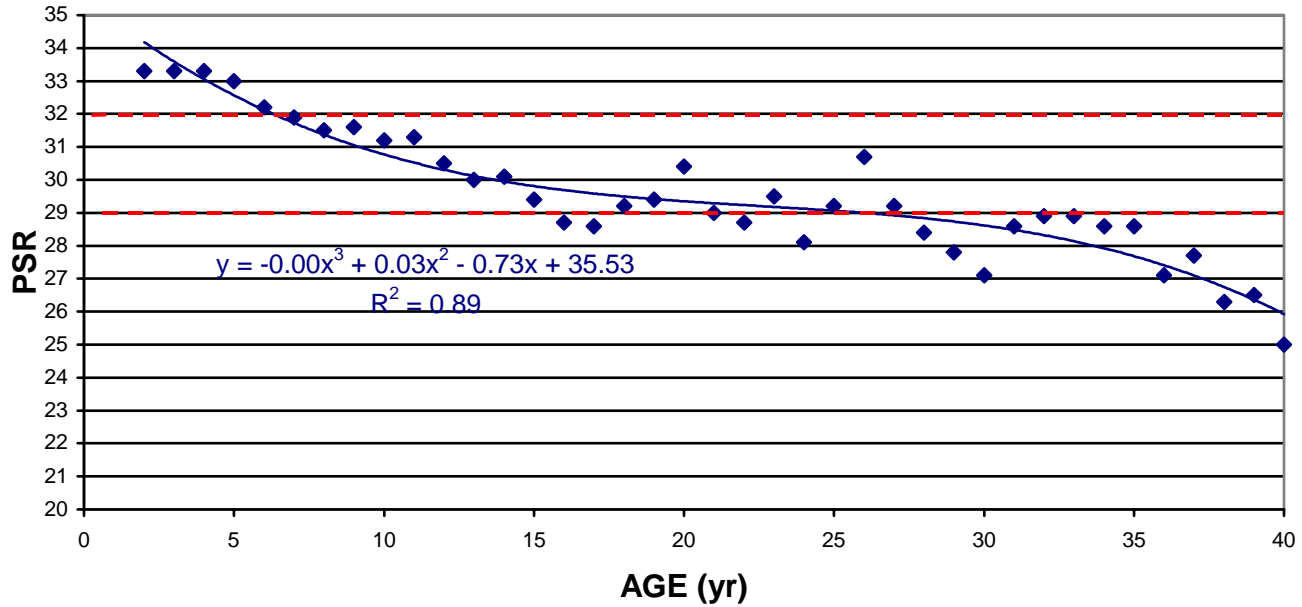
Average PCCP PSRs deteriorate gradually for the first sixteen to seventeen years and then level off somewhat. A 3<sup>rd</sup> degree polynomial regression approximates the trend well. Maintenance activities such as patching and joint repairs probably account for some of the leveling, however; it would be very difficult without accurate maintenance histories to measure what affect the improvements had on the performance scores. Whatever the case, it can be assumed the conditions were judged not to merit resurfacing. Average time before PCCPs descend to an unacceptable PSR is around 25 years. Ride and condition trends are similar to PSR.

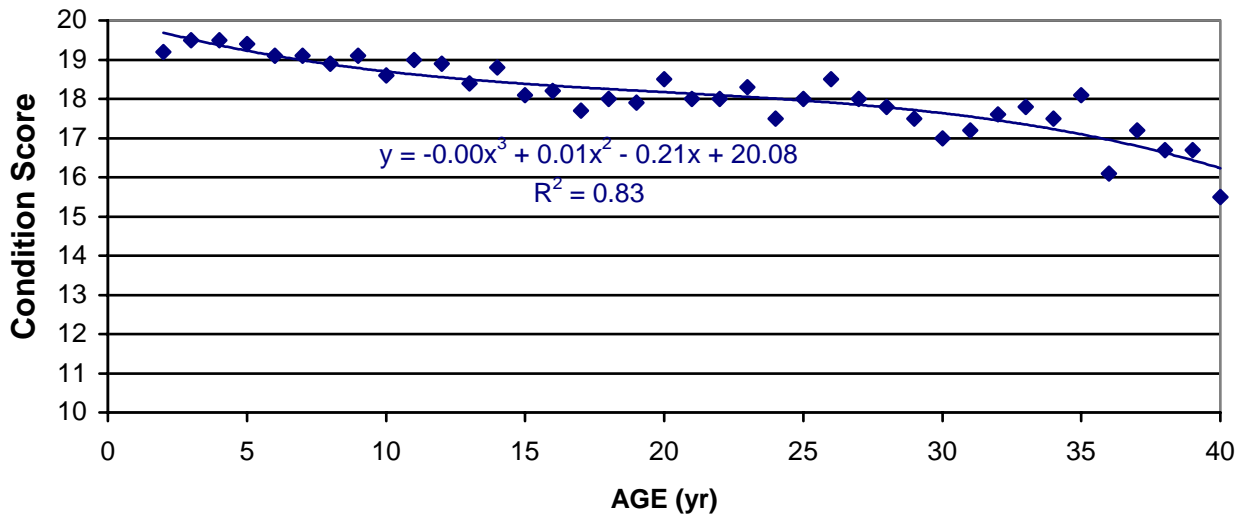
# Condition for PCC on Divided NHS 1995-2000 ARAN Data

**PAST AVERAGE  
PERFORMANCE LIFE (at least  
marginal) TILL FIRST MAJOR  
REHABILITATION REQUIRED  
FOR PCC PAVEMENT  
ON NHS  
= 25 YEARS**

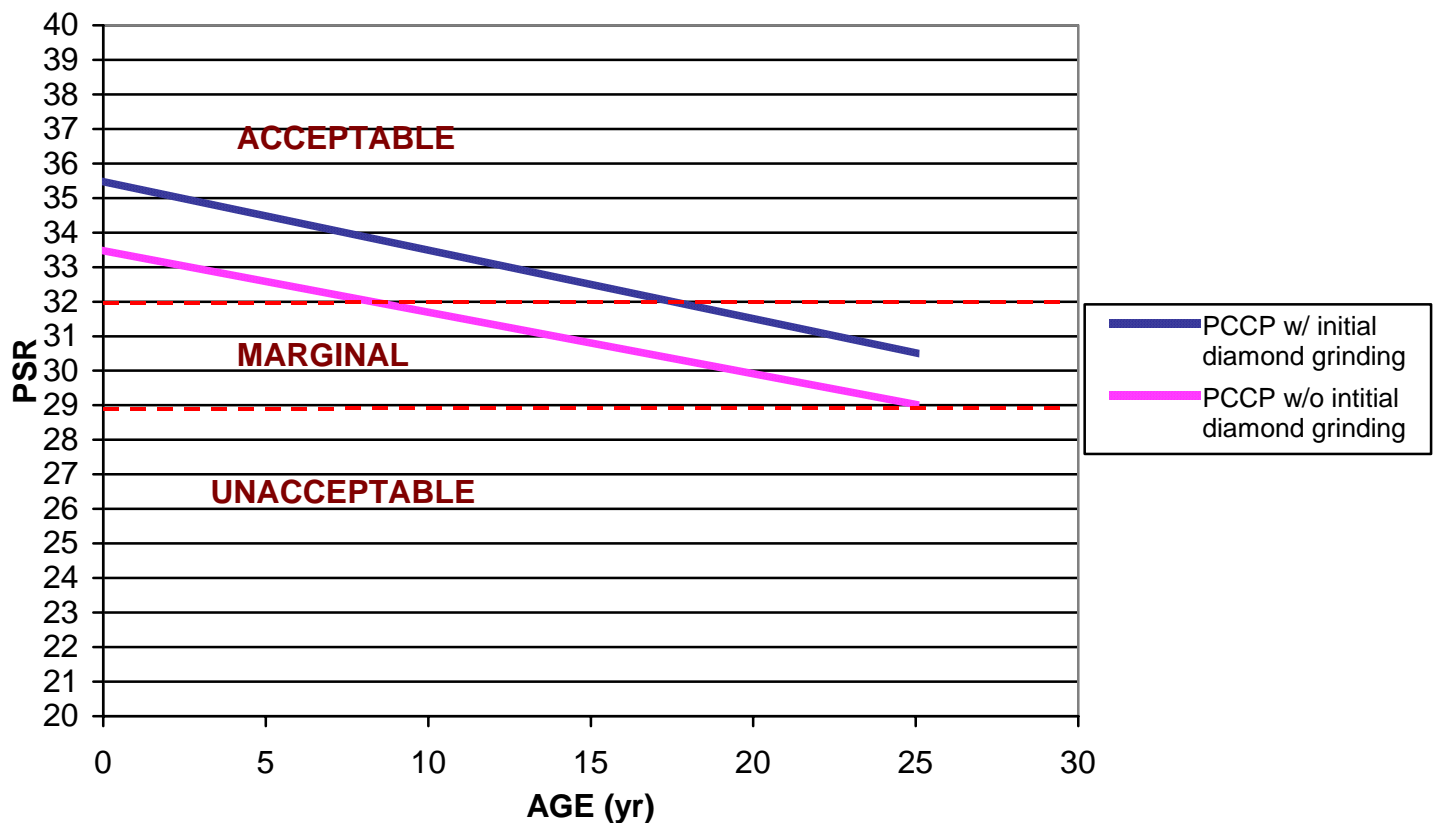
### Effect of Initial Smoothness on PCCP Performance Life

To illustrate this concept, let's look at two PCCPs that are identical in every way, except that one has had its surface diamond ground while the other has not. Assume the change in Condition scores for each is 1.5 points over a 25-year period, which is consistent with the historical average in the previous Condition chart. Then assume the change in Ride for the non-diamond ground PCCP is approximately 1.5 points, which is consistent with the historical average in the previous Ride chart and that this is 85 percent of the change in Ride for the diamond ground PCCP. Based on the ARAN data for the US 60 diamond grinding project, it can also be assumed the overall initial increase in PSR for a diamond ground PCCP is around 2 points. Therefore, the diamond-ground pavement starting with a PSR of 35.5 would drop to 30.5 after 25 years, while the non-diamond-ground pavement would change from 33.5 to 29.

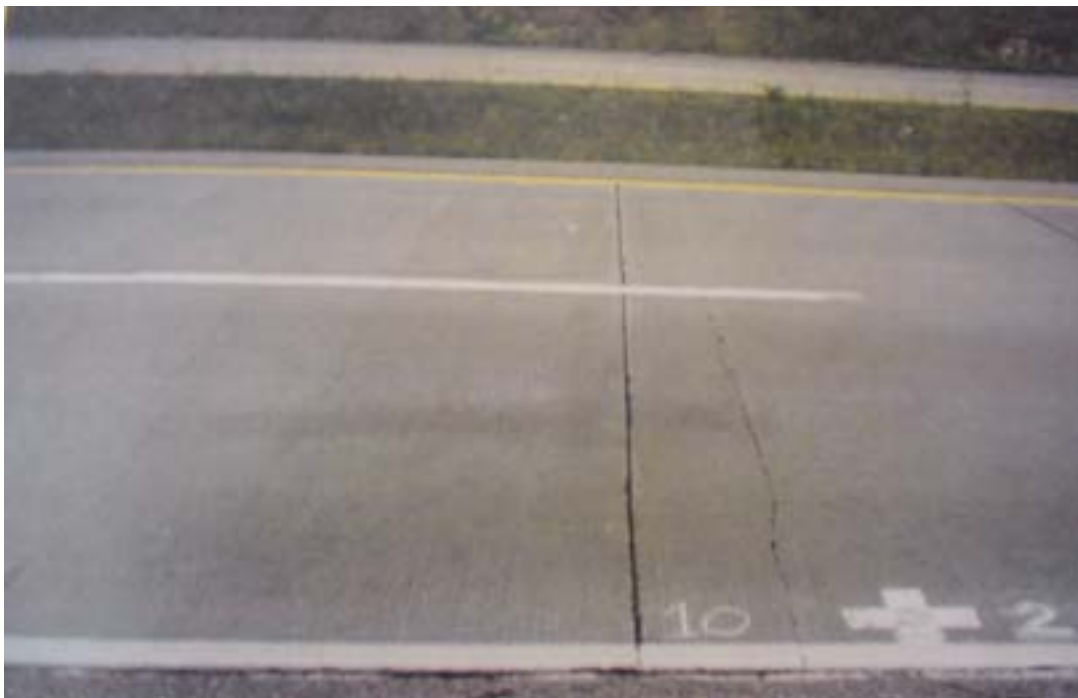
Bonded concrete overlay on NB US 67 in Jefferson County

The U.S. 67 project contained test sections with bonded overlay thickness ranging from 3-5 inches. There were problems with debonding and excessive transverse and longitudinal cracking on some sections, which appeared to be related to the type of surface preparation. Other portions of the pavement are doing well.

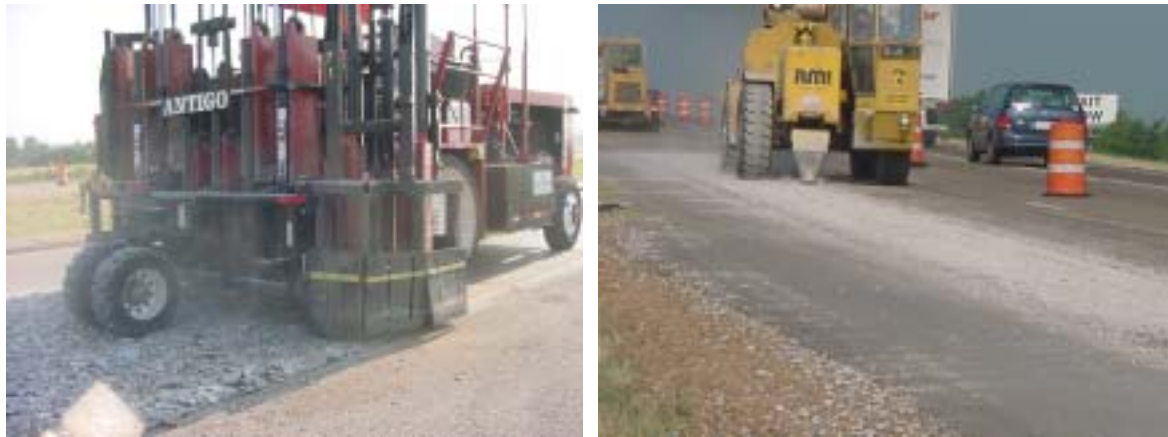
Multiple-head breaker (left) and Resonant breaker (right)

States word their rubblization specifications to allow use of either the multiple head breaker (shown at left below) or the resonant breaker (shown at right below), although pavement engineers in each state may have their own preferences for one or the other.

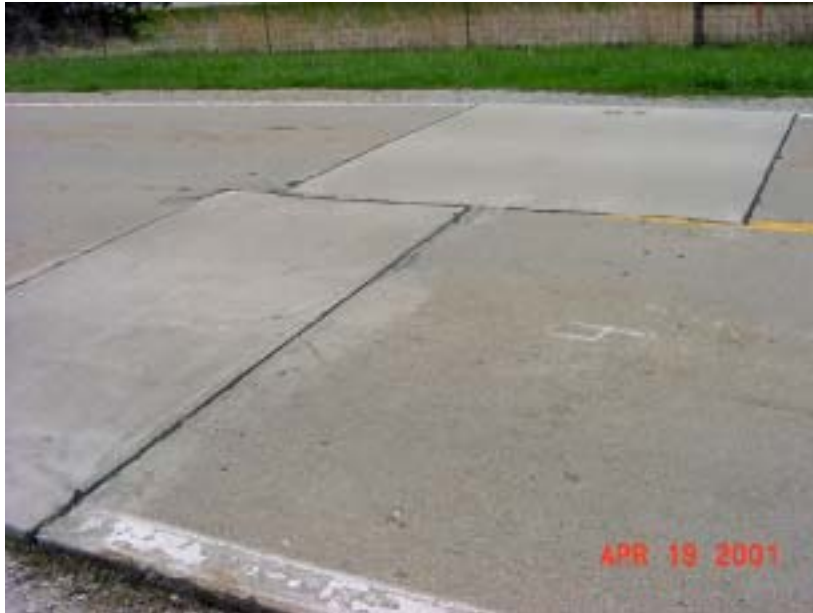
Full-depth repairs

been studied in past Missouri research efforts, but no known estimate of extended pavement service life was ever developed. The photo below shows typical full-depth repairs.

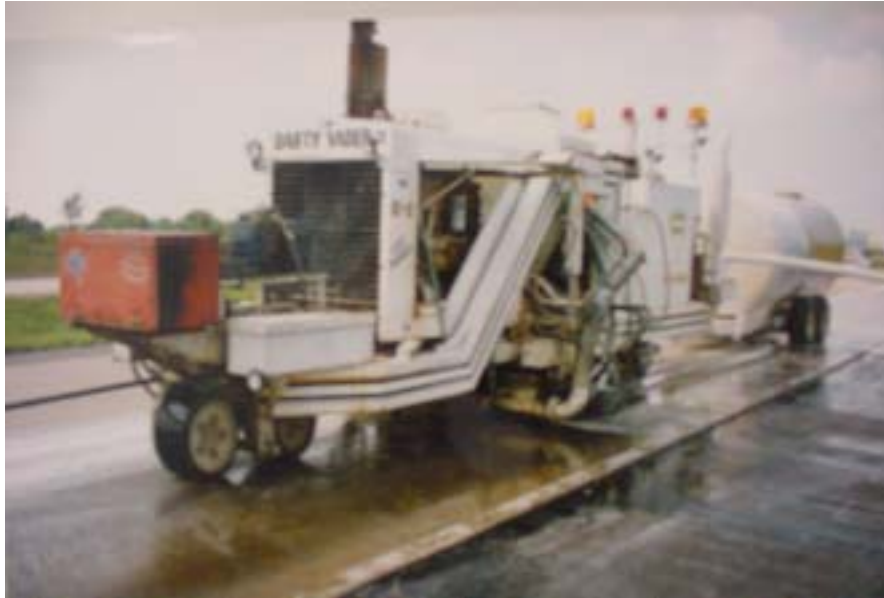
Diamond grinding on I-44 in Greene County

Based on these results it was recommended that diamond grinding in Missouri be limited to pavements with adequate load transfer and support and maximum average faulting around one-half inch. Expected service lives should be five to ten years depending on the type and condition of the pavement.

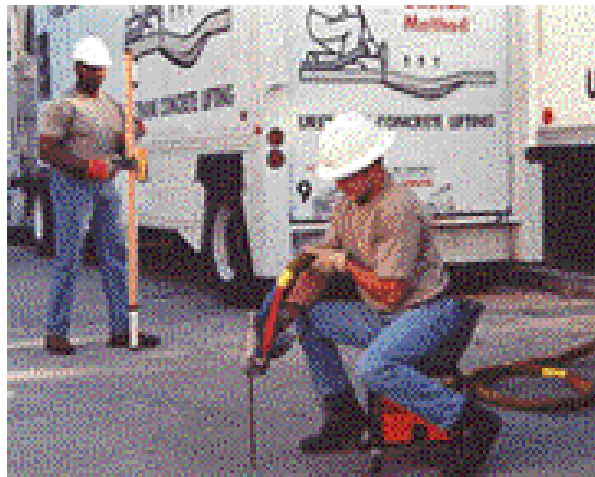
Polyurethane undersealing

Missouri has had extensive experience undersealing, both by maintenance forces and contractors. In fact, Missouri may be one the few remaining states that uses it routinely. The performance of undersealed slabs has never really been monitored in Missouri, often because they are about to be covered with an AC overlay.

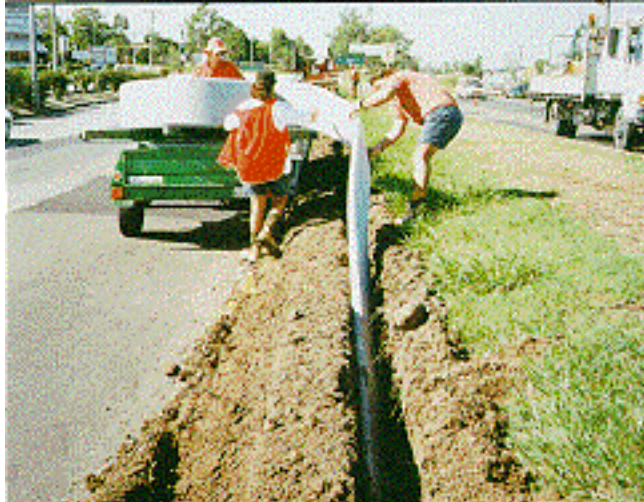
Geocomposite edge drain retrofitting

Missouri has retrofit longitudinal edge drains on a few projects including several test sections at the LTPP site in Harrison County. It has been difficult to tell if they have had any real impact. Although there is water coming out of the retrofit outlets, it appears to be collecting only local moisture close to the pipes.

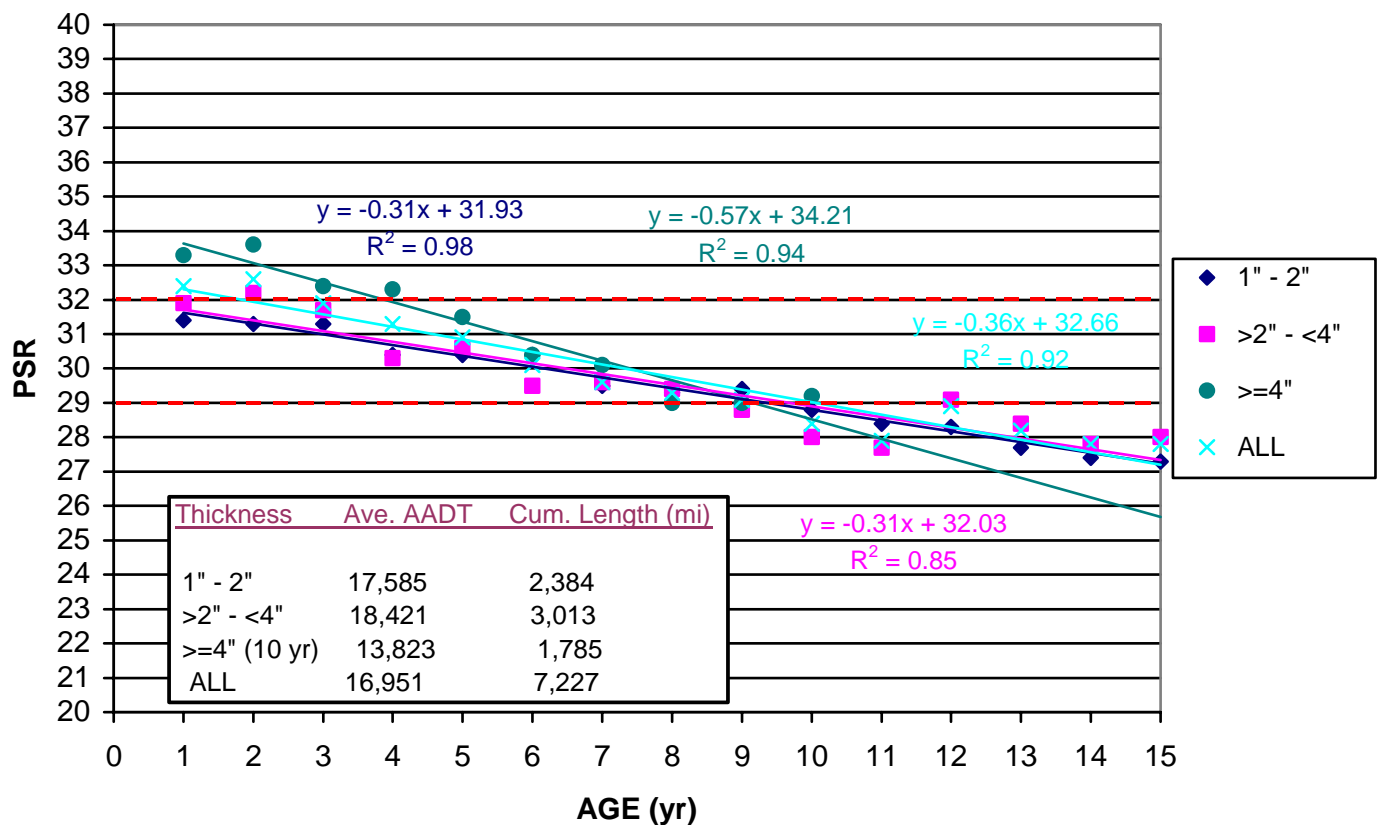
### AC overlays split by thickness

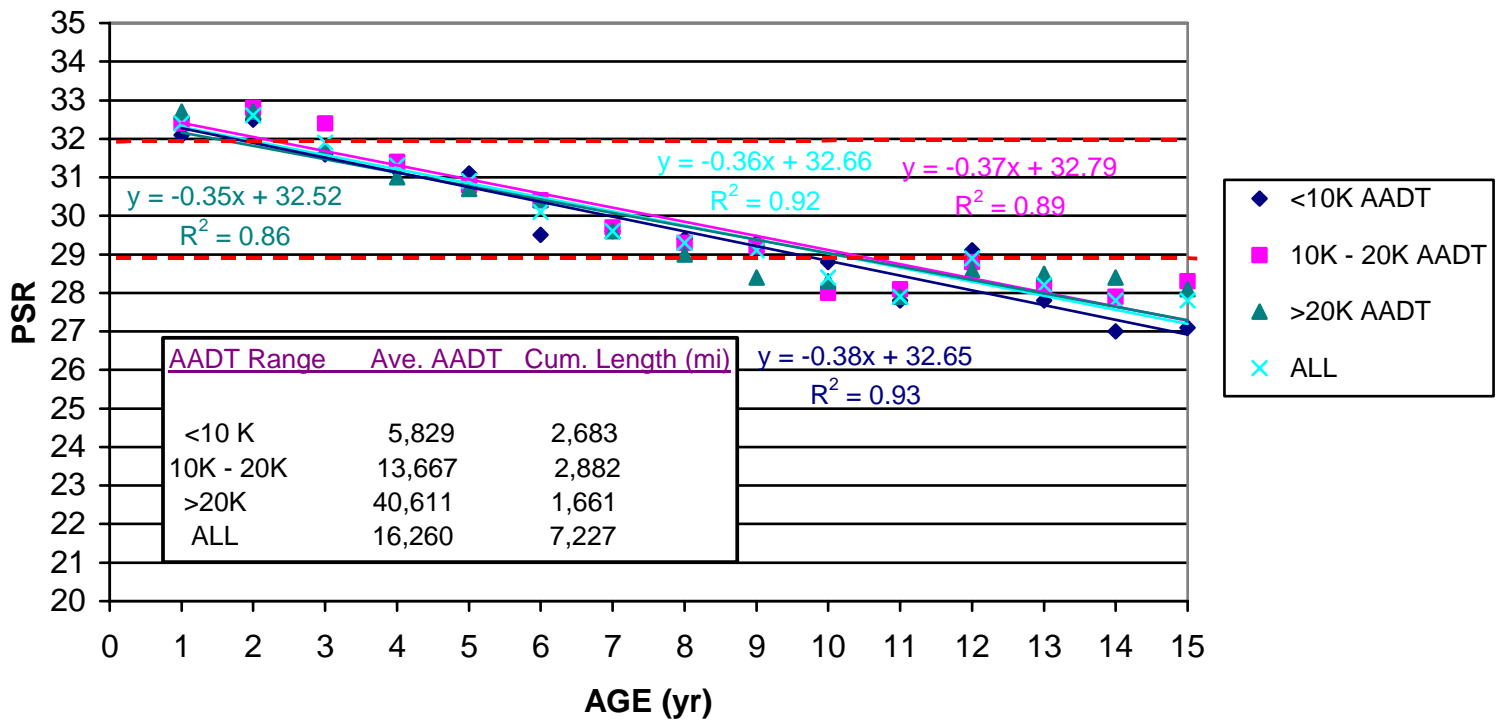
*AC overlays split by AADT range*

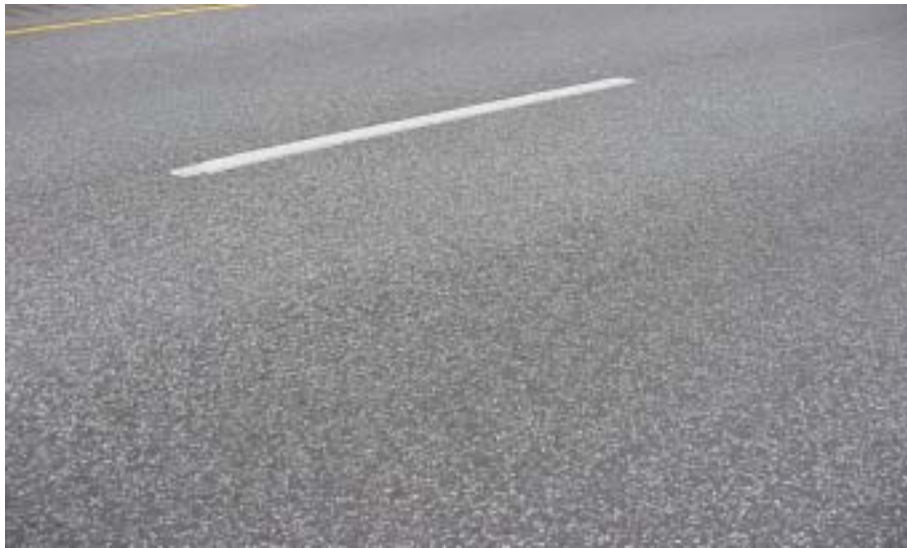
SMA on WB I-70 in Boone County

Stone matrix asphalt (SMA) overlays are an alternative to standard hot mix wearing courses. Their stone-to-stone matrix, blend of superior coarse aggregates and fiber additives are designed to withstand rutting and wear. SMAs were first placed in Missouri in 1991. Most SMA wearing courses were placed on I-B binder mixes, which have since been replaced by SP250 (Superpave) mixes.

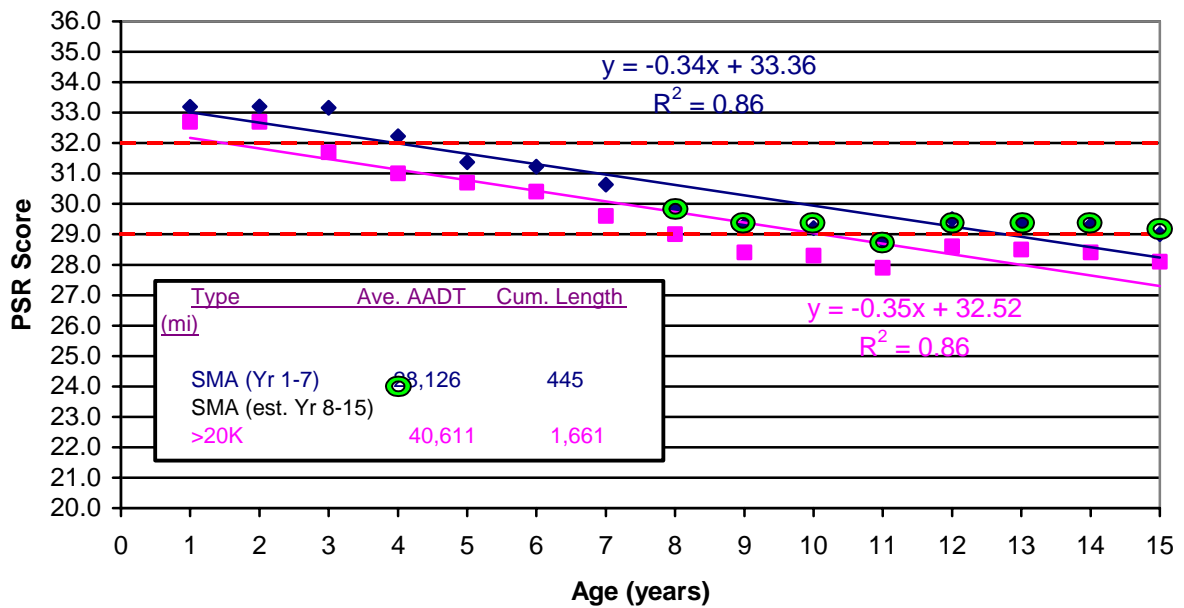
## PSR for Stone Matrix Asphalt vs ACOL (> 20,000 AADT)

Based on this estimated extrapolation of performance data SMA overlays have roughly two more years of serviceable life than conventional ACOLs. The reasons for this increase seem to be identified in the rutting and cracking graphs below. SMAs appear to slow down the advent of reflective cracking more than conventional ACOLs. Also, their rutting, after initial traffic compaction, saw no increase, whereas conventional ACOL rutting kept growing.

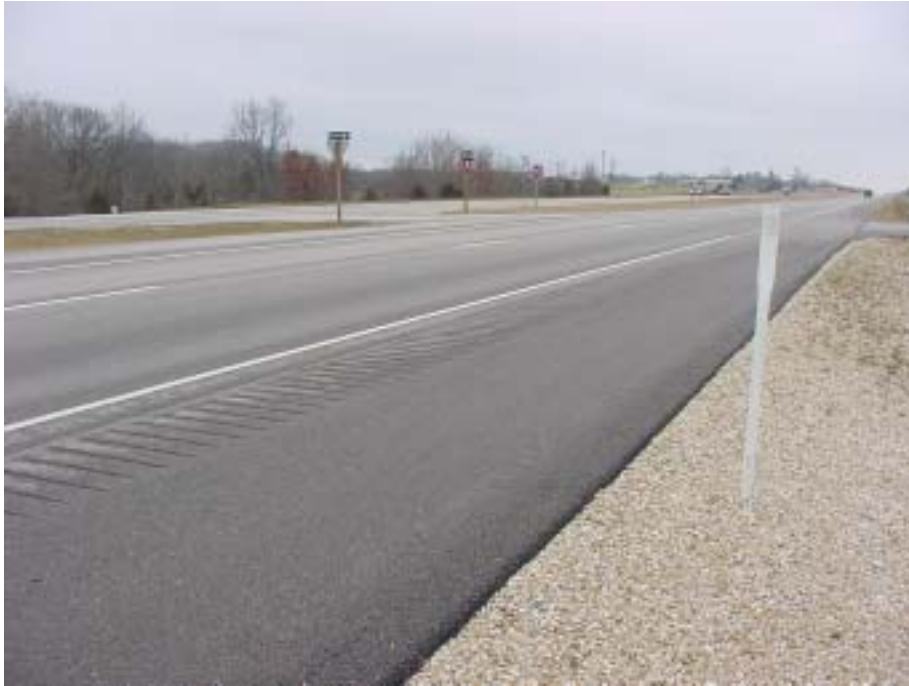
Full depth Superpave pavement on northbound US 63 in Boone County

Missouri has constructed a handful of full-depth Superpave pavements. As with Superpave overlays, the performance of full-depth Superpave mixes in Missouri is difficult to ascertain for the same reasons that no other state has been able to; they haven't been down long enough. We have two to three years of data for two projects, Route 21 in Iron County and U.S. 54 in Camden County. Early performance on these projects has been superb.

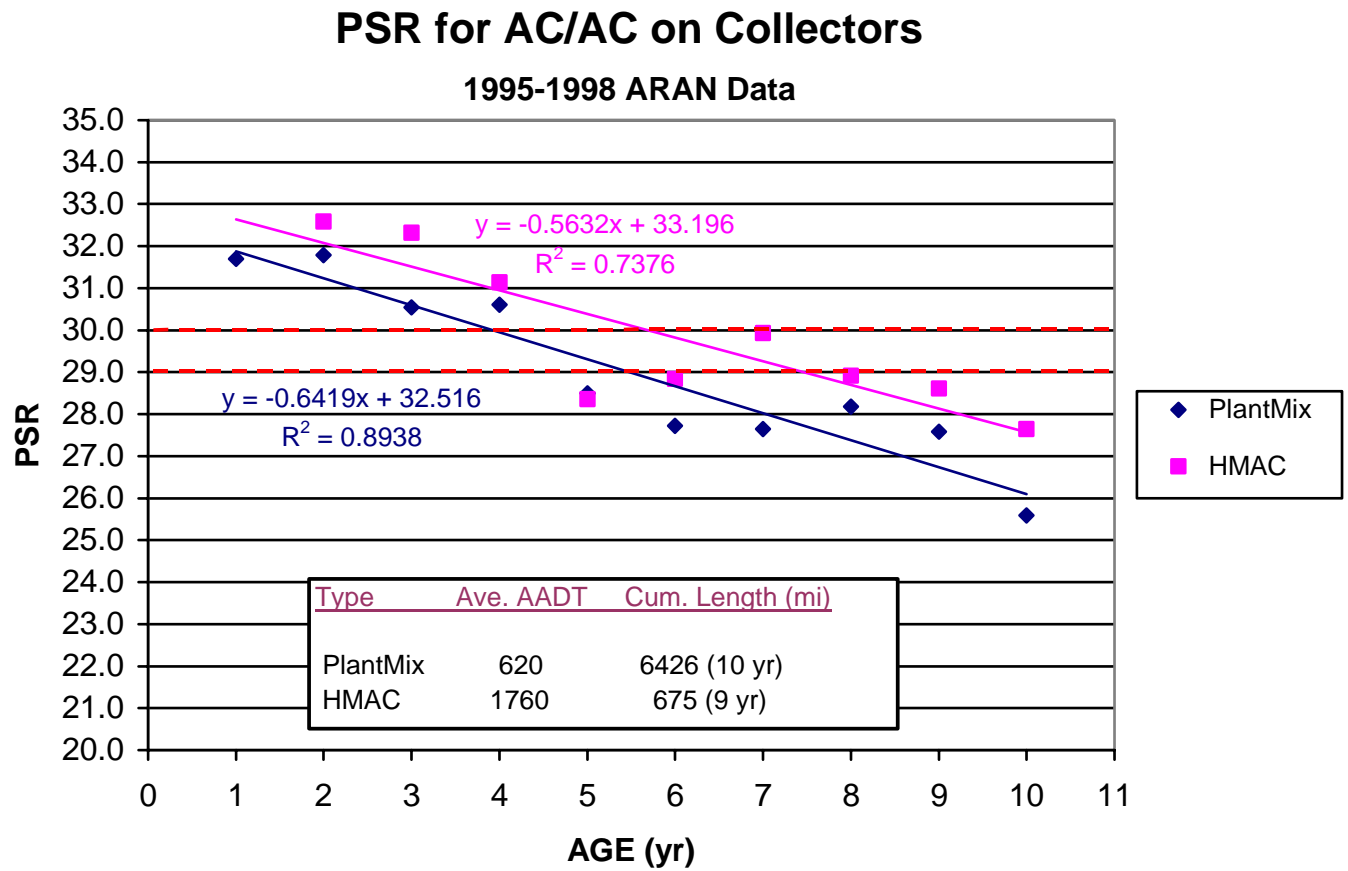
Long-term performance of ACOLs on full depth AC on collectors is similar to that on arterials. The “Plant Mix” category falls into the unacceptable zone at six years. The “HMAC” performs adequately for about a year longer than the “Plant Mix”.

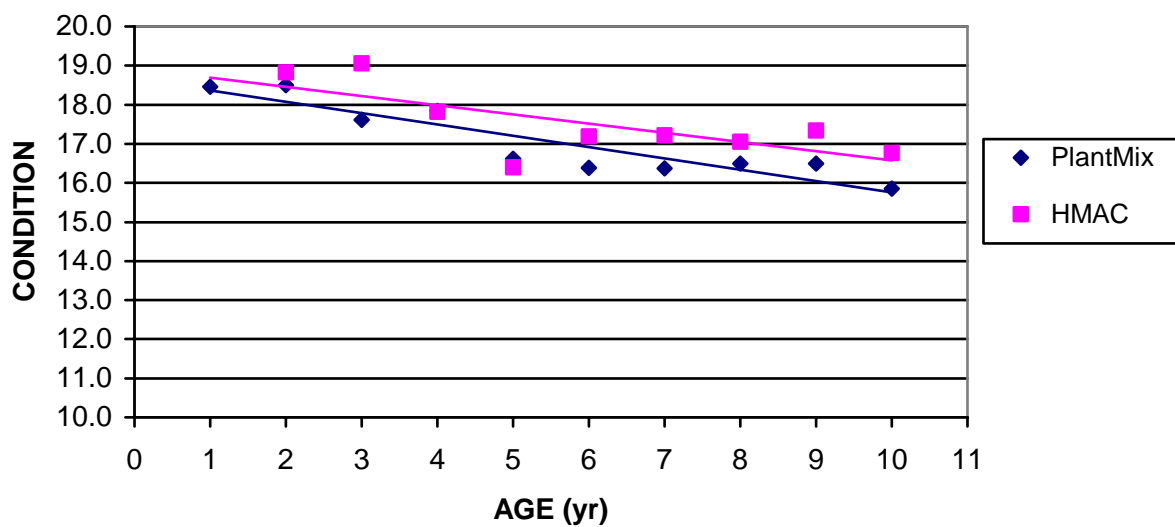
## Condition for AC/AC on Collectors

The IRI and condition graphs below provide a picture of how the full depth AC collectors increase in roughness and visual distress.

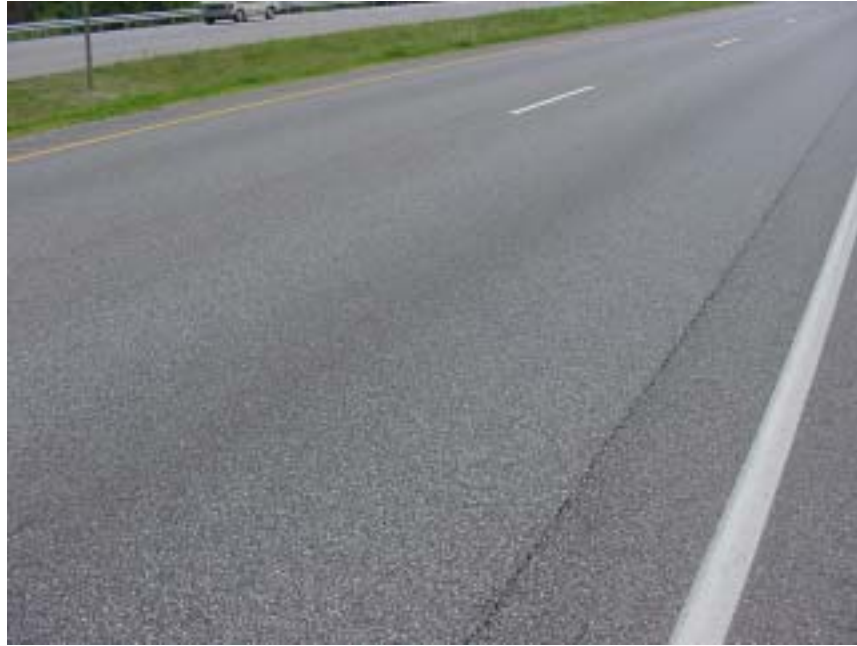
Full depth Superpave AC on US 54 near Camdenton

First and most importantly, Superpave mix designs are expected to yield high performance dividends. The rigorous mix and binder testing specifications raise the bar for product acceptability.

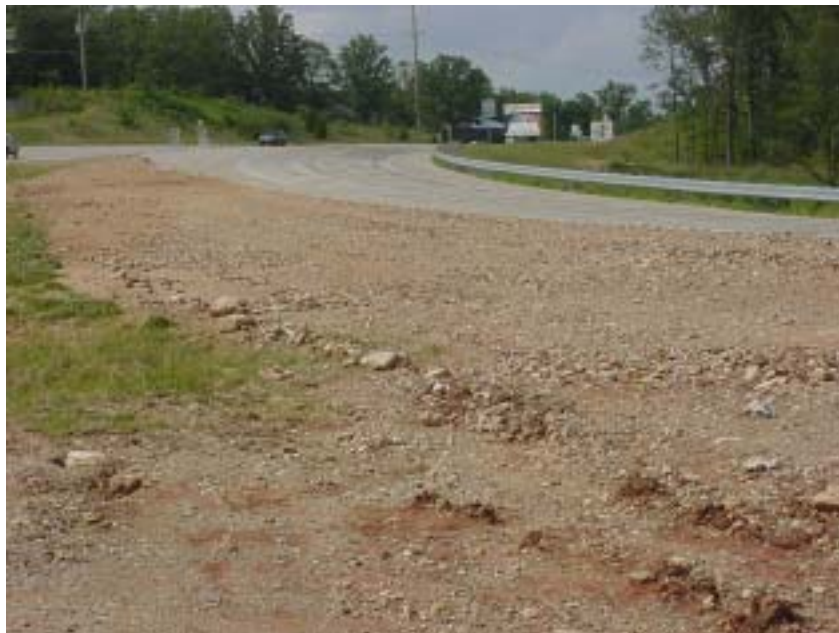
Two-foot rock base on US 54 near Eldon

Second, the two-foot rock base, when used, provides superior support. Unlike thick PCC, which is theoretically nearly impervious to moderate changes in base and subbase stiffness, AC pavements greatly benefit from stiffness increases. This layer reduces fatigue by decreasing bottom radial strains, and rutting by better withstanding vertical compressive stresses.

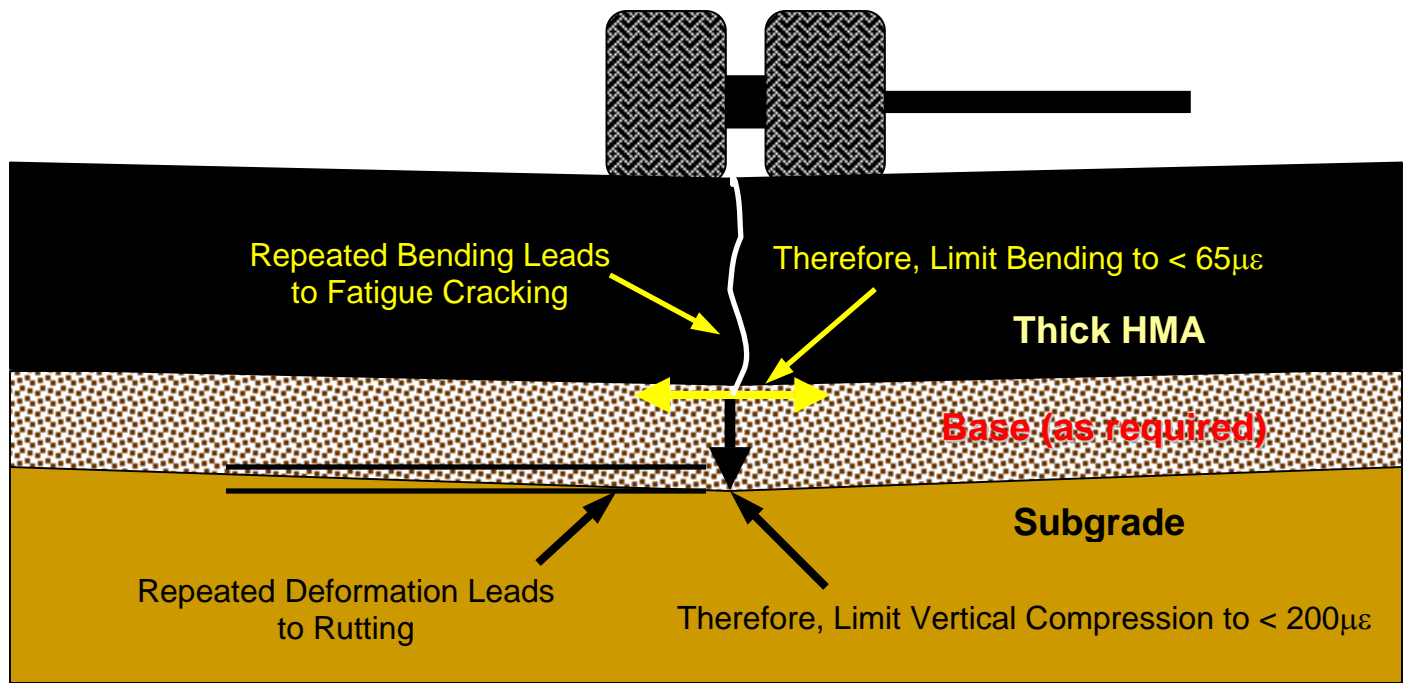
Perpetual Pavement Design

“Perpetual pavement” is an expression coined by the National Asphalt Pavement Association (NAPA) and the Asphalt Institute (AI) to describe a full-depth AC design that pushes back the traditional time for rehabilitation. The concept is not really new, but better defined. Since the two fundamental pavement responses that initiate distresses in AC are tensile strains at the bottom of the AC layer (which lead to fatigue cracking) and compressive stresses on top of the unbound base or subgrade (which leads to rutting), then the pavement need only be designed to minimize them. Providing a stiff, thick surface course on top of an intermediate binder layer dissipates compressive stresses. Constructing a rich, densely compacted bottom layer renders the pavement immune to repetitive tensile strains. The combined layer thickness is significant.
