# Instrumentation and Monitoring of Rustic Road Geosynthetic Reinforced Soil (GRS) Integrated Bridge System (IBS)

Final Report Prepared for Missouri Department of Transportation  
November 2016 Project TR201417 Report cmr16-019

16. Abstract An instrumentation and monitoring system was implemented for a geosynthetic reinforced soil (GRS) integrated bridge system (IBS) constructed in Boone County, Missouri in 2014. The project location is subjected to relatively frequent flash flooding, which was a significant consideration in the design of the bridge and the design of the monitoring system. The monitoring system includes 26 surveying points on the bridge exterior to monitor external movement; settlement plates and inclinometers to monitor vertical and horizontal exterior movement, respectively; earth pressure cells to monitor total stresses within the abutment backfill; and vibrating wire piezometers to monitor pore pressures and drainage within the abutment backfill. The GRS-IBS was monitored for a period of 19 months after construction. The monitoring period included several high-water events, but none overtopped the bridge. The results indicate satisfactory performance, includi

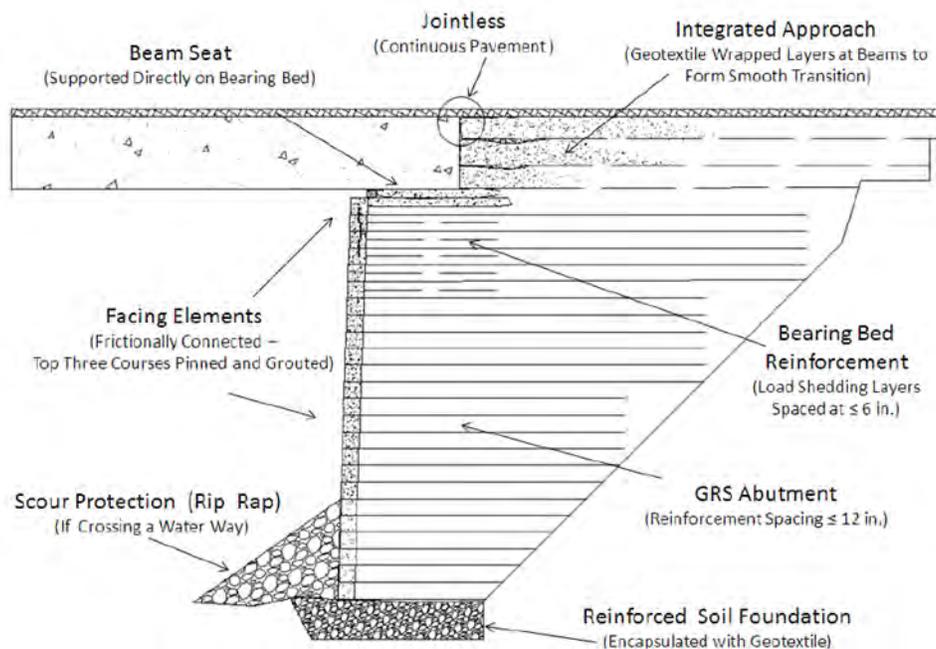
**Figure 1: Components of a GRS-IBS abutment from Adams et al. (2012).**

Early implementations of GRS primarily involved retaining walls and slopes, but its use for bridges via GRS-IBS (Figure 1) has accelerated since FHWA introduced GRS-IBS as an Every Day Counts initiative in 2011 (Adams et al., 2011). As part of the initiative, FHWA published the *GRS-IBS Interim Implementation Guide* (Adams et al., 2012) and the *GRS-IBS Synthesis Report* (Adams et al., 2011). The guide includes recommended material specifications and procedures for design and construction of GRS-IBS, as well as recommended inspection methods, QA/QC procedures, and maintenance procedures. The synthesis report documents technical background for GRS-IBS, including the research studies and case histories used to develop the implementation guide.

Chapter 3 of the guide presents information regarding materials for GRS-IBS walls, the most significant of which are shown in Figure 1. The facing elements for GRS-IBS are most frequently concrete masonry unit (CMU) blocks. CMU blocks have several advantages: they are relatively inexpensive, they provide a form for compaction of backfill material, and extending the geosynthetic between the rows of CMU blocks serves as a frictional connection. Selection of GRS backfill material is critical since the GRS is a structural component directly supporting the bridge load. The guide recommends either well-graded or open-graded

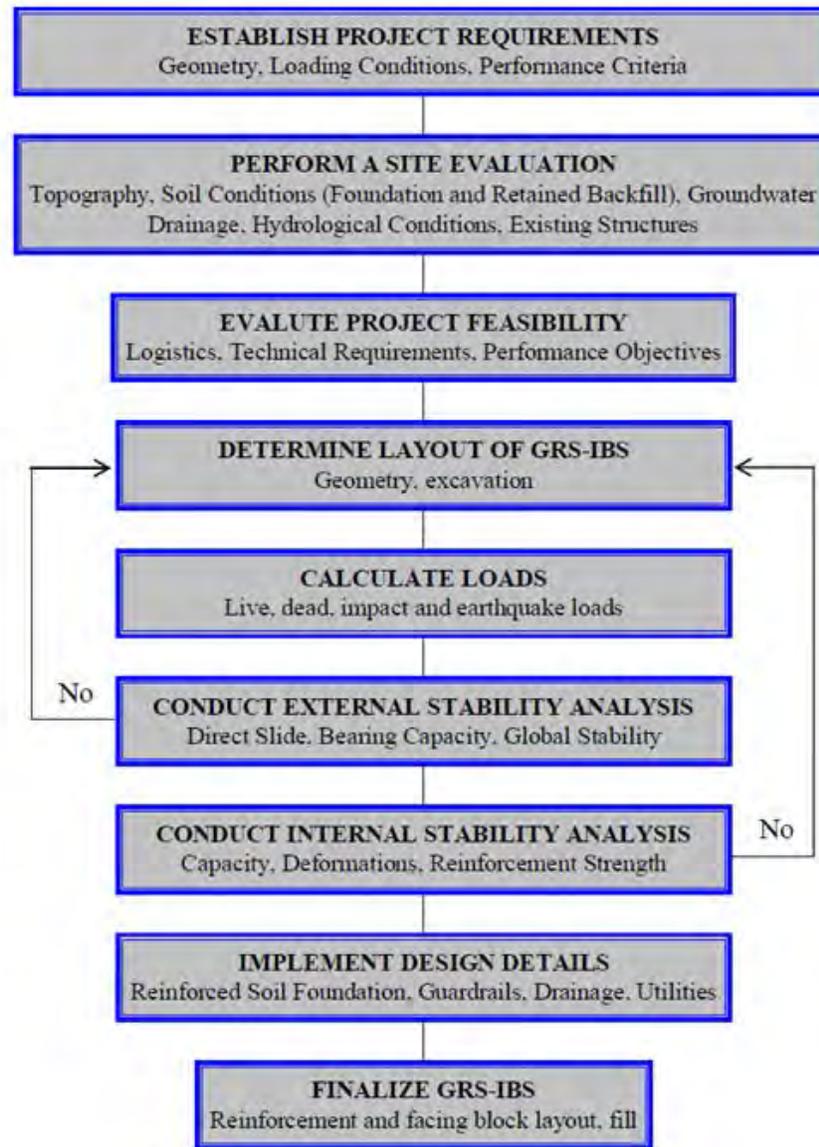
Figure 4: GRS-IBS design steps from FHWA *Interim Implementation Manual* (Adams et al., 2012).

A detailed GRS-IBS design procedure is presented in Chapter 4 of the guide, which begins with the outline of the procedure shown in Figure 4. The guide states that GRS has been shown to perform well “under certain extreme conditions,” but the guide limits its recommendations to GRS-IBS structures with heights not exceeding 30 ft and spans not exceeding 140 ft. The guide also emphasizes requirements for backfill compaction to 95% of maximum dry density and reinforcement spacing less than 12 in. in the introduction to the design guidance. The design procedure detailed in the guide and outlined in Figure 4 is similar to the procedure FHWA recommends for design of MSE walls, with a few important differences. One difference is the third step, which involves evaluating the feasibility of using GRS-IBS. The guide primarily discusses the importance of evaluating scour for GRS-IBS over water since GRS-IBS have no deep foundation elements. Another main difference is the load calculation. GRS-IBS is subjected to significant loading from the bridge dead and live loading; in a typical MSE abutment, the bridge loads are transferred to deep foundation elements rather than the MSE backfill. Finally, the internal stability analysis procedure is notably different for GRS-IBS since GRS backfill is a composite material (e.g., the differences between Equations 1 and 2 for required reinforcement strength).

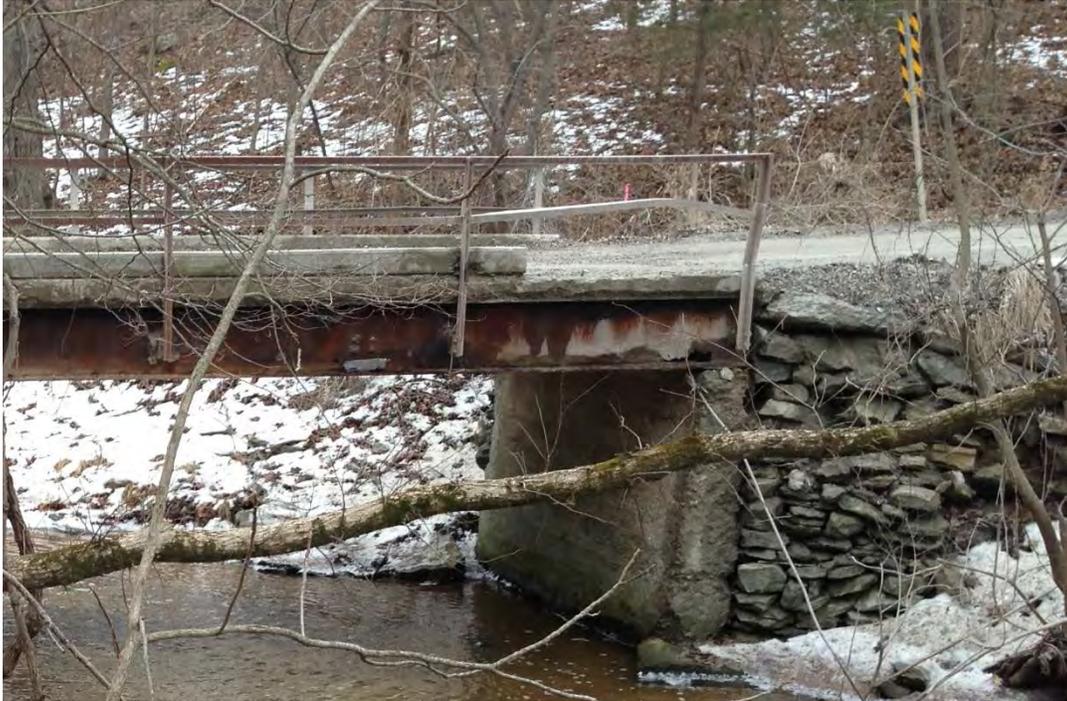
**Figure 5: Original Rustic Road bridge showing deterioration of the outer girder, including corrosion through an entire portion of the web near the abutment.**

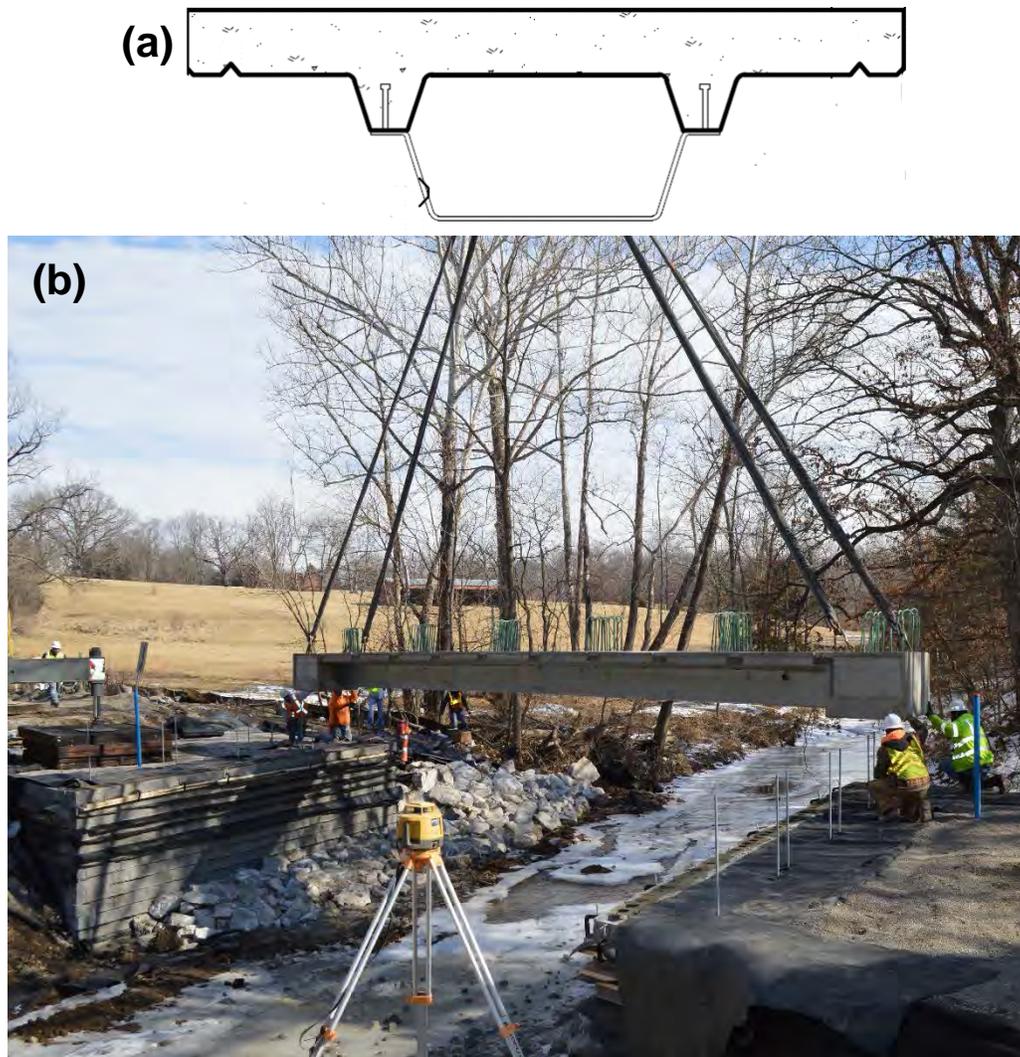
**Figure 6: Tub girders with precast bridge deck: (a) cross-section and (b) photograph of tub girder being lowered into place.**

Design of the bridge replacement was completed by Bartlett and West, Inc. of Jefferson City, Missouri. The design was completed largely in accordance with the FHWA *GRS-IBS Interim Implementation Manual* (Adams et al., 2012). Plans for the completed design are included in the appendix. GRS-IBS was not the only innovative initiative included for the Rustic Road bridge replacement. The superstructure consists of four tub girders with attached precast bridge deck sections as shown in Figure 6. The four pieces were fabricated off-site, and placement of the girders was completed during the course of one day. To counter buoyancy forces on the tub girders, each girder was anchored to plates embedded approximately 3 ft in the GRS via the bolts shown in Figure 6(b). Plates are shown in Figure 23. Vent holes were also included in the girders to prevent trapped air from forming between the tubs during a flood.

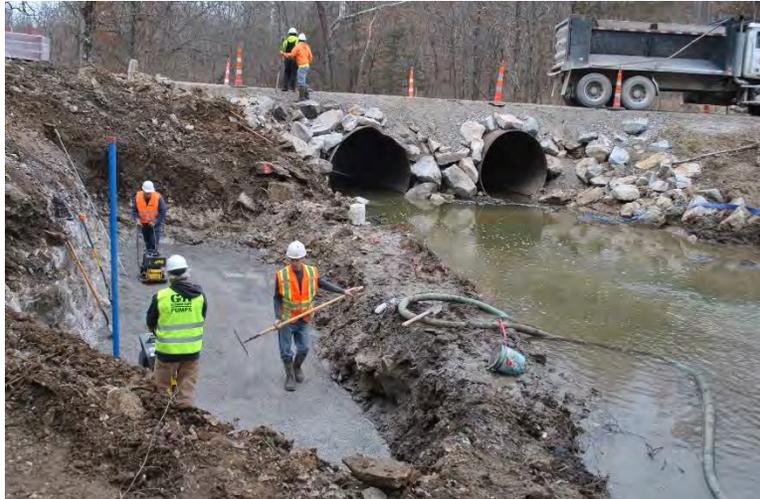
Figure 9: Compaction of reinforced soil foundation for the south abutment.

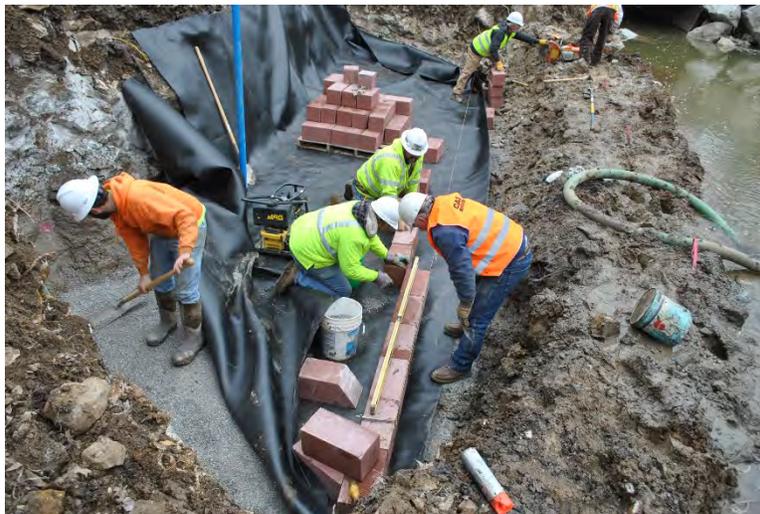
Figure 10: Placement of bottom row of CMU blocks for south abutment. Red blocks were used for first five rows for scour indication. Leveling the bottom row is critical per FHWA *Implementation Manual* (Adams et al., 2012).

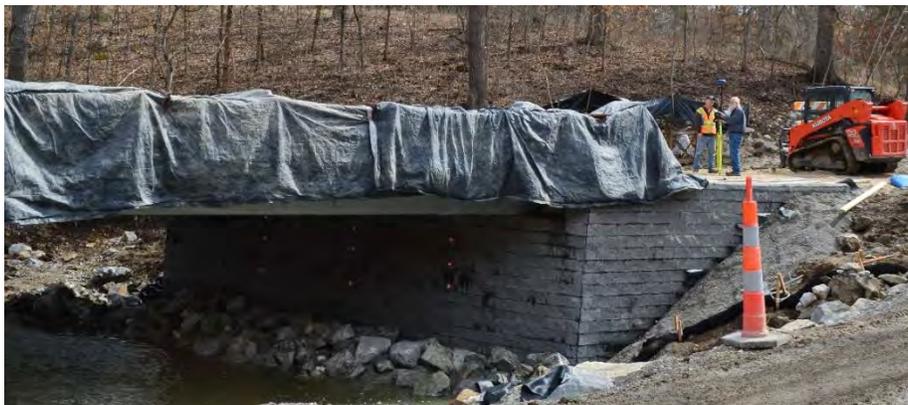
**Figure 35: City of Columbia survey crew performed initial survey after Rustic Road GRS-IBS was substantially complete but before it was open to traffic.**

Surveying was conducted by the City of Columbia survey crew on a quarterly basis, with an initial survey conducted upon completion of construction of the GRS-IBS as shown in Figure 35. The benchmark for all site surveys was a survey marker established in the limestone bedrock exposed in the bed of the creek below Rustic Road GRS-IBS (Figure 36). The survey crew used a total station device to perform the surveying. Twenty-eight points on the Rustic Road GRS-IBS were surveyed each quarter to monitor external movement. The points include 12 reflective markers on the face of each abutment as shown in Figure 37 as well as the four corners of the bridge. In addition, the survey crew surveyed the settlement plate devices described in the next section.

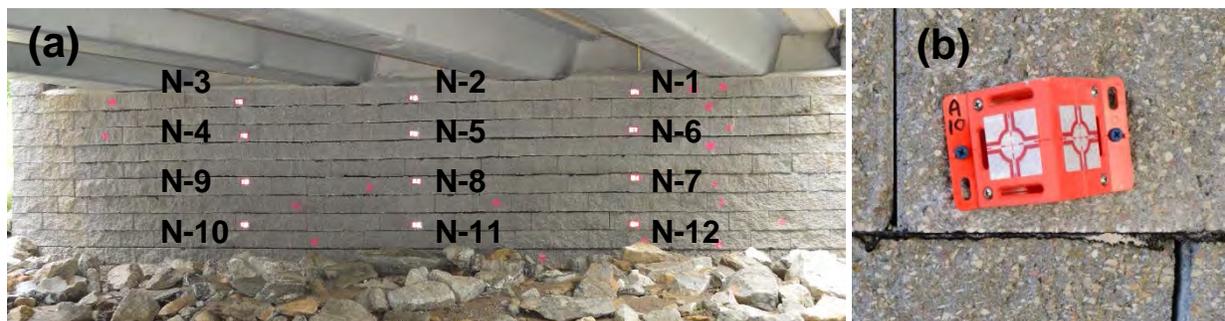
Figure 37: A grid of 12 reflective survey markers bolted to CMU blocks was installed on the face of each abutment: (a) Grid for north abutment with marker labels as established by survey crew and (b) close view of reflective marker. Labeling for south abutment markers is similar after substituting “S” for “N,” but the location of markers 1 and 3, 4 and 6, and 7 and 9 are reversed.

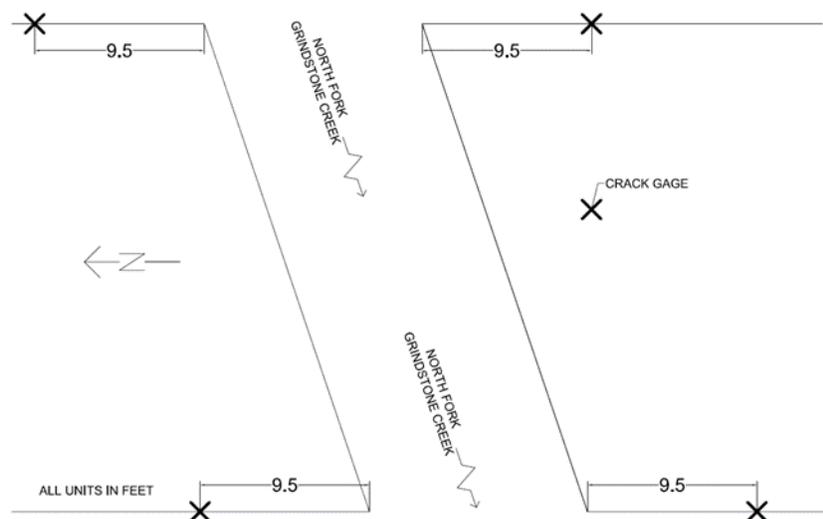
Figure 38: Crack gages were installed where cracks developed on all four wing walls (plan view).

Shortly after construction completion, cracks developed at the top of all four abutment wing walls at the locations shown in Figure 38. The cracks are discussed in Chapter 4. Each crack was monitored using a crack gage as shown in Figure 39. Each crack gage has two plastic pieces, one with a 40 mm by 20 mm grid and the other with a crosshair. Epoxy was used to attach the pieces to opposite sides of the crack being monitored so that further opening of the crack would be indicated by movement of the crosshair with respect to the grid.

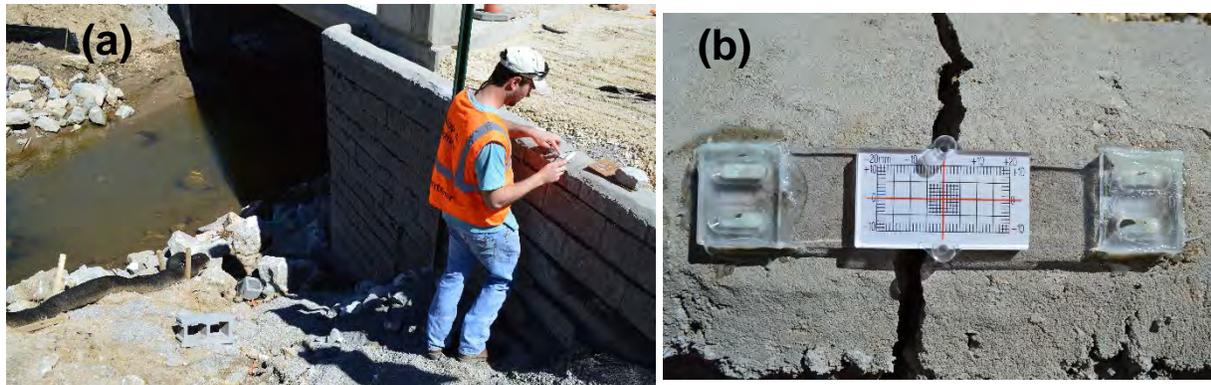
**Figure 39: Crack gages were used to monitor cracks that developed shortly after completion of GRS-IBS: (a) installation of gage and (b) close view of crack gage.**

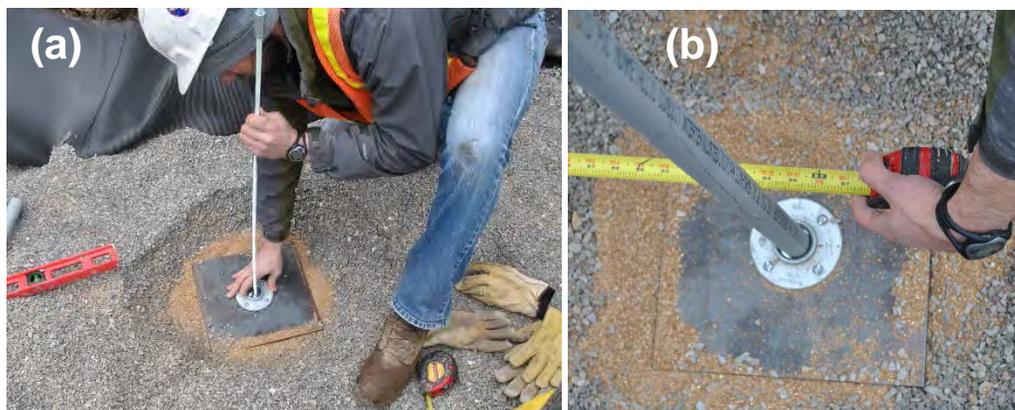
**Figure 40: Installation of bottom settlement plate: (a) placement and leveling on thin layer of coarse sand and (b) loose PVC sleeve over steel rod prevents friction between rod and aggregate.**

As shown in Figure 40, the settlement plate devices consist of 12-in. square, 0.25-in. thick steel plates that were embedded in the backfill, with threaded steel rods extending up from the plates to the top of the abutment. Coarse sand was placed between the bottom of the settlement plate and the coarse gravel GRS backfill to facilitate horizontal installation of the plates. The threaded rods extended up to the top of the abutment through loose PVC sleeves, which prevent friction between the rod and backfill (Figure 40b). As shown in Figure 41, the three settlement plates were installed above one another (i.e. along a vertical line) about 5 ft behind the north abutment wall, with the bottom plate about 2 ft above the reinforced soil foundation, the middle plate about 6 ft above the foundation (i.e. mid-height), and the top plate about 3 ft below the pavement. The upper two plates were slotted to allow the rod and pipe from the lower plate(s) to pass through the upper plates as shown in Figure 42. The pipes and rods from all three plates were housed in a common cast iron housing embedded in the pavement (Figure 43). In plan view, the settlement plates were located in the center of one driving lane to reduce the incidence of vehicle tires striking the housing. Settlement plate measurements were collected via the land survey performed by the City of Columbia survey crew as described in the previous section. The surveys were collected quarterly throughout the monitoring period.

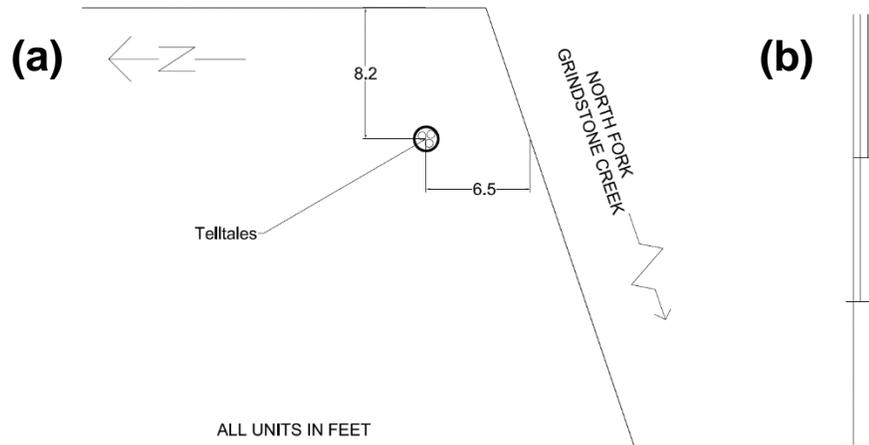
Figure 41: Settlement plate locations within the north abutment: (a) plan and (b) elevation.

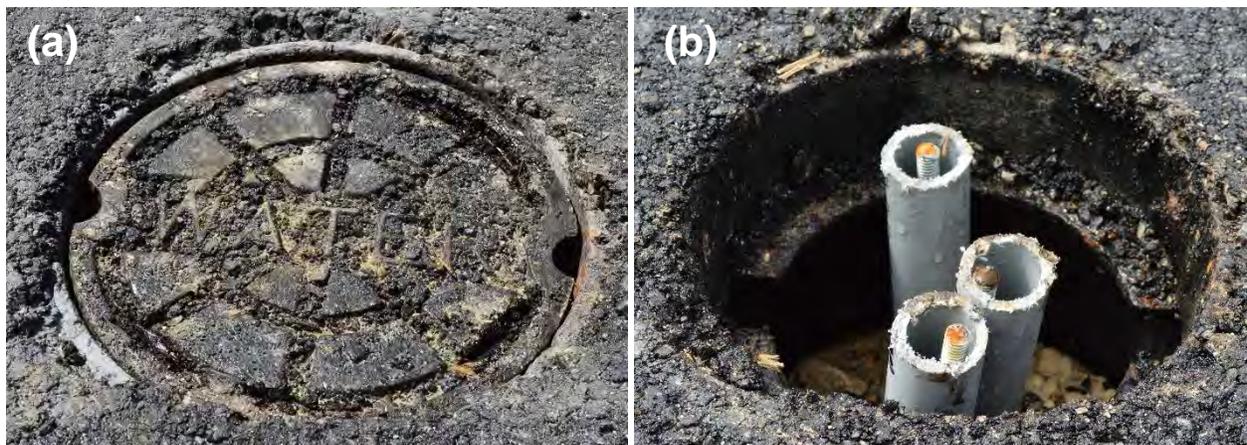
Figure 43: Settlement plate rods and PVC were extended to common cast iron housing embedded in the roadway surface: (a) housing with cover and (b) housing without cover.

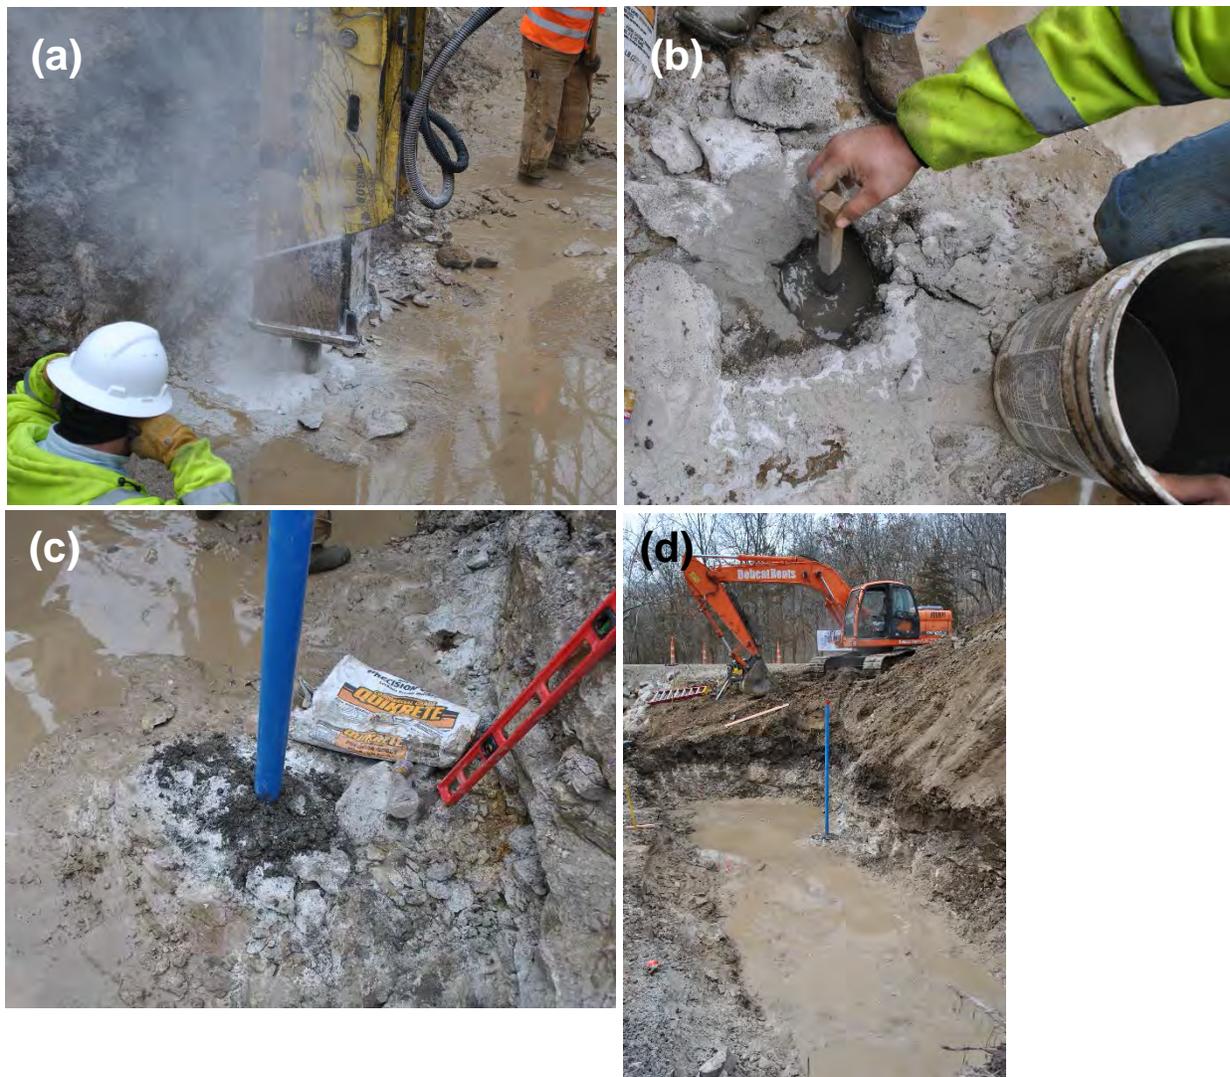
**Figure 44: Inclinometer casing installation: (a) chipping out 12-in. of limestone bedrock, (b) mixing grout within hole in bedrock, (c) casing is inserted in grouted hole, and (d) view of final installation. GRS abutment was built up around casing as shown in Chapter 2 photographs.**

An inclinometer system was used to measure lateral internal displacement of each GRS abutment. The inclinometer system consists of a proprietary plastic casing and an inclinometer probe. The casing has four machined grooves at 90-deg. angles running along its length. The casing is installed so that the bottom of the casing is fixed and the top is accessible at the ground surface. For the Rustic Road abutments, the bottom of each casing was fixed as shown in Figure 44: a 12-in. deep hole into limestone bedrock was established by chipping, the hole was filled with grout, and the casing was set in the hole. The probe has wheels that travel along the casing grooves. As the probe is lowered down and raised up the casing (Figure 45), the probe records measurements of angle with respect to gravity. Integration of the measurements results in an interpreted casing shape, and comparison of subsequent sets of readings produces change in casing shape, which is interpreted as lateral deflection of the abutment. Additional details of the inclinometer system are provided in the system instruction manual (Slope Indicator, 2011). Like the settlement plates, inclinometer casings were also located about 5 ft behind the abutment wall face and in the center of a driving lane (Figure 46), and the tops of the casings were located in cast iron housings. Inclinometer readings were collected by the University during each monitoring site visit. The visits occurred monthly for the first year of monitoring and then every other month for the following six months.

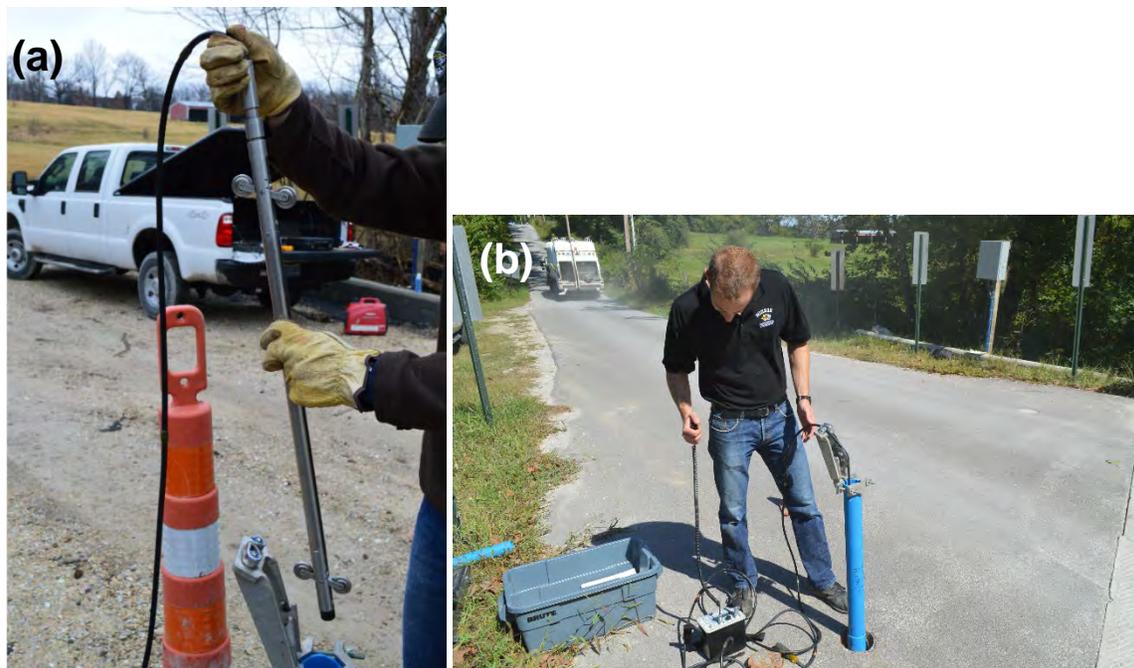
**Figure 45: Collection of inclinometer data: (a) inclinometer probe is inserted into casing and (b) probe measurements are recorded in 2-ft increments as the probe is lowered to the bottom of casing and then raised back up to the ground surface. A pulley assembly and casing extension were used to facilitate data collection.**

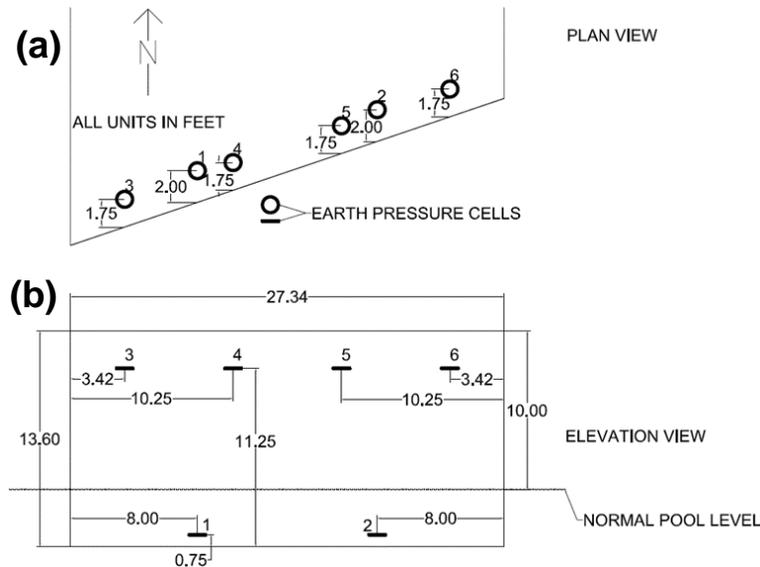
**Figure 47: Earth pressure cell locations: (a) plan and (b) elevation. Six cells were installed in the north abutment, two near the bottom and four near the top beneath the center of each girder.**

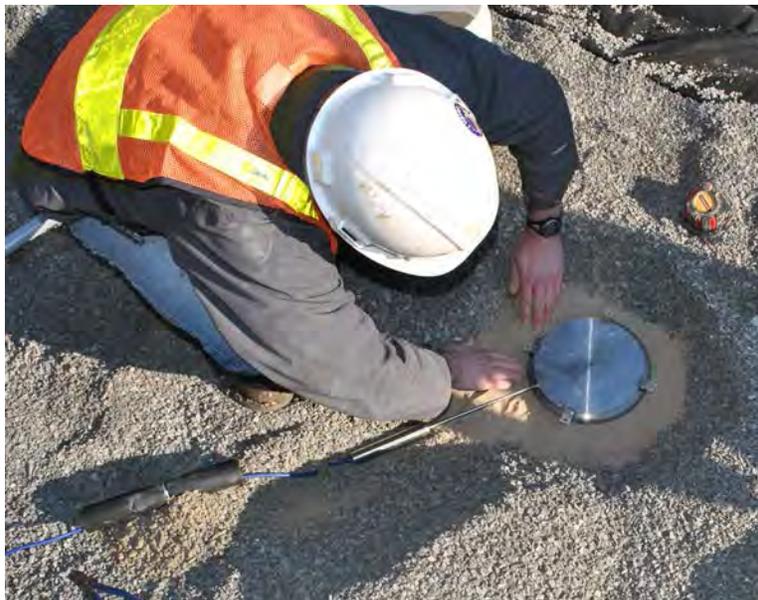
**Figure 48: Installation of EPC-1 near the bottom of the north abutment.**

Vibrating-wire earth pressure cells were used. A photograph of one of the instruments is shown in Figure 48. The instruments consist of two circular stainless steel plates welded together with a thin space between the plates that is filled with hydraulic oil (Geokon, 2011). Theoretically, the pressure of the hydraulic fluid is equal to the pressure applied by the soil in contact with the plates. In practice, the pressure applied by the soil is typically somewhat different from the actual total stress within the soil because the stiffness of the pressure cells is not equal to the stiffness of the soil, resulting in a redistribution of load. If the cells are stiffer than the soil, the earth pressure indicated by the cells will be greater than the actual earth pressure (i.e. the earth pressure that would be experienced if the cells were not present). If the cells are less stiff than the soil, the earth pressure indicated by the cells will be less than the actual earth pressure. Note that the “earth pressure” measured by the instruments is equivalent to “total stress” in conventional geotechnical parlance. To determine effective stress, the pore pressure at the cell location must be subtracted from the total stress.

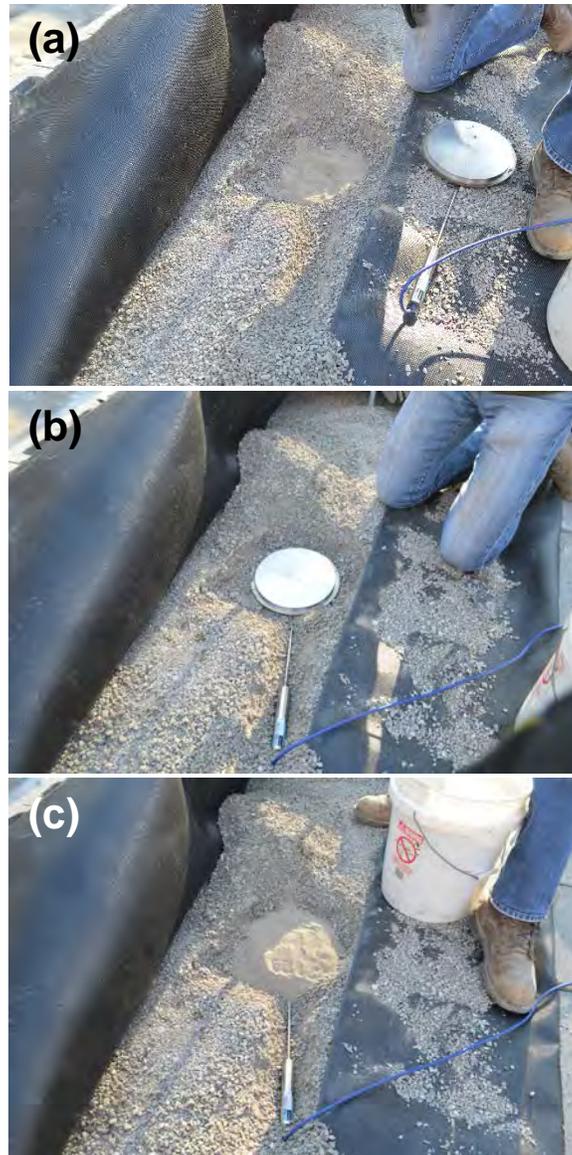
**Figure 49: Installation of EPC-3 in bottom layer of bridge seat: (a) thin layer of fine sand is placed across bottom of hole for earth pressure cell, (b) earth pressure cell is placed atop fine sand, and (c) another layer of fine sand is placed atop earth pressure cell.**

Earth pressure measurement difficulties associated with stiffness contrasts can be exacerbated by installation issues. The goal of the installation is to achieve a uniform stress distribution across the plates and above and below the cell. To achieve a uniform distribution, the instruments were installed horizontally and with a thin layer of fine sand above and below the cells as shown in Figure 49. The sand prevents the uneven distribution that would result from angular pieces of gravel directly in contact with the cells. The sand layers were relatively thin to prevent large changes in backfill density above and below the cell. Installation of EPC-3 through EPC-6 was complicated by GRS-IBS details for the beam seat, which include two 4-in. thick layers of backfill wrapped in geotextile as shown in the project plans included as an appendix to this report. EPC-3 through EPC-6 were installed in the bottom 4-in. thick layer (Figure 49).

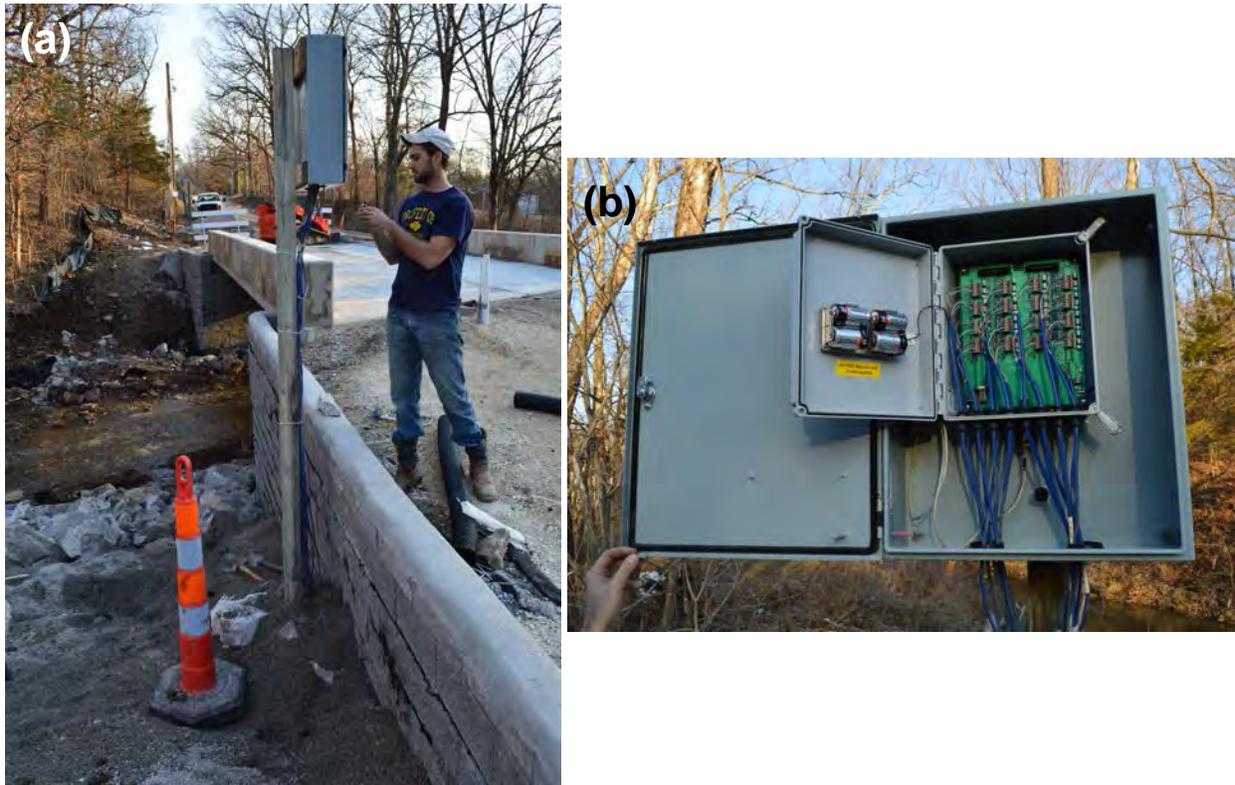
**Figure 50: NEMA enclosure housing datalogger: (a) post installed just east of the north abutment, with bottom of enclosure above 100-year flood level and (b) front view of the NEMA enclosure and datalogger. Each blue cable carries signals from one vibrating wire device.**

Measurements from the cells were read and recorded by a data logger on site as shown in Figure 50. The logger was set to record measurements every 2 hours; the research team collected data during each site visit. The logger also recorded measurements from the pore pressure instruments described in the next section. Additional details regarding the logger are included in its instruction manual (Geokon, 2013b). The logger was housed in a National Electrical Manufacturer Association (NEMA) enclosure, which was installed on a post just east of the north abutment. The enclosure was installed so that the bottom of the enclosure was above the 100-year flood elevation for the project site.

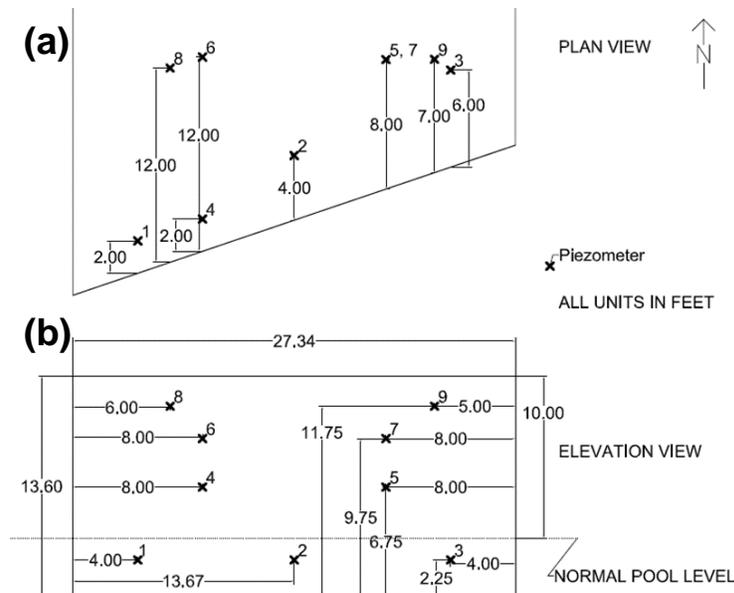
Figure 51: Piezometer locations within north abutment: (a) plan and (b) elevation.

For Rustic Road, ten vibrating wire piezometers were installed to measure pore pressure within the north abutment backfill. The piezometers were distributed as shown in Figure 51 to obtain a representative sampling of the pore pressures throughout the abutment. A photograph of a piezometer during installation is shown in Figure 52. The piezometers were installed inside sand pockets with the GRS backfill to stabilize the pore pressure measurements.

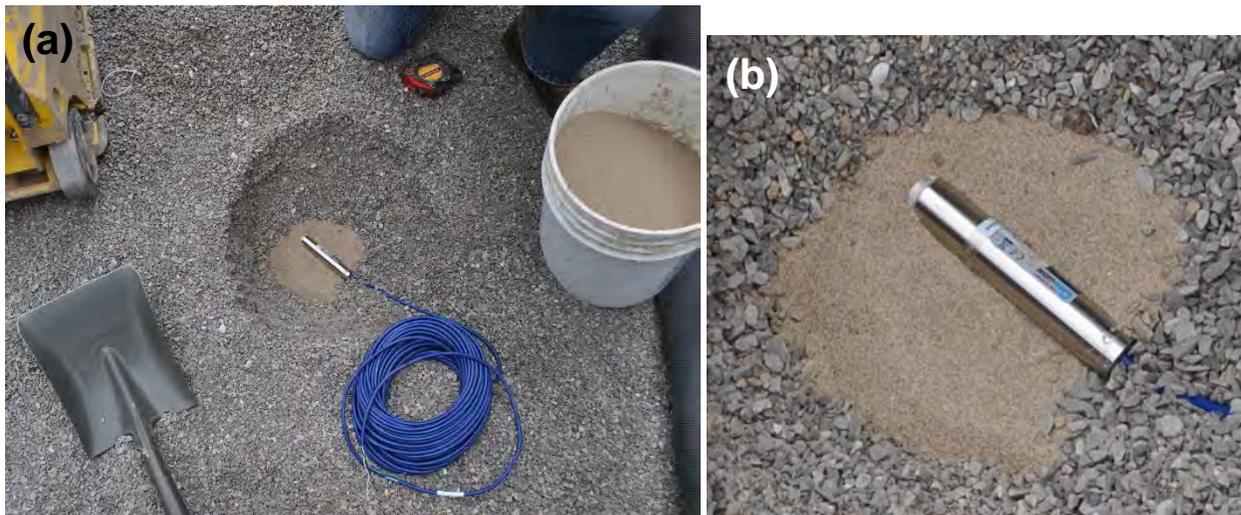
Figure 52: Piezometer PZ-1: (a) installation in sand pocket within GRS backfill and (b) close view of vibrating wire piezometer.

The piezometer measuring device, a diaphragm that responds to changes in pore pressure within the backfill, is located inside the stainless steel housing (Geokon, 2013a). A filter stone is located on one end

of the housing. Signals from the vibrating wire element and an internal thermistor are transmitted via a cable exiting the opposite end of the housing. Measurements from the cells were read and recorded by the same data logger that was used to record earth pressure cell data (Figure 50). The logger was set to record measurements every 2 hours; the research team collected data during each site visit.

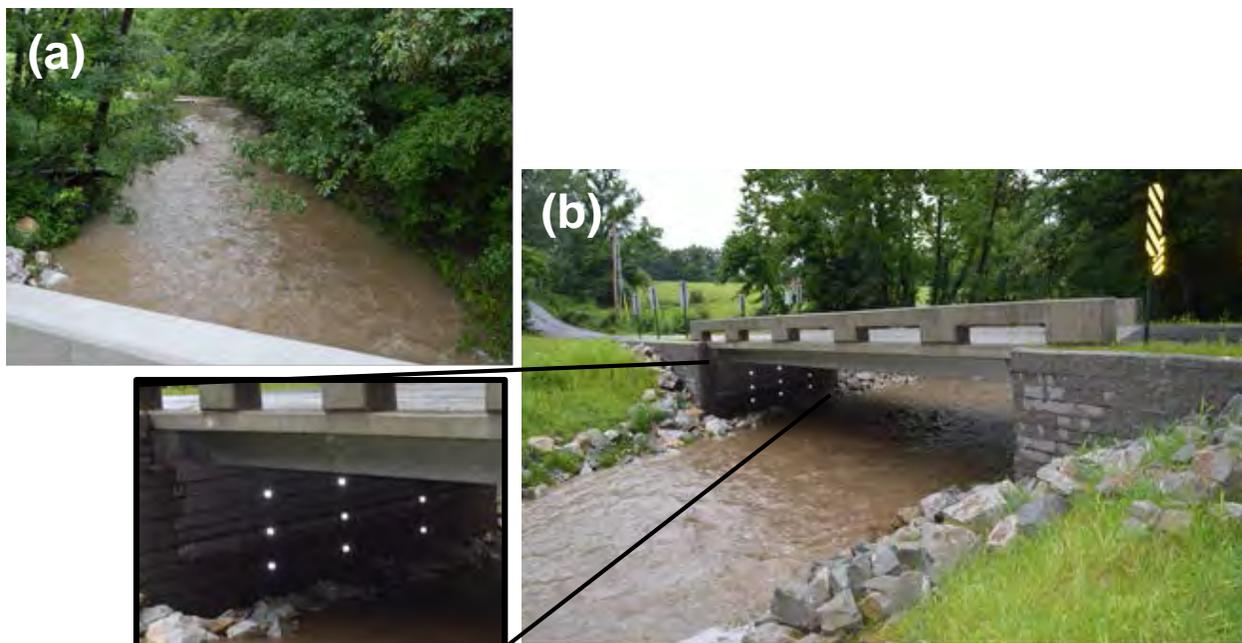
Figure 53: Rustic Road GRS-IBS during July 2015 high water event: (a) looking upstream from atop the bridge, showing creek high up its banks and (b) looking at north abutment.

In late June and early July 2015, a series of rain events in Boone County led to a significant water level increase in the North Fork of Grindstone Creek as shown in Figure 53. During the site visit when the photograph was taken several days after rain had stopped, the creek level was observed near the top of the rip rap, approximately 3 ft above the normal level. The normal creek level is just above the reinforced soil foundation as shown in figures throughout Chapter 2. Water marks on the CMU blocks shown in Figure 53 indicate the creek level had been several feet higher than its level at the time of the photograph. The marks indicate the maximum water level was just below the abutment mid-height.

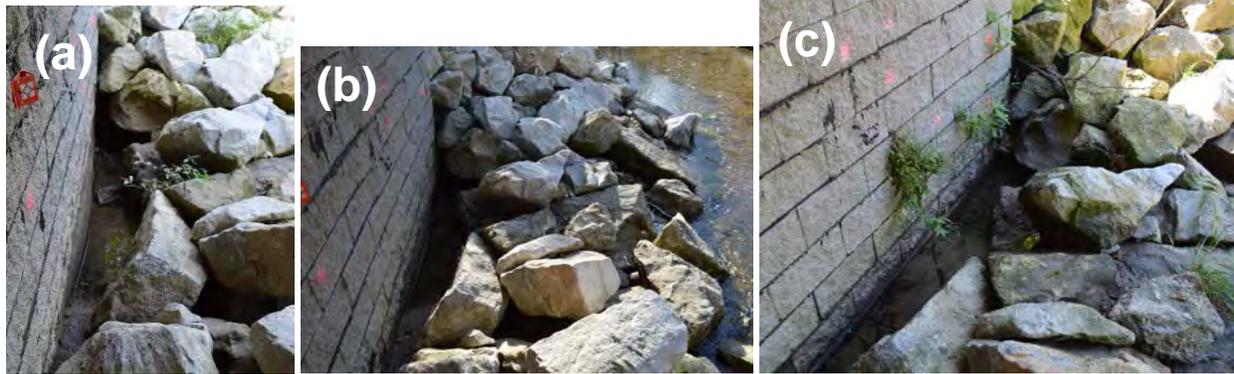
**Figure 54: Photographs of downstream corner of south abutment: (a) August 31, 2015, (b) February 25, 2016, and (c) September 22, 2016. A gap between the abutment face and rip rap scour protection was first observed during the August 31, 2015 site visit, but no changes in the gap were observed throughout the course of subsequent monitoring.**

During a site visit in August 2015, one month after the high water event, a gap was observed between the downstream (west) corner of the south abutment and the rip rap scour protection as shown in Figure 54(a). It is possible the gap formed in response to the high water event; it is also possible the gap was present from the first placement of the scour protection in May 2015 since that portion of the scour protection was underwater during June and July 2015 site visits. Regardless, observations during subsequent site visits as shown in Figure 54(b) and Figure 54(c) have not indicated any growth in the size of the gap nor any significant shifting in the rip rap.

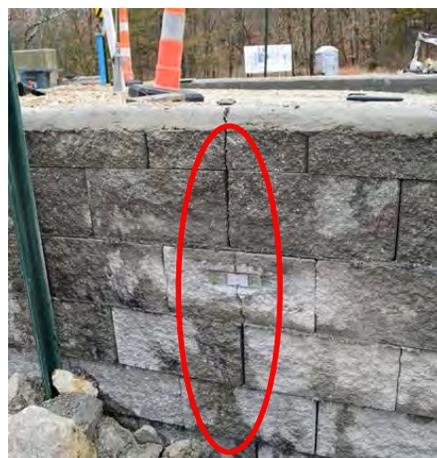
**Figure 55: Crack on east wing of north abutment wall.**

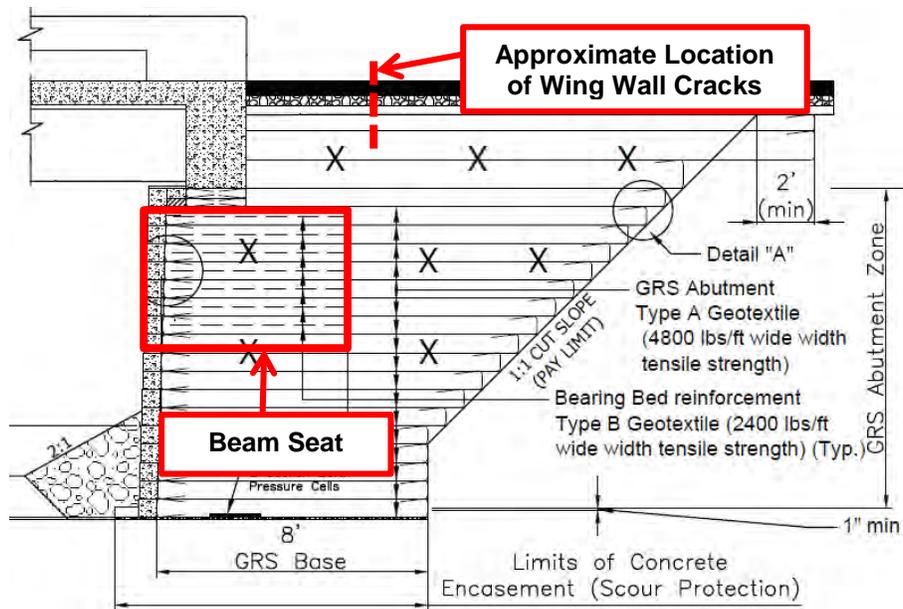
Figure 56: Crack location relative to bearing bed. Drawing is from Rustic Road plans included as an appendix to this report; annotations are original. As-constructed cut slope was steeper than 1:1.

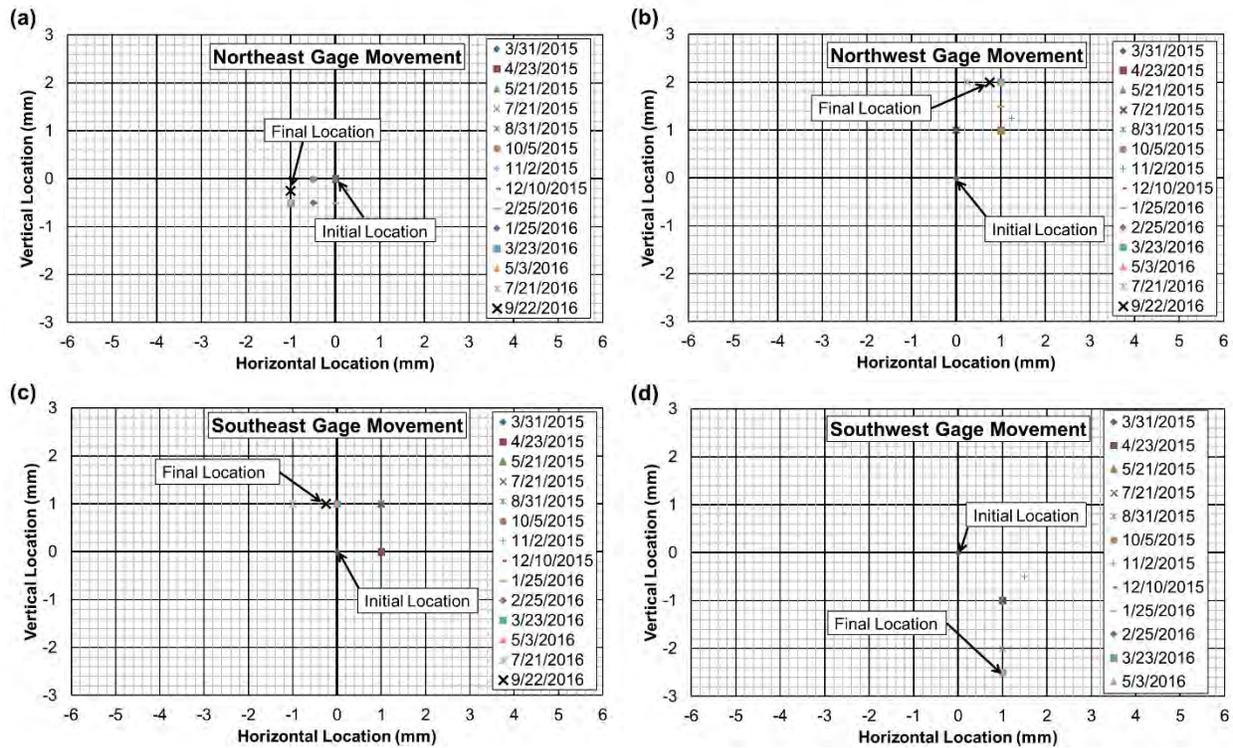
Figure 57: Crack gage data for each wing wall: (a) northeast, (b) northwest, (c) southeast, and (d) southwest. For each gage, initial (installed) and final (September 22, 2016) locations of the gage crosshair is shown.
