# Instrumentation and Monitoring of Rustic Road Geosynthetic Reinforced Soil (GRS) Integrated Bridge System (IBS)

Final Report Prepared for Missouri Department of Transportation  
November 2016 Project TR201417 Report cmr16-019

16. Abstract An instrumentation and monitoring system was implemented for a geosynthetic reinforced soil (GRS) integrated bridge system (IBS) constructed in Boone County, Missouri in 2014. The project location is subjected to relatively frequent flash flooding, which was a significant consideration in the design of the bridge and the design of the monitoring system. The monitoring system includes 26 surveying points on the bridge exterior to monitor external movement; settlement plates and inclinometers to monitor vertical and horizontal exterior movement, respectively; earth pressure cells to monitor total stresses within the abutment backfill; and vibrating wire piezometers to monitor pore pressures and drainage within the abutment backfill. The GRS-IBS was monitored for a period of 19 months after construction. The monitoring period included several high-water events, but none overtopped the bridge. The results indicate satisfactory performance, includi

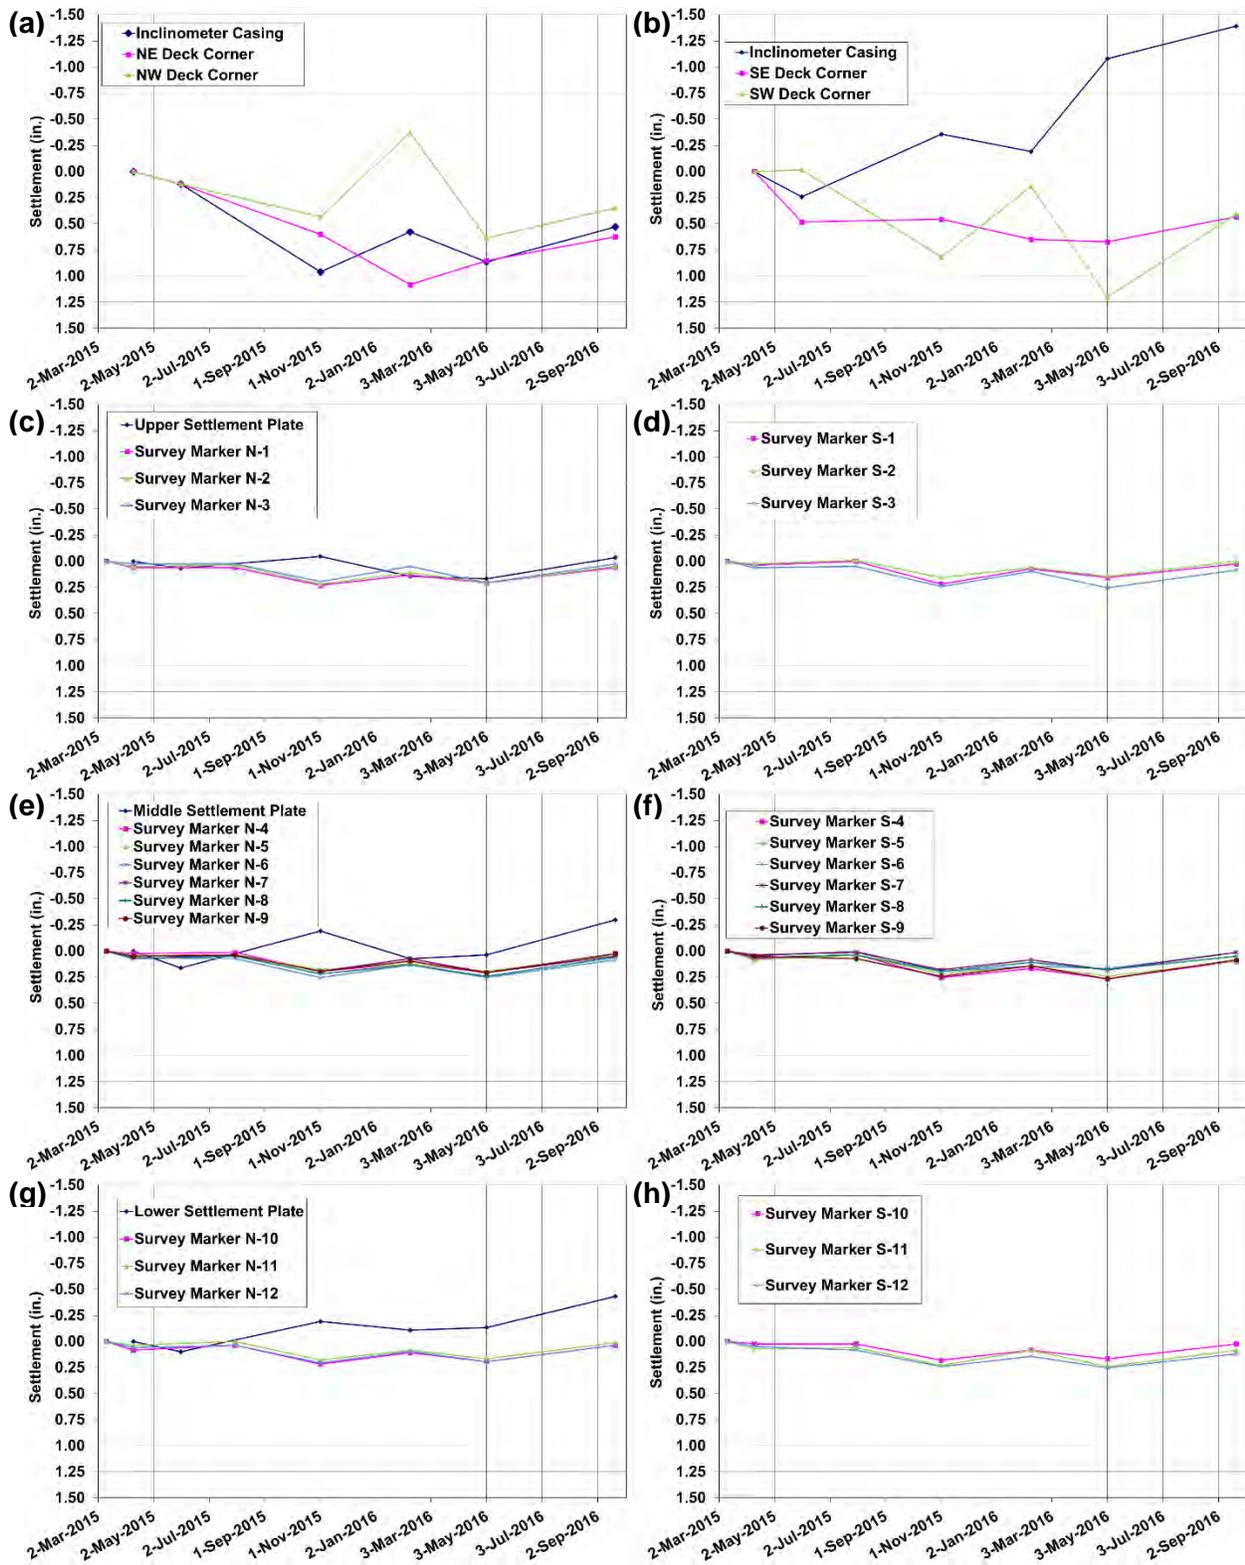
Figure 58: Settlement from survey data: (a) surface of north abutment, (b) surface of south abutment, (c) upper markers of north abutment, (d) upper markers of south abutment, (e) middle markers of north abutment, (f) middle markers of south abutment, (g) lower markers of north abutment, and (h) lower markers of south abutment. Positive settlement is movement downward.

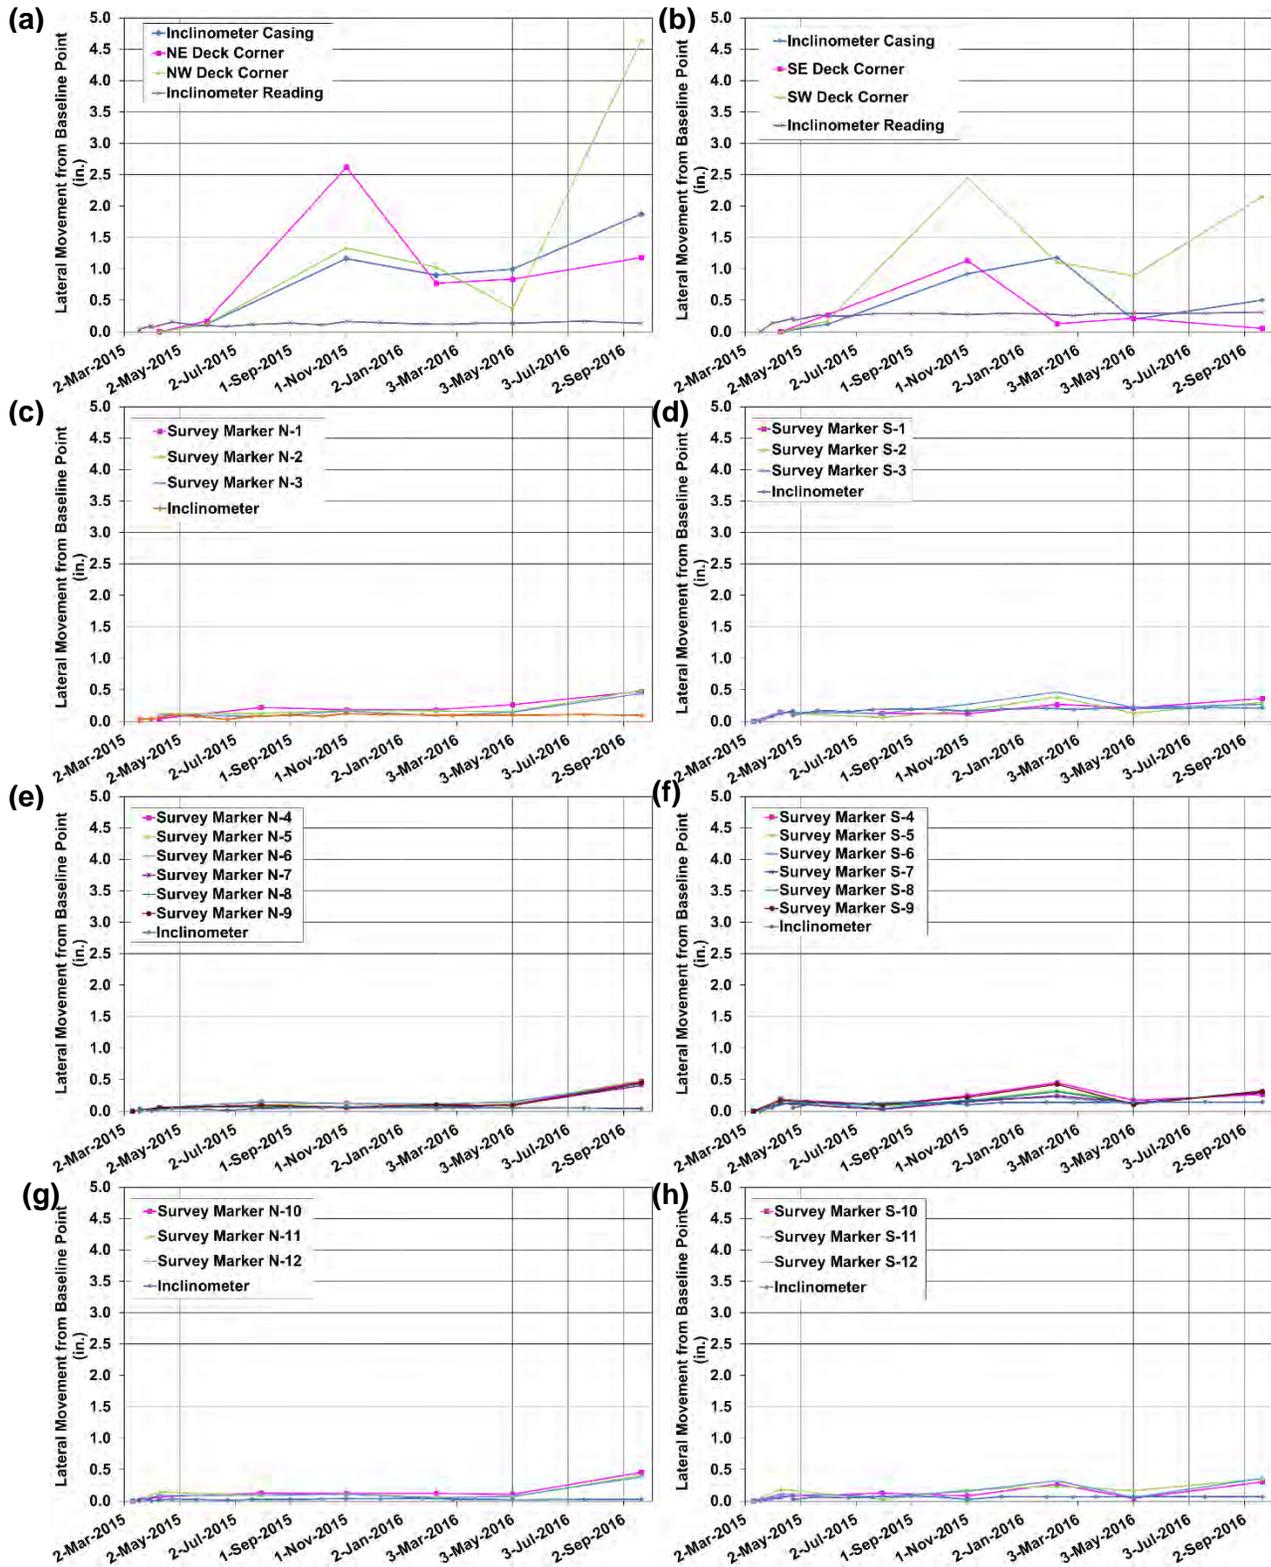
Figure 59: Lateral movement from survey data: (a) surface of north abutment, (b) surface of south abutment, (c) upper markers of north abutment, (d) upper markers of south abutment, (e) middle markers of north abutment, (f) middle markers of south abutment, (g) lower markers of north abutment, and (h) lower markers of south abutment.

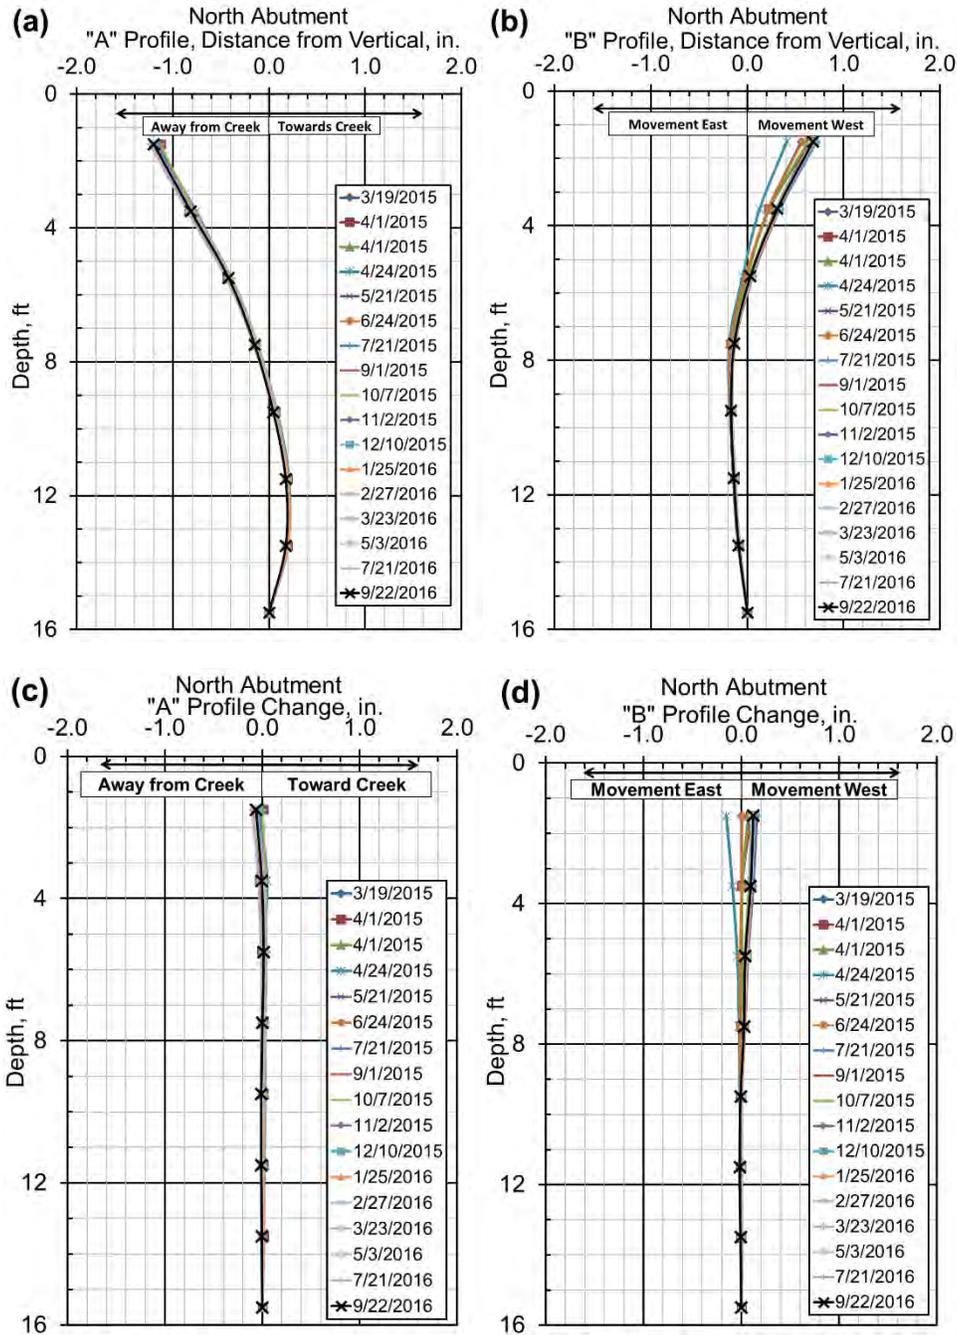
Figure 61: Inclinometer results for north abutment: (a) casing profile in direction toward creek, (b) casing profile in east-west direction, (c) change in casing profile in creek direction, and (d) change in casing profile in east-west direction. The data in plots (a) and (b) represent the absolute shape of the casing, and the curvature is dominated by the installed shape of the casing. The data in plots (c) and (d) represent the relative change in casing shape since installation and indicates negligible movement.

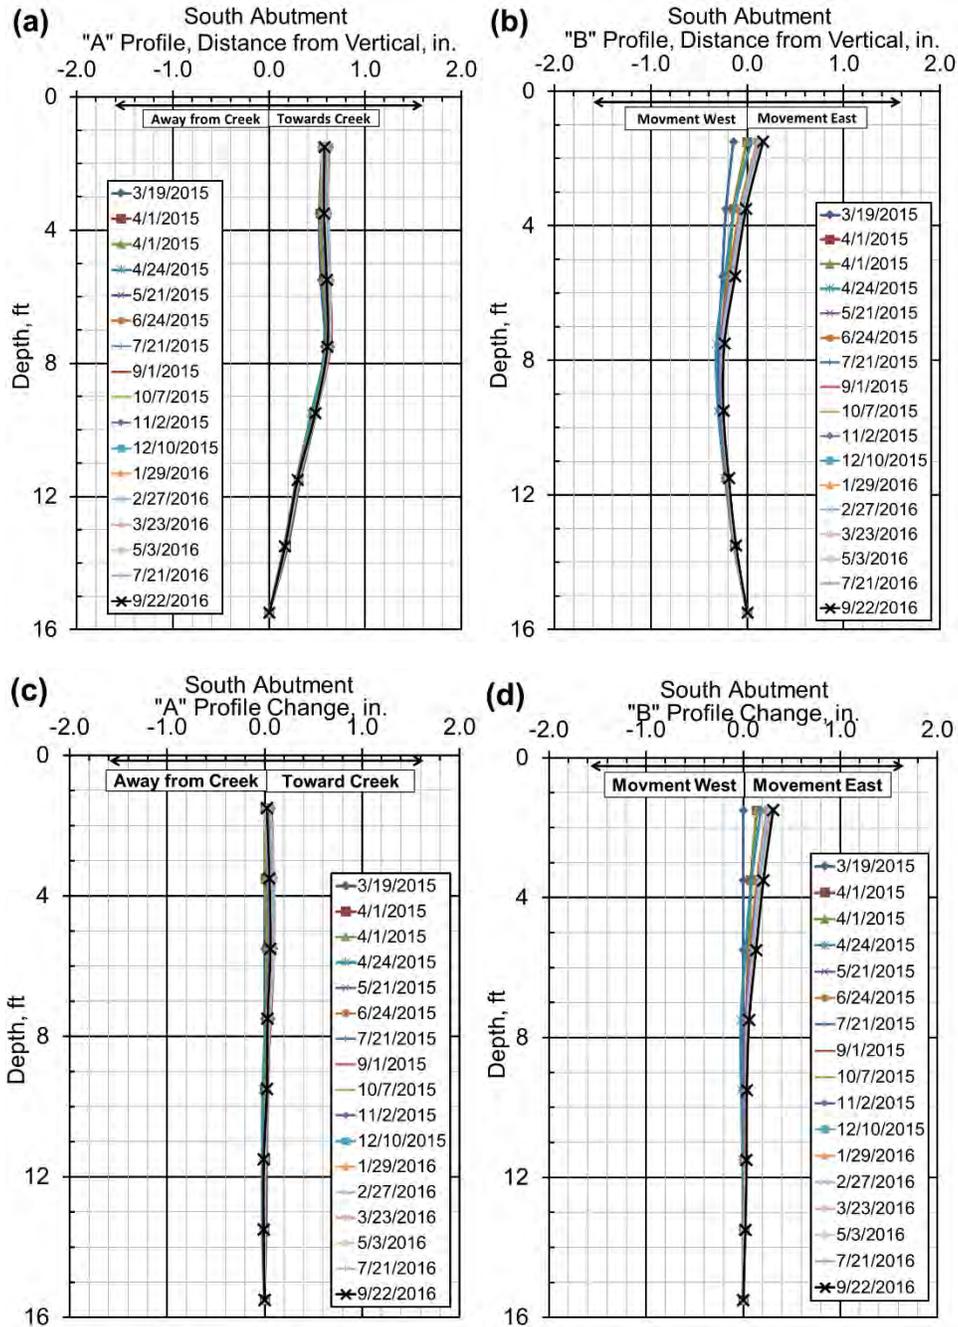
**Figure 62: Inclinometer results for south abutment: (a) casing profile in direction toward creek, (b) casing profile in east-west direction, (c) change in casing profile in creek direction, and (d) change in casing profile in east-west direction. The data in plots (a) and (b) represent the absolute shape of the casing, and the curvature is dominated by the installed shape of the casing. The data in plots (c) and (d) represent the relative change in casing shape since installation and indicates negligible movement.**

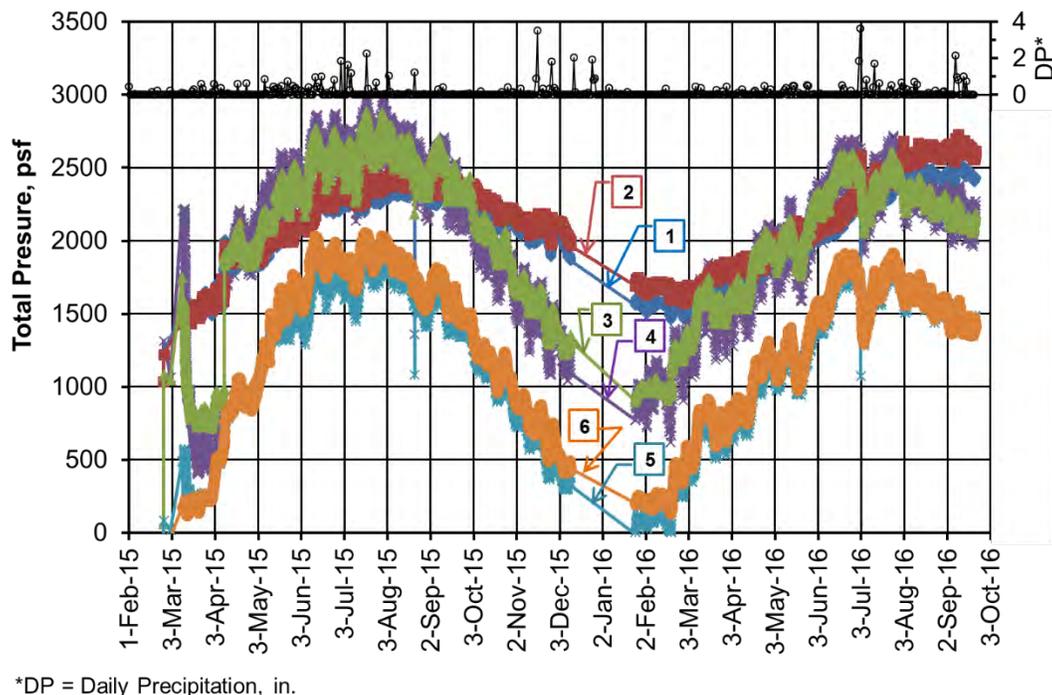
**Figure 63: Earth pressures (total stresses) in north abutment from vibrating wire earth pressure cells. Cells EPC-1 and EPC-2 were installed near the bottom of the abutment backfill; each of the other cells was installed beneath one of the bridge girders (Figure 47). Daily precipitation records from nearby weather stations were averaged, and the result is shown atop the graph.**

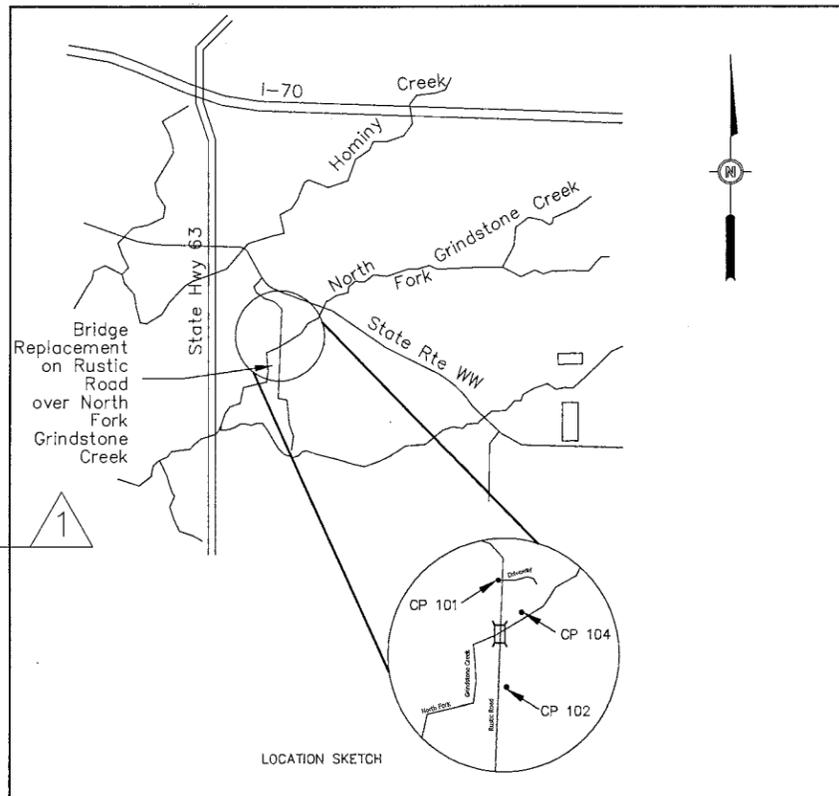
HYDROLOGIC DATA	
Drainage Area = 6.45 Square Miles	
BACKWATER/BASE FLOOD DATA (100 YR)	
High Water Elev. = 688.53	
Design Discharge = 6,400 cfs	
Estimated Backwater = 0.84 ft.	
Ave Velocity thru Opening = 7.64 ft/s	
FREEBOARD	
Design Frequency = 25 (year)	
Design Discharge = 54,400 cfs	
Freeboard = -2.99 ft.	
Design High Water (DHW) Elev. = 686.91	
ROADWAY OVERTOPPING	
Design Elev.(1' Below Shoulder) = 685.87	
Design Discharge = 2000 cfs	
Design Frequency > 4 (year)
