# Foundation Reuse: Length, Condition, and Capacity of Existing Driven Piles

Final Report Prepared for Missouri Department of Transportation  
May 2018

Project TR201714

Report cmr18-008

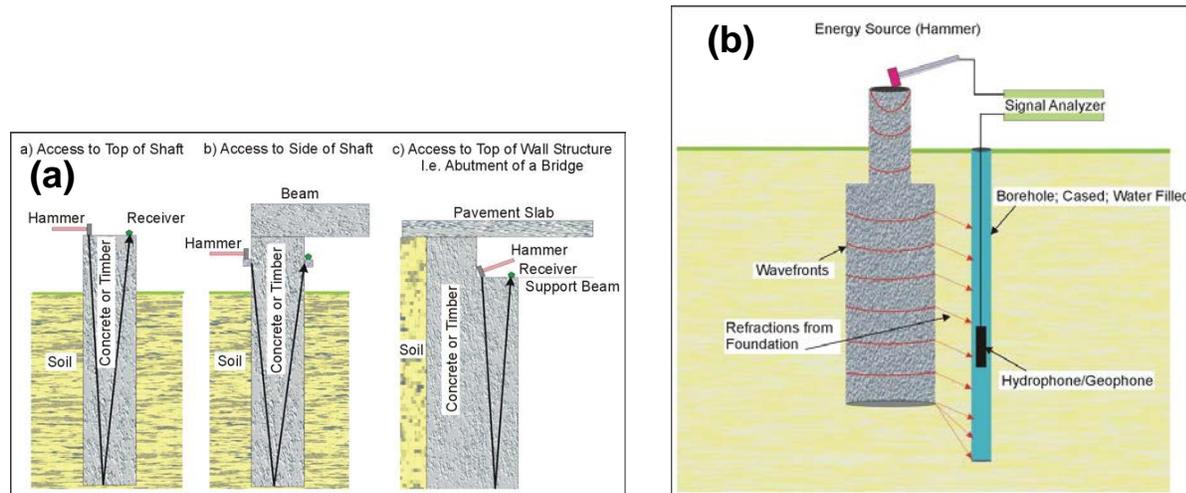
**Figure 3: General testing arrangement for performing (a) SE/IR measurements with different foundation configurations and (b) Parallel Seismic measurements. Reused with permission.**

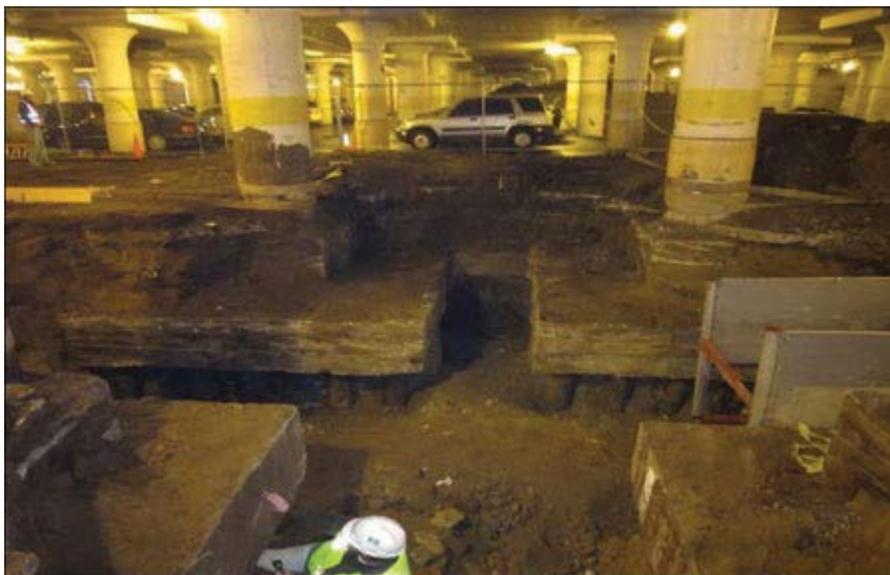
**Figure 4: Test pit exposing timber piling. From Johnson and Chauvin (2013).**

Direct methods to investigate the condition of existing foundations include several destructive or partially destructive techniques. Test pits involve excavating to expose the deep foundation element as shown in the example of Figure 4. Test pits are useful because they allow direct observation of significant portions of the foundation elements, and often the portions exposed (near the ground surface) are in the area of groundwater fluctuation that is most associated with corrosion. However, excavation of test pits is typically limited to relatively shallow depths, and in some cases may not be feasible (to any depth) because of

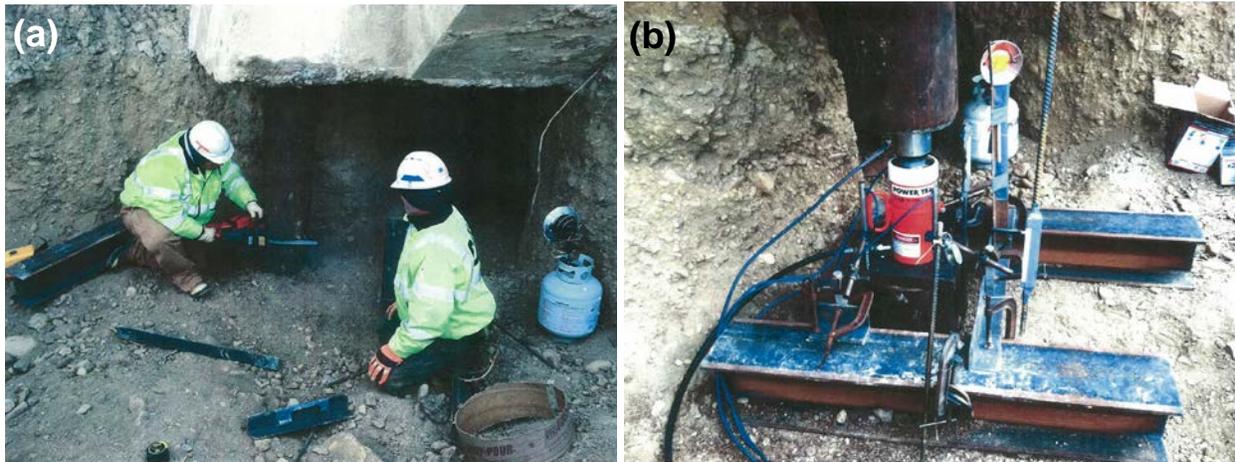
Figure 6: Field load test of timber piles for the Maine DOT Haynesville Bridge: (a) cutting timber piles to make room for (b) hydraulic cylinder used to apply load.

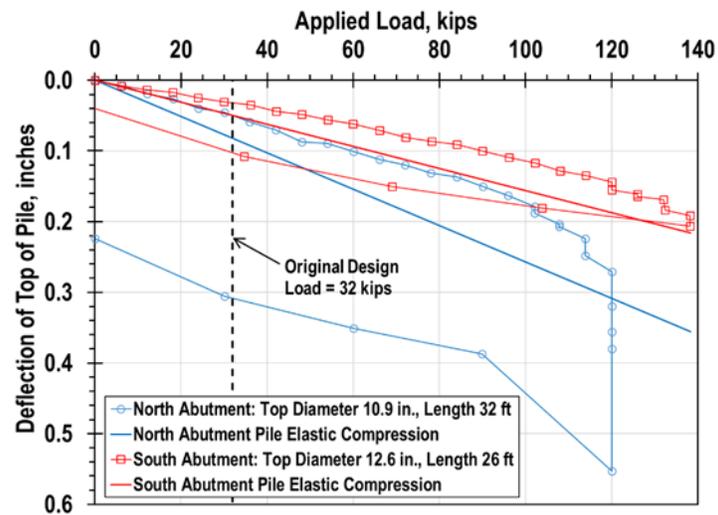
Figure 7: Axial load displacement curves for the top of test piles from the Haynesville Bridge. Results were originally presented in NCHRP Synthesis 505 (Boeckmann and Loehr, 2017). Reused with permission.

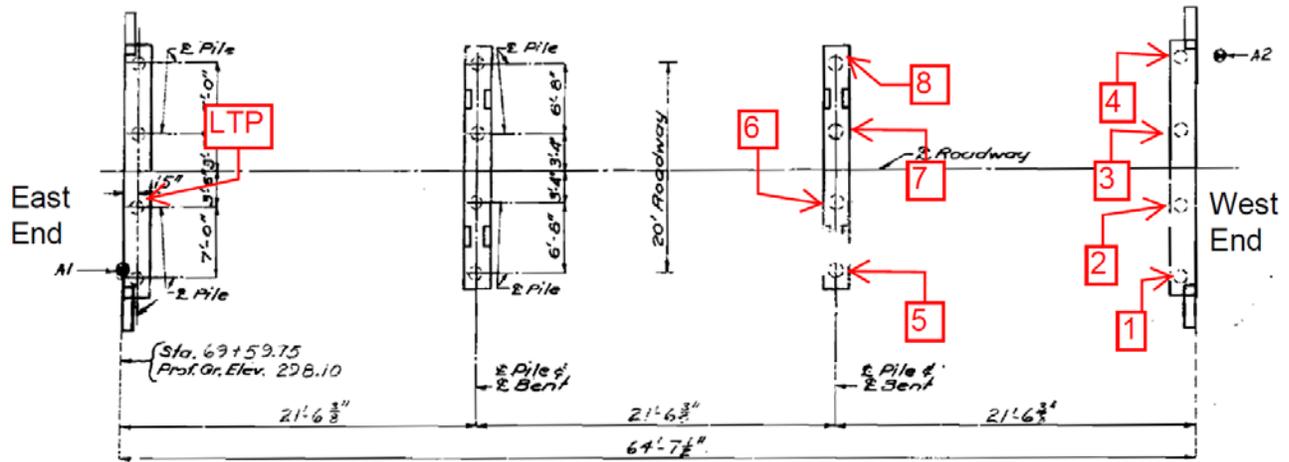
Figure 9: Pile layout and numbering used in this study for the Route U bridge with precast piles. Note that the west end bent is shown to the right and the east end bent is on the left. LTP is the load test pile.

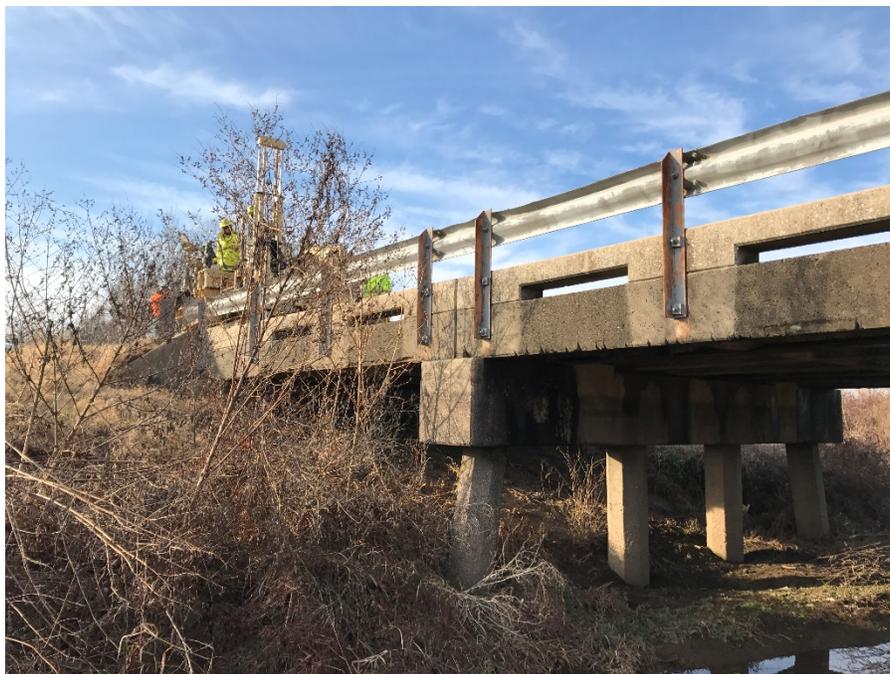
Figure 10: Photo of west end of the Route U precast pile bridge prior to replacement.

The Route U bridge was constructed in 1967 and is located 2.9 miles northeast of New Madrid, Missouri where Route U crosses over Dry Run Ditch. The bridge is approximately 65-ft long and is supported on four bents, each consisting of four driven piles, as shown in Figure 9. A photo of the west end of the bridge prior to demolition is shown in Figure 10. The piles are precast concrete with a 16-in wide octagonal cross-section at the top. The cross section tapers significantly over the bottom 5 ft of the pile to a width of 8 in, as shown in Figure 11. Geophysical investigations were performed primarily on piles located on the west end of the bridge. The numbering convention used to identify the piles in this report is shown in Figure 9. The load test was performed on a pile on the east end of the bridge, labeled as LTP in Figure 9. Piles 1, 2, 3, 4, 6, 7 and LTP were installed with a vertical orientation. Piles 5 and 8 are battered outward from the bridge centerline, as shown in Figure 10. The slope of the batter is approximately 2 in. per foot

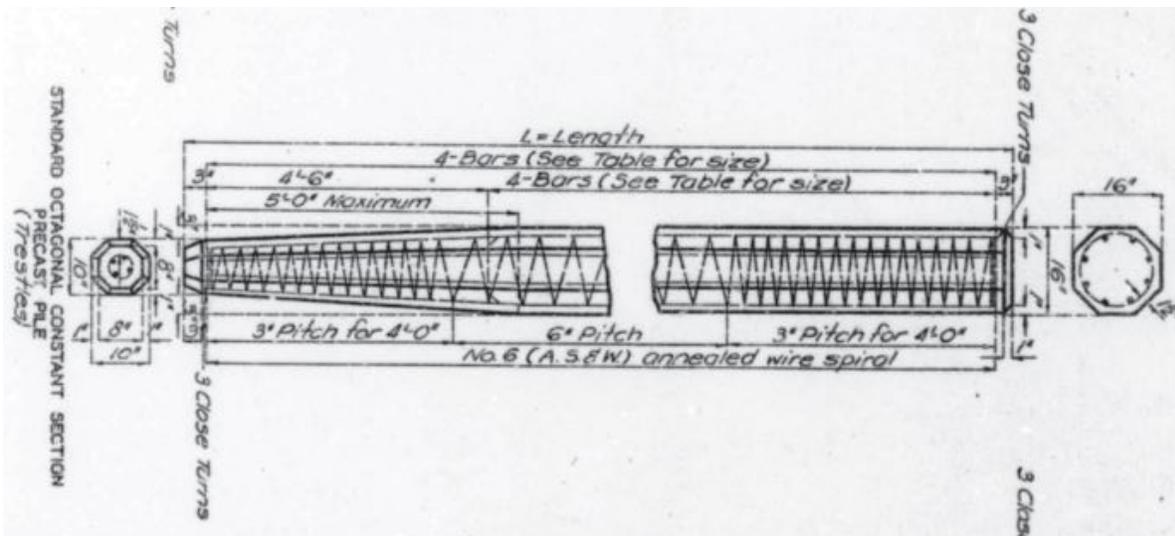
**Figure 11: Plan drawing of precast pile used at the Route U site with octagonal cross-section and tapered ends over the last 5 ft.**

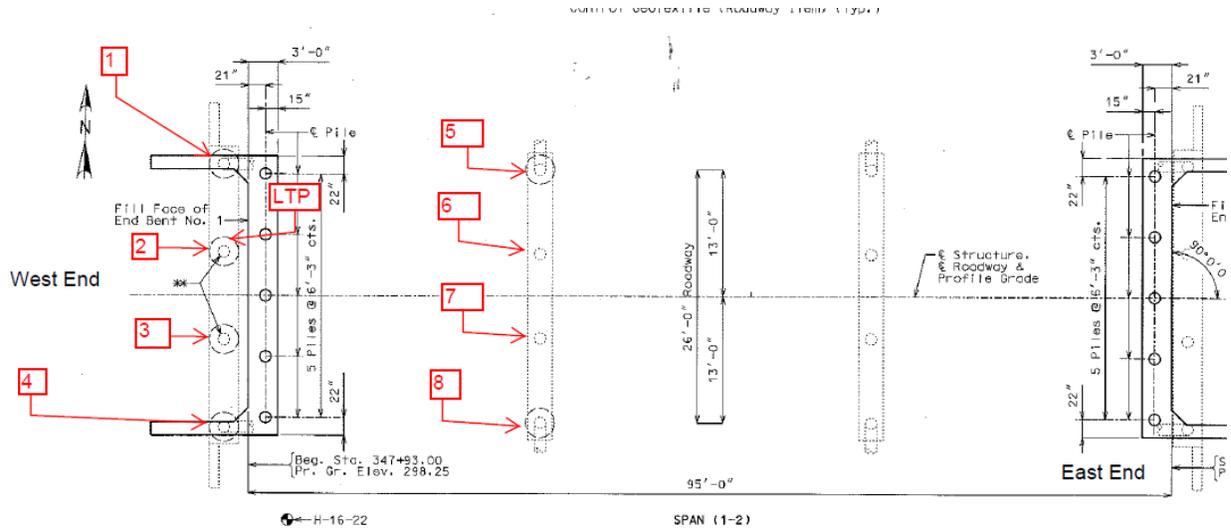
Figure 12: Pile layout and numbering used in this study for the Route WW bridge with CIP piles. All work was performed on the west end bents, as shown. LTP is the load test pile.

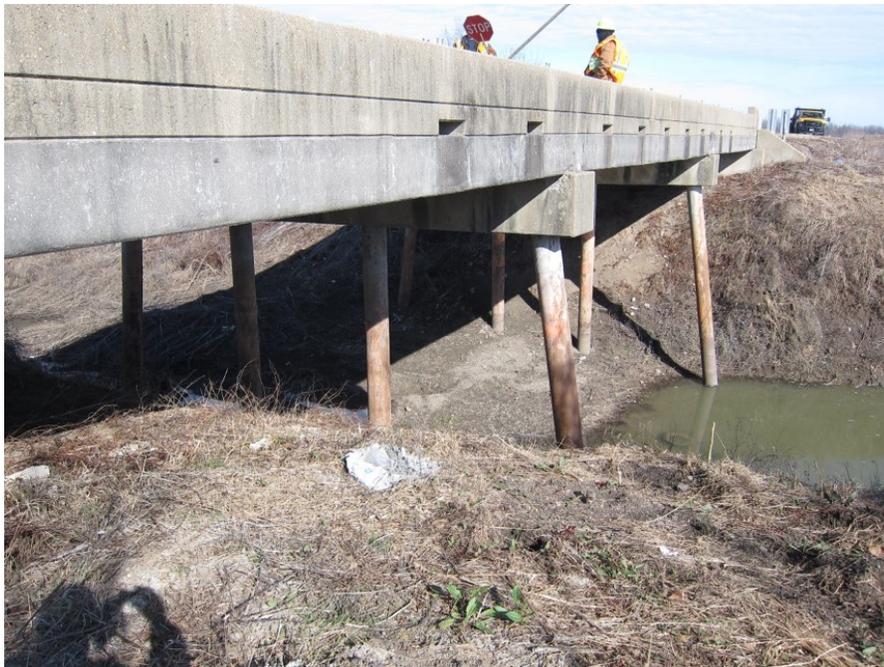
Figure 13: Route WW Bridge with CIP piles.

The Route WW bridge was constructed in 1968 and is located 6.5 miles northeast of New Madrid, Missouri where Route WW crosses the Wilson Bayou, as shown in Figure 8. The bridge is approximately 95-ft long and is supported on four bents, each consisting of four driven piles. The piles tested in this study are on the west end of the bridge, as shown in Figure 12. A photograph of the Route WW bridge is shown in Figure 13. The piles at this site are cast-in-place (CIP) piles, which consist of a closed-end pipe pile that is filled with unreinforced concrete after driving. The CIP piles supporting the Route WW bridge are 14-in. diameter with a nominal wall thickness of 0.25 in. A photograph of the cross section of the pile is shown in Figure 14. Piles 2, 3, 6, and 7 were oriented vertically, while Piles 1 and 4 were battered toward the abutment at 3 in. per ft and Piles 5 and 8 were battered outward from the bridge centerline at 2 in. per ft.

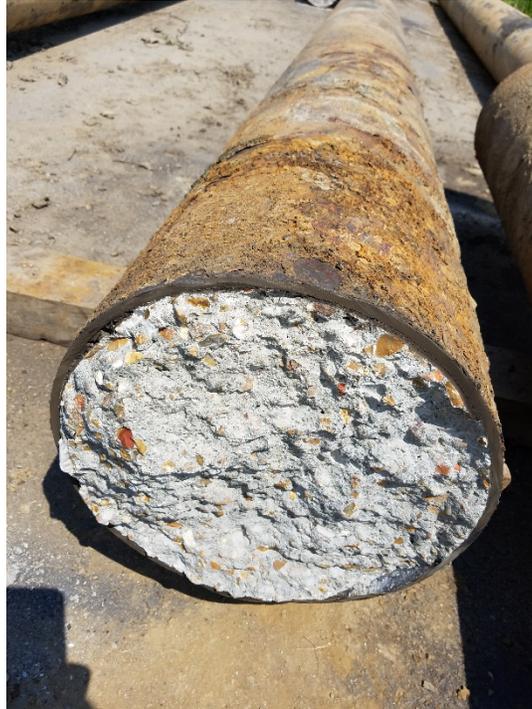
**Figure 14: Concrete filled CIP pipe pile from the Route WW bridge site.**

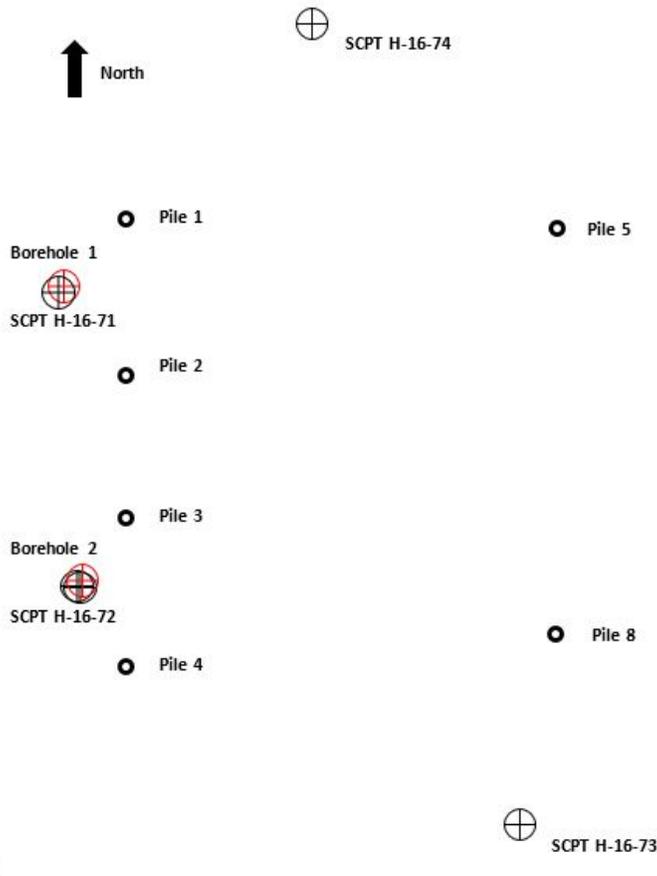
Figure 15: SCPT, borehole and precast pile locations at the Route U bridge site.

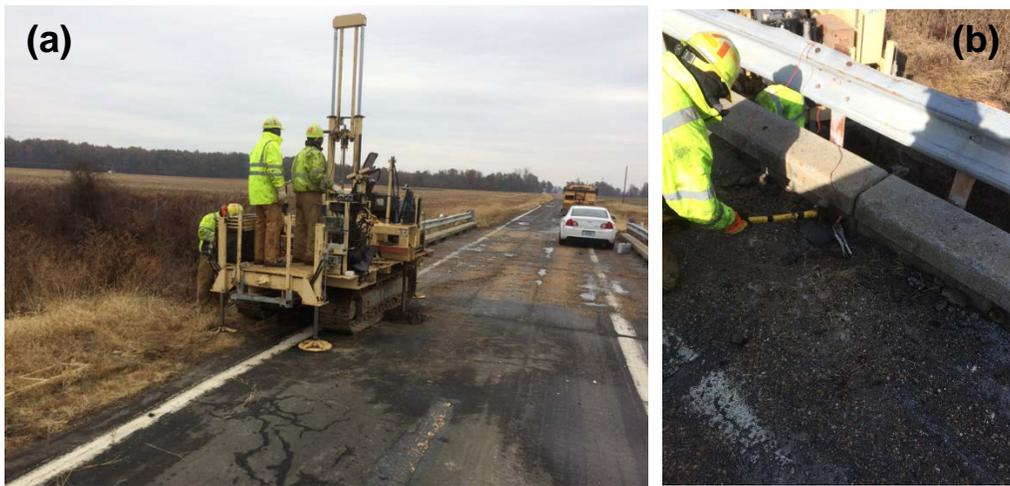
Figure 16: PS testing at the Route U bridge site: (a) SCPT rig and (b) impact hammer.

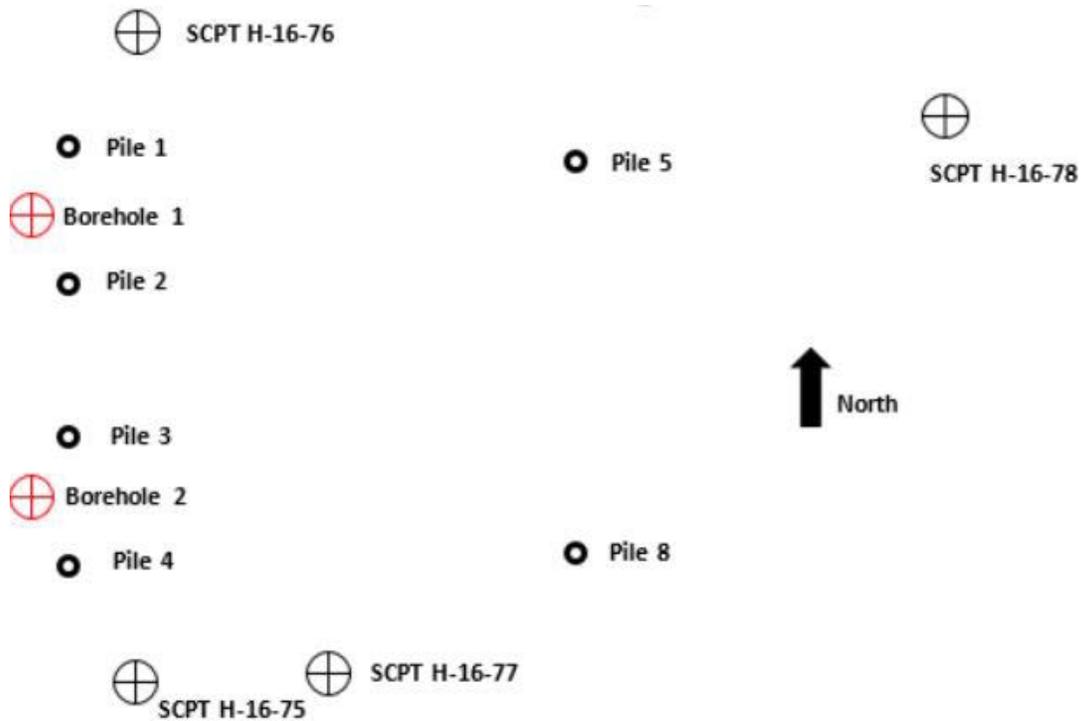
Figure 17: SCPT, borehole and CIP pile locations at Route WW site.

The same general procedure was used at the Route WW site with CIP piles. Four soundings, labeled as H-16-75, H-16-76, H-16-77, and H-16-78 were advanced at this site, as shown in Figure 17. The elevations of each of the soundings are presented in Table 3. The distance between the SCPT locations and the piles at Route WW are presented in Table 4. At this site it was not possible to locate the SCPT soundings close to the piles of interest, so distances between the SCPT and piles were larger than at the Route U site. Also, due to the longer expected pile lengths at this site, the penetration depth of interest was greater. In some cases, the capacity of the rig was insufficient to penetrate the dense sand layer and the sounding was terminated at a depth that did not allow for determination of the pile length.

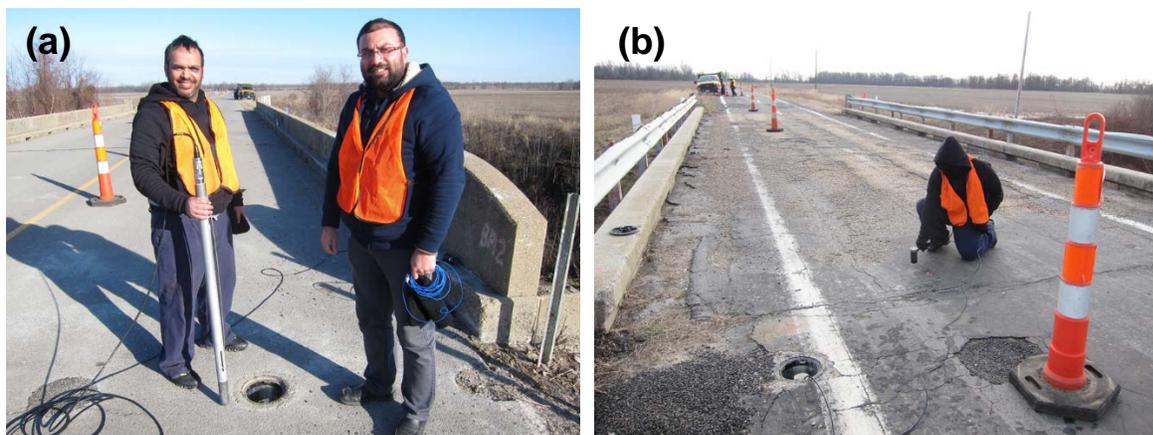
**Figure 18: Parallel Seismic equipment used: (a) three-component downhole sensor (shown next to Borehole 2) and (2) instrumented sledge hammer (impacting over Pile 2 location).**

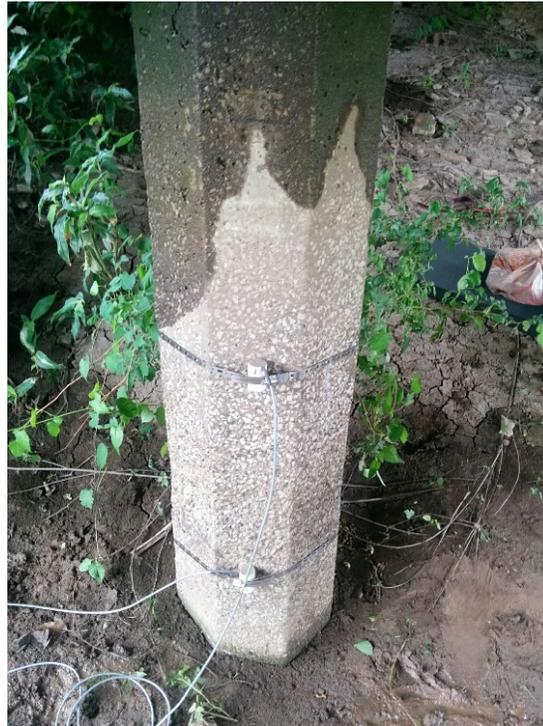
**Figure 19: SE test setup on precast Pile 7 at the Route U site.**

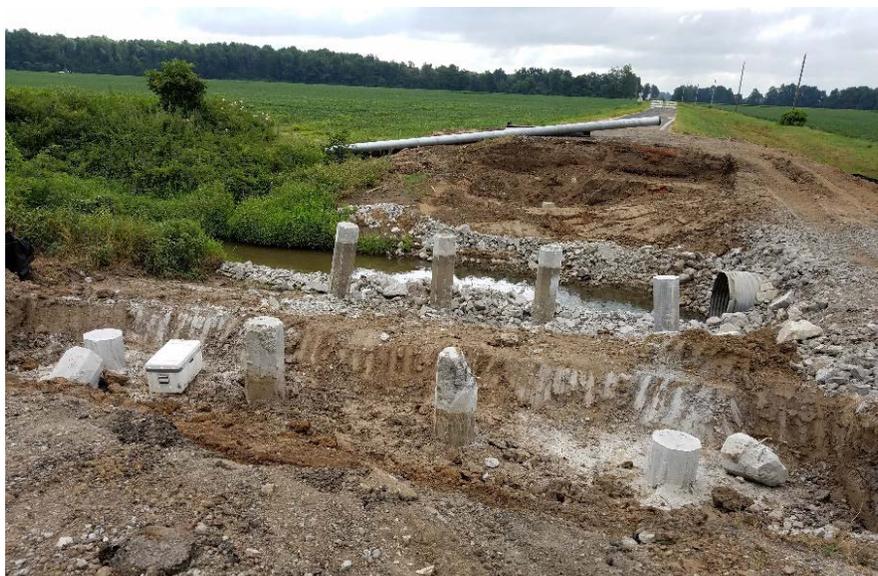
Figure 20: Overview photo of Route U site after bridge was removed and precast piles were cut.

Sonic Echo and Impulse Response tests were performed on: (1) July 12 and 13, 2017 on the piles used for the load tests at the Route U and Route WW sites, (2) on July 18, 2017 for the other CIP piles at the Route WW site and (3) on July 27, 2017 on the remaining precast piles at the Route U site. After the bridge superstructure was removed, the tops of test piles were cut by the contractor to produce a flat and smooth surface. A photograph of the Route U site after the piles had been prepared is shown in Figure 20. Elevations of the cut pile surfaces are presented in Table 5 and Table 6 for Route U and Route WW, respectively. Vibrations were detected using a 28-Hz geophone which was epoxied to the surface of the pile, as shown in Figure 21. At the Route U site, a piezoelectric accelerometer was also used to allow for comparisons of the results obtained using different sensor types. The geophone and the accelerometer showed nearly identical results, so only data collected with the geophones are presented in this report. Energy was excited using a vertical impact from a 3-lb (PCB 086D20) instrumented sledge hammer. The time domain SE data were recorded using the Data Physics 4-channel signal analyzer with a sampling frequency of 102 kHz to ensure good resolution in the time domain. The IR frequency domain data were recorded with a slower sampling frequency of 5120 Hz to produce better frequency domain resolution.

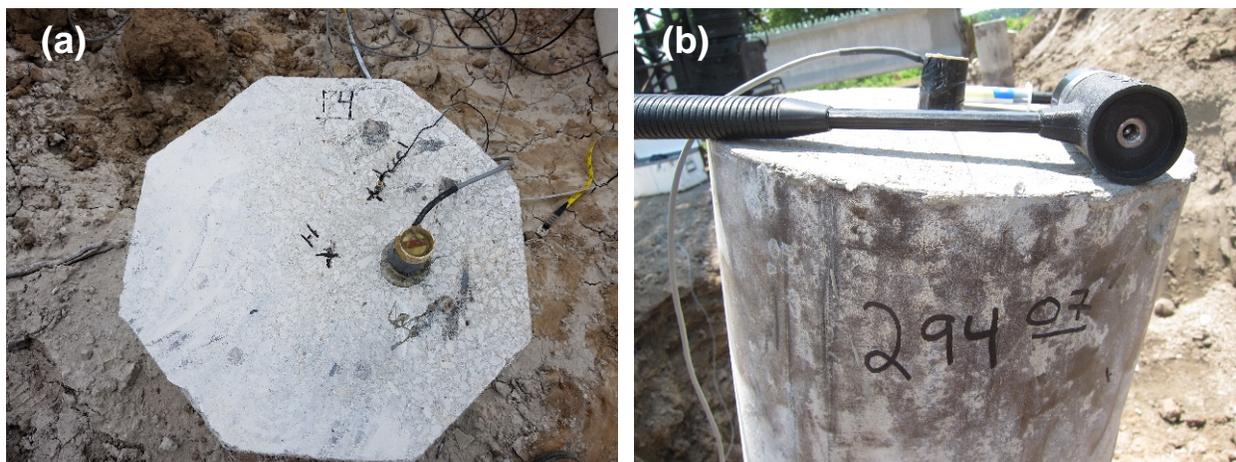
Figure 21: Test setup for SE-IR after removal of bridge deck at (a) Route U (precast pile) and (b) Route WW (CIP pile).

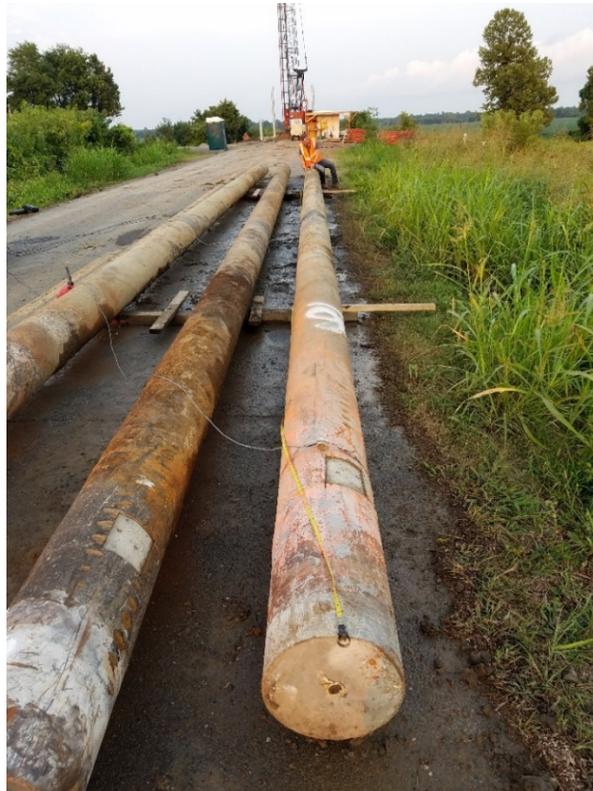
**Figure 22: Experimental setup for measuring wave velocities in exhumed CIP piles at Route WW.**

Direct measurements of compression wave velocity were also performed on the exhumed piles from each site. To perform these measurements, 28-Hz geophones were clamped to the side of the pile and compression wave energy was excited by striking the end of the pile with an instrumented hammer. For the Route U precast piles, a single geophone was placed at approximately the mid-length of the pile. For the CIP piles at Route WW, which are significantly longer than the Route U precast piles, geophones were placed at multiple locations along the pile. The locations corresponded to distance intervals ranging from 12 to 45 ft. The experimental set-up for the testing of the exhumed CIP piles from Route WW is shown in Figure 22.

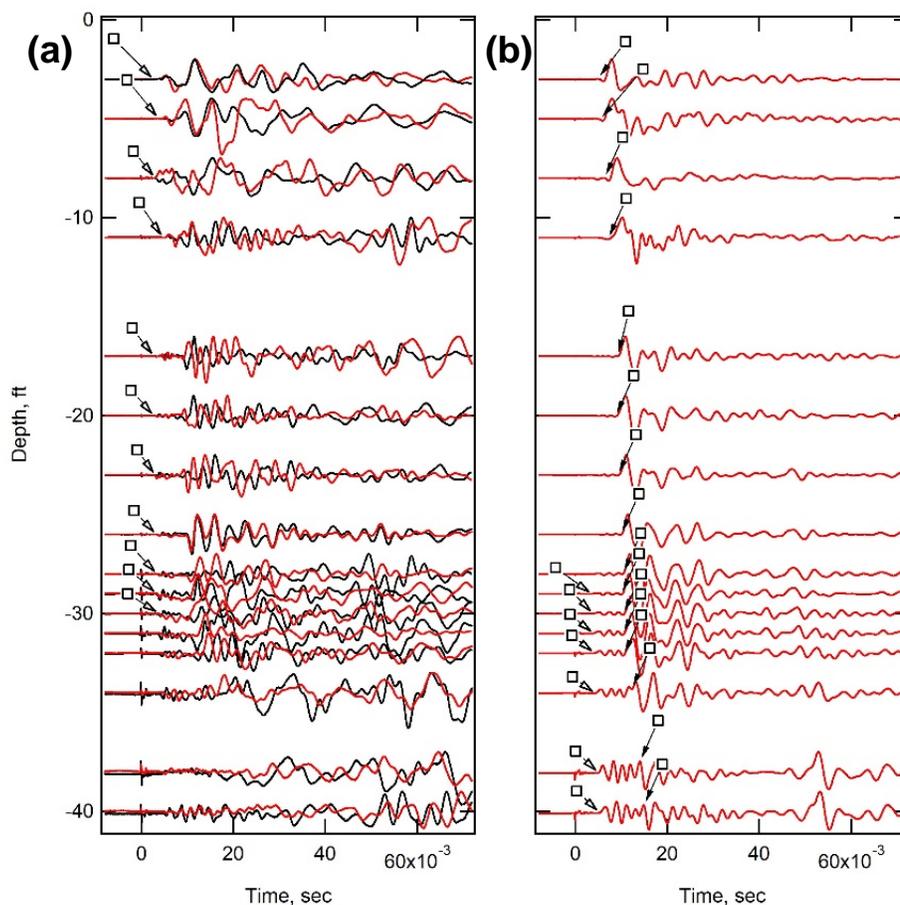
**Figure 23 Example showing picks of compression wave arrivals (open arrows) and shear wave arrivals (closed arrows) from Parallel Seismic testing on precast Pile 2 at Route U site recorded on the horizontal geophones (left) and vertical geophones (right).**

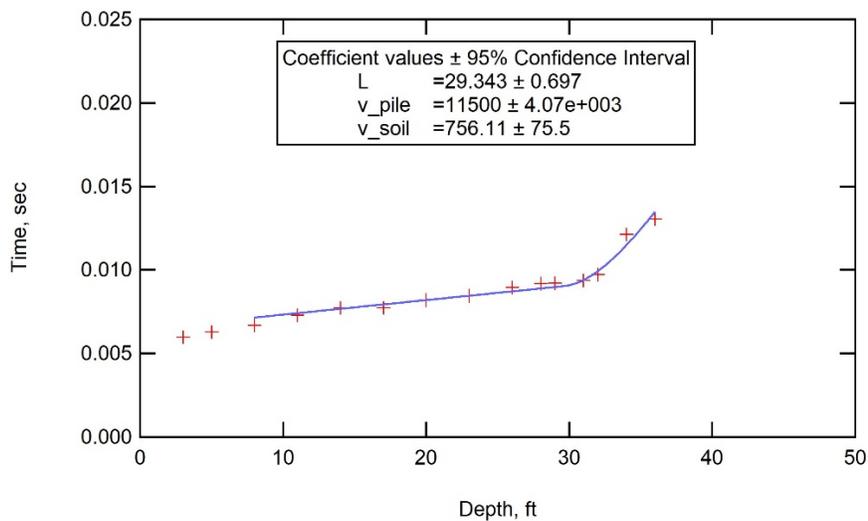
**Figure 24 Example of the model fit to p-s wave arrivals from BH1 to precast Pile 2 at Route U.**

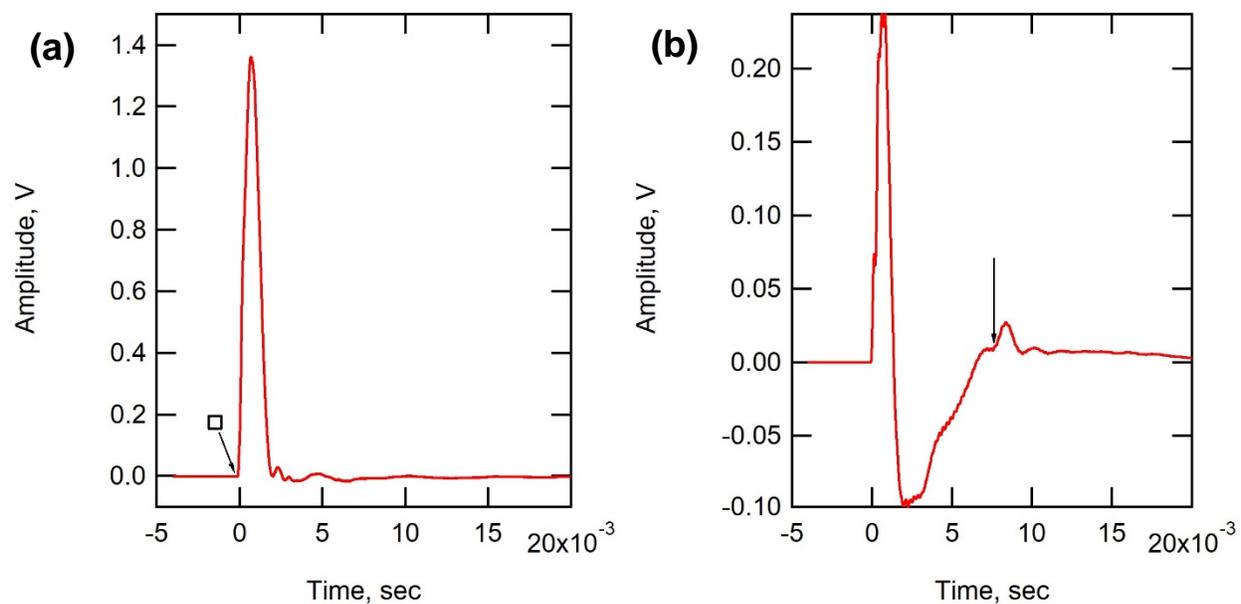
**Figure 25: Example SE records from CIP Pile 2 at Route WW showing times of (a) impact and (b) reflected arrival.**

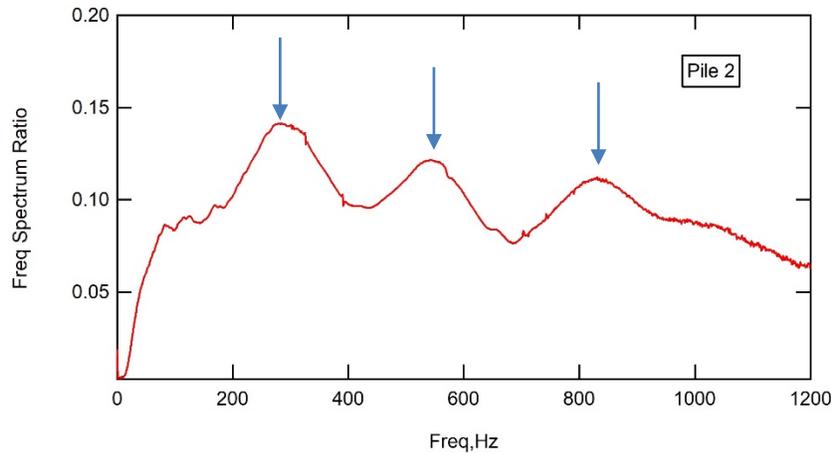
**Figure 26: Example Impulse-Response records from precast Pile 2 at Route U.**

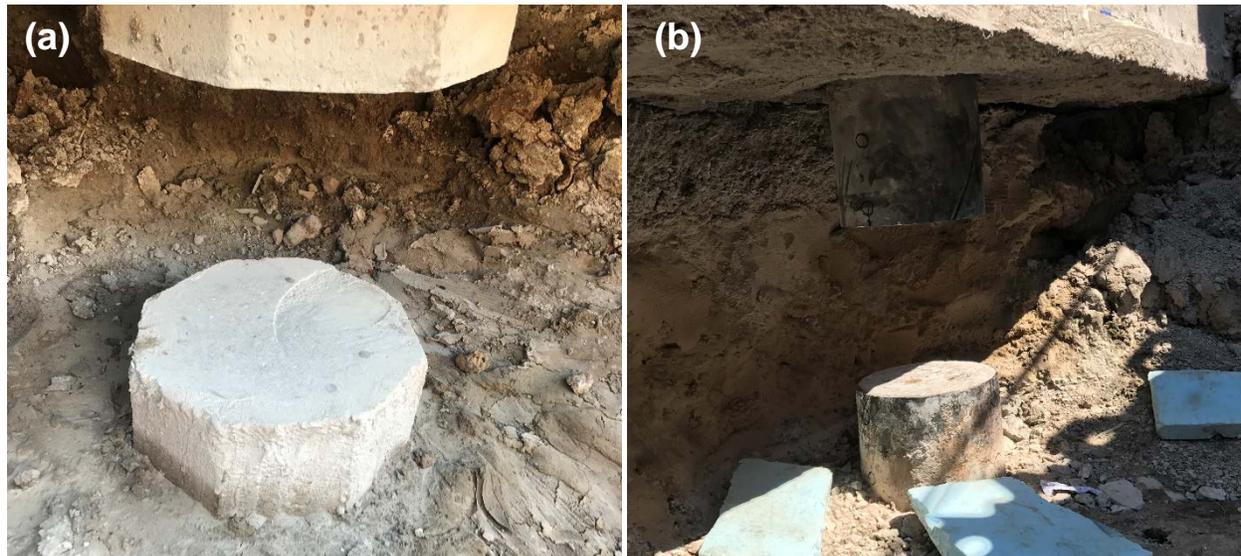
Figure 27: Test piles after removing segments to make room for hydraulic cylinder: (a) precast pile and (b) CIP pile.

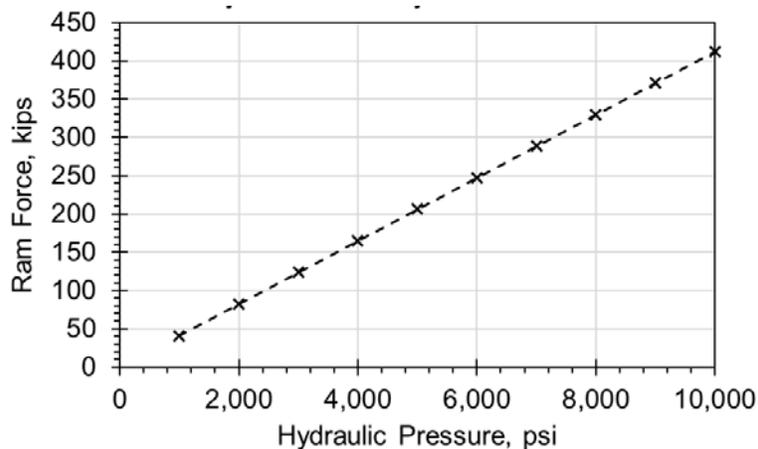
Figure 28: Calibration of hydraulic cylinder prior to load testing.

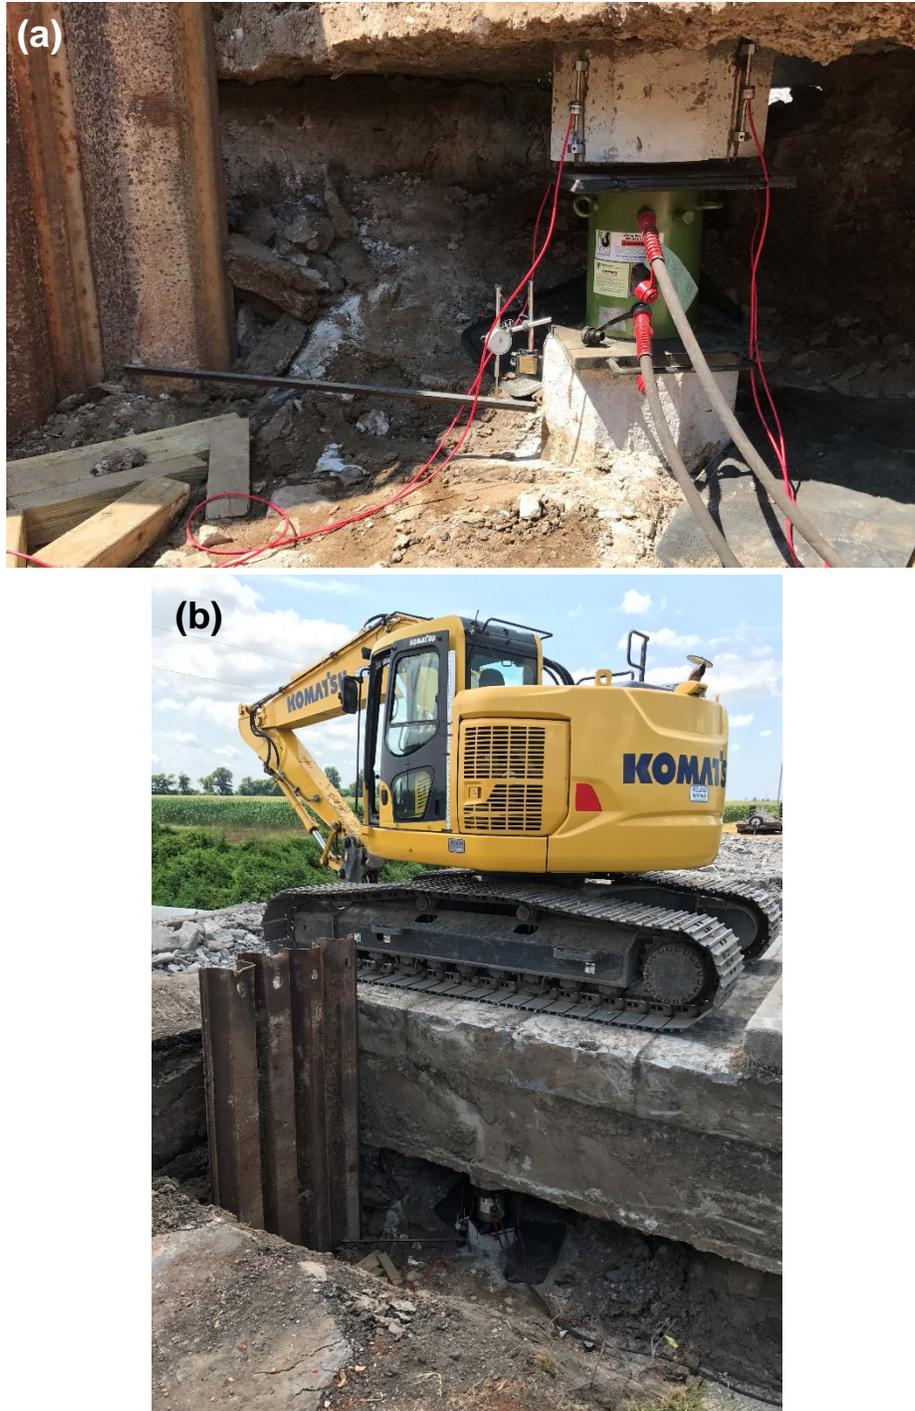
**Figure 29: Photographs of load test of precast pile: (a) hydraulic cylinder applies load while strain gages are used to measure load at the top of pile and dial gage measures displacement of the top of the pile; and (b) backhoe is parked atop reaction beam to reduce loads in capping beam and reaction piles.**

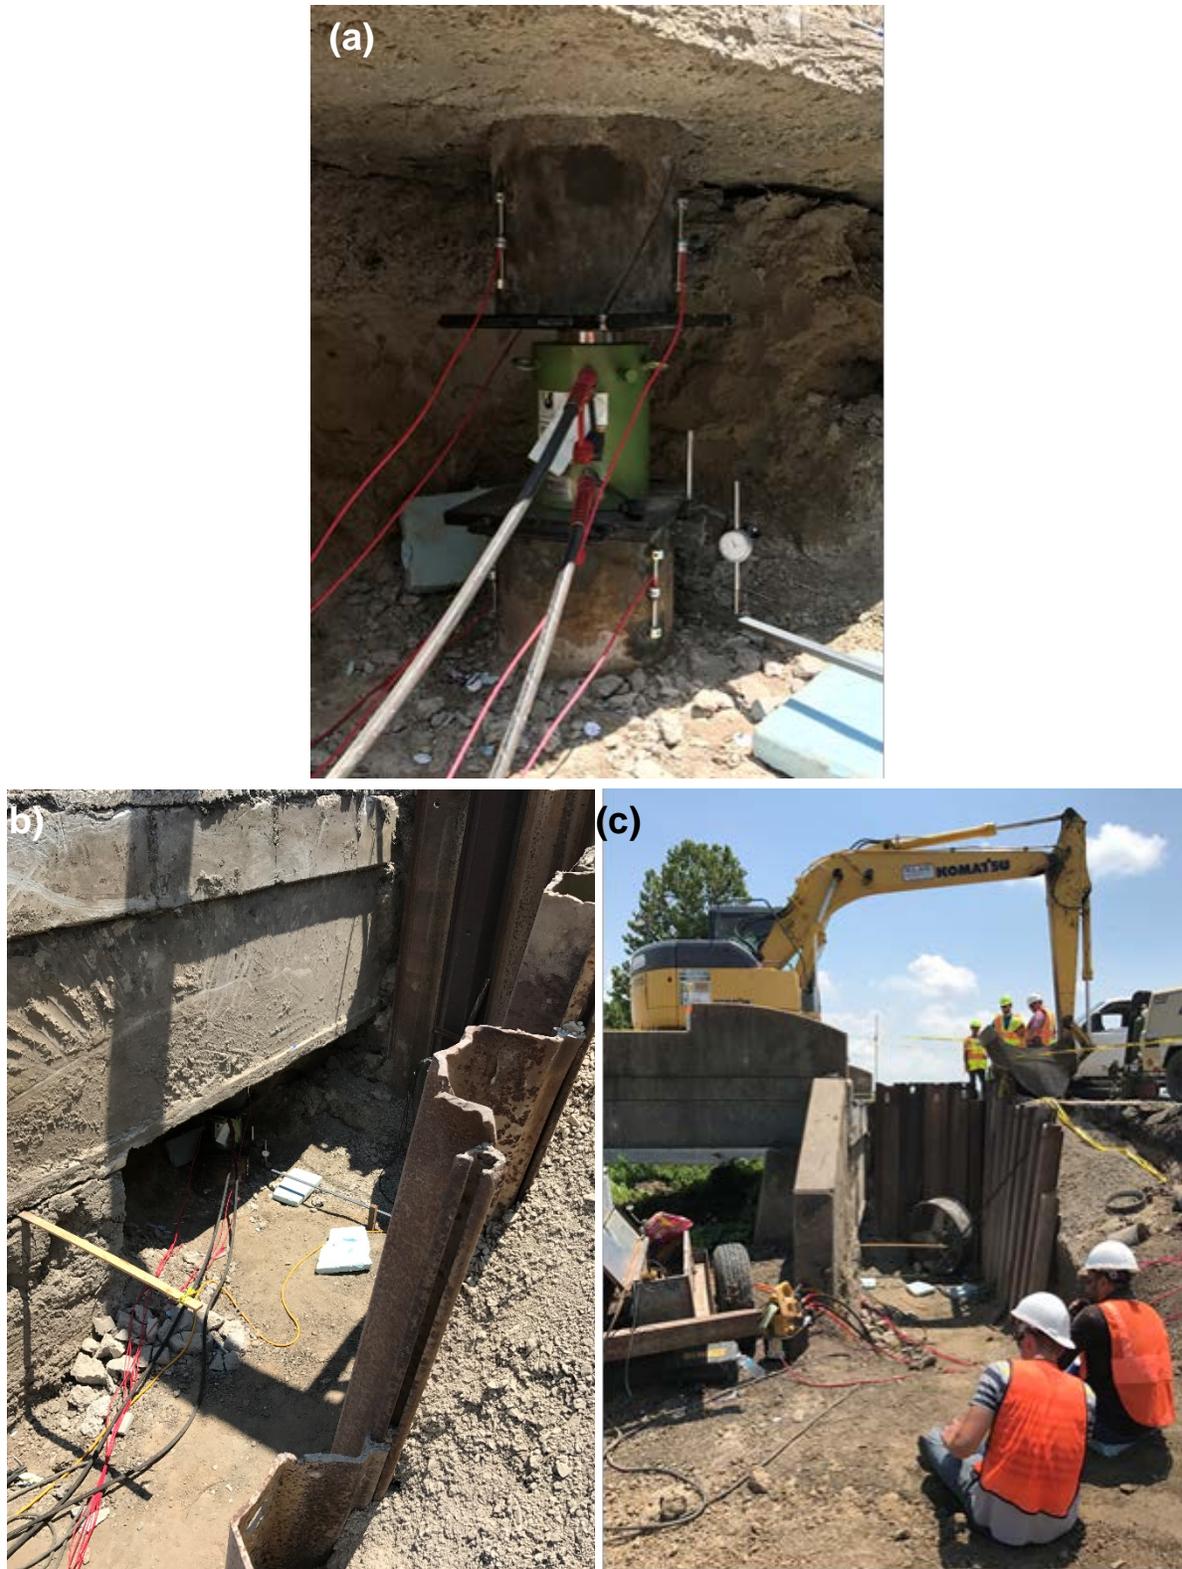
**Figure 30: Photographs of CIP test pile load test: (a) hydraulic cylinder applies load while strain gages are used to measure load at the top of pile and dial gage measures displacement of the top of the pile; (b) view of test pile beneath existing bridge capping beam; and (c) backhoe is parked atop reaction beam to reduce loads in capping beam and reaction piles.**

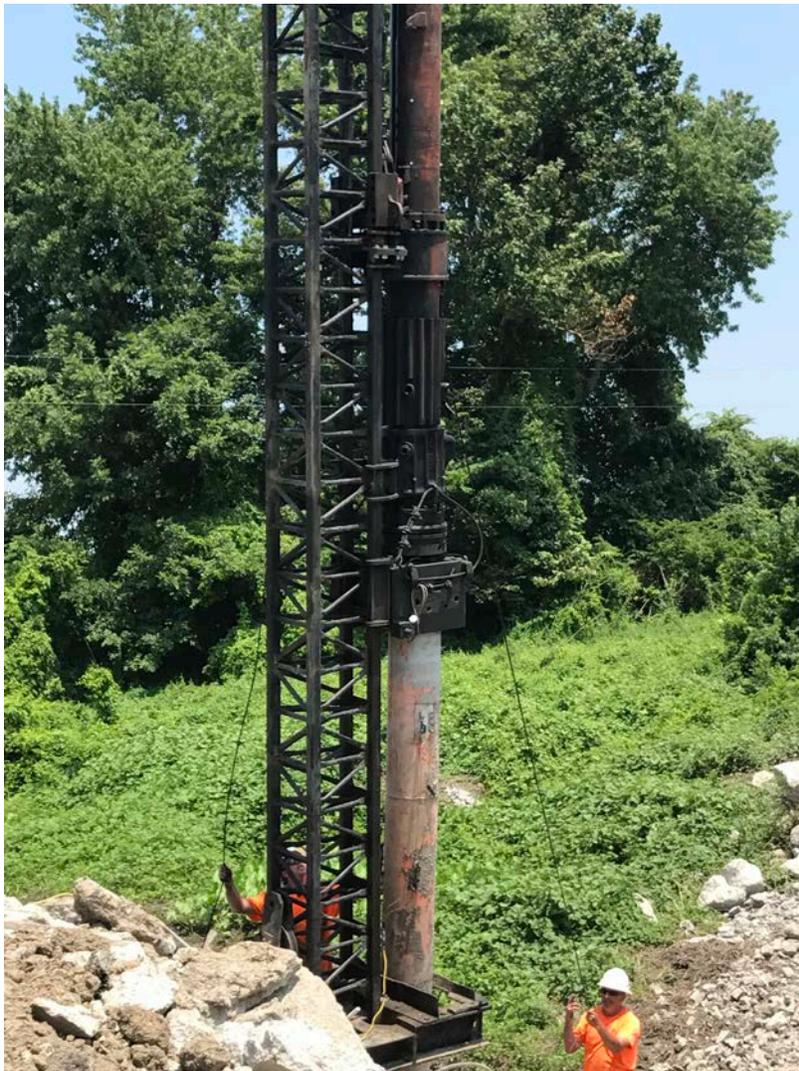
**Figure 31: Restrike test of a CIP pile.**

After the static load tests and demolition of the bridges were complete, Koehler Engineering performed dynamic pile driving analysis (“CAPWAP”) of the existing piles by restriking the piles. Six piles were tested at each bridge. A photograph of one of the restrike tests at Route WW (CIP pile bridge) is shown in Figure 31. The restrikes were completed using a Delmag D-15 diesel hammer. Dynamic test data were collected using a Pile Driving Analyzer, including strain gages at the pile head. Test data were analyzed by GRL Engineers, Inc. GRL Engineers documented the tests and results in reports presented in Appendix D.

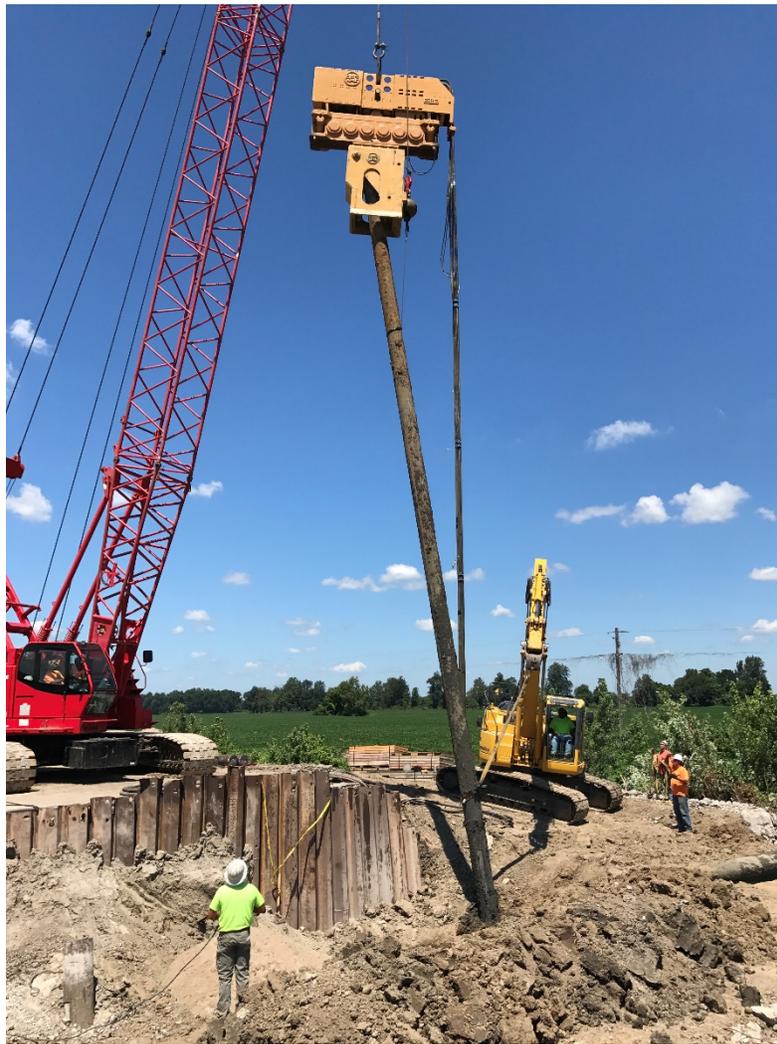
**Figure 32: Pile exhumation at the Route WW site.**

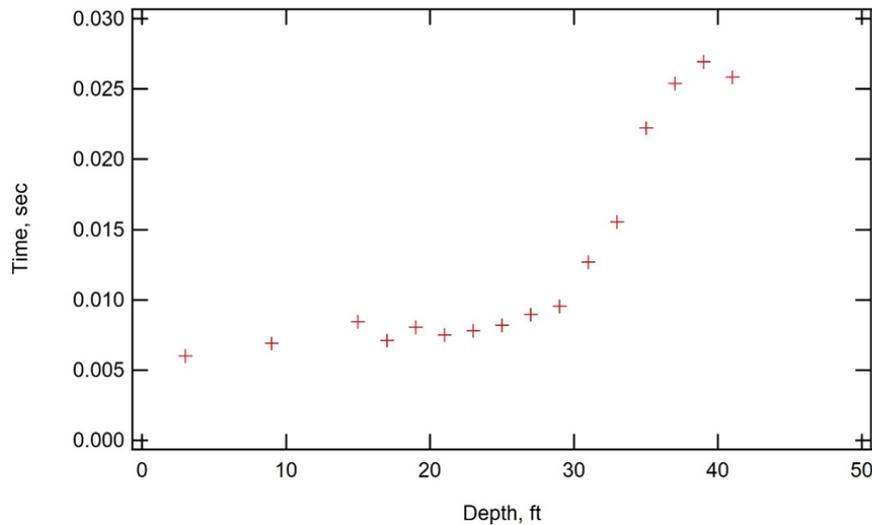
**Figure 33: Wave arrivals at Borehole 2 from hitting above precast Pile 1 at Route U site.**

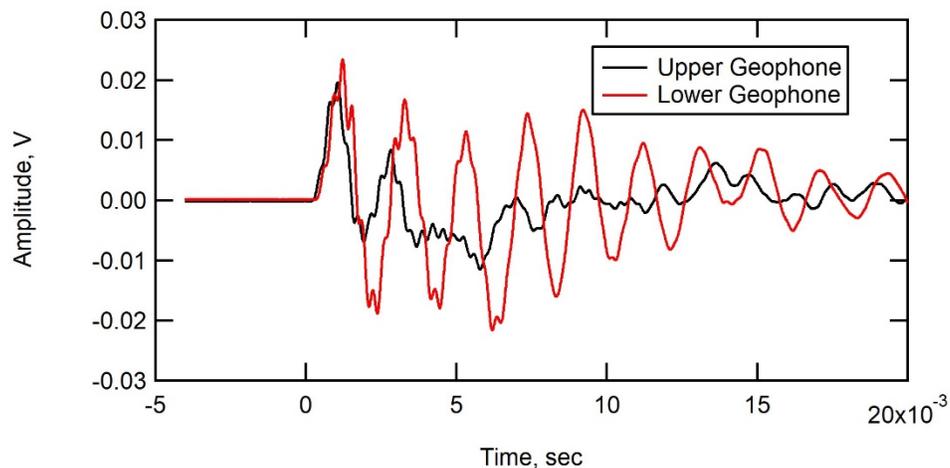
**Figure 34: Time records from SE measurements performed on precast Pile 7 prior to Route U bridge removal.**

Sonic-Echo measurements were performed on two of the piles at each bridge site prior to removal of the bridge superstructure, as described in Section 3.3.3. The objective of these measurements was to determine if the reflected return from the tip of the pile could be detected when the pile remained connected to the bridge superstructure. When the pile remains connected to the bridge superstructure the waves propagating in the pile are much more complicated and difficult to interpret. To aid in the interpretation, two receivers were used such that downward moving waves will arrive first on the upper receiver and upward propagating waves reflecting from the tip of the pile will arrive first on the lower geophone. Unfortunately, attempts to detect reflections from the tip of the pile while the pile remained connected were not successful at either site. Example results from precast Pile 7 at the Route U site are presented in Figure 34. No indication of a reflected wave arrival from the pile tip is evident in these records. For comparison, the results obtained from the same pile after the bridge superstructure was removed is shown in Figure 35. Similar results were obtained from testing CIP piles at the Route WW site.

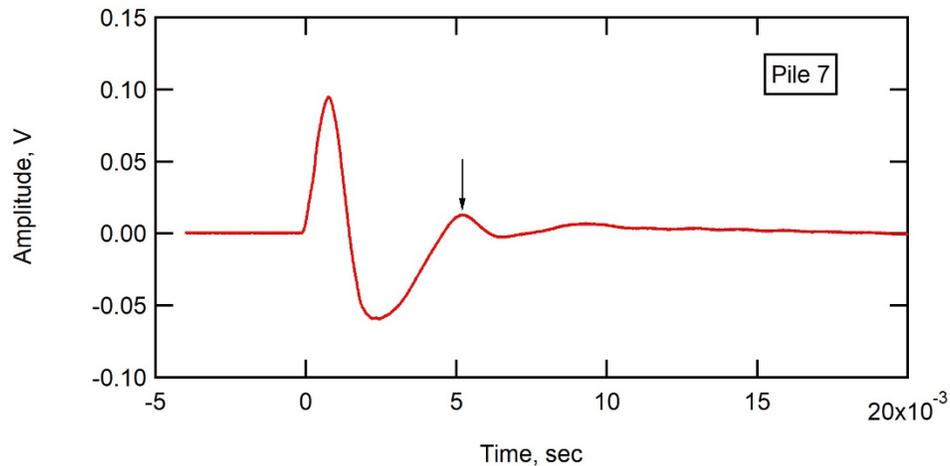
**Figure 35: Time record from SE measurement performed on precast Pile 7 after Route U bridge removal.**
