# Foundation Reuse: Length, Condition, and Capacity of Existing Driven Piles

Final Report Prepared for Missouri Department of Transportation  
May 2018

Project TR201714

Report cmr18-008

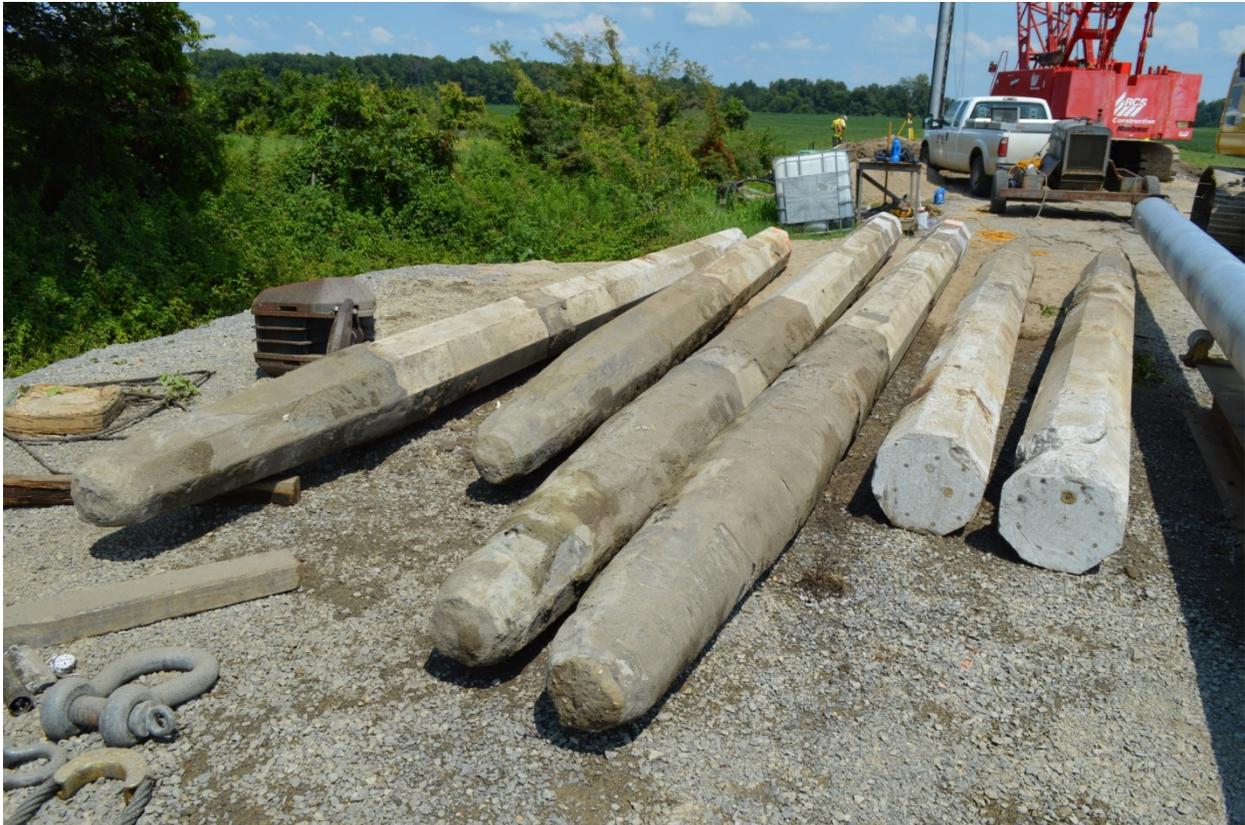
Figure 36: Exhumed precast piles.

As described in Section 3.7, six precast and six CIP piles were exhumed after completing the static load tests and pile restrikes. Photographs of the exhumed precast piles from the Route U site are shown in Figure 36, Figure 37, and Figure 38. The photographs indicate the precast piles were in excellent condition, with no evidence of any significant concrete cracking or surface damage. The most noteworthy observation regarding the precast piles was the strong adhesion of sand to the tips of the piles. In fact, application of a high-pressure water jet to the tips of the pile was mostly incapable of removing the sand, which appeared to be chemically bonded to the pile concrete. The cemented sand increased the effective size of the precast piles, which could have increased the load capacity of the precast piles.

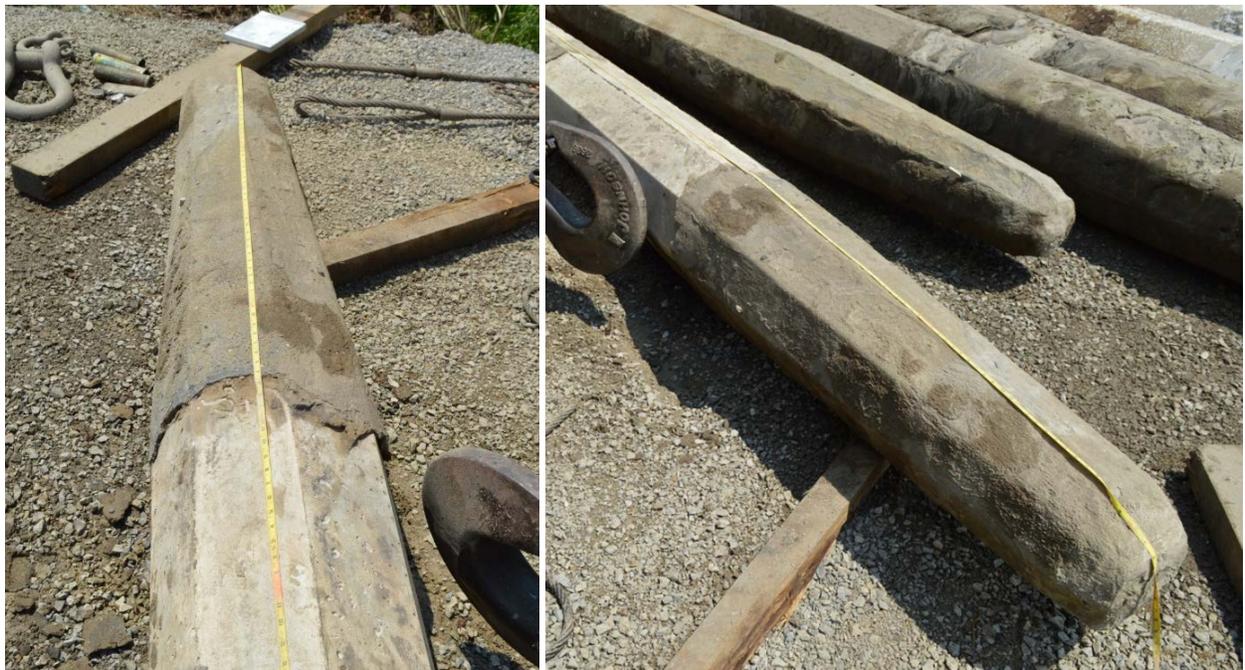
Figure 37: Photographs of tips of exhumed precast piles.

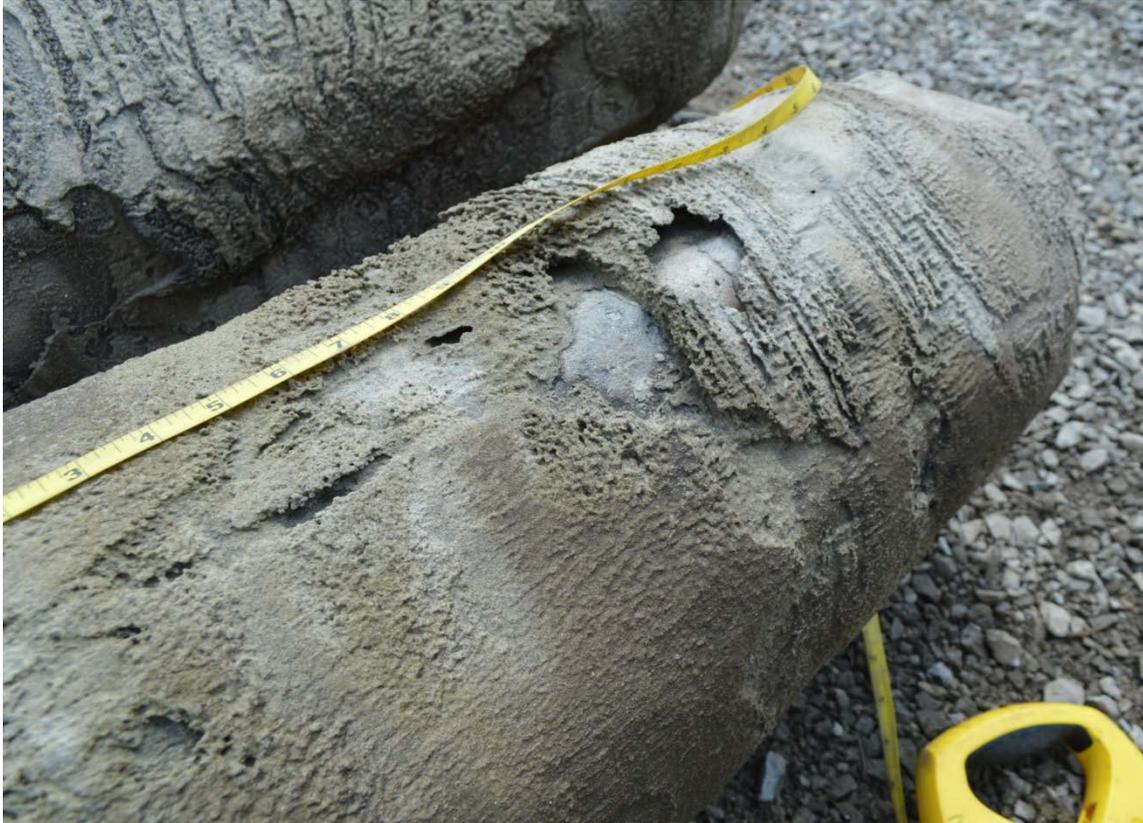
**Figure 38: Close-up view of tip of exhumed precast pile showing sand adhered to pile surface.**

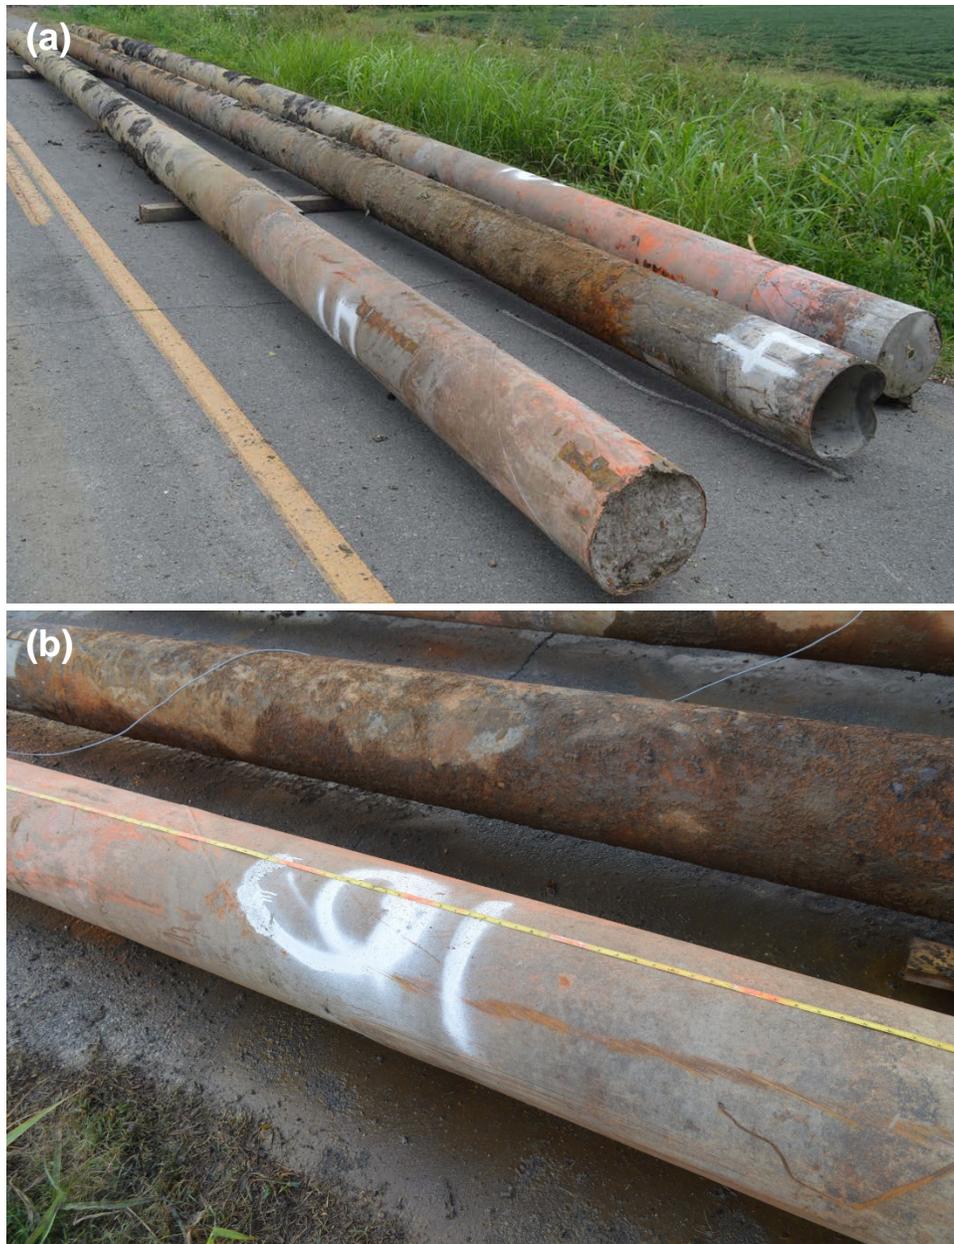
**Figure 39: Photographs of exhumed CIP piles: (a) full length and (b) length of pile without surface corrosion in foreground and length of pile with surface corrosion in background. Note that although it is marked as Pile 6 this is Pile 8.**

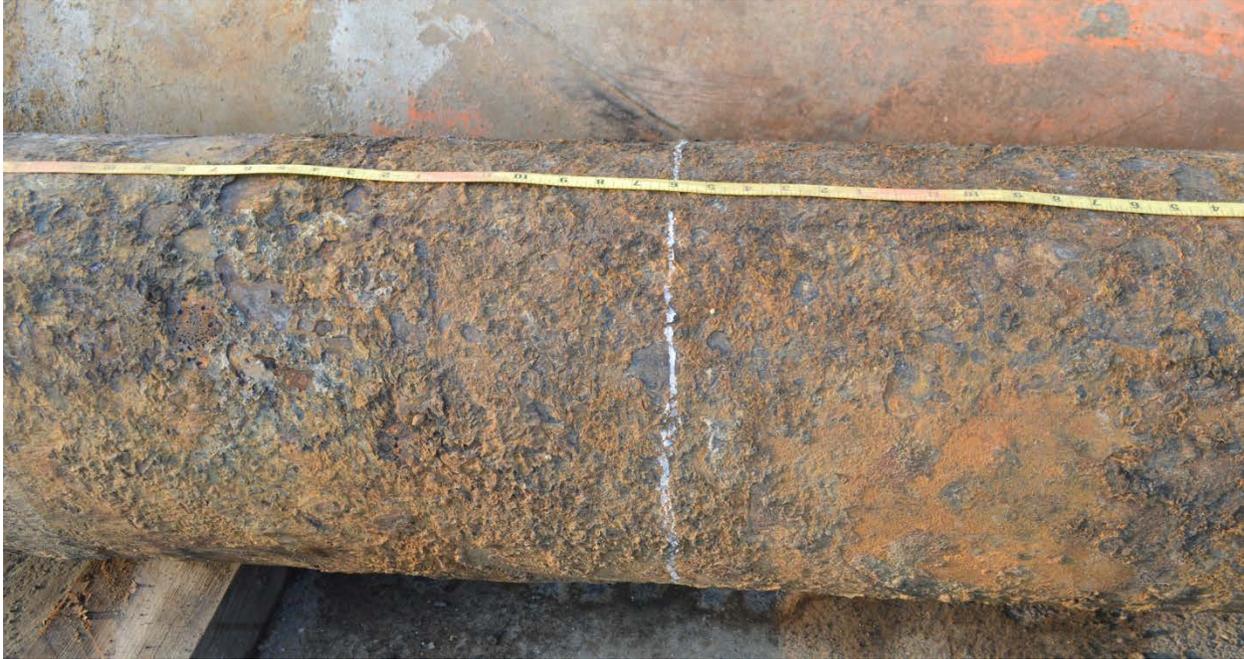
**Figure 40: Close-up view of segment of exhumed CIP pile with surface corrosion. White line is location of future cut to expose pile cross-section.**

Figure 40 is a photograph showing a close-up view of the corroded length of one exhumed CIP pile. To further examine the extent of corrosion, measurements of steel pipe thickness were made at 19 locations using calipers, with results shown in Table 22. The measurement locations included the top of each exhumed pile as well as 13 cross-sections exposed by cutting the piles. The cuts were made using a circular demolition saw. Approximately half of the cut locations had visible surface corrosion while the other half did not. Sample photographs of the cut cross-sections are shown in Figure 41, which includes one section with corrosion and one without. The photographs indicate no visible difference in the steel condition between the two locations. Caliper measurements of steel thickness (Table 22) also did not indicate any difference in thickness. In fact, the average steel thickness measured in sections without visible surface corrosion was 0.266 in., which is actually 2.5 percent less than the average steel thickness measured in sections with visible surface corrosion, 0.272 in. For both sets of cross-sections, steel thickness measurements were relatively uniform, with coefficients of variation less than 5 percent. Based on the 1960s standard for CIP piles, the minimum wall thickness for CIP piles was either 0.23 or 0.25 in. As shown in Appendix A, the value is unclear; regardless, the measured thickness values in locations with and without corrosion are greater than the specified values.

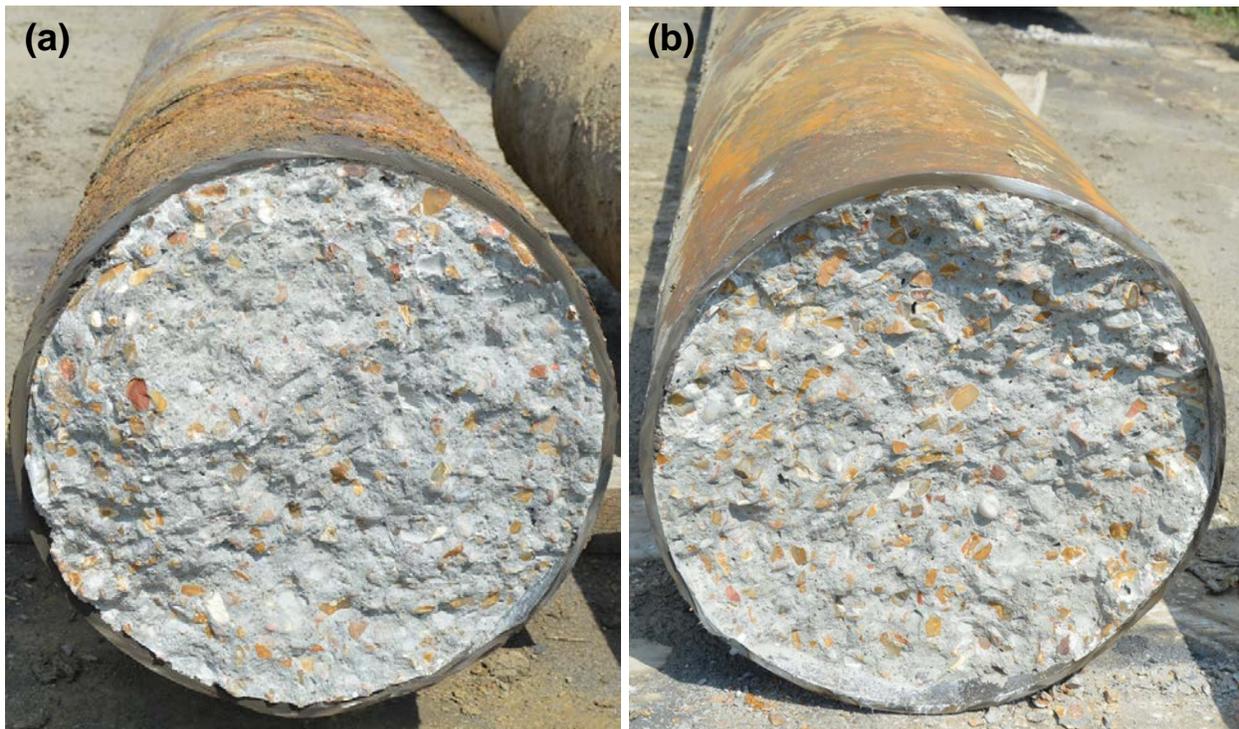
**Figure 41: Cross sections of exhumed CIP piles after making cuts at select locations: (a) location with apparent surface corrosion and (b) location with negligible surface corrosion.**

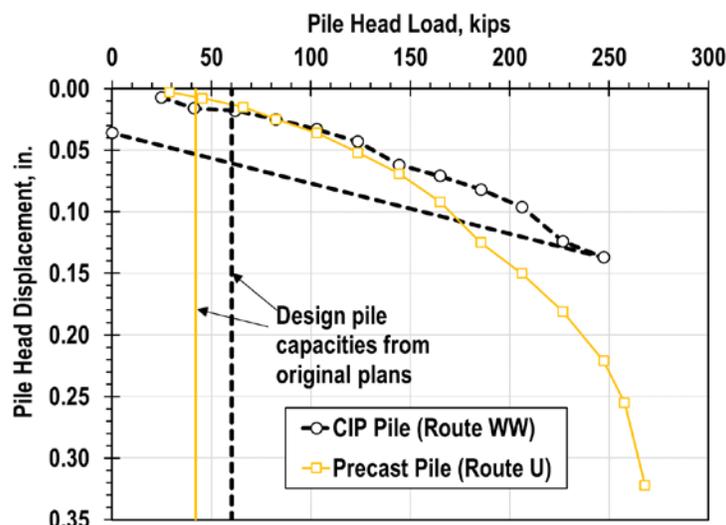
Figure 42: Load-displacement curves for the top of test piles.

For the CIP pile bridge, fracture of the capping beam was more sudden, producing an audible noise and a visible crack that appeared to extend the full depth and full width of the beam. Based on the load-displacement curve shown in Figure 42, the CIP test pile had not yet achieved ultimate geotechnical resistance at the maximum test load of 247 kips. One potential explanation of the greater beam capacity at the precast bridge is that the greater displacement of the reaction piles, which are shorter at the precast bridge, resulted in wider load distribution along the precast capping beam and therefore a more ductile response.
