Consultant Support for IC-PMTPS Projects

May 2020
Final Report

Project number TR201902
MoDOT Research Report number cmr 20-005

The Transtec Group, Inc.

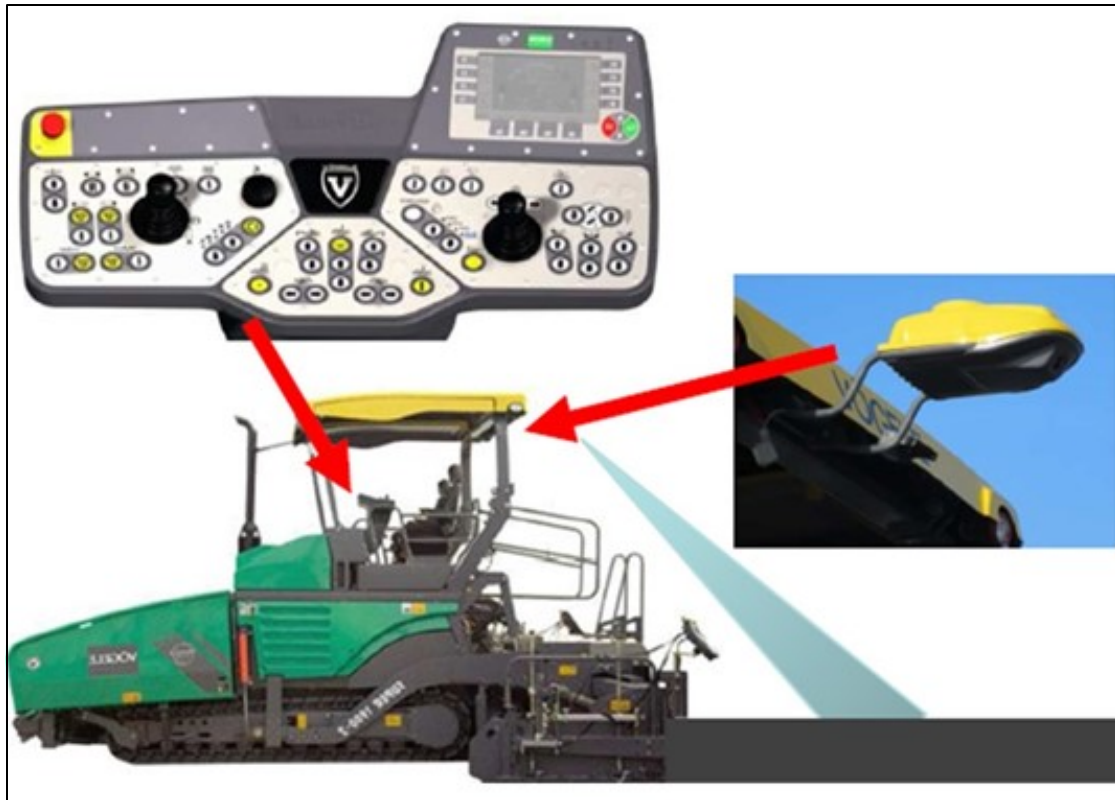
Figure 8: Vogele RoadScan Thermal Imaging System

Currently, the Vogele RoadScan system can be mounted only on certain models of Vogele asphalt pavers. Images of the equipment are shown in Figure 8 and Figure 9.

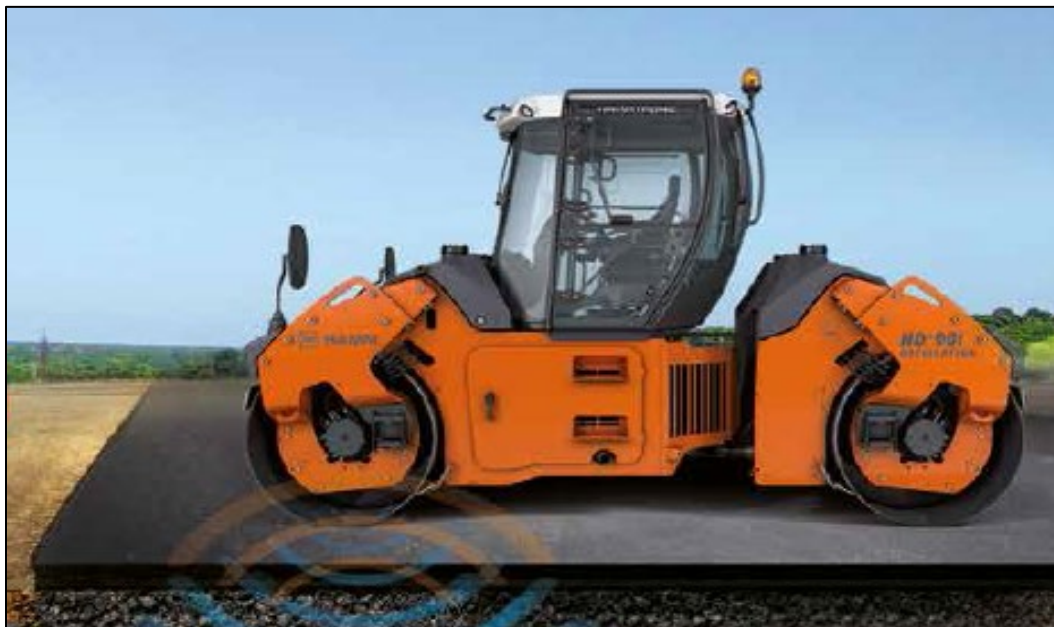
Figure 10: HAMM HCQ Intelligent Compaction System

The HAMM Temperature Meter shows the current asphalt surface temperature. It enables the roller driver to decide where and how the asphalt needs to be compacted, thus making optimum use of the working time window and avoiding damage. The HAMM system is shown in Figure 10 and Figure 11.

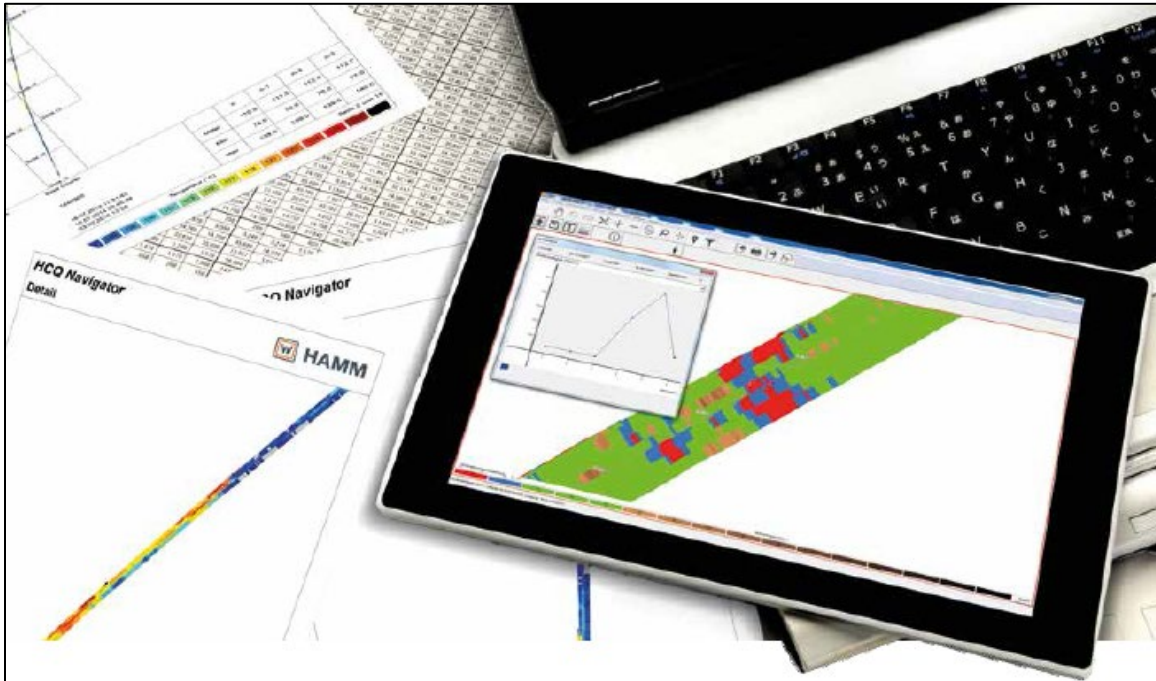
Figure 12: HAMM HCQ Navigator Software

Evaluations with the HCQ Navigator can also identify weaknesses in the roadbed that are invisible to the eye. During proof rolling, the roller is driven over the prepared roadbed before beginning the asphalt work, and the pass is recorded with the HCQ Navigator. An evaluation of the data can reveal any weak areas of the roadbed in question. This simple detection of inadequately compacted areas can prevent expensive damage that generally only becomes apparent years later.

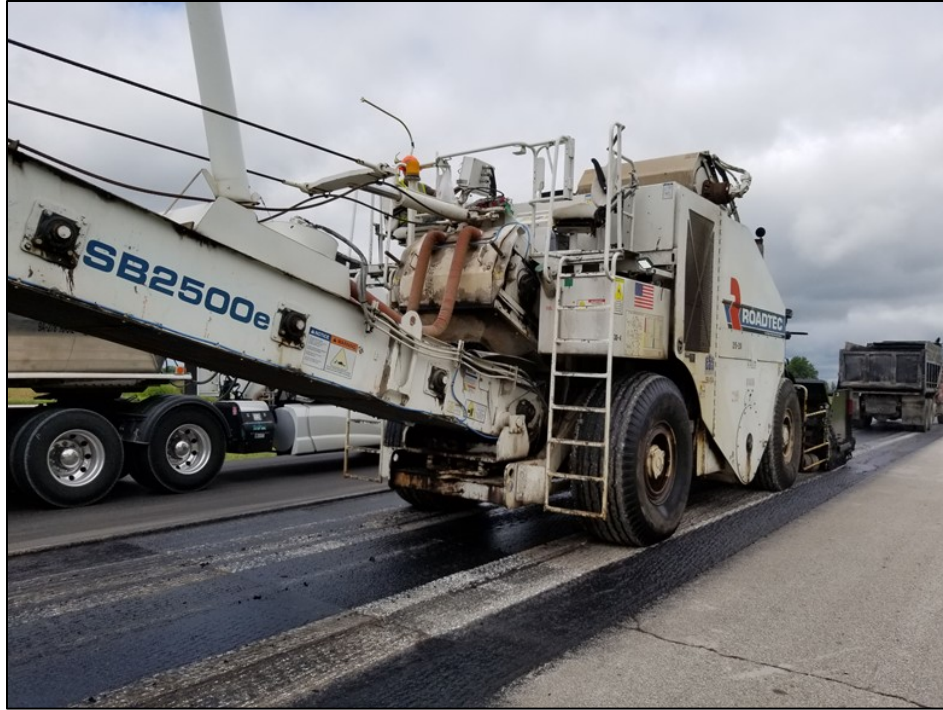
Figure 13: Roadtec Material Transfer Vehicle (MTV) On-Site (HWY 61/24 Project)

A Roadtec material transfer vehicle (MTV) was used at the project (Figure 13). Figure 14 shows Vogele RoadScan PMTPS mounted on a Vogele Paver. Figure 15 shows the RoadScan PMTPS data in Veta. HAMM HCQ equipment is shown in Figure 16.

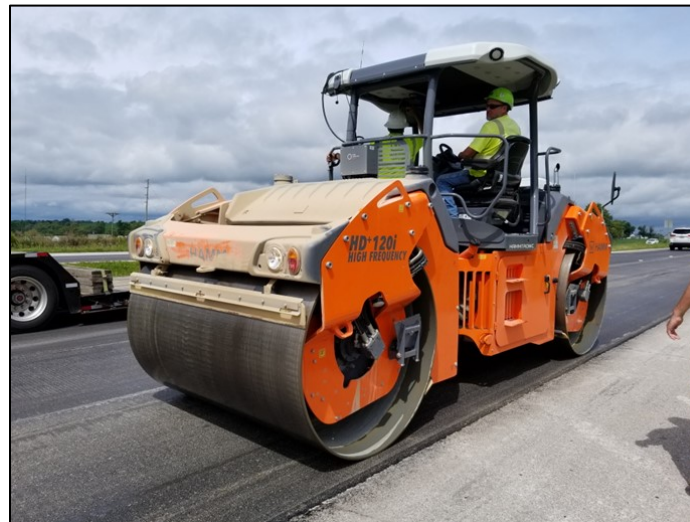
Figure 16: HAMM HCQ Intelligent Compaction System On-site (HWY 61/24 Project)

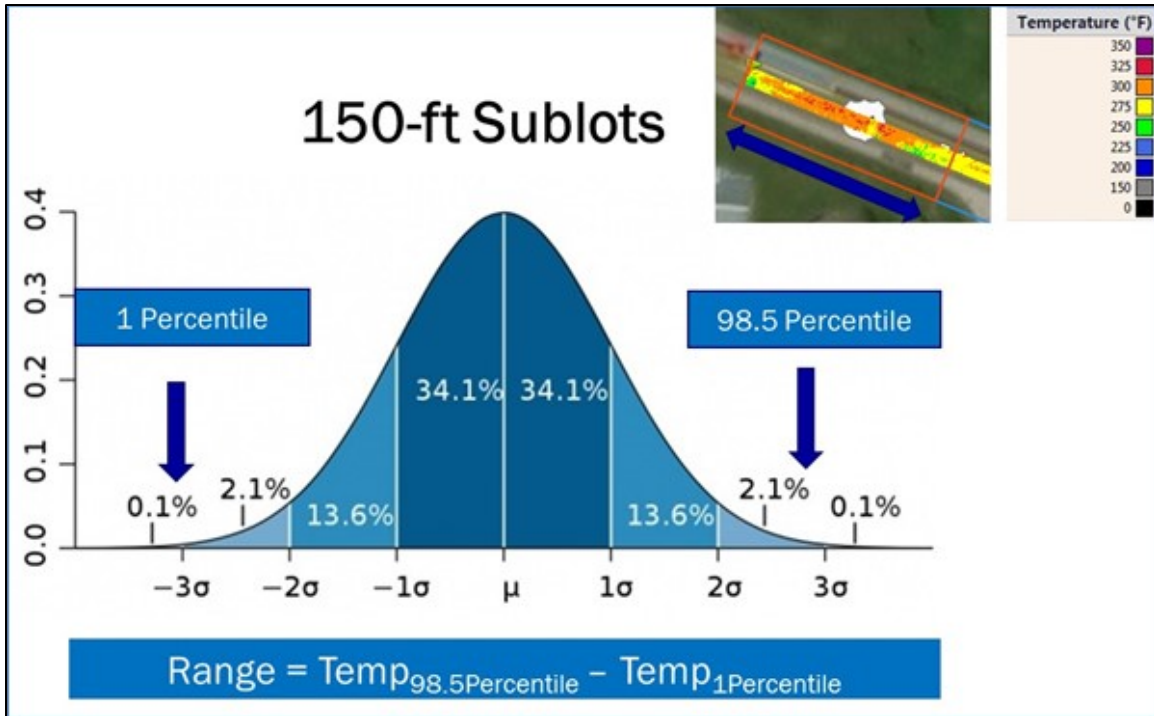
Figure 19: AASHTO PP80 IR Analysis Method: Computation of “Range” Value

The remaining data are used to calculate the range value, 98.5th percentile – 1st percentile (Figure 19). The classification of temperature segregation is based on the Range value as follows: Low ($\text{Range} \leq 25.0\text{ }^{\circ}\text{F}$); Moderate ($25.0\text{ }^{\circ}\text{F} < \text{Range} \leq 50.0\text{ }^{\circ}\text{F}$); and Severe ($\text{Range} > 50.0\text{ }^{\circ}\text{F}$), as shown in Figure 20.

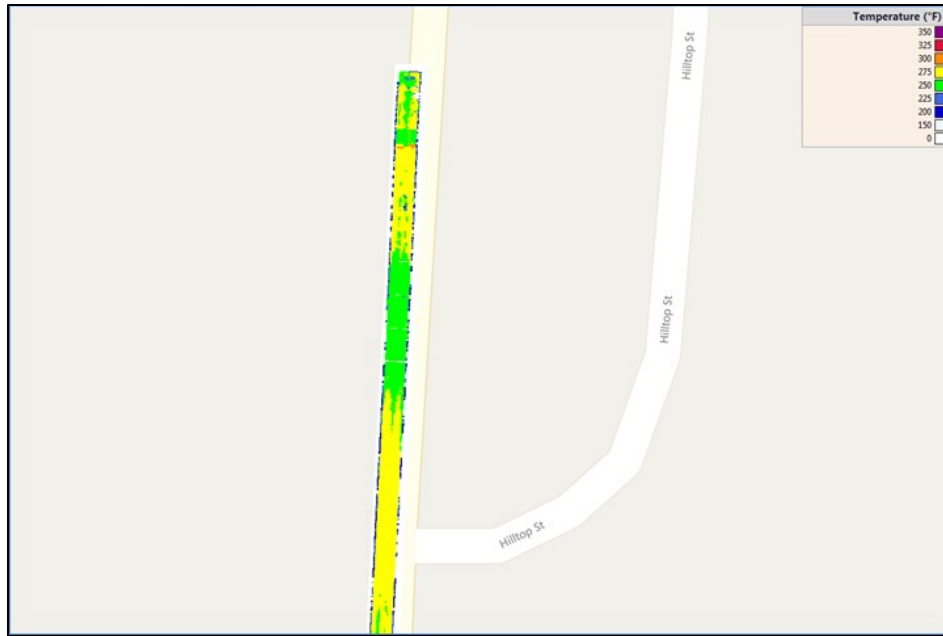
Figure 22: Veta View Screen for PMTPS Data Analysis

The MOBA PAVE-IR data is imported to Veta 5.2 and saved as J5S3207-20181022-IR.vetaproj. There are minor data points with invalid coordinates. A few invalid coordinates are typical and not of concern. The “raw” thermal profile data shows the cold edges of adjacent existing asphalt (Figure 22).

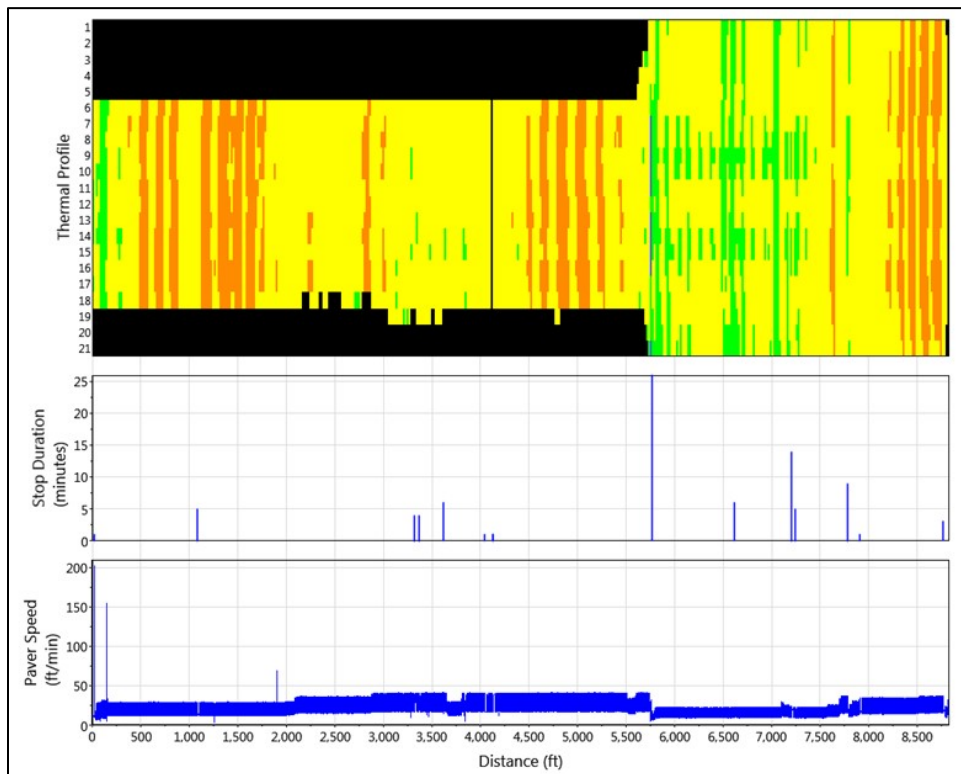
Figure 29: Veta Thermal Profile/Paver Stops/Paver Speed Screen of PMTPS Data Analysis

The thermal profile, paver stops, and speed plots can be viewed in Veta as shown in Figure 29. Note that the thermal profile width changes at 5,550ft. It is recommended to verify this change of paving width with the contractor.

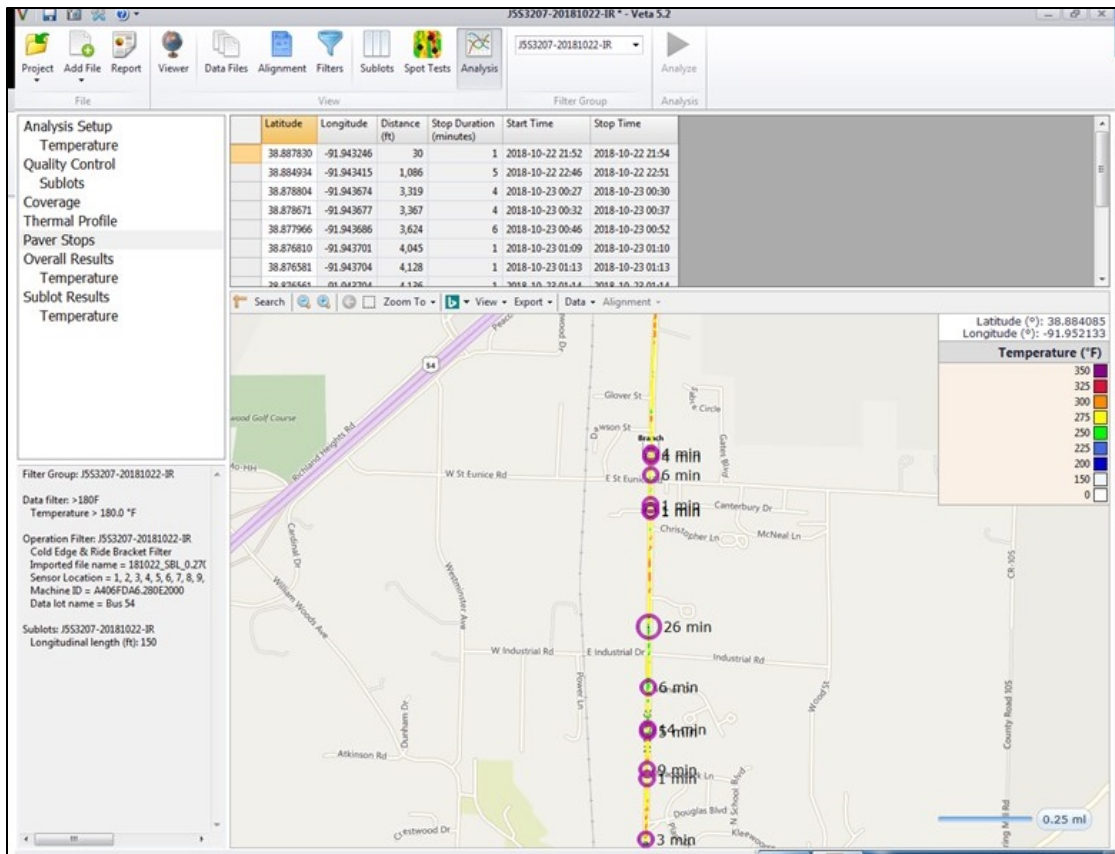
Figure 30: Veta Stop Map Screen of PMTPS Data Analysis

The paver stop maps can be seen in the “Paver Stops” results. The stop location and duration is displayed as shown in Figure 30. The count and percent of temperature differentials analyzed according to AASHTO PP80 are displayed in Veta as shown in Figure 31. One example of a subplot with severe temperature segregation coincides with a paver stop as shown in Figure 32.

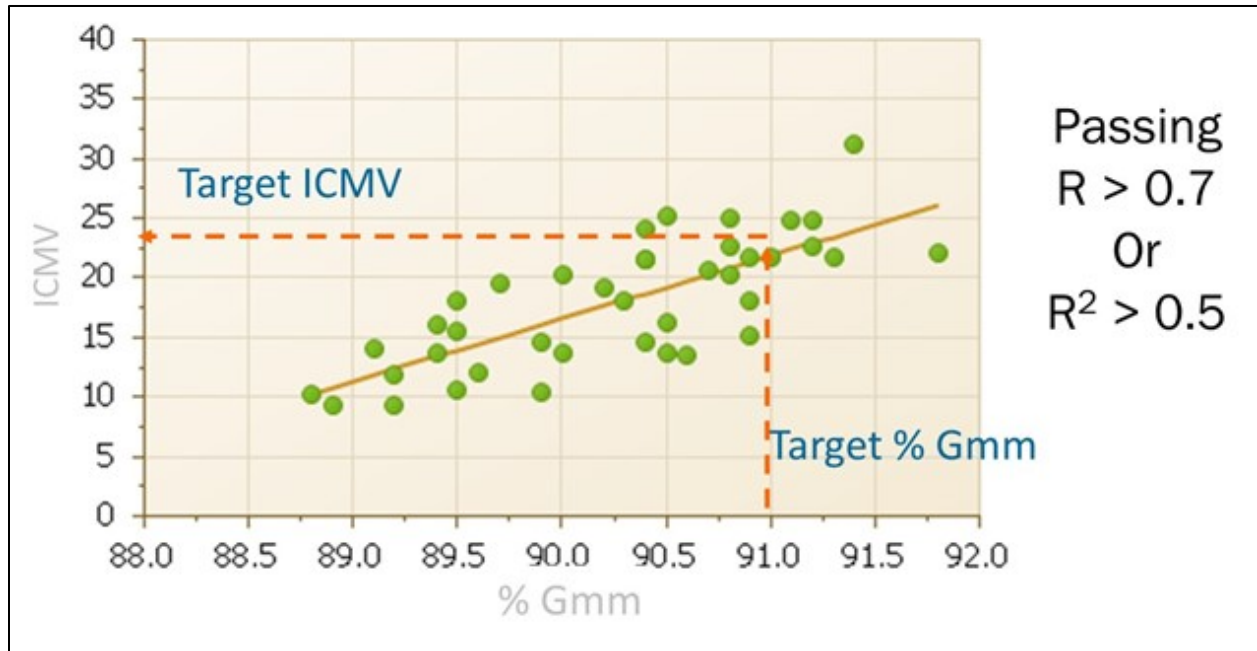
Figure 33: Target ICMV Determined by Correlation Between ICMV and Acceptance Spot Tests from Trial Section Data

The target ICMV can be determined based on the correlation between the ICMV data and acceptance spot tests from the trial section (Figure 33). The requirements for the acceptable correlation between ICMV and acceptance spot tests is $R > 0.7$ or $R^2 > 0.5$, based on most of the international IC specifications.

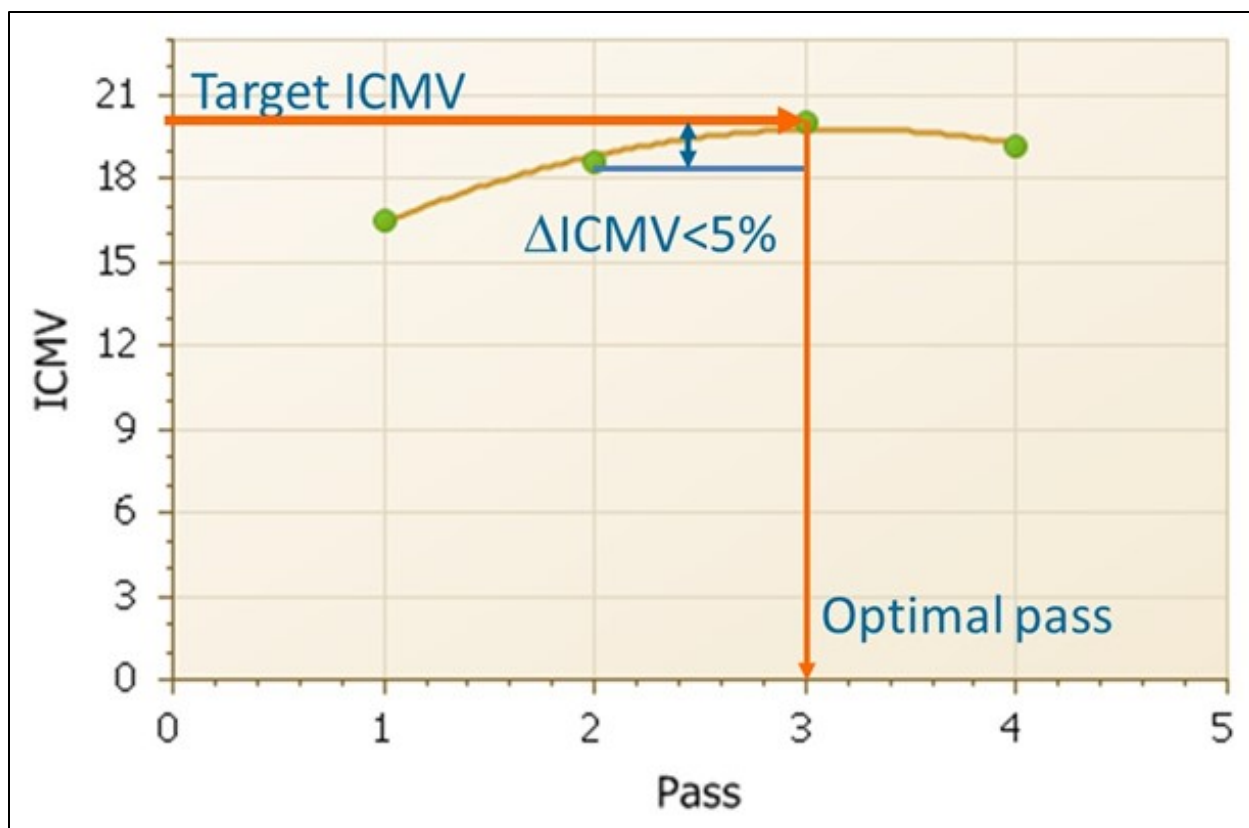
Figure 34: Target ICMV Determined by an ICMV Compaction Curve when Spot Tests from Trial Section Data are Not Available

Note that ICMV and acceptance spot tests are often fundamentally different mechanisms and not all ICMV methods are equal. The FHWA ICMV Tech Brief provides additional details on this issue (FHWA-HIF-17-046). Since ICMV is measured only with vibratory passes, the projects that use only static passes or mix of vibratory/static passes did not have sufficient or valid ICMV data for further analysis. When vibratory passes are used, but there are no companion spot tests, the target ICMV and optimal passes can be determined based on the ICMV compaction curve where the increment of ICMV with each subsequent pass is less than 5% (Figure 34).

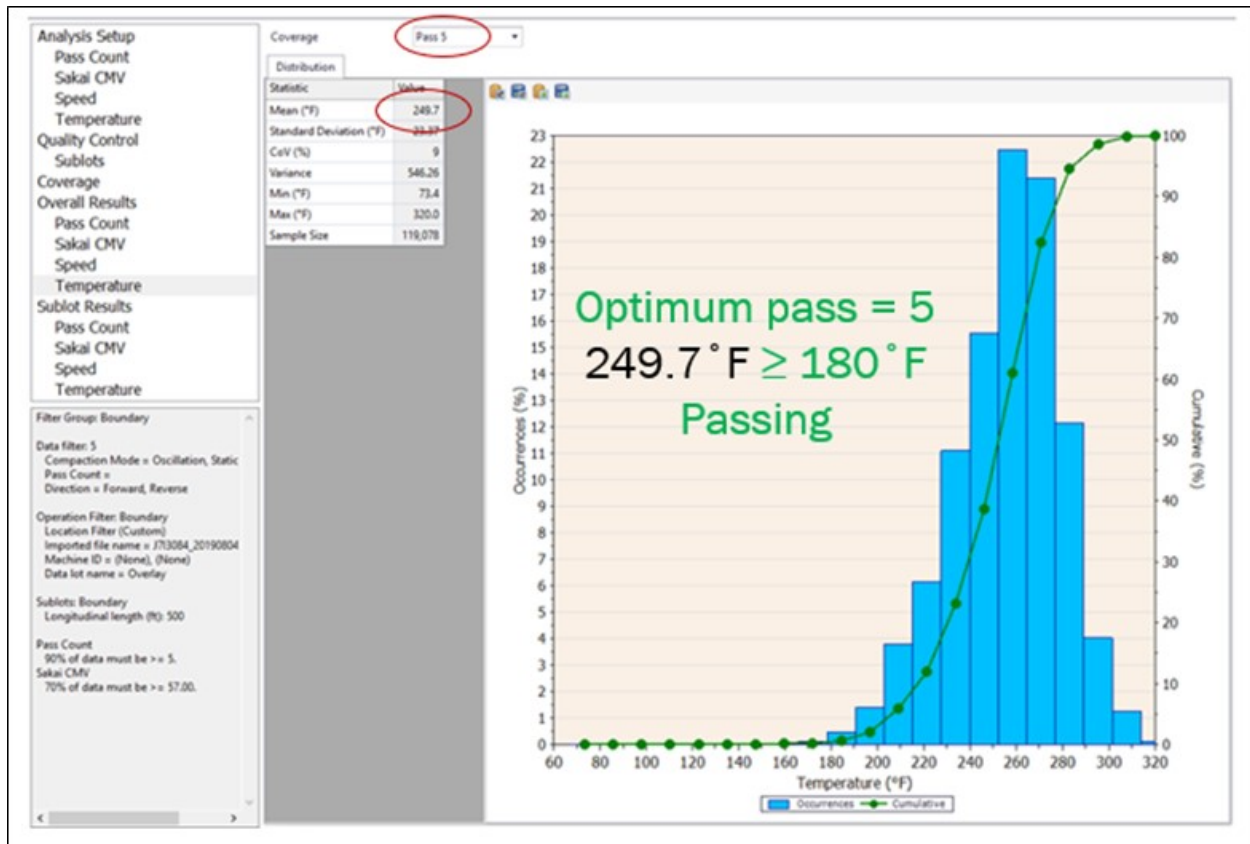
Figure 36: Mean Temperature at Optimum Pass Meets the Requirements of Greater than 180°F

The Veta analysis for the temperature requirement includes analyzing individual passes and looking at the mean temperature value at the optimum pass. Figure 36 shows an example of the mean temperature results at the optimum pass after analyzing in Veta.

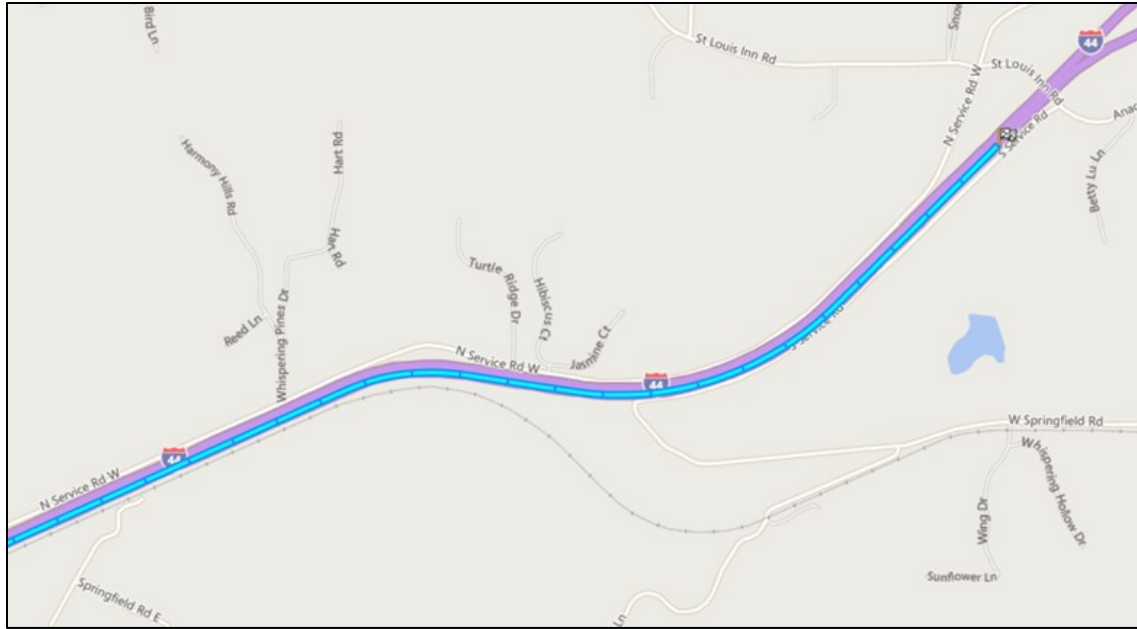
Figure 42: Veta Sublot Screen of IC Data Analysis J6I3189, I-44

1000 foot sublots can be created and used to analyze smaller sections of the paved area as shown in Figure 42. 1000 foot sublots are industry standard. Note that sublots are not required per the MoDOT specifications as an IC segment is considered one day's production. However, analyzing the data using sublots can identify potential localized coverage and temperature problems.

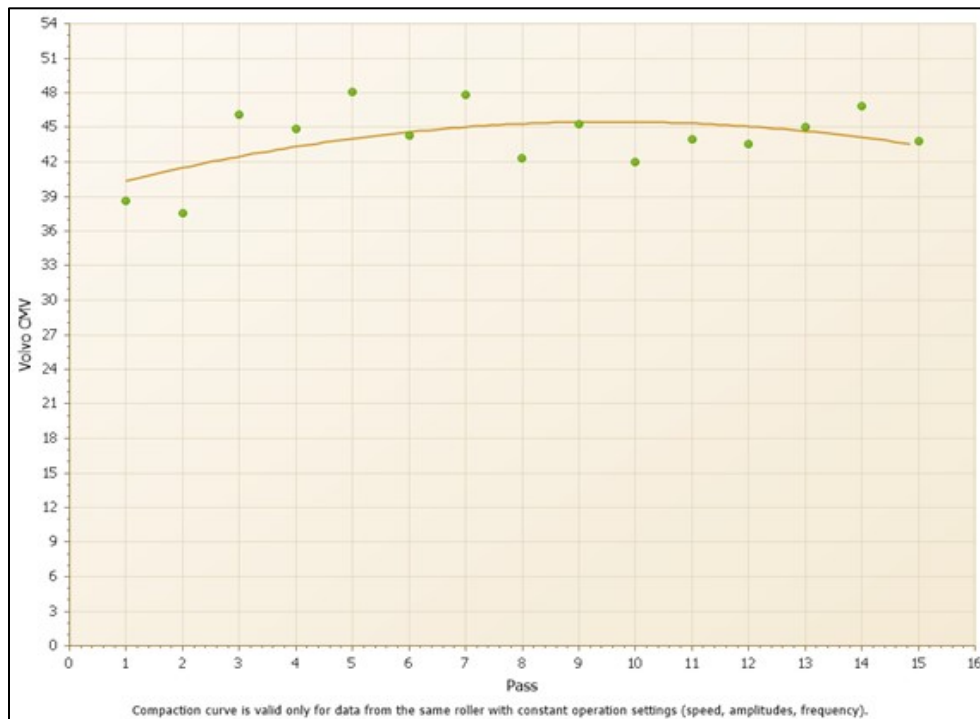
Figure 43: Veta Compaction Curve Screen of IC Data Analysis J6I3189, I-44

The all-passes CCV compaction curve is generated in Veta during analysis. CCV plateaus around five passes as shown in the compaction curve in Figure 43. This mirrors the compaction curve created using the NDG during the trial section. Based on this curve the optimum ICMV is set at 43.

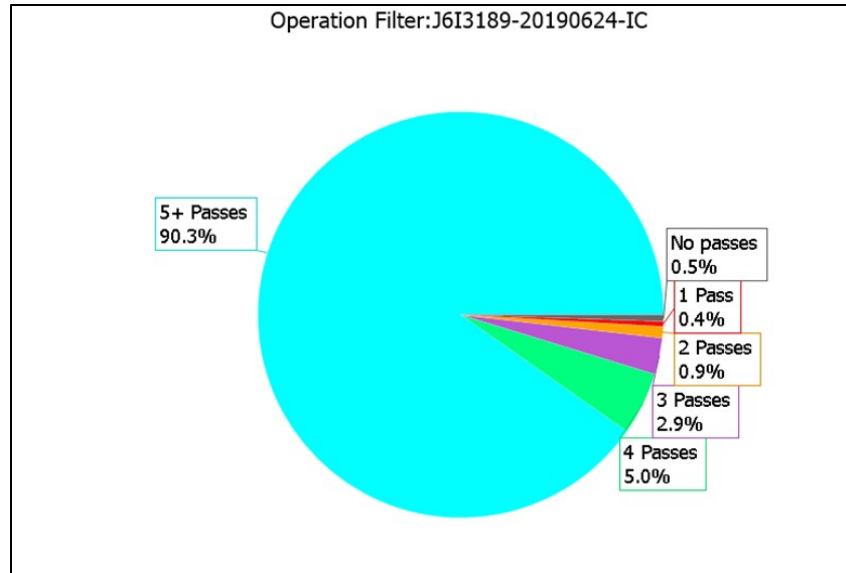
Figure 46: Veta Pass Count Coverage Screen of IC Data Analysis J6I3189, I-44

After analysis the results can be viewed. The overall pass count coverage is 90.3% (Figure 46) meeting the target passes (passing 90%) requirement for price incentive.

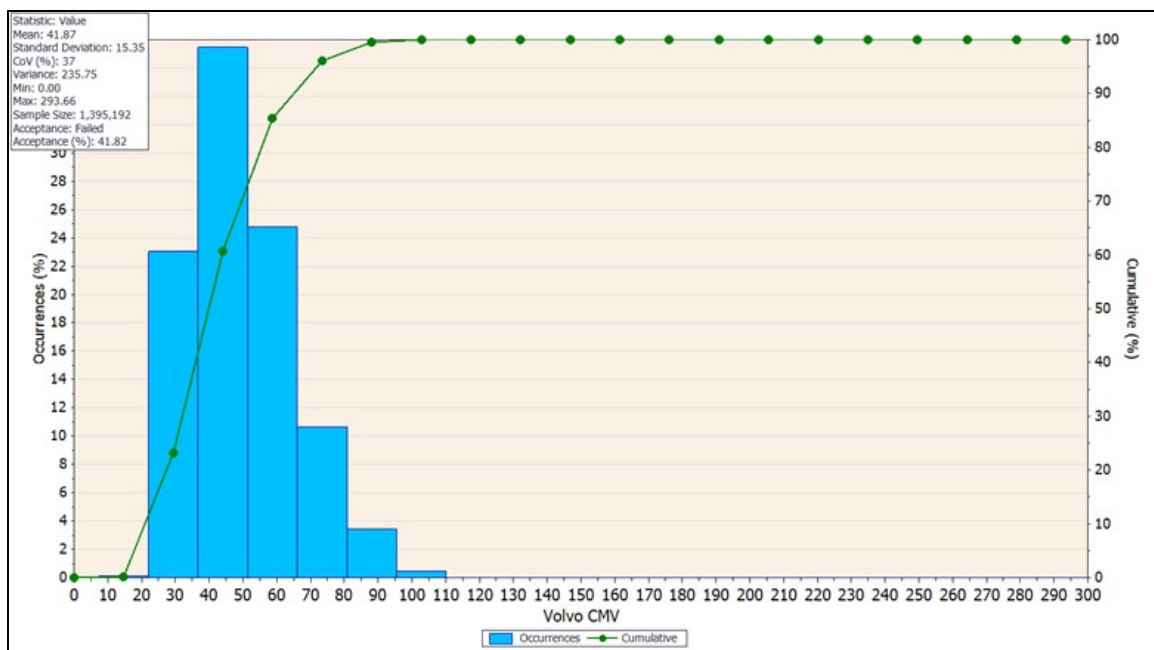
Figure 47: Veta CMV Statistics of IC Data Analysis J6I3189, I-44

The target ICMV coverage is 45.18% (Figure 47) which is less than the 70% requirement. However, due to the poor correlation between the level 1 CMV and core density, minimum requirements for ICMV are not recommended.

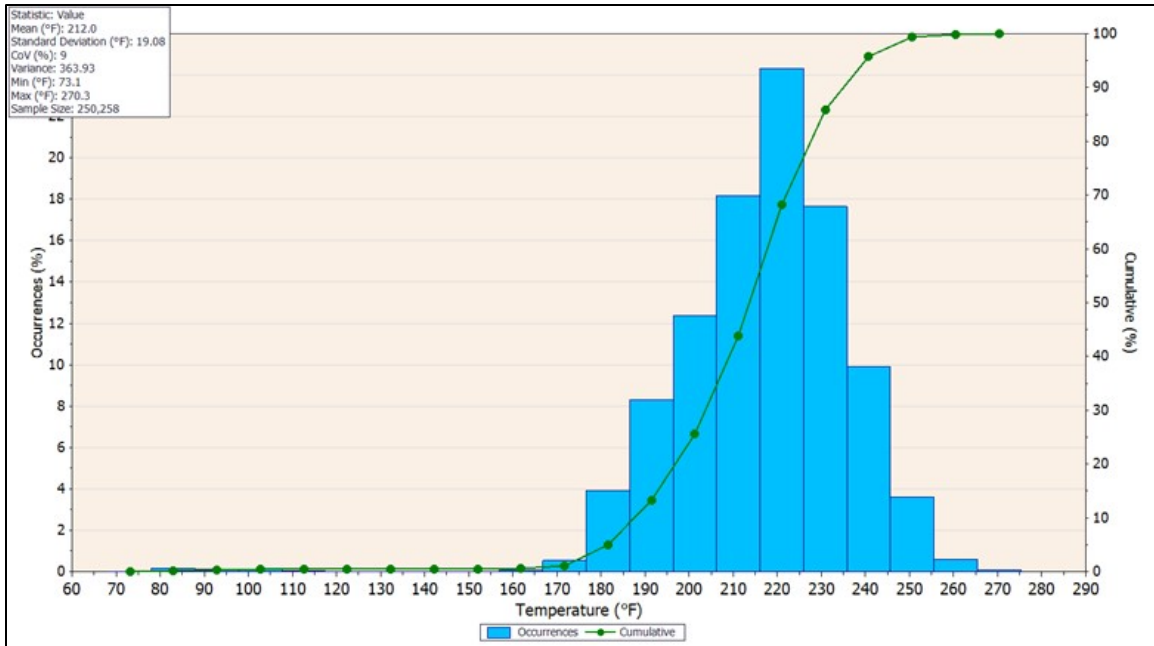
Figure 48: Veta Temperature Statistics Screen of IC Data Analysis J6I3189, I-44

The mean temperature at pass 5 is 212 degrees Fahrenheit. This meets the specification requirement of greater than 180 degrees at optimum pass.

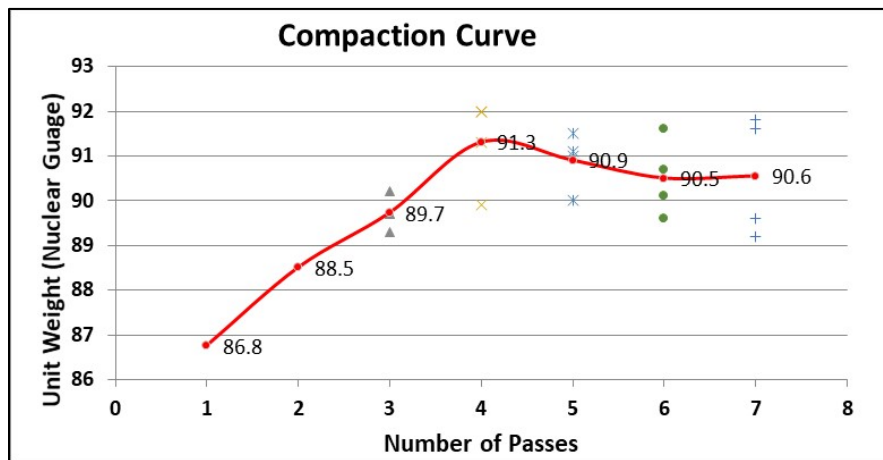
Figure 59: Trial Section Compaction Curve for J6I3189, I-44

The established rolling pattern is 5 passes as shown in the compaction curve in Figure 59. Note that the number of passes begins at pass 2 per contractor's notes. This was used as optimum pass count for the pass count coverage and mean temperature specification requirements.

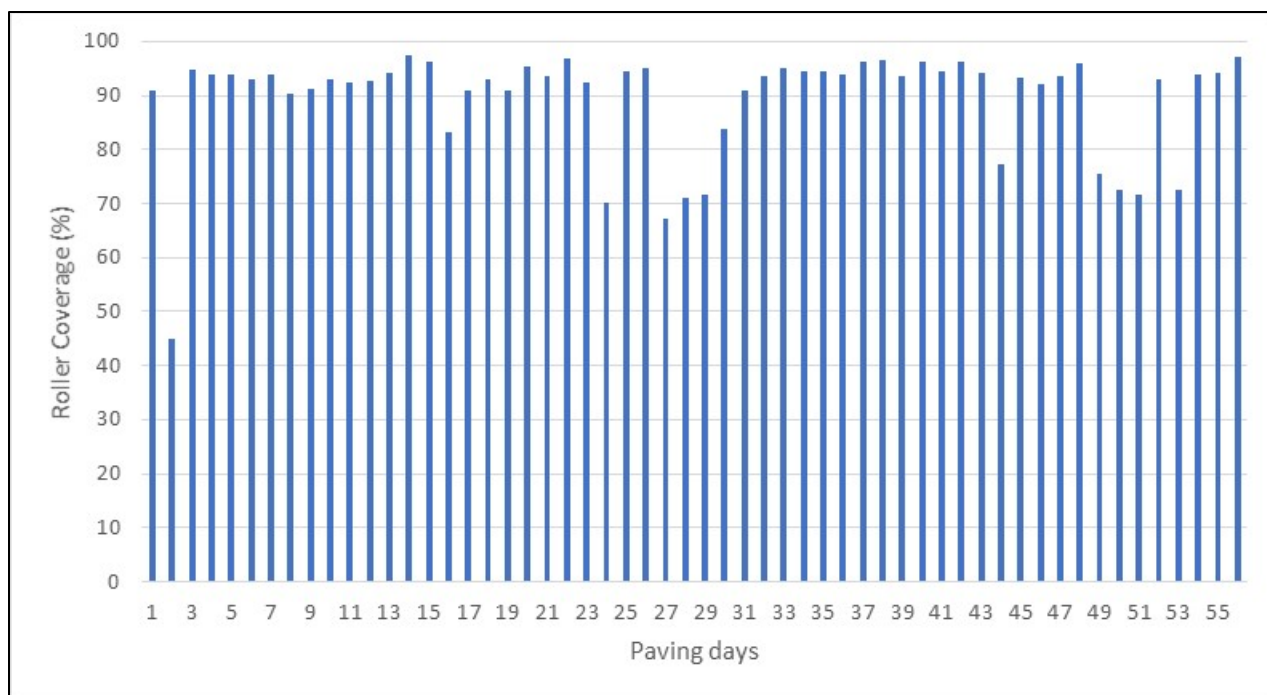
Figure 61: Summary of Roller Coverage Report for J6I3189, I-44

A summary of PMTPS and IC results are shown in the remainder of this section. Note that there were several days when there were GPS issues on one of the four rollers. This caused a lower than typical coverage for those days. The contractor used MOBA analysis and reports for the PMTPS data as allowed in their specification from 2018.

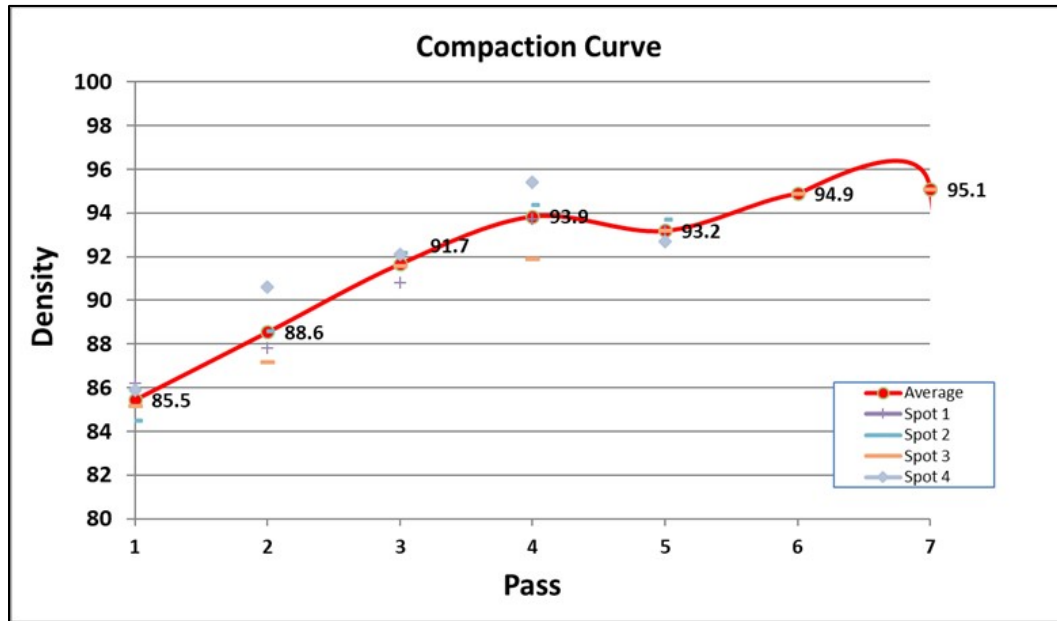
Figure 62: Trial Section Compaction Curve for J6I3165, I-70

The established rolling pattern is 7 passes as shown in the compaction curve in Figure 62. This was used as optimum pass count for the pass count coverage and mean temperature specification requirements. Note that this is the second trial section for this project. The first trial section established optimum pass count at 4 passes, however there was a discrepancy between core data and NDG data. The core densities on the first trial section failed.

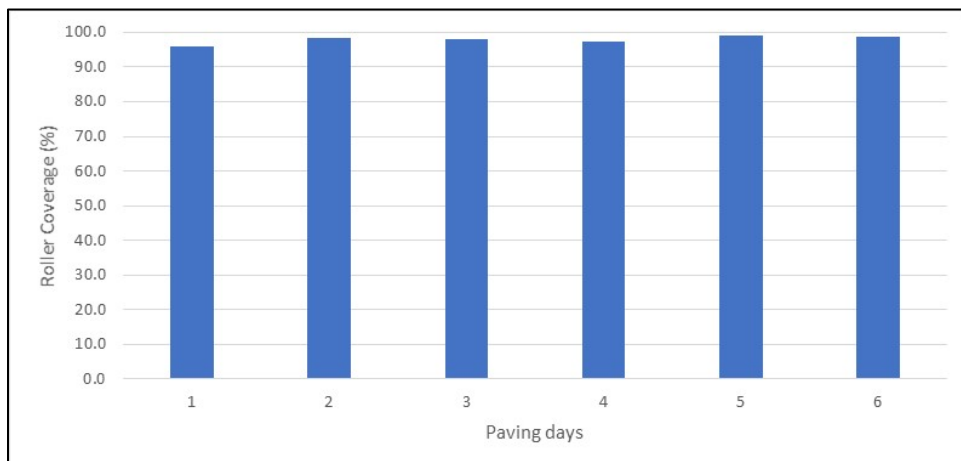
Figure 70: Summary of Roller Coverage Report for J9S3271, Rte. 62

No.	Dates	Roller % Coverage	Roller % Coverage Classification	Target ICMV % Coverage	Target ICMV Classification	Mean Temp at Optimum Pass - MTOP (F)	MTOP Classification
1	7/8/2019	95.8	Passed	70		230.6	
2	7/9/2019	98.5	Passed	70		227.4	
3	7/9/2019	98.0	Passed	70		238.7	
4	7/11/2019	97.2	Passed	70		247	
5	7/11/2019	98.9	Passed	70		247.6	
6	7/18/2019	98.8	Passed	70		240.3
