Use of Thermal Integrity Profiling (TIP) in Drilled Shaft Evaluation

January 2022
Final Report

Project number TR202015
MoDOT Research Report number cmr 22-002

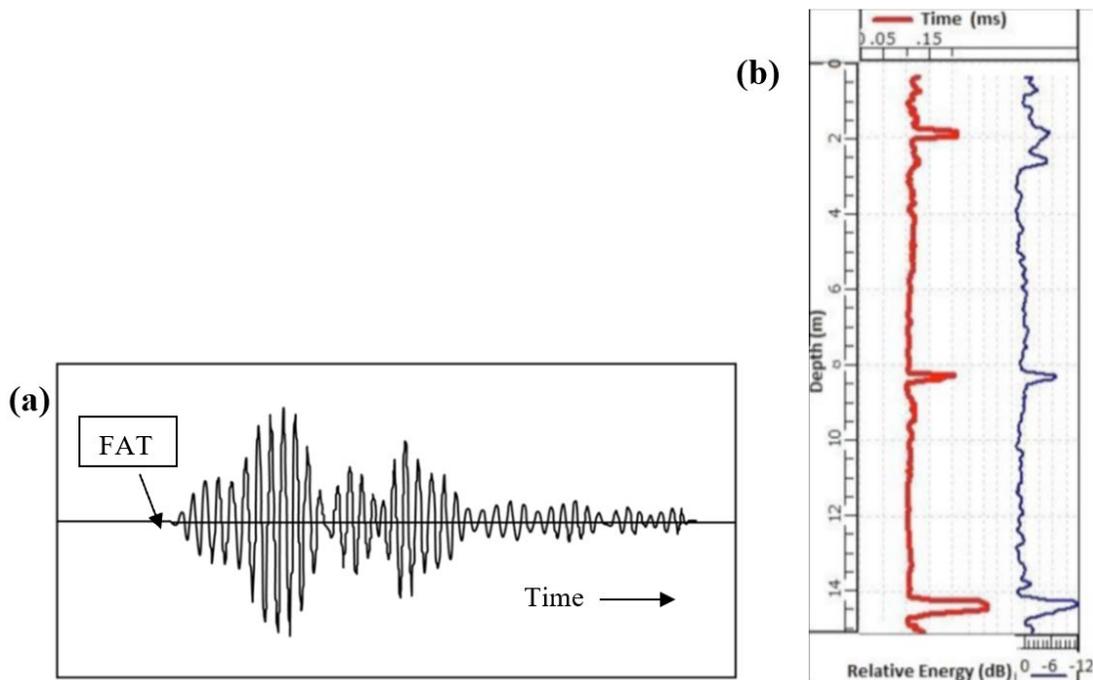
Figure 2-2: (a) Time record for a single depth and single access tube pair; (b) plots of FAT (red line, left) and relative energy (blue line, right) versus depth. Modified from ASTM (2016).

During the test, a source probe and receiver probe (geophones) are simultaneously raised from the bottom of separate access tubes. Per ASTM D6760, a common pulley equipped with a depth-encoding device is used to raise the probes. Ultrasonic pulses are sent from the source to the receiver as the probes are raised, and the ultrasonic response from the receiver is recorded for many depths. An example time record is shown in Figure 2-2(a) (ASTM, 2016). From each time record, the first arrival time (FAT) is interpreted, typically automatically by proprietary test software (rather than by test personnel). From the FAT, wave velocity can be interpreted by dividing the distance between tubes by the FAT. The relative energy is also commonly calculated for each time record from the amplitude of the pulses. The test is repeated for each combination of access tubes. The most common method for reporting results is to plot profiles with depth of FAT or wave velocity and relative energy for each combination of access tubes. An example profile set (FAT and relative energy) is shown in Figure 2-2(b) (ASTM, 2016). Spikes in arrival time and/or relative energy can be used to identify defective concrete, as discussed at the end of this chapter. For the record of Figure 2-2(b), spikes near 2, 8, and 14 m would likely be interpreted as anomalies.

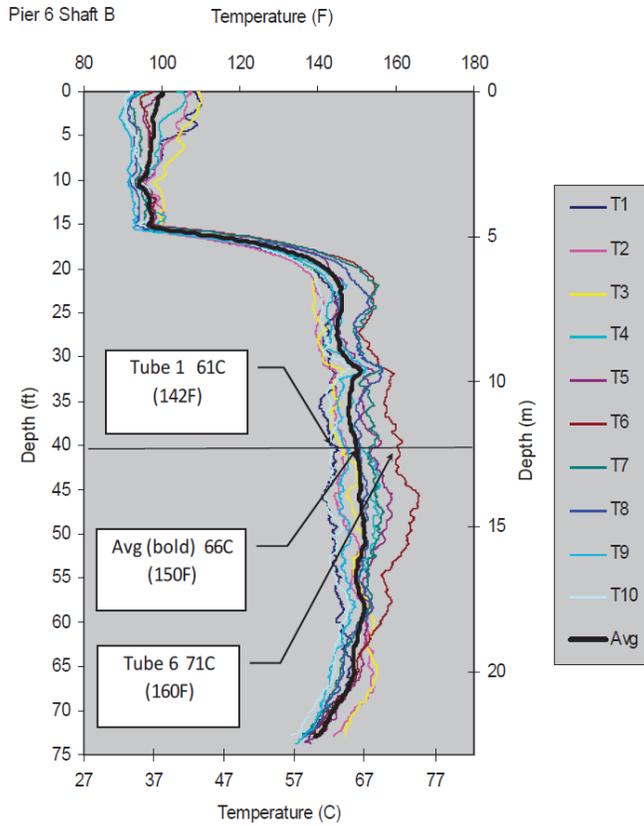
Figure 2-3: Example TIP result from Mullins (2010).

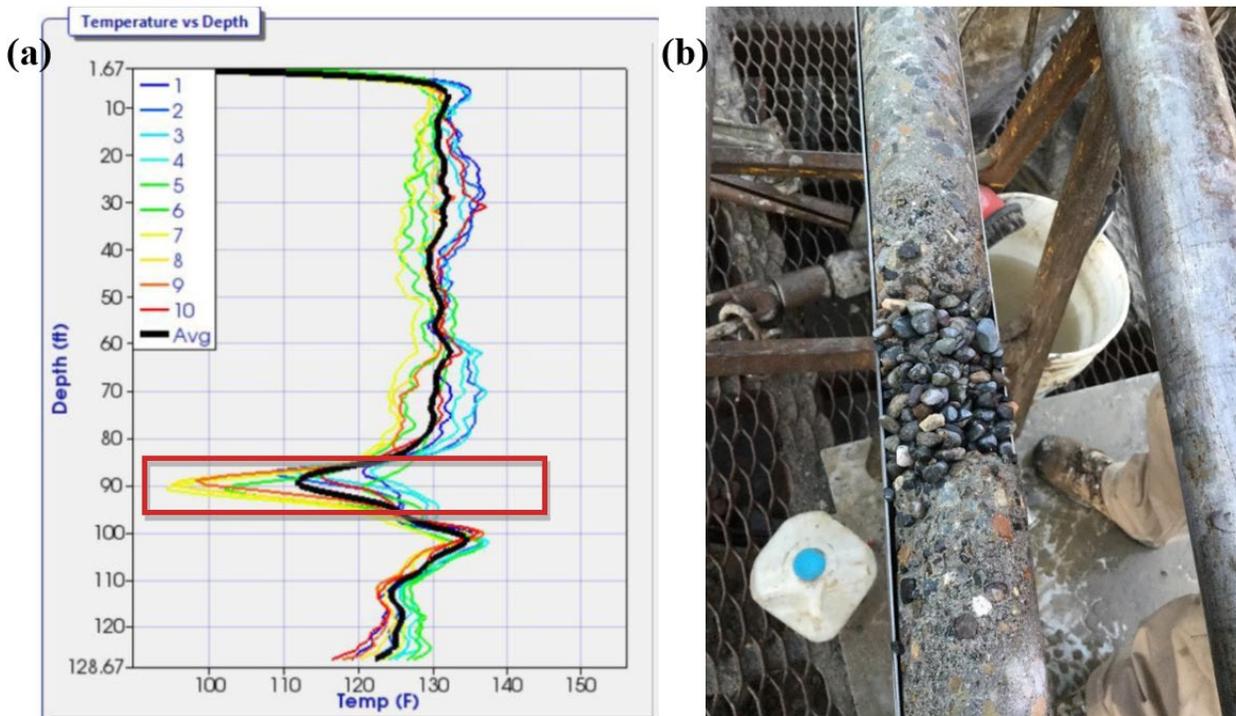
Figure 2-4: Example TIP result from Pisciacko et al. (2016): (a) TIP record and (b) core photograph from a depth of 90 ft.

Example TIP results with a zone of defective concrete are shown in Figure 2-4. The example case was documented by Piscsalko et al. (2016). The TIP data were recorded for a 10 ft diameter by 125 ft long drilled shaft with 10 TIP wires. A significant decrease in temperatures was observed in the TIP data at a depth of 90 ft (Figure 2-4(a)). The shaft was cored to investigate the potential defect. As shown in the photograph of Figure 2-4(b), the core results confirmed segregated concrete at 90 ft. The shaft was subsequently repaired by grouting.

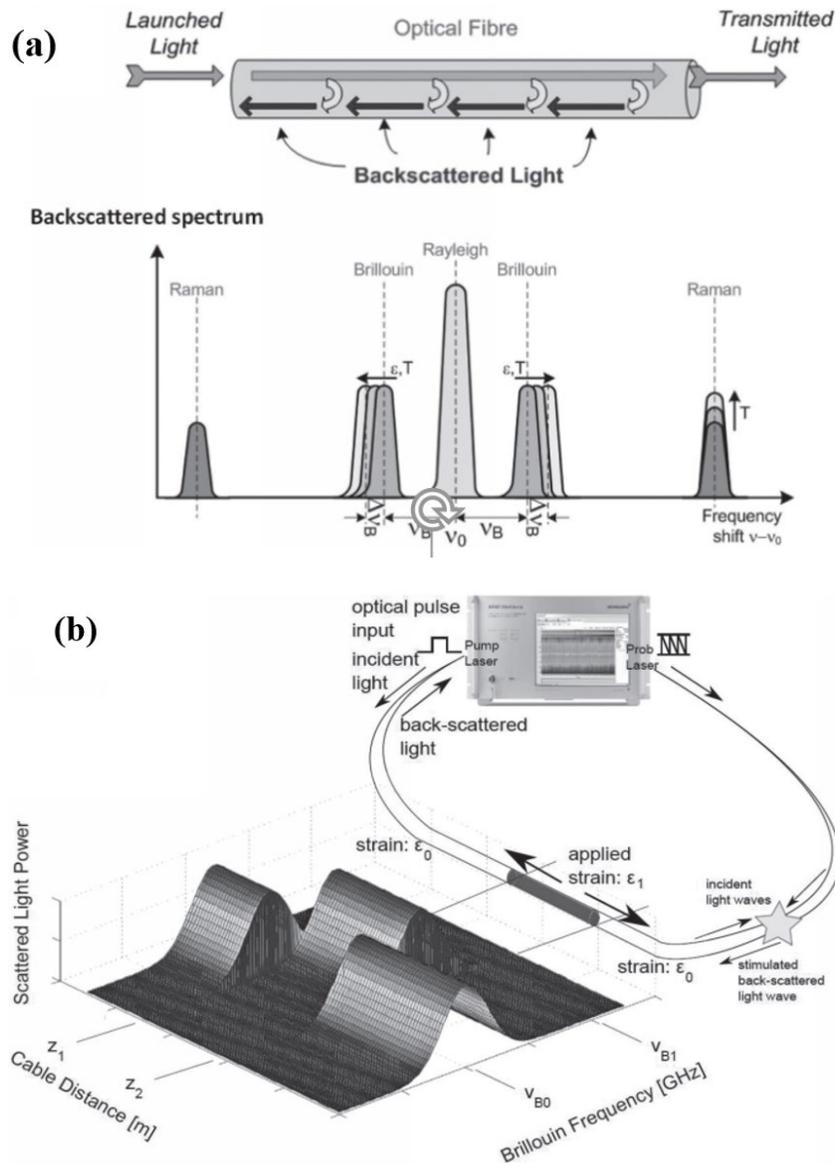
Figure 2-5: (a) Backscattered light phenomenon and (b) Brillouin optical time-domain analyzer function (from Soga, 2014).

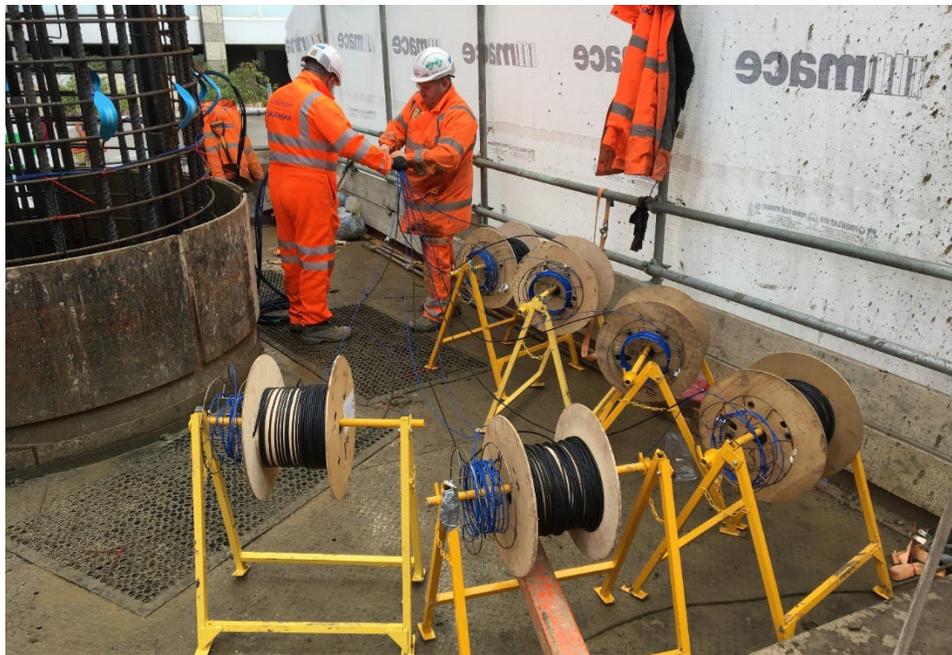
Figure 2-6: Distributed fiber optic sensing cable installation for a drilled shaft in the United Kingdom.

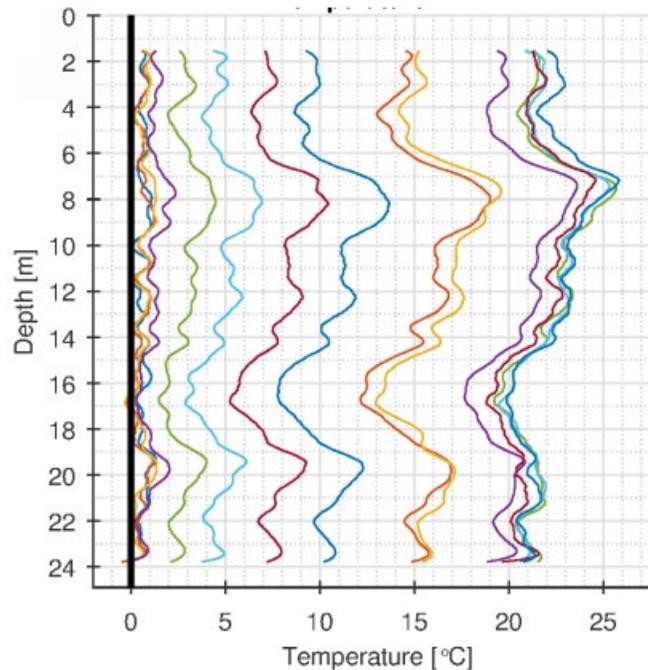
Figure 2-7: Hourly concrete curing temperature change with depth (de Battista 2016). Each line represents a different measurement time.

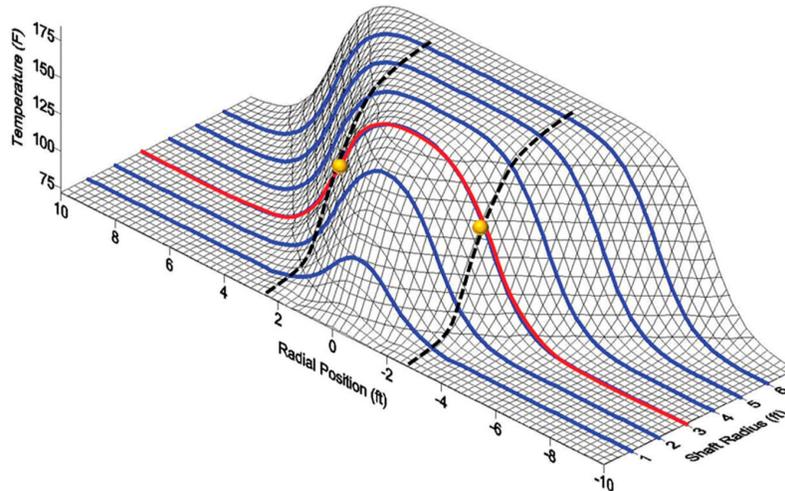
Figure 2-8: Drilled shaft temperatures as a function of radial position and shaft radius. From Mullins (2013).

The premise of the effective radius approach is that concrete temperatures near the edge of a drilled shaft are strongly influenced by two factors: shaft radius and radial position, defined as the distance from the center of the shaft. This concept can be observed in Figure 2-8. The graph in Figure 2-8 is from Johnson (2016), who based the graph on results of analytical thermal models by Mullins (2013). The sloping surfaces shown in the figure represent significant increases in temperature with (1) increasing shaft radius and (2) decreasing distance from the shaft center. Applied to TIP, this means that depths of greater-than-average measured temperatures could be explained by either (1) the shaft being larger or (2) the measurement points being closer to the center of the shaft. These explanations correspond to the yellow circle points in Figure 2-8 being (1) further right along the black dashed line or (2) being closer to the center along the solid red line. By incorporating multiple TIP wires (or access tubes), it is possible to distinguish between the two effects at a given depth: (1) increases in temperature due to larger shaft radius would be indicated by increases in the average wire temperature whereas (2) increases in temperature due to wire location would be indicated by differences in the temperatures among the various wires.

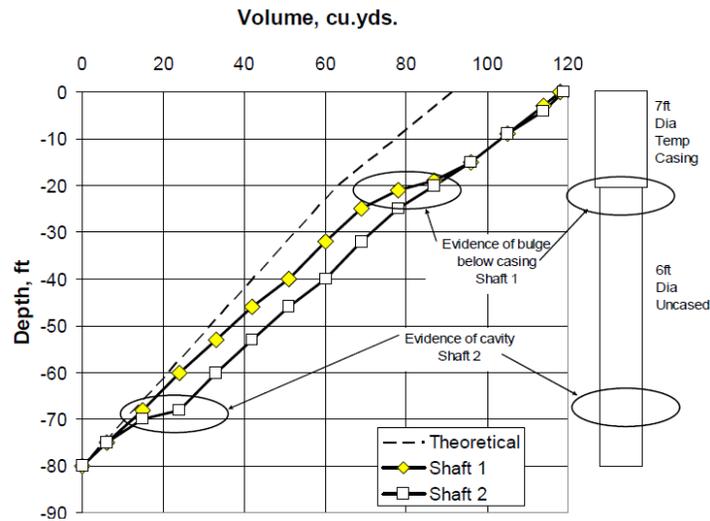
Figure 2-9: Example concrete volume record from FHWA’s Drilled Shaft manual (Brown et al., 2018).

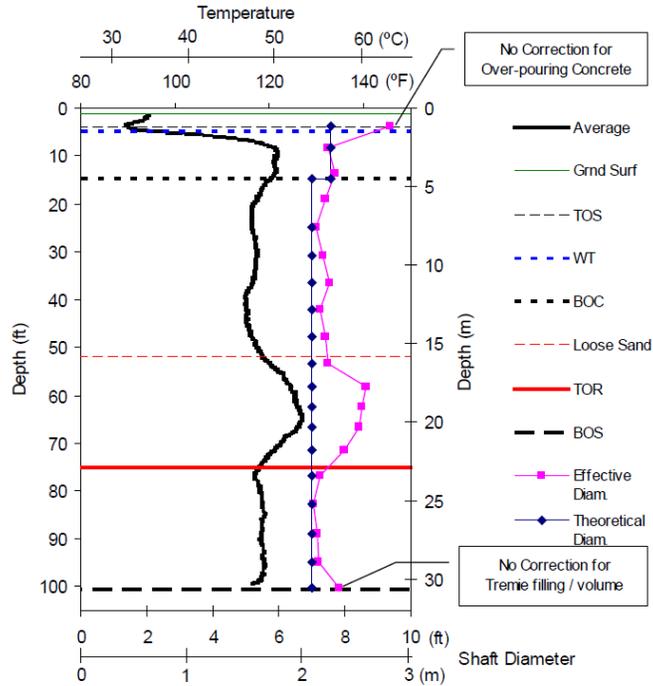
Figure 2-10: TIP data used for example temperature-radius model by Mullins and Winters (2011).

Example temperature-radius data for a Level 2 assessment by Mullins and Winters (2011) are shown in Figure 2-10, which is a profile of TIP and shaft diameter values with depth for a 7 ft diameter shaft. The heavy black line in the figure is the average temperature from the TIP data, and the pink line with square dots is the shaft diameter as interpreted from the concrete volume log. There appears to be significant correlation between the average temperature and the shaft diameter, as the shape of both plots is similar. The correlation is confirmed by the temperature-radius model shown in Figure 2-11. The temperature-radius relationship used for the data is from linear regression.

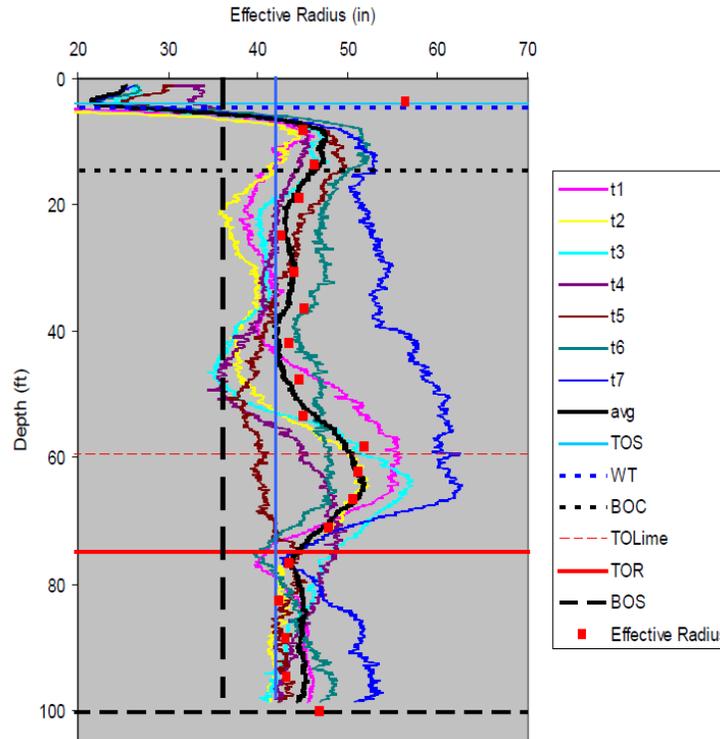
Figure 2-12: Example effective radius analysis from Mullins and Winters (2011) using TIP data from the example of Figure 2-10 and the temperature-radius model shown in Figure 2-12.

Figure 2-12 shows the results of applying the temperature-radius model from Figure 2-11 to all of the TIP data collected for the shaft in order to produce effective radius values. Specifically, each TIP temperature measurement is used in the regression equation to infer the effective radius with depth for each TIP access tube. Also shown in Figure 2-12 is the design radius of 3.5 ft, represented by a vertical blue line. The effective radius interpretation implies the overall average shaft radius is greater than design, since most points are to the right of the blue line. This implication follows directly from the observation that the total volume of concrete placed was greater than the theoretical volume. The vertical dashed black line in Figure 2-12 represents the design cage location; the distance between the dashed black line and the solid blue line, 6 in., is the design concrete cover distance. Accordingly, the effective radius results near a depth of 50 ft imply a complete loss of cover at TIP access tubes t3 and t4.

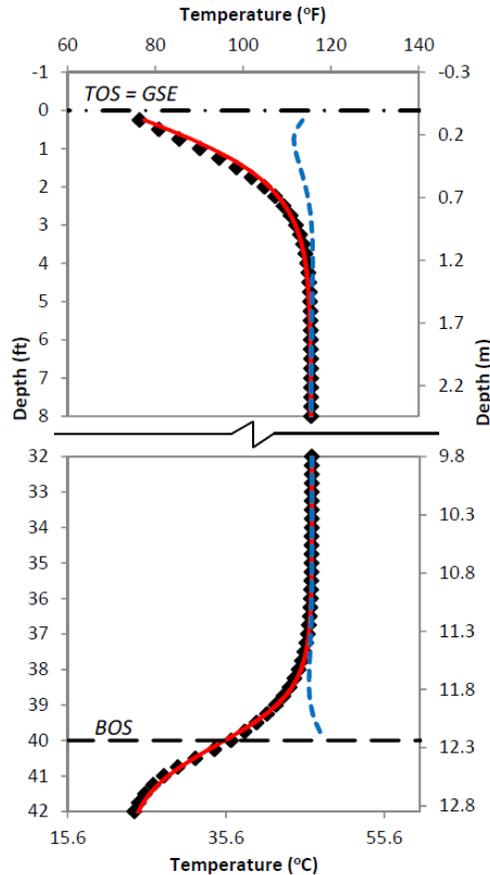
Figure 2-13: Curve fitting at roll-off zones at top of shaft (TOS) and bottom of shaft (BOS) from Johnson (2014).

In Figure 2-13, the black points represent TIP measurements, the solid red line is the fitted hyperbolic tangent function, and the dashed blue line is the corrected temperatures. Because the hyperbolic curves fit the measured data at the top and bottom of the shaft well, the corrected temperatures in the roll-off zones are similar to the temperatures just outside the roll-off zones. If the agreement between measured temperatures and the fitted hyperbolic tangent curve were weaker, corrected temperatures would deviate from the temperatures outside the roll-off zones. The TIP software implemented by PDI applies the corrected temperature adjustments at the top and bottom of each shaft by default. It also includes an option to include adjustments at user-specified depths for transitions between the ends of the shaft.

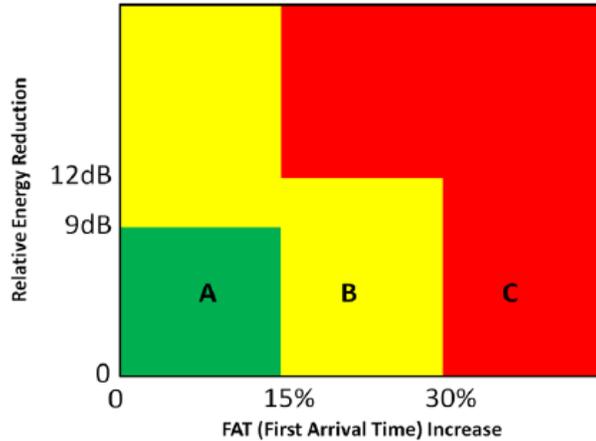
Figure 2-14: CSL evaluation criteria recommended by DFI (2018).

- Class A, Acceptable
- Class B, Conditionally Acceptable: “assessment is needed to determine the significance of results relative to shaft performance,” which should include consideration of the depth(s) and tube pairing(s) affected.
- Class C, Highly Abnormal. Class C ratings generally require evaluation by the Engineer of Record, likely more invasive testing (e.g. coring), and potentially remediation.

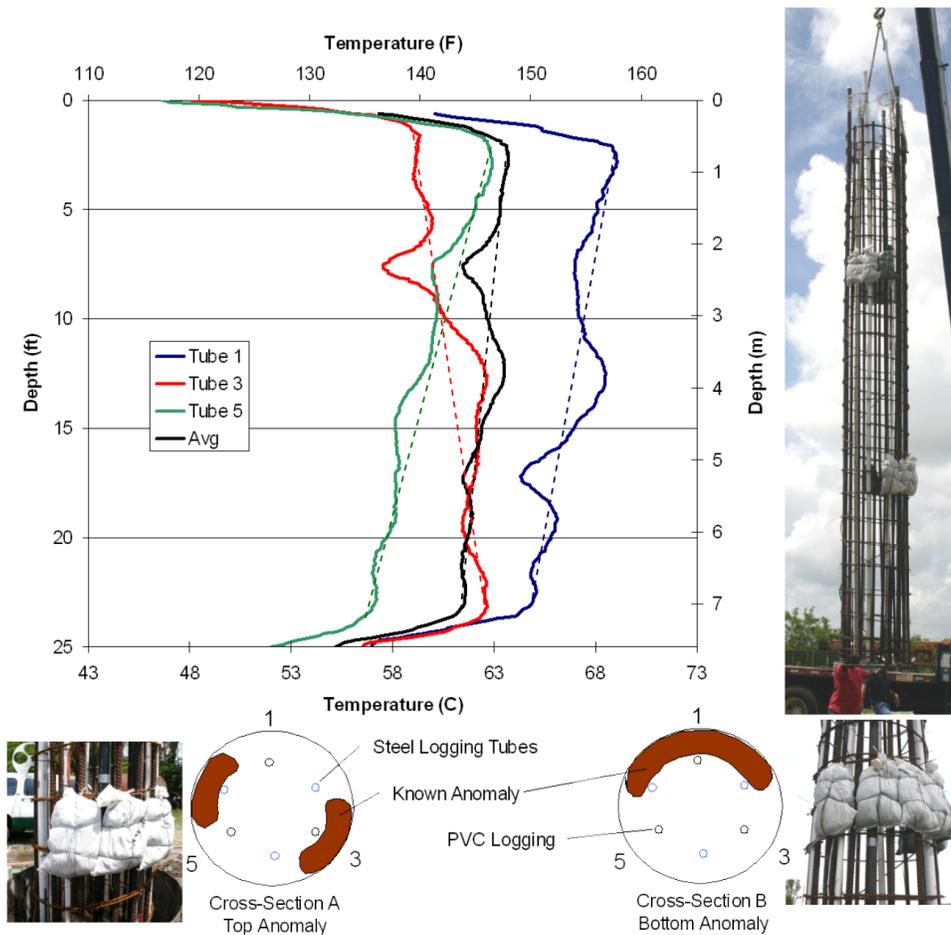
Figure 2-15: Results of FDOT TIP study by Mullins et al. (2007), as presented by Mullins and Winters (2011).

outside of the reinforcing cage. The cross-sectional area of each defect represented approximately 10% of the shaft. The shallower defect, at a depth of 8 ft, had bags tied to two opposite sides of the reinforcing cage as shown at the bottom of Figure 2-15. The deeper defect, at a depth of 17 ft, had all bags tied on one side of the reinforcing cage, centered around Tube 1 as shown in Figure 2-15.

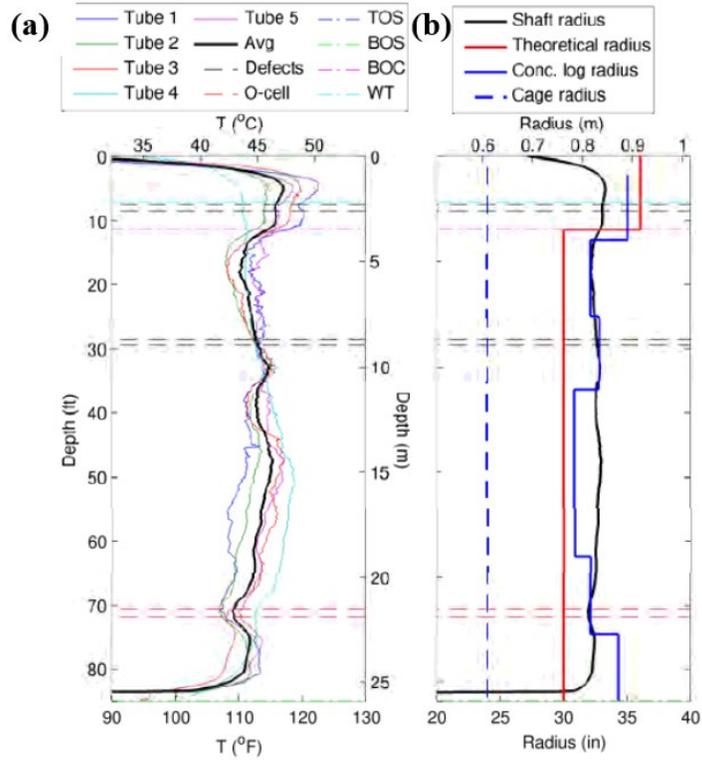
Figure 2-16: TIP results for Test Shaft 1 from Ashlock and Fotouhi (2014): (a) temperature and (b) effective radius.

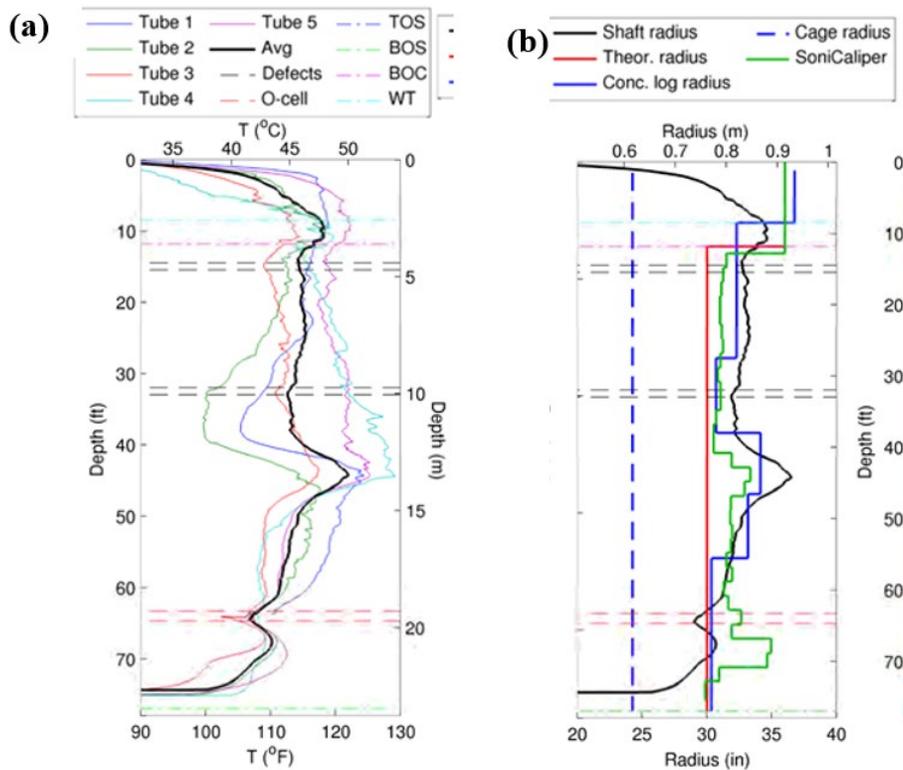
Figure 2-17: TIP results for Test Shaft 2 from Ashlock and Fotouhi (2014): (a) temperature and (b) effective radius.

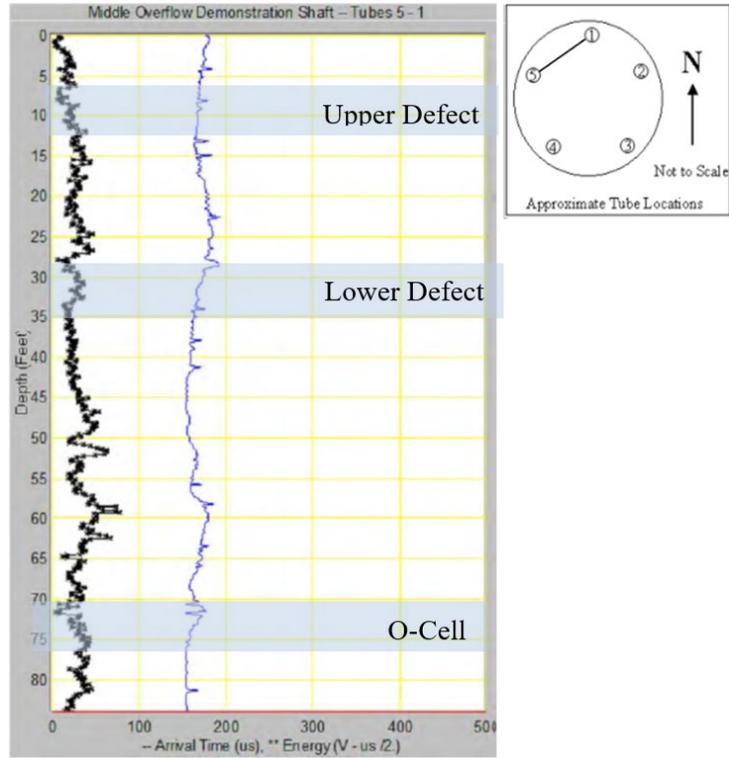
Figure 2-18: CSL results for Test Shaft 2 from Ashlock and Fotouhi (2014).

CSL results from Ashlock and Fotouhi (2014) are presented in Figure 2-18 for Test Shaft 1 and in Figure 2-19 for Test Shaft 2. CSL results for Test Shaft 1 showed no significant increase in arrival time for either defect. For Test Shaft 2, an increase in arrival time of approximately 25% was observed for both defects. Such an increase straddles the line between questionable and actionable, depending on acceptance criteria (Table 2-2).

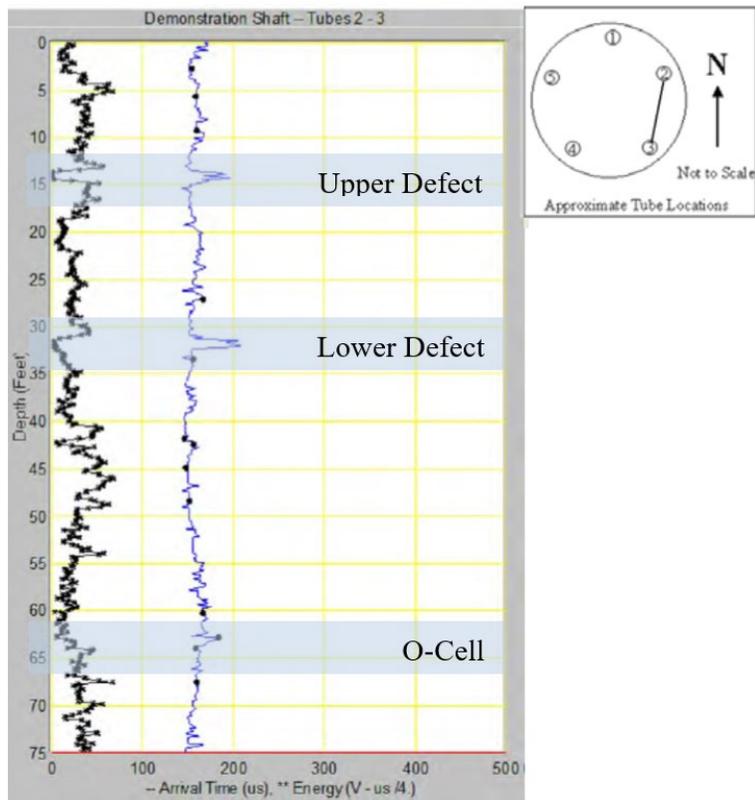
Figure 2-19: CSL results for Test Shaft 2 from Ashlock and Fotouhi (2014).

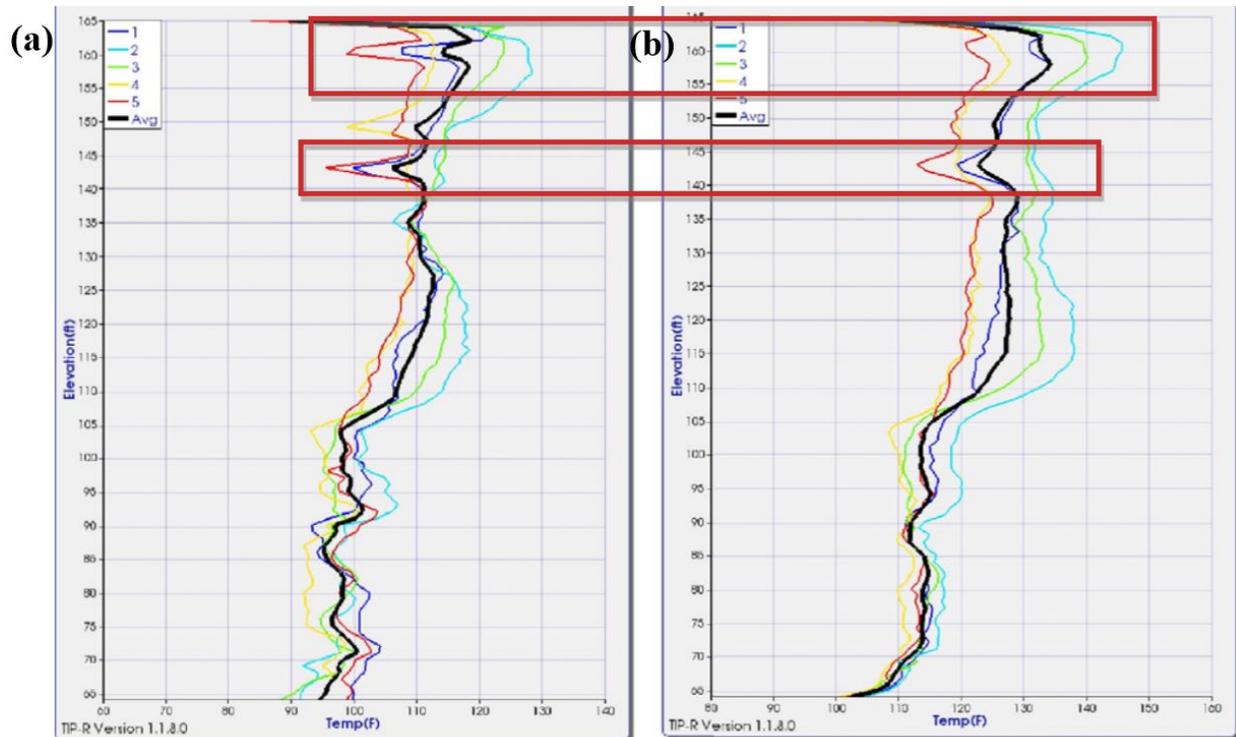
Figure 2-20: Example TIP result showing decreases in temperature at two known defect locations: (a) 14 hours and (b) 34 hours, the peak time. From Schoen et al. (2018).

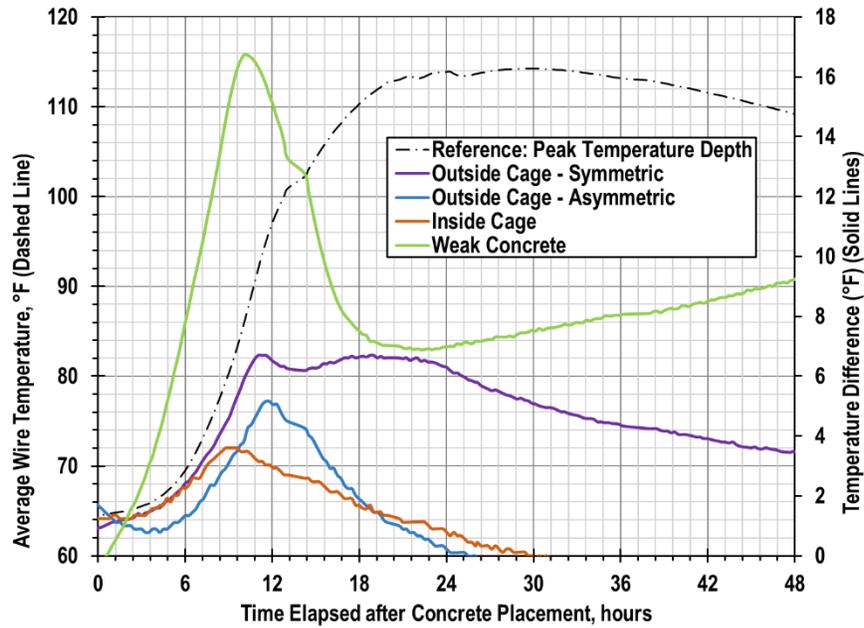
Figure 2-21: Temperature and temperature difference versus time based on results from Boeckmann and Loehr (2018).

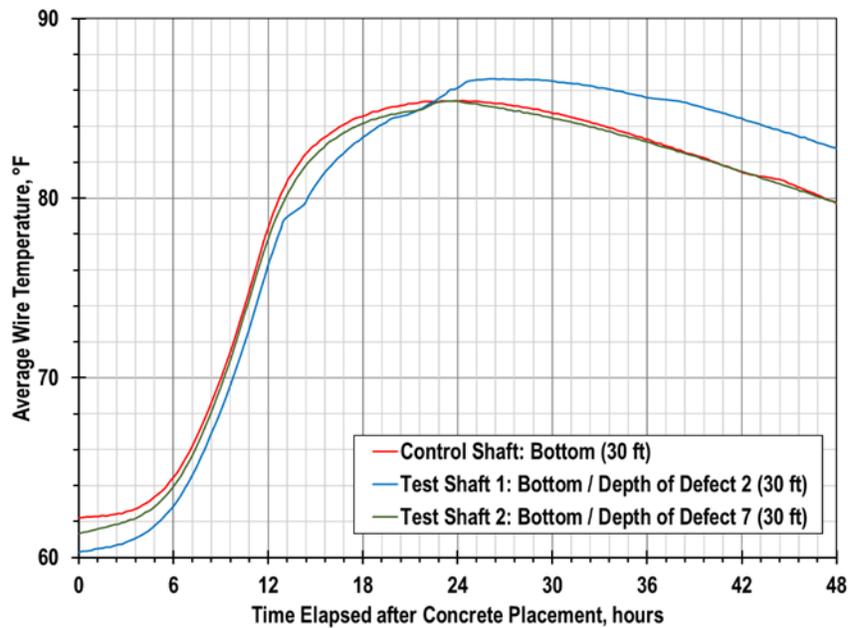
Figure 2-22: Temperature versus time for the bottom of shafts from Boeckmann and Loehr (2018).

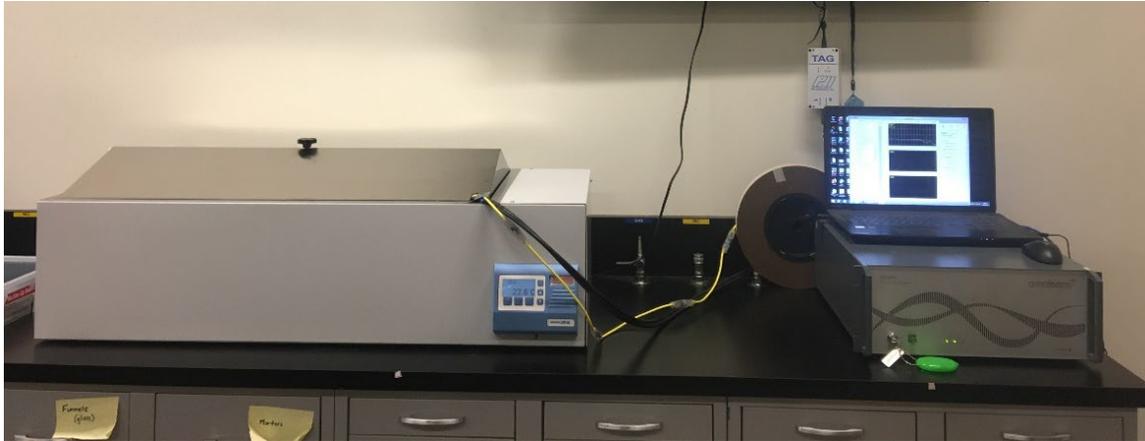
Figure 3-1: Photograph of the water bath testing setup.

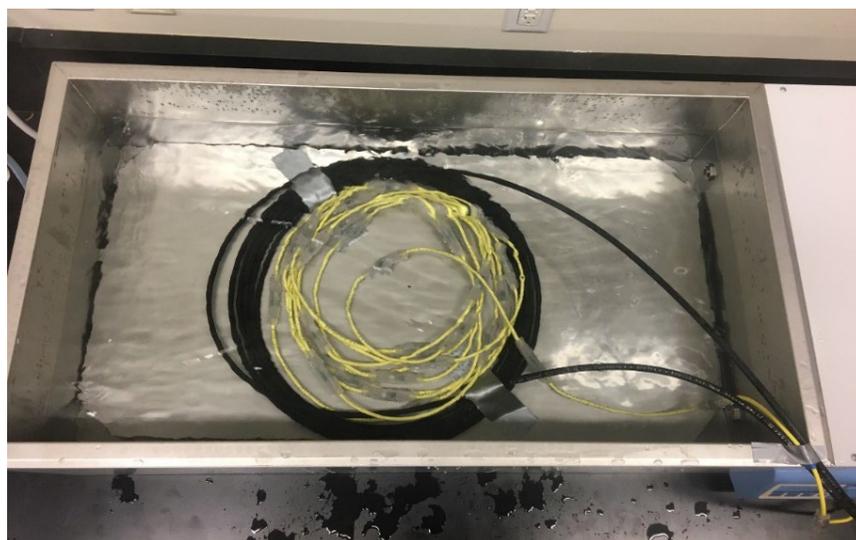
Figure 3-2: Photograph of the cable configuration within the water bath.

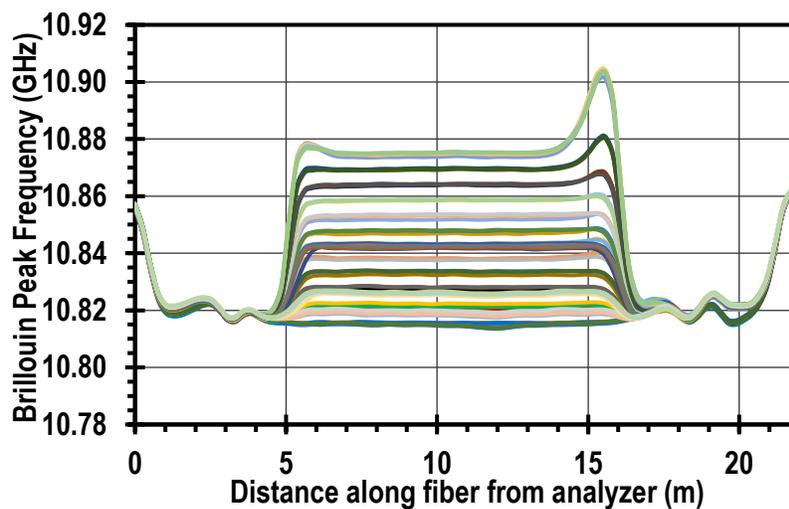
Figure 3-4: Fiber optic peak frequency during water test. Each line represents a different time during the test.

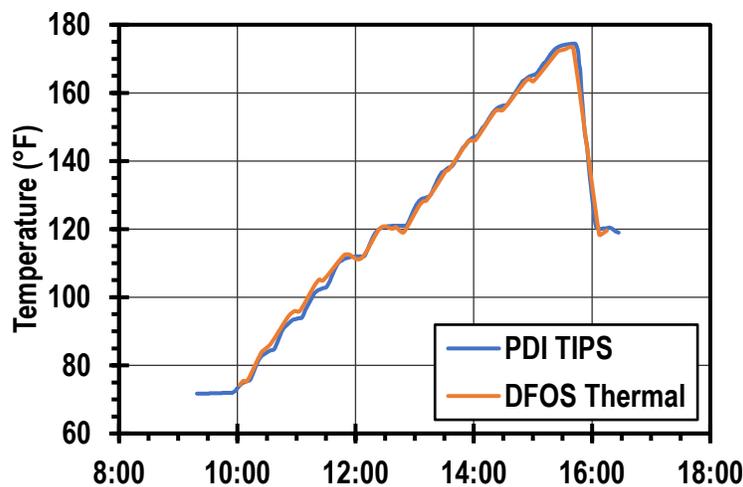
Figure 3-5: Recorded temperature during the water bath test from the two measurement systems.

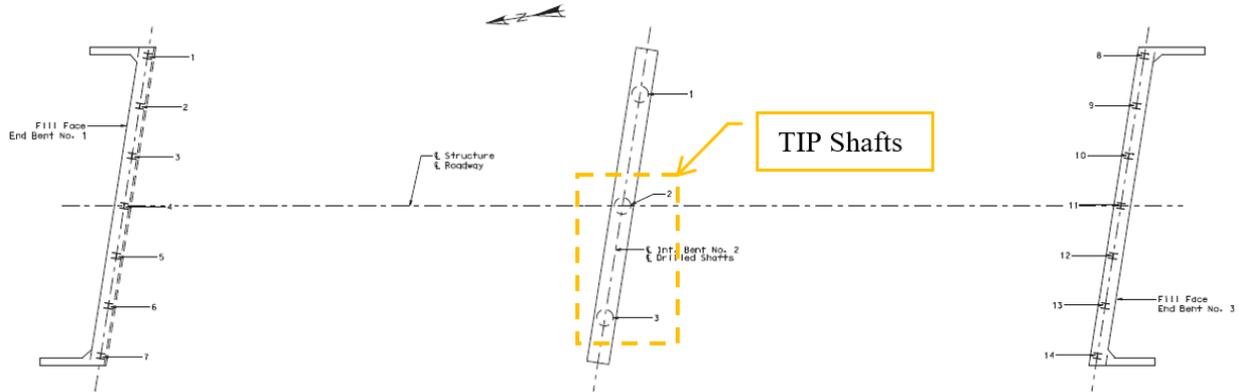
Figure 4-1: Plan view of Ewing Ave. bridge.

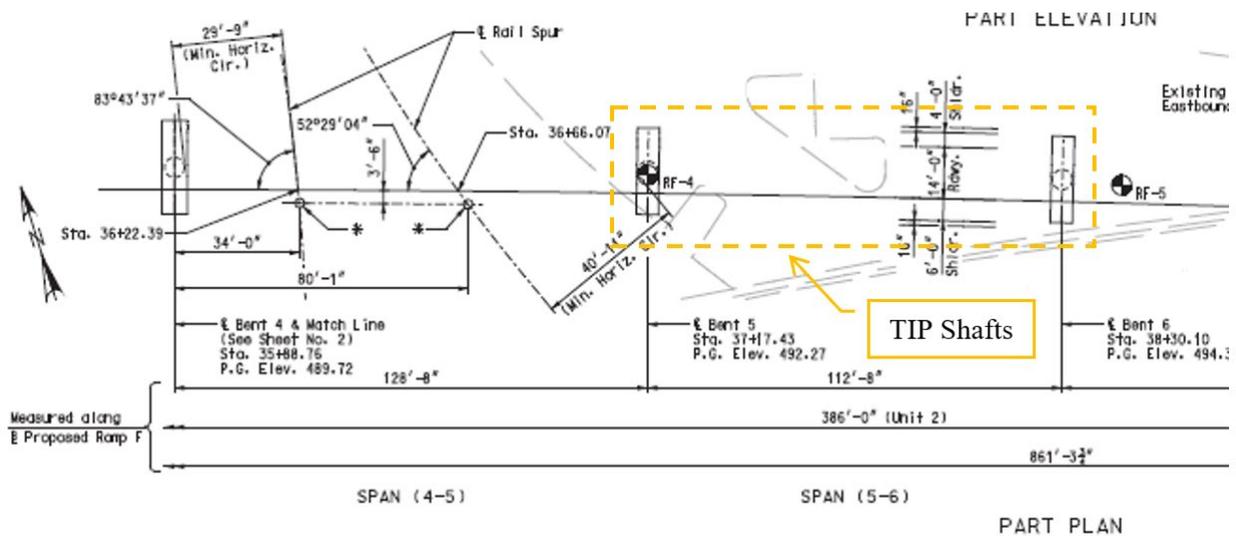
Figure 4-2: Partial plan view of Ramp F overpass bridge.

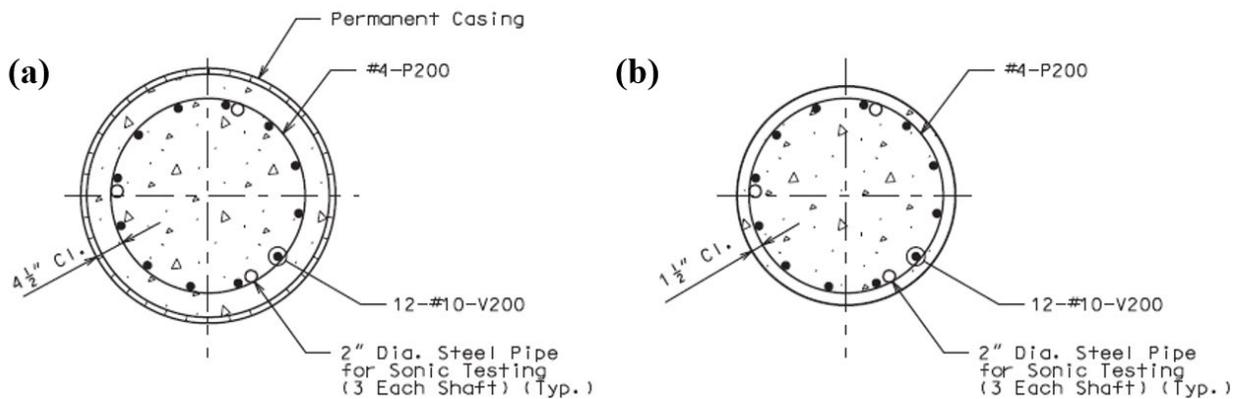
Figure 4-3: Drilled shaft cross-section for Ewing Ave. shafts: (a) within permanently cased section and (b) in uncased rock socket.

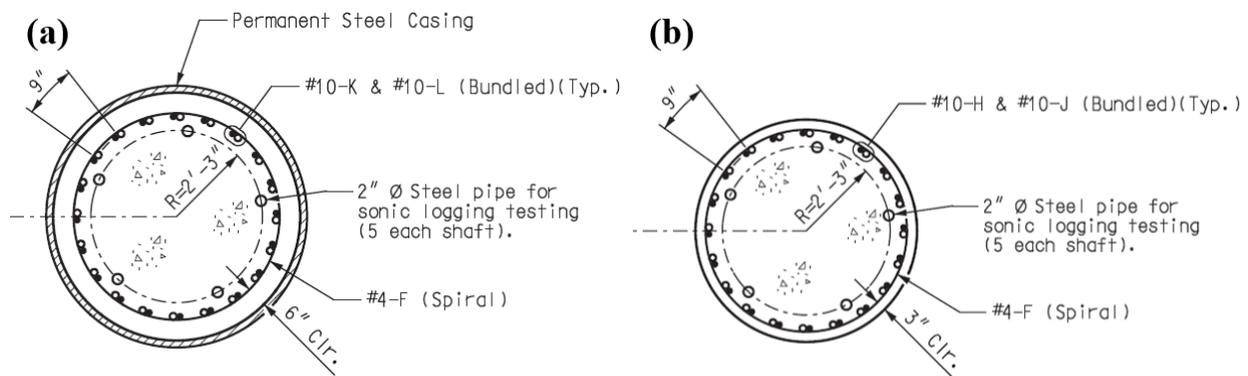
Figure 4-4: Drilled shaft cross-section for Ramp F shafts: (a) within permanently cased section and (b) in uncased rock socket.

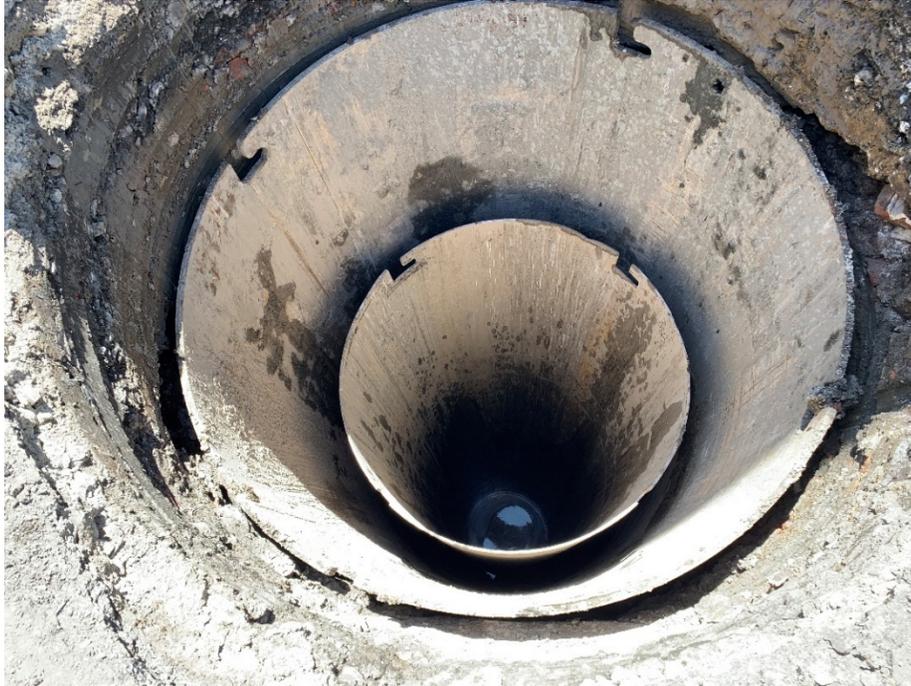
Figure 4-5: Excavated shaft for Ramp F Bent 6 with the permanent (innermost) 72-inch casing and temporary 84-inch casing shown.

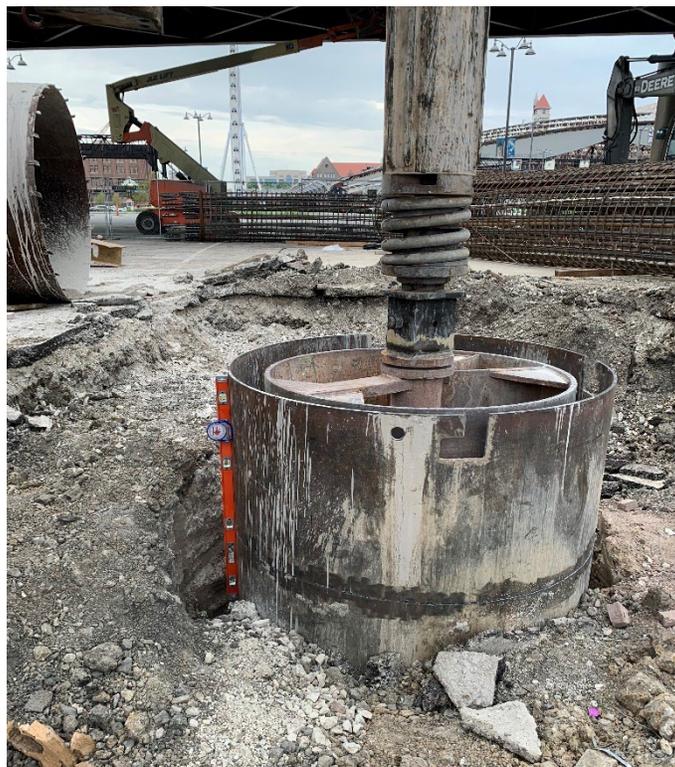
Figure 4-6: Ramp F Bent 6 shaft after welding an extension piece to the top of the permanent casing. In this photo, the temporary casings have been removed and the ground near the shaft has been excavated to provide a safe working space for reinforcing cage and concrete placement.

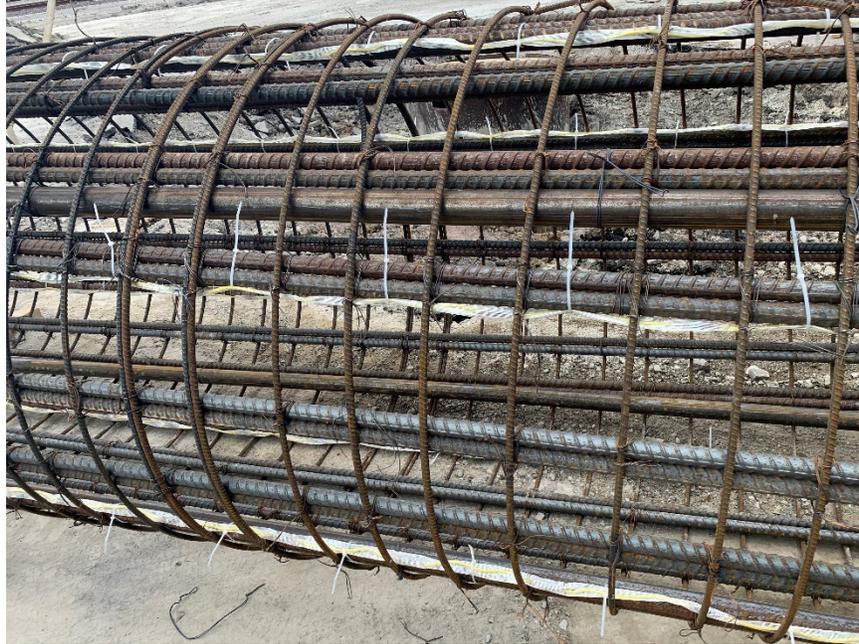
Figure 4-7: Conventional TIP wires affixed to the reinforcing cage for the Ramp F Bent 6 drilled shaft.

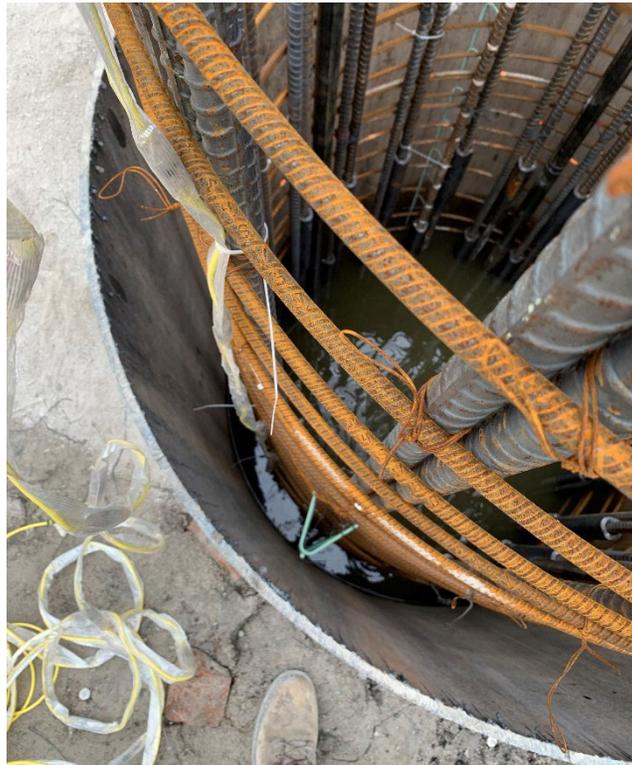
Figure 4-8: Conventional TIP wires affixed to the outside of the reinforcing cage for the Ramp F Bent 6 drilled shaft.

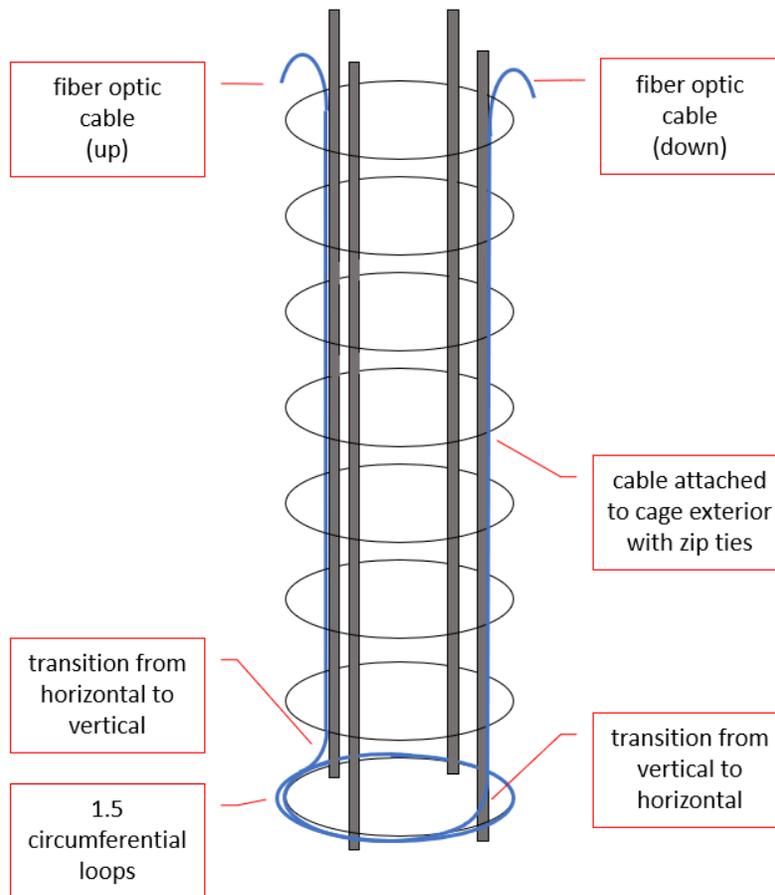
Figure 4-9: Schematic diagram of the fiber optic cable routing for a single loop / vertical pair.

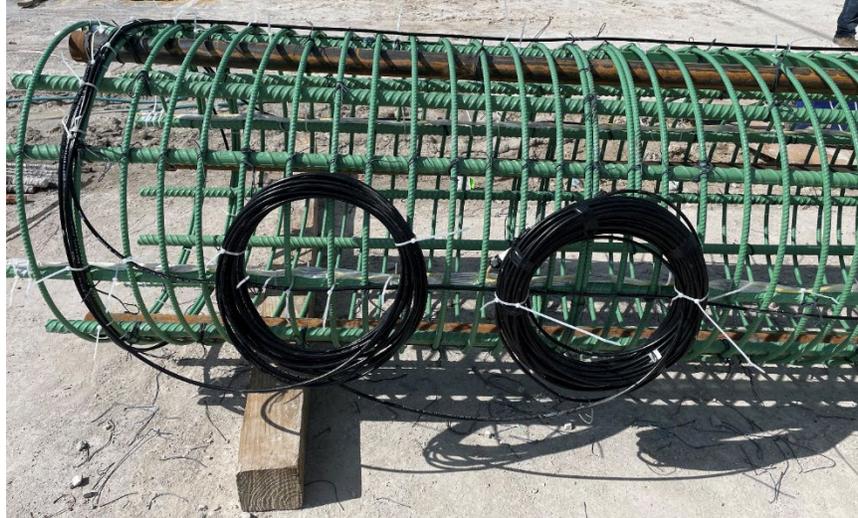
Figure 4-10: Thermal fiber optic cables pre-installed on bottom section of reinforcement cage, with bundles for final vertical attached to the side of the cage.

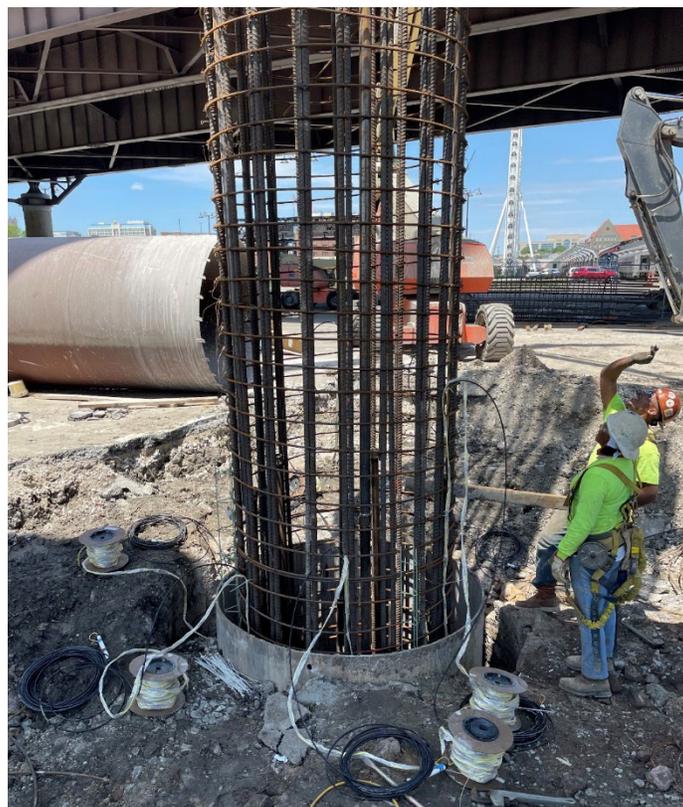
Figure 4-11: Lowering of the reinforcing cage for the Ramp F Bent 6 shaft, with the TIP and thermal fiber optic cable spread radially around the shaft.
