Use of Thermal Integrity Profiling (TIP) in Drilled Shaft Evaluation

January 2022
Final Report

Project number TR202015
MoDOT Research Report number cmr 22-002

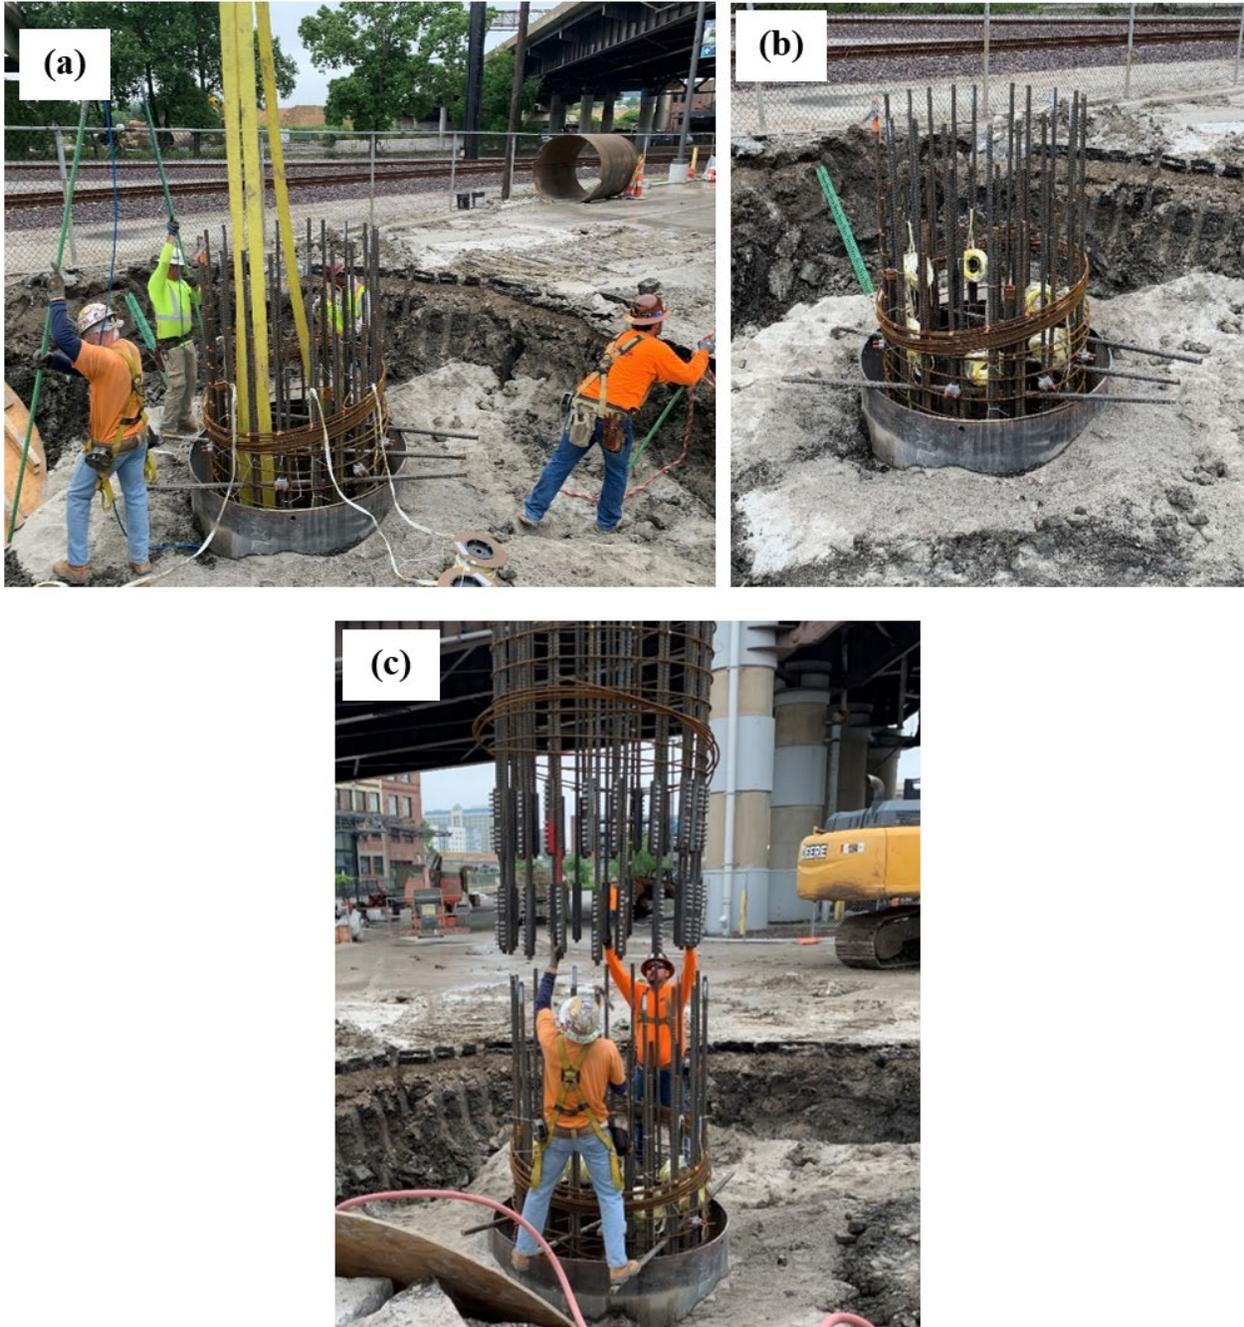
Figure 4-12: Reinforcing cage placement for the Ramp F Bent 5 drilled shaft: (a) lower half of cage suspended with the crane, (b) lower half of cage resting on casing, and (c) top half of cage aligned with bottom half prior to engaging mechanical bar splices.

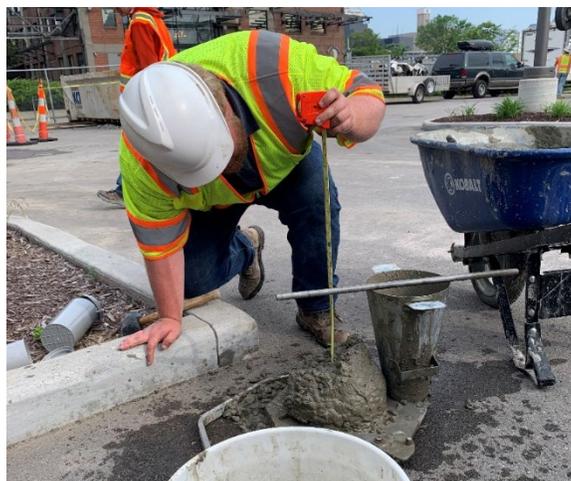
Figure 4-14: Concrete slump test performed for Ramp F Bent 5 drilled shaft.

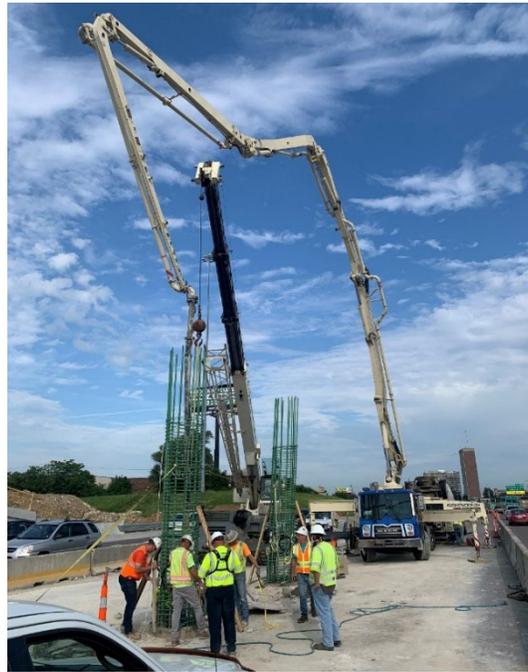
Figure 4-15: Concrete placement for Ewing Ave. Shaft 2.

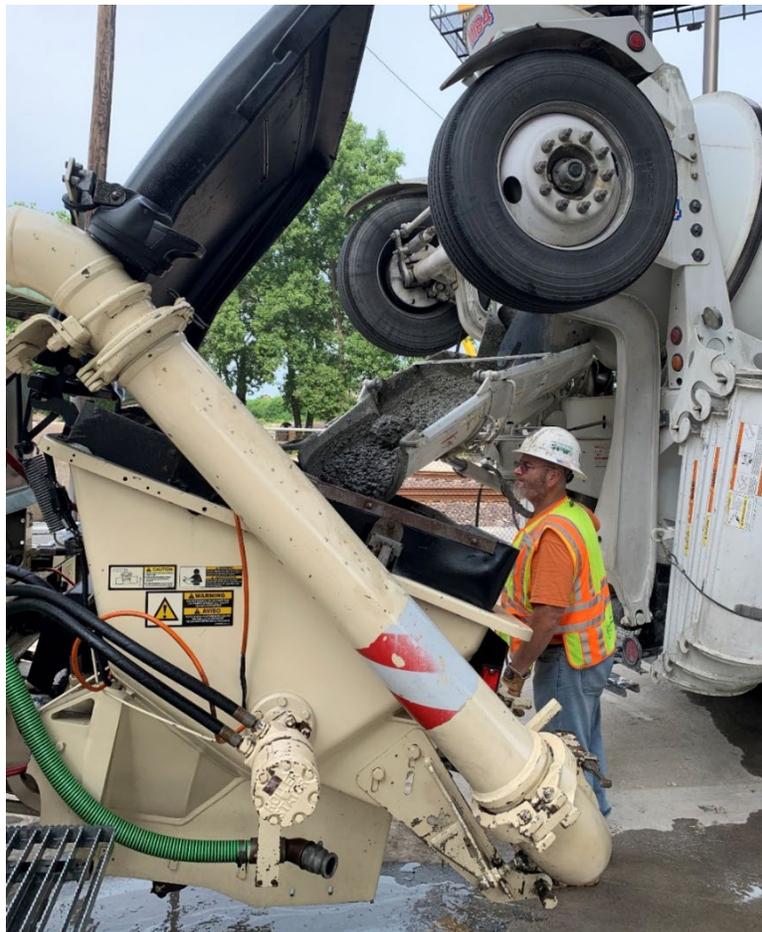
Figure 4-17: Concrete is transferred from concrete truck to pump truck.

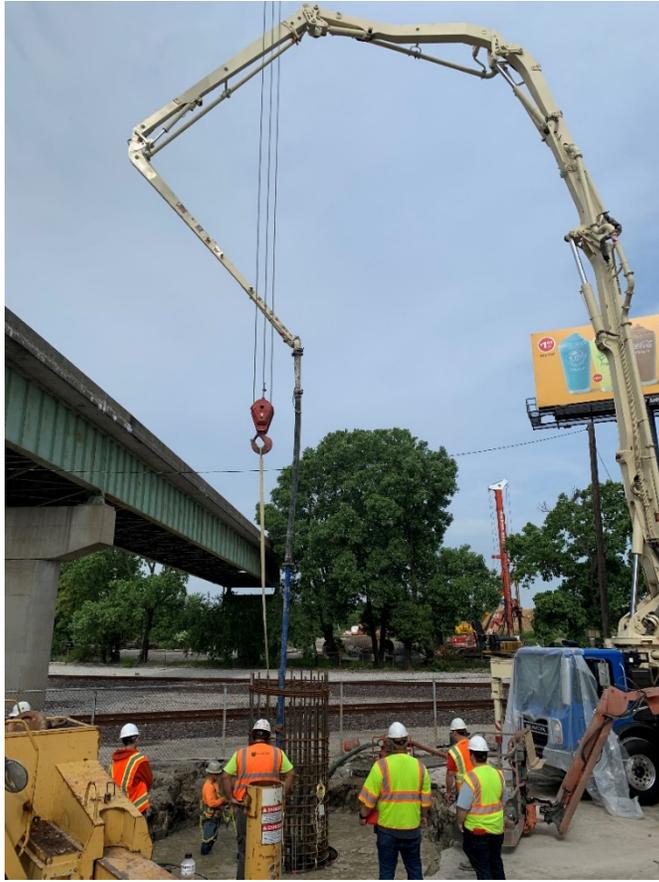
Figure 4-18: Placement of concrete by tremie in the drilled shaft for Ramp F Bent 5.

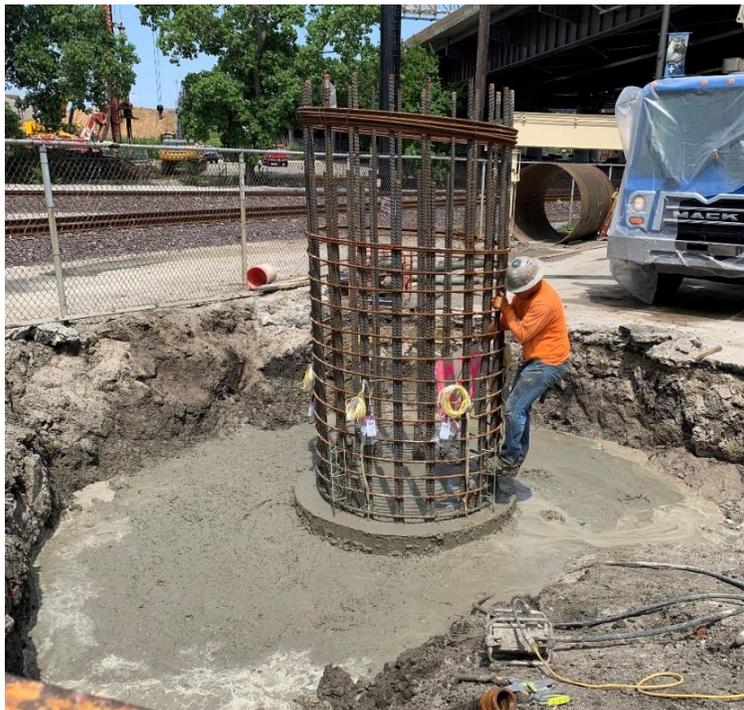
Figure 4-19: Concrete for Ramp F Bent 5 drilled shaft is over-poured.

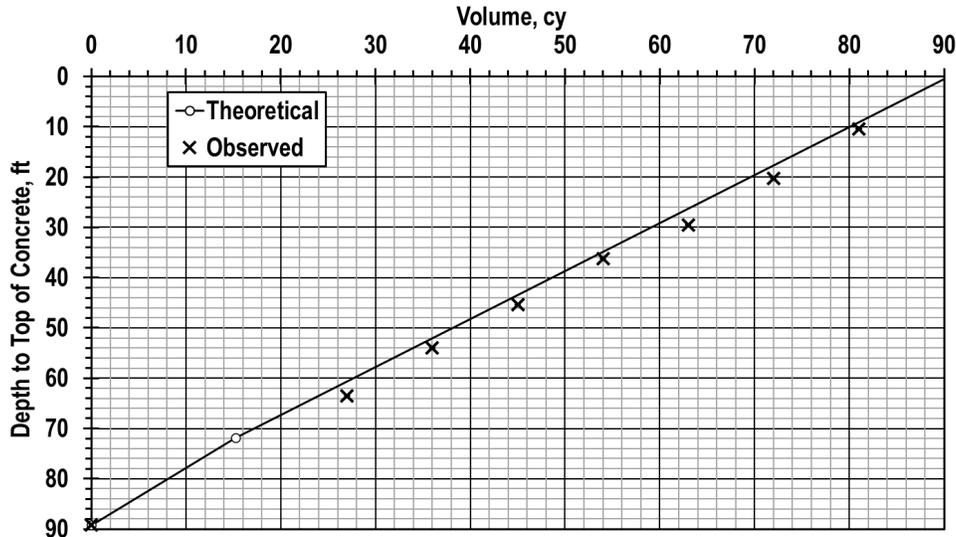
Figure 4-20: Concrete volume curve for the drilled shaft at Ramp F Bent 6.

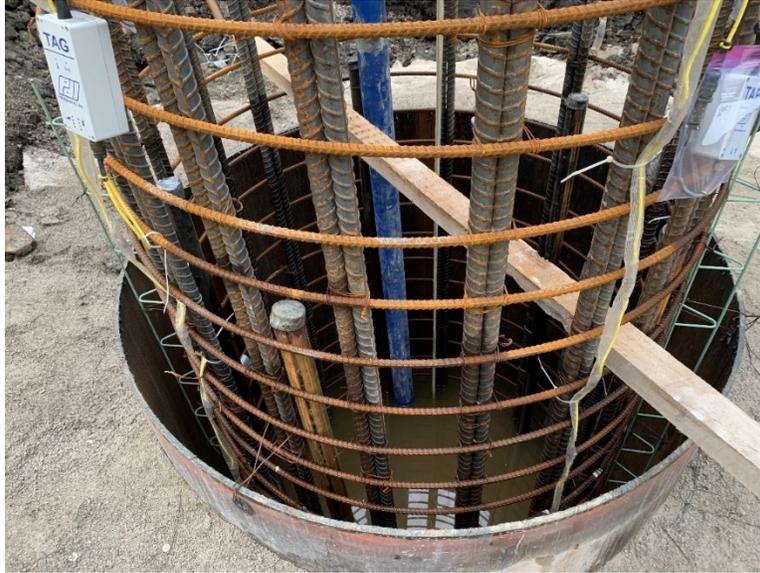
Figure 4-21: TIP wires connecting into a TAG box (left) and TAP box (right). The boxes are attached to the top of the reinforcing cage for the Ramp F Bent 5 drilled shaft.

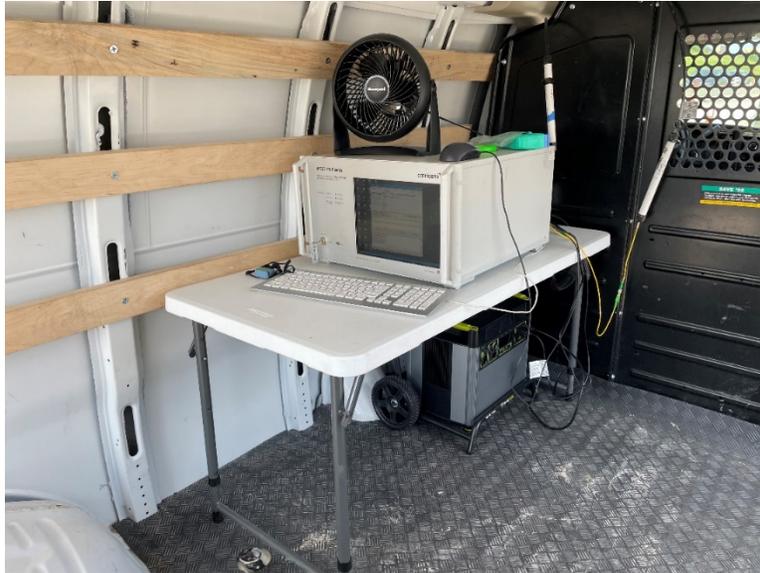
Figure 4-22: Photograph of the fiber optic analyzer setup in the rear of the cargo van.

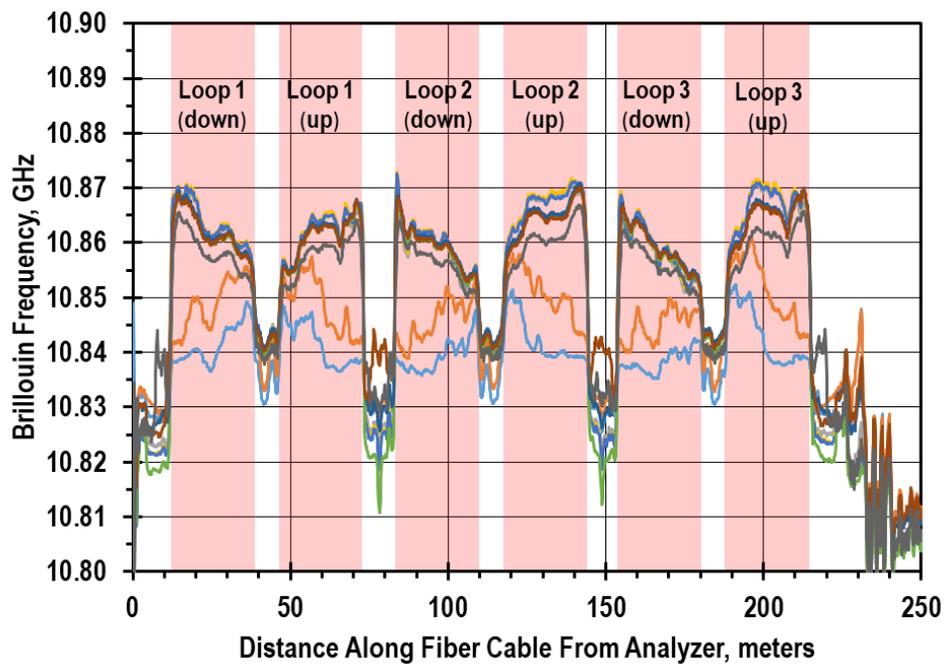
Figure 4-23: Raw fiber optic data from Ramp F, Bent 6, with thermal loops networked in series. Different lines correspond to different time stamps.

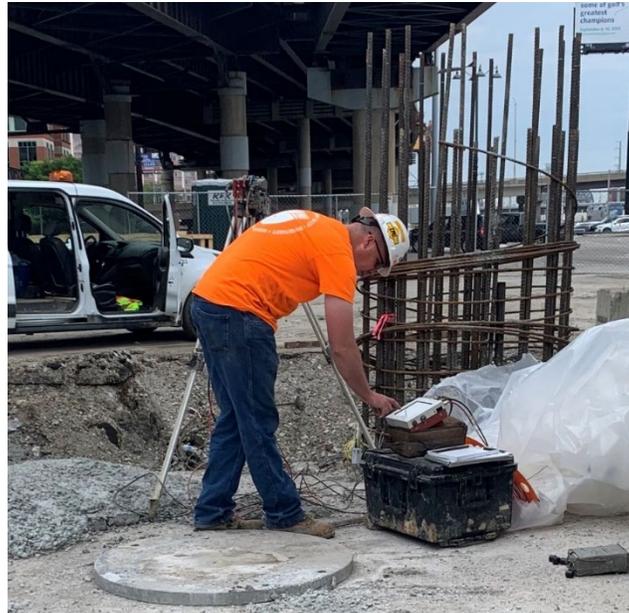
Figure 4-24: CSL testing is performed on the shaft for Ramp F Bent 5.

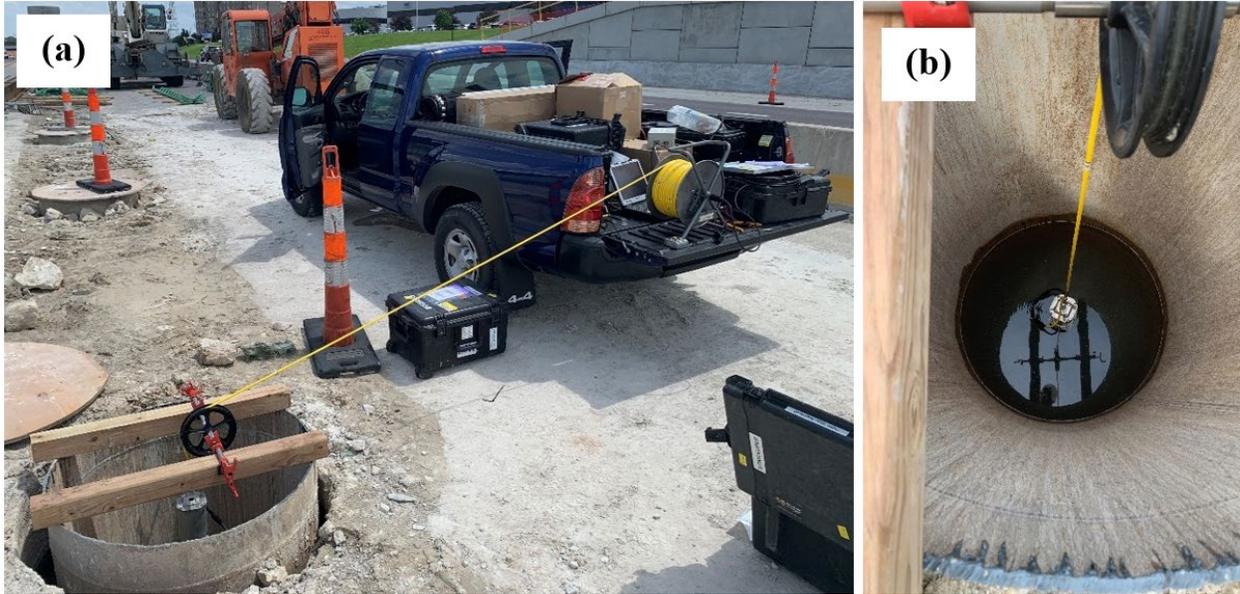
Figure 4-25: Performance of SONICaliper test: (a) overview and (b) caliper device within shaft.

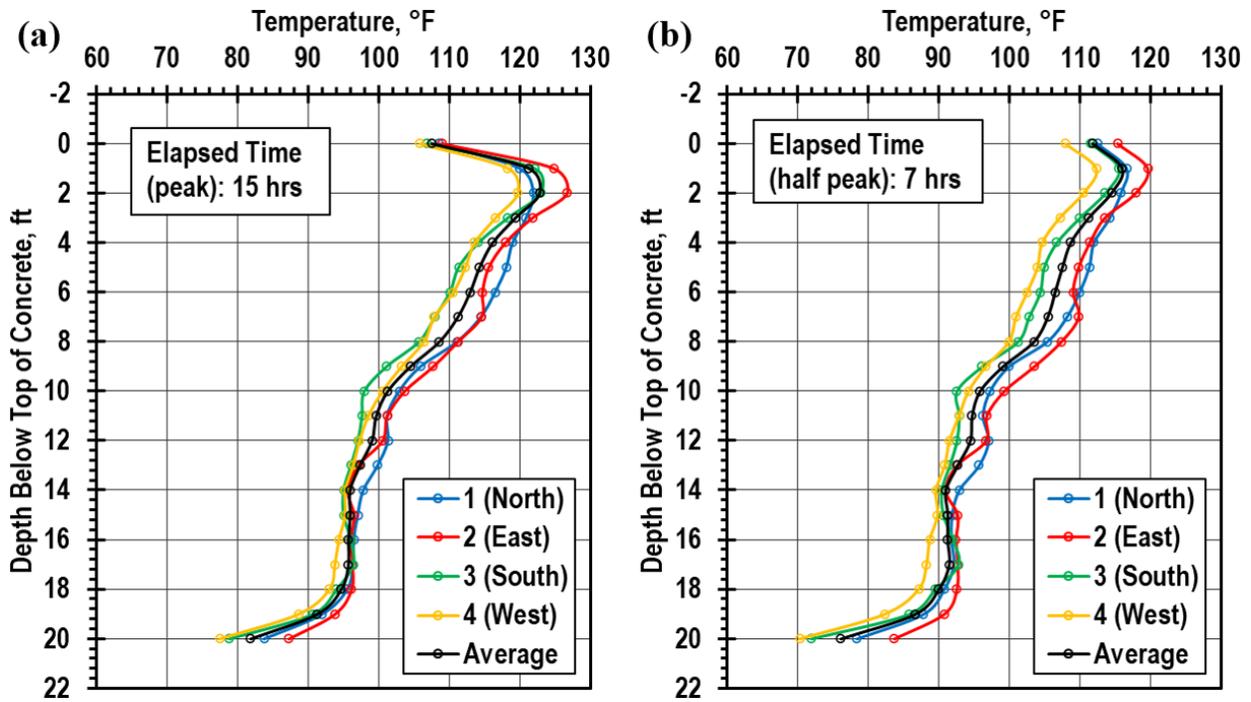
Figure 5-1: Temperature versus depth for Ewing Shaft 2: (a) time of peak temperature, (b) half the time of peak temperature.

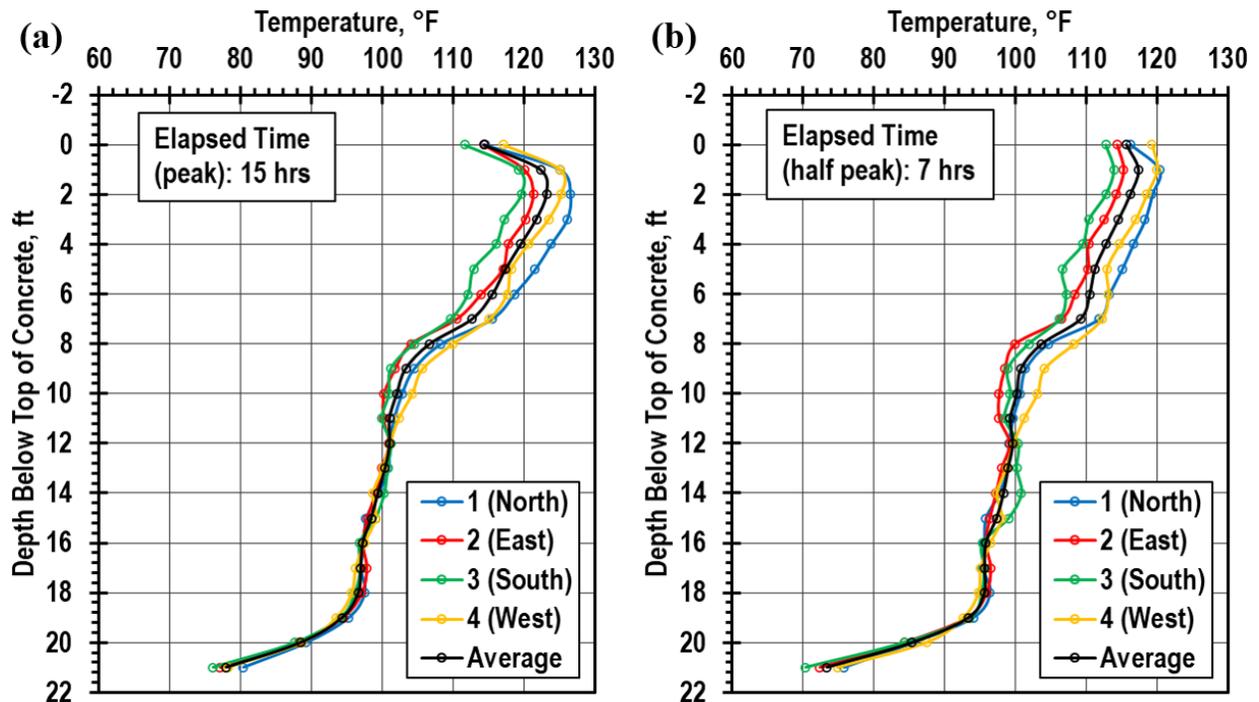
Figure 5-2: Temperature versus depth for Ewing Shaft 3: (a) time of peak temperature, (b) half the time of peak temperature.

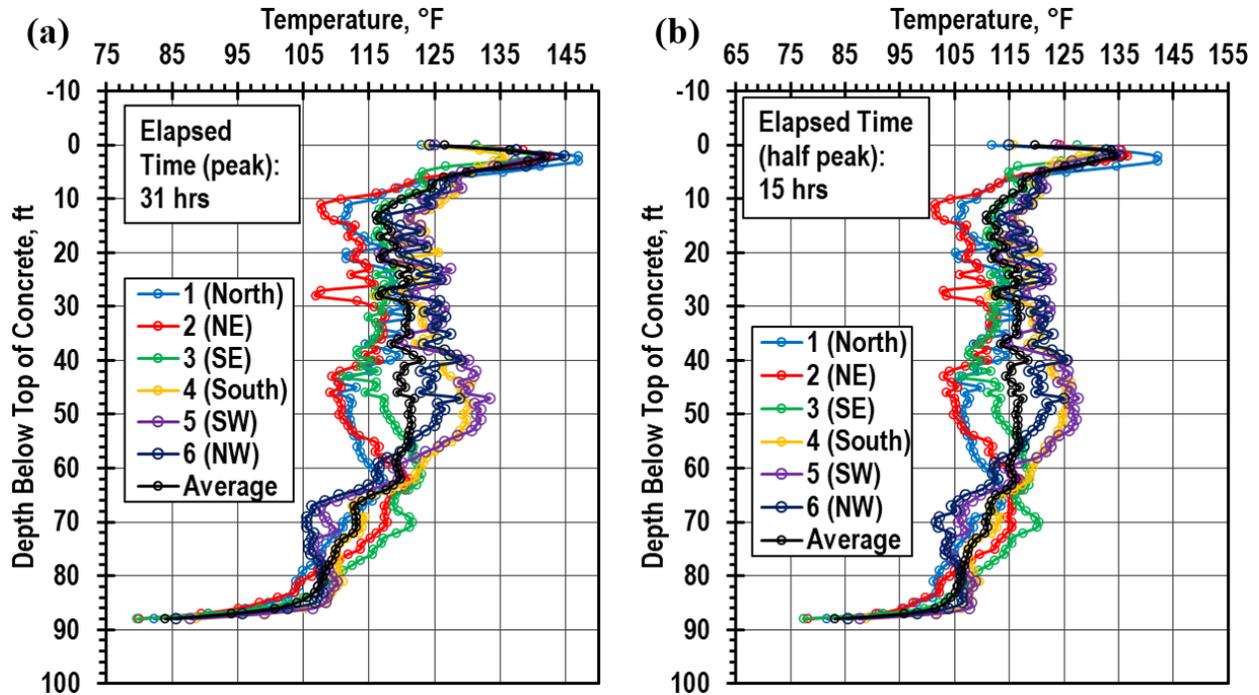
Figure 5-3: Temperature versus depth for Ramp F Bent 5: (a) time of peak temperature, (b) half the time of peak temperature.

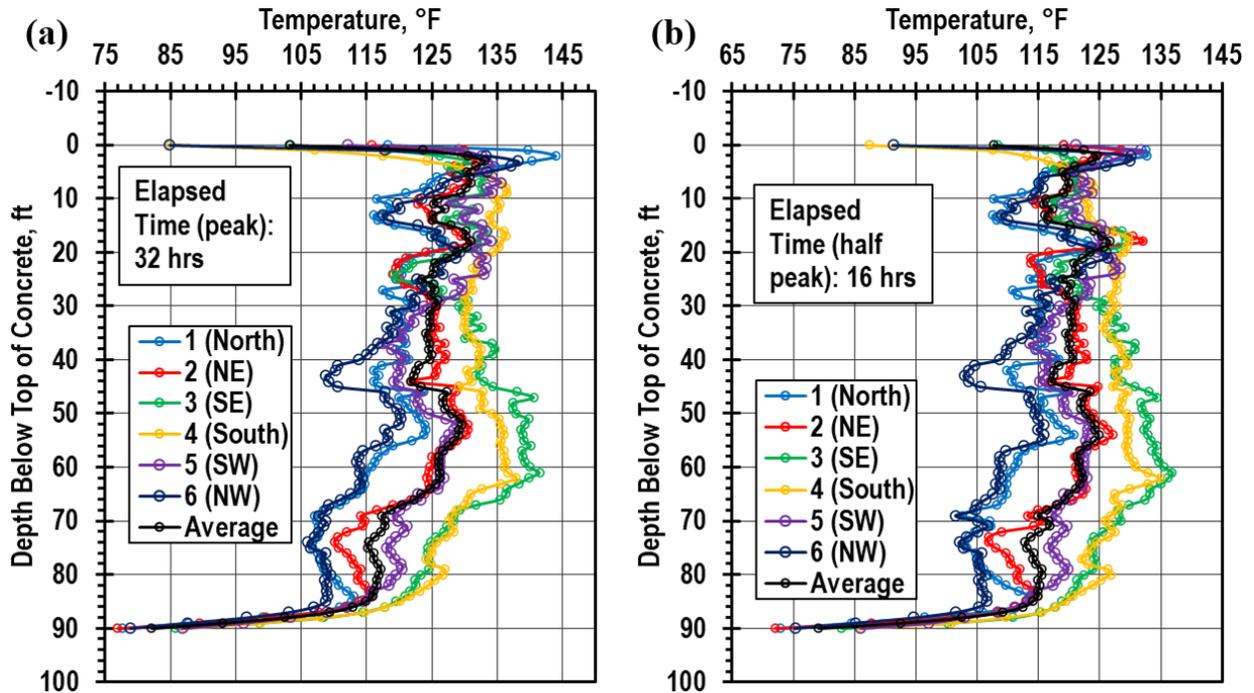
Figure 5-4: Temperature versus depth for Ramp F Bent 6: (a) time of peak temperature, (b) half the time of peak temperature.

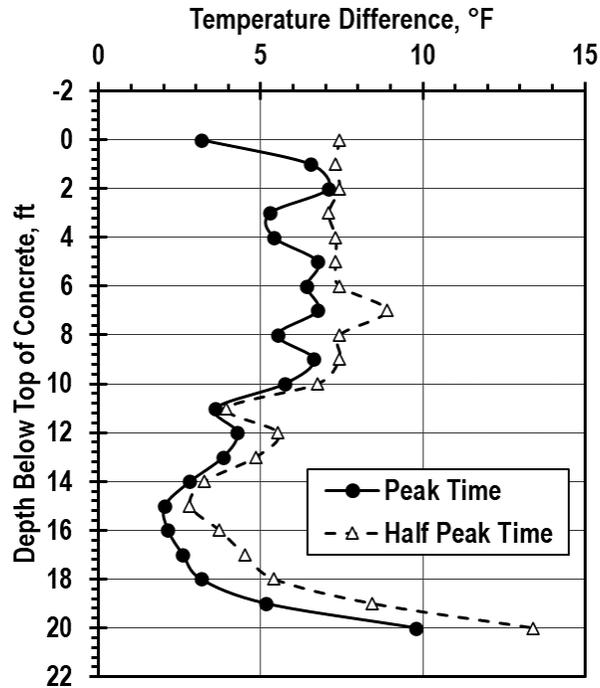
Figure 5-5: Temperature difference versus depth for Ewing Shaft 2.

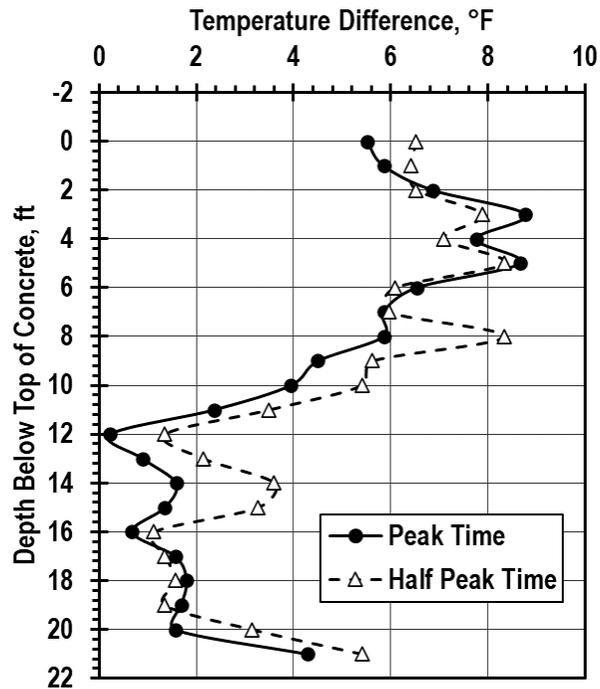
Figure 5-6: Temperature difference versus depth for Ewing Shaft 3.

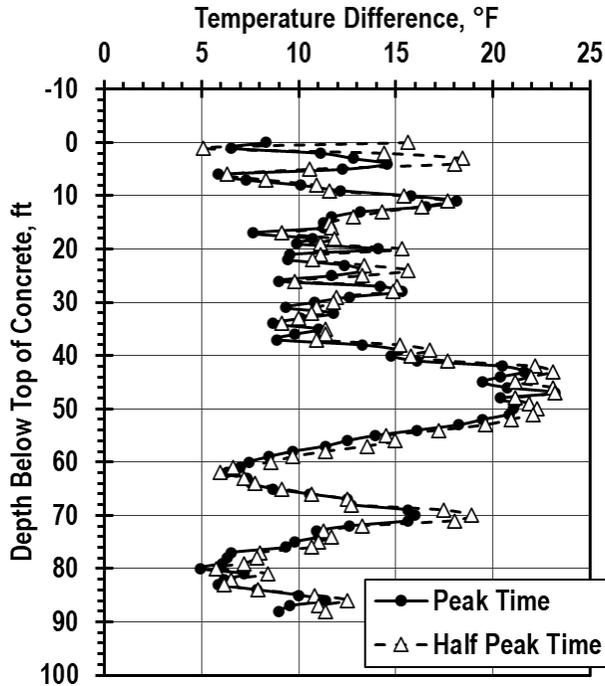
Figure 5-7: Temperature difference versus depth for Ramp F Bent 5.

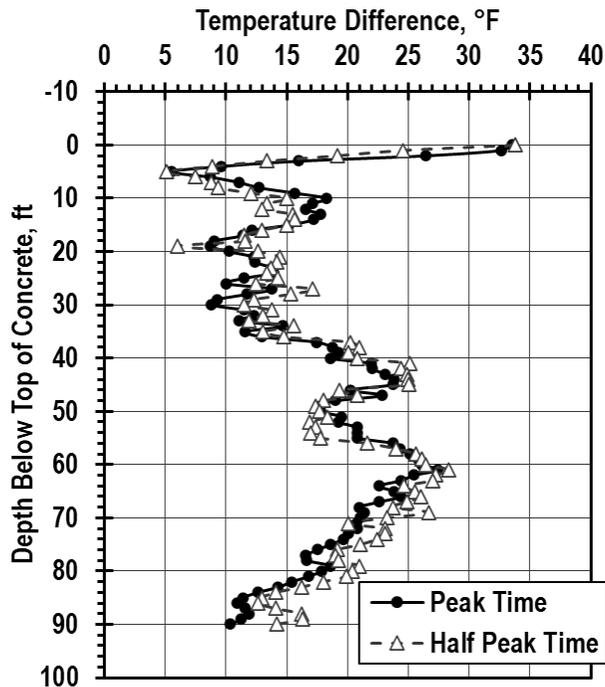
Figure 5-8: Temperature difference versus depth for Ramp F Bent 6.

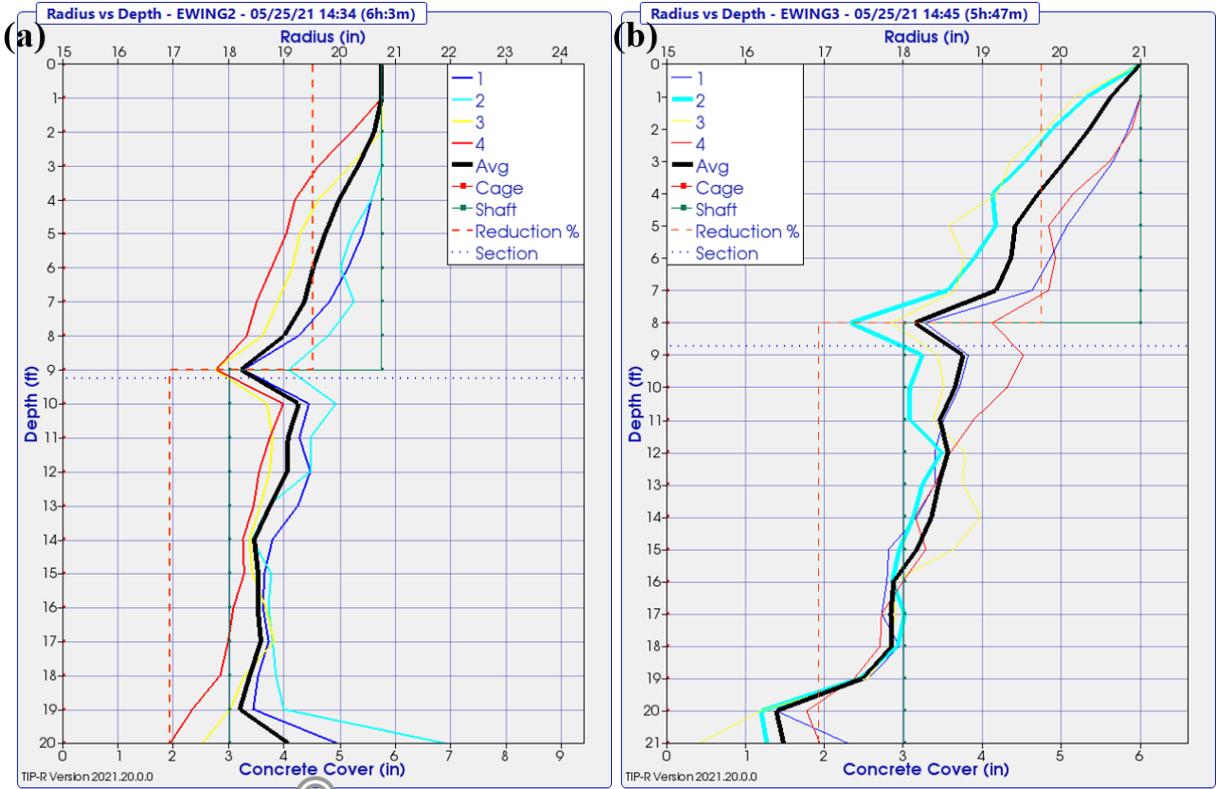
Figure 5-9: Effective radius versus depth at half peak for Ewing Ave. (a) Shaft 2 and (b) Shaft 3.

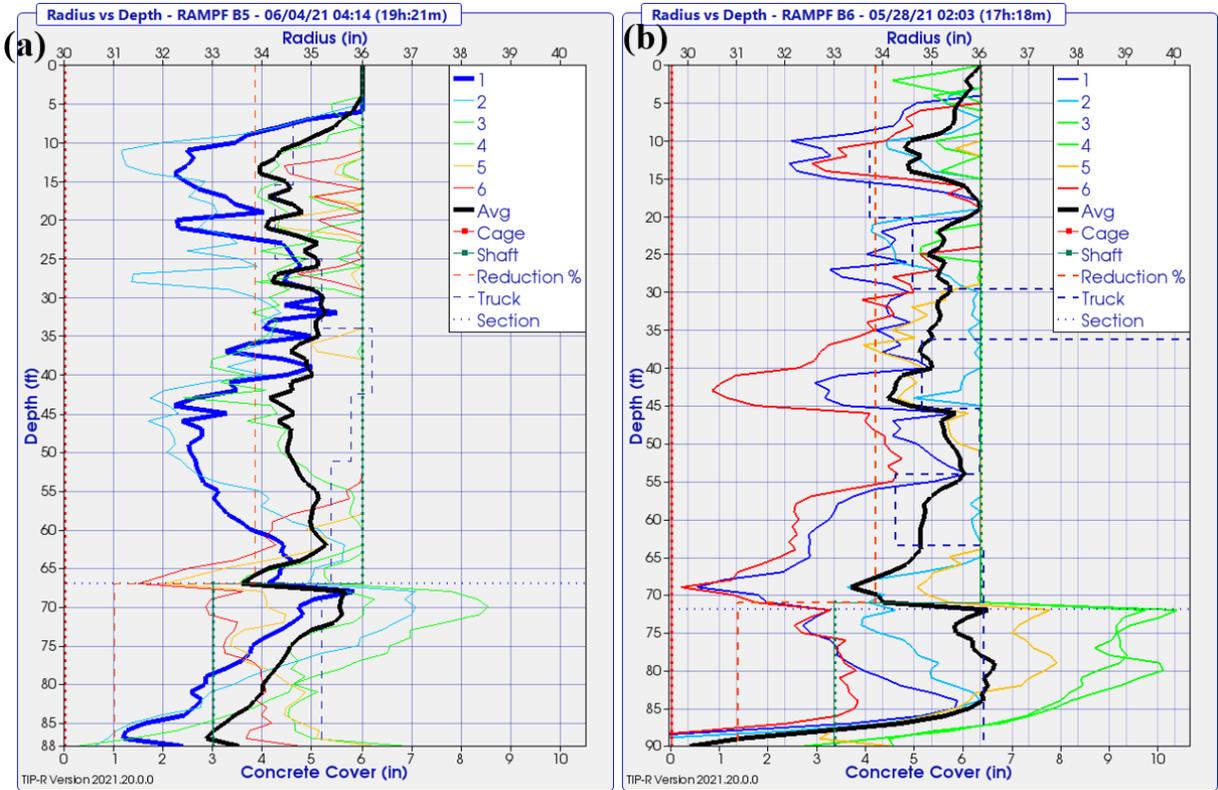
Figure 5-10: Effective radius versus depth at half peak for Ramp F (a) Bent 5 and (b) Bent 6.

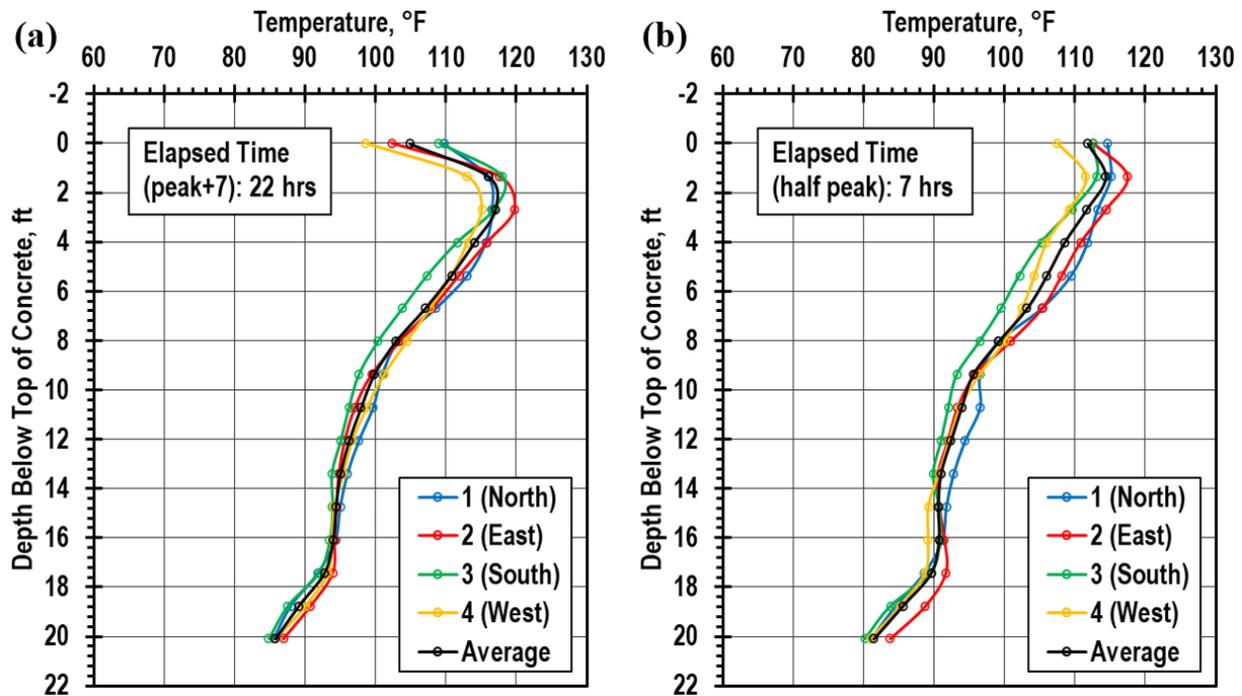
Figure 5-11: Fiber optic temperature versus depth for Ewing Shaft 2: (a) 7 hours after time of peak temperature, (b) half the time of peak temperature.

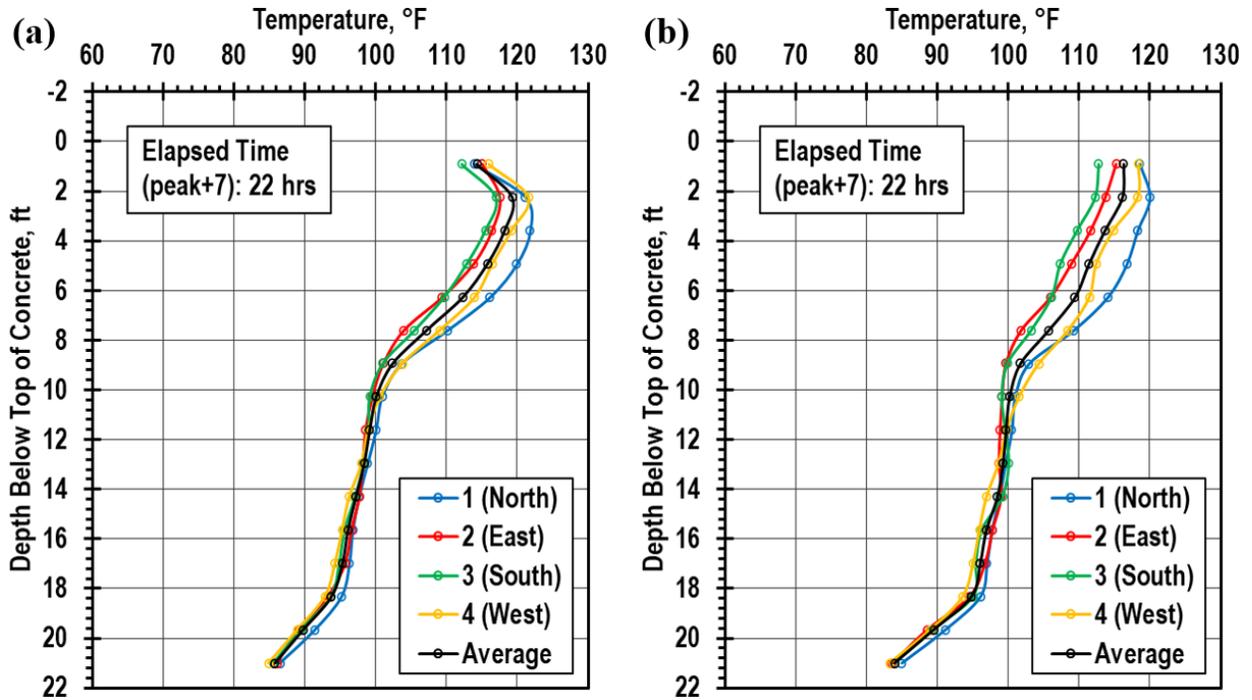
Figure 5-12: Fiber optic temperature versus depth for Ewing Shaft 3: (a) 7 hours after time of peak temperature, (b) half the time of peak temperature.

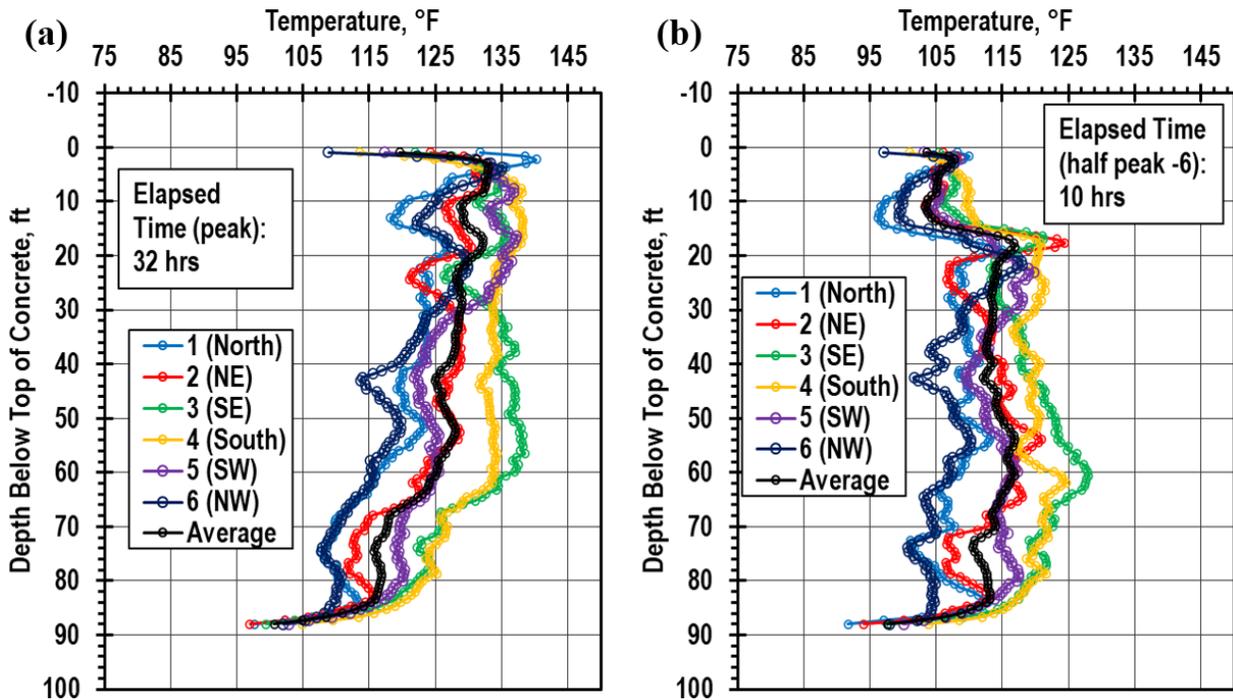
Figure 5-13: Fiber optic temperature versus depth for Ramp F Bent 6: (a) time of peak temperature, (b) 6 hours prior to half the time of peak temperature.

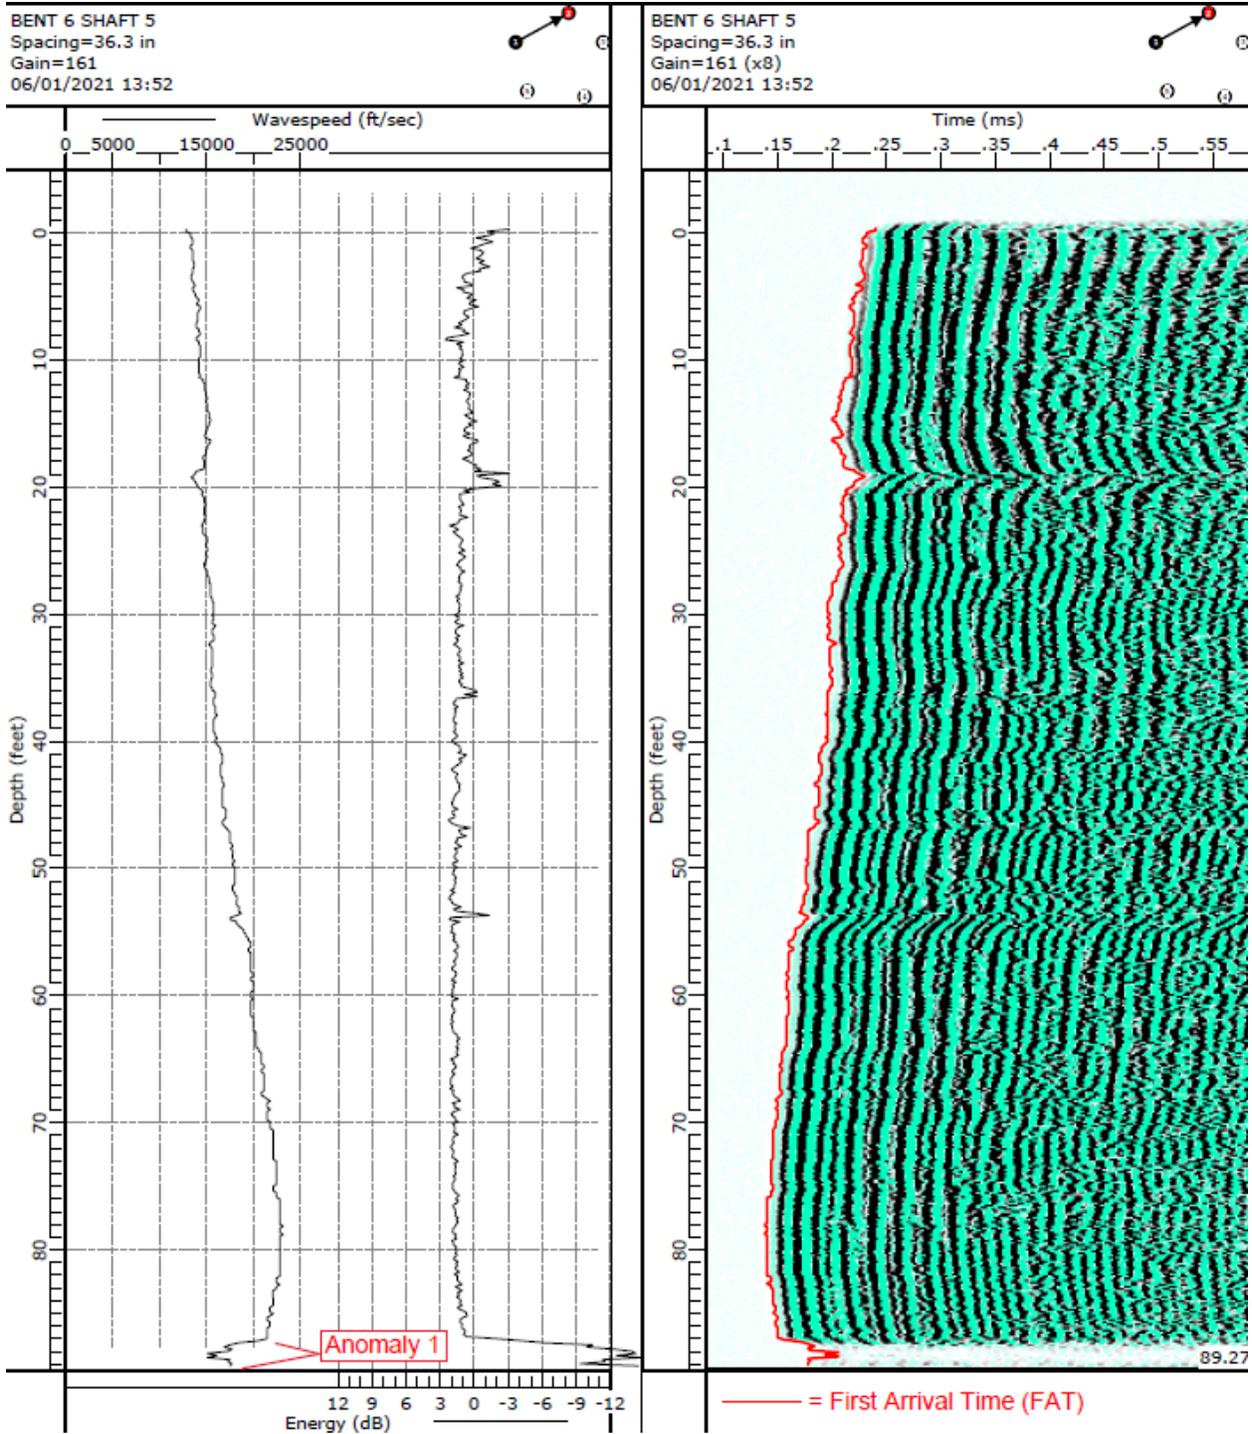
Figure 5-14: Example CSL result for Ramp F Bent 6 (Tube Pairing 1-2).

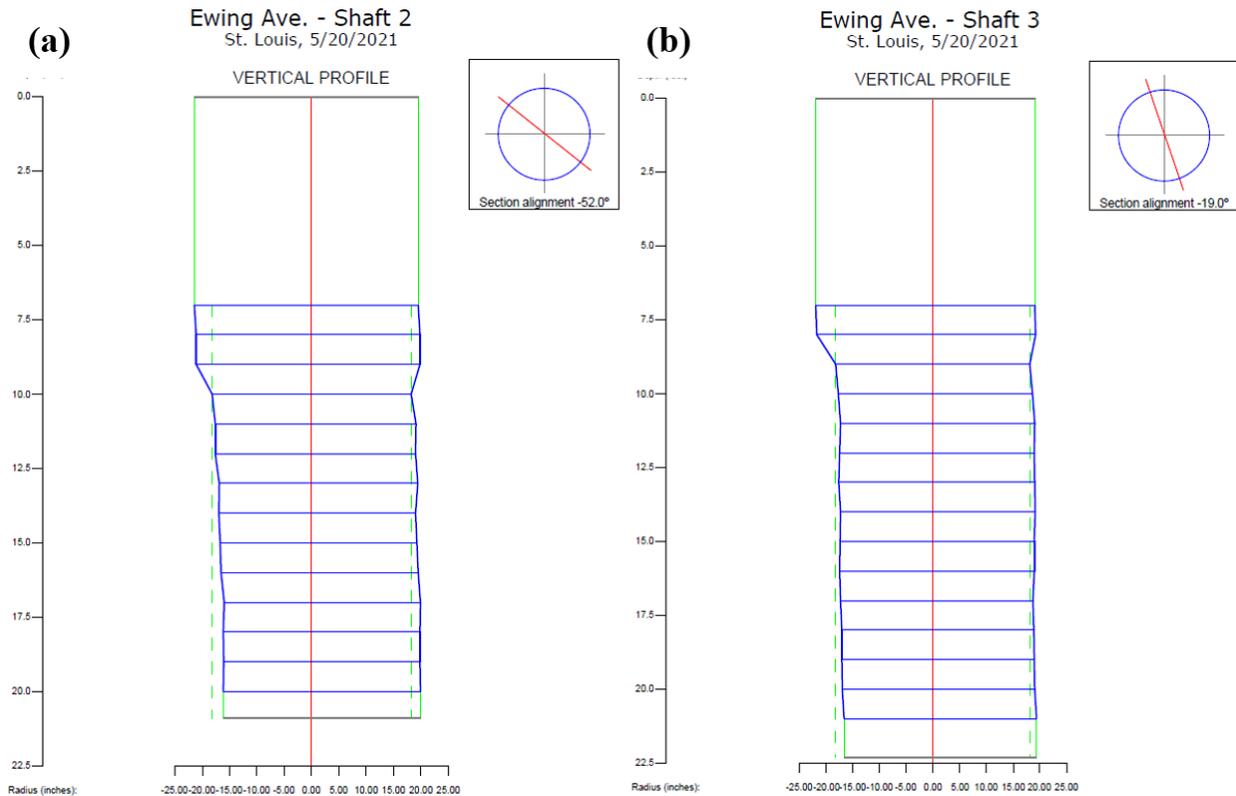
Figure 5-15: SONICaliper shaft profiles for Ewing Ave.: (a) Shaft 2 and (b) Shaft 3.

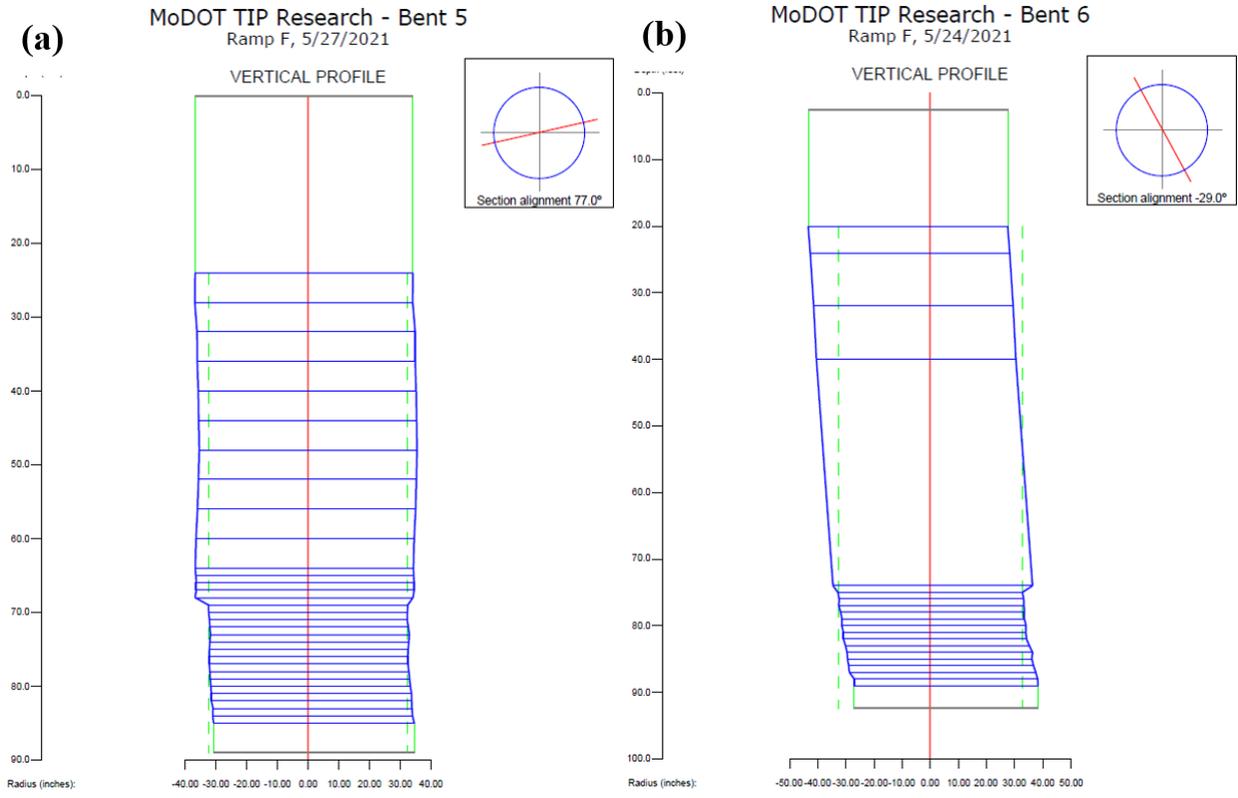
Figure 5-16: SONICaliper shaft profiles for Ramp F: (a) Bent 5 and (b) Bent 6.

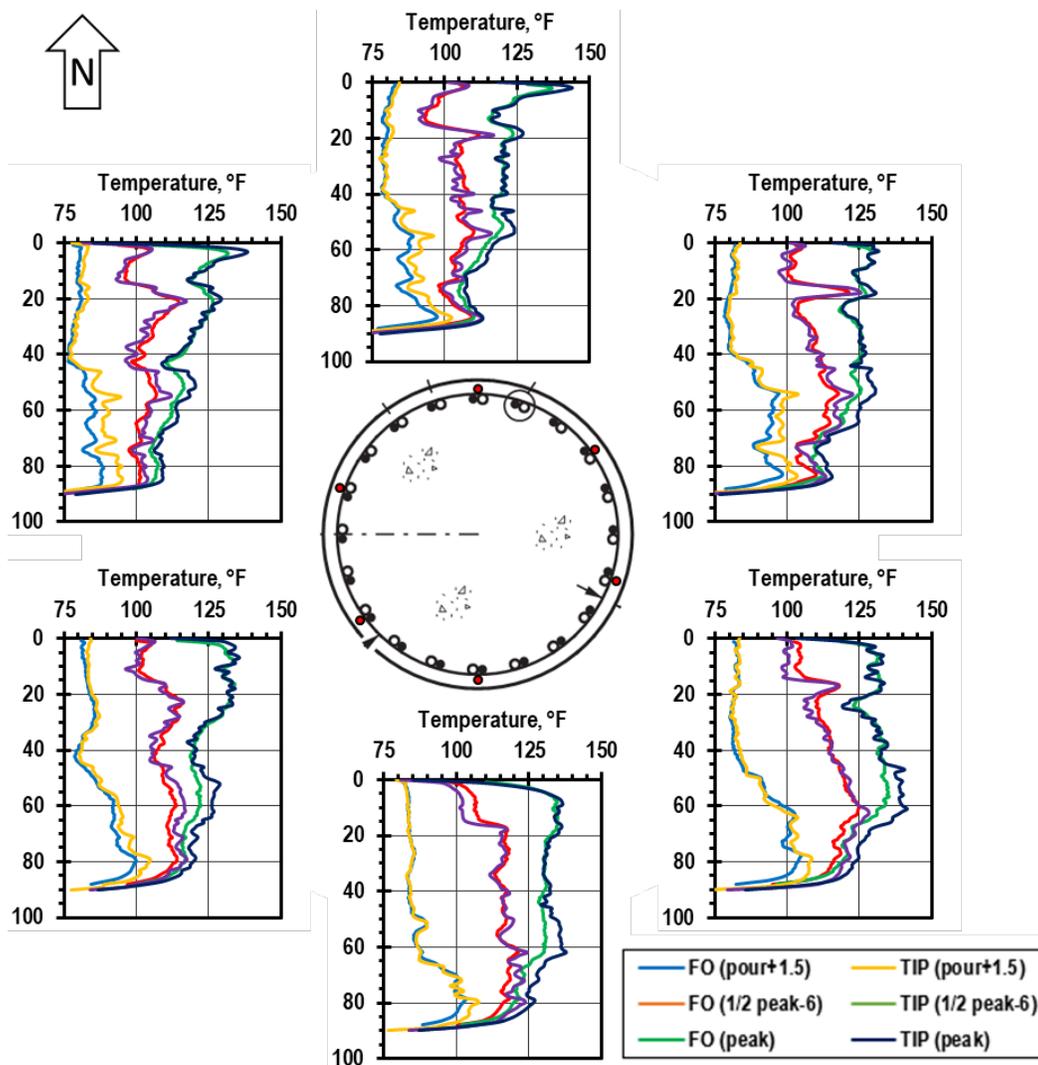
Figure 6-1: Fiber optic and conventional TIP thermal profiles at three times during curing of Ramp F Bent 6.
