Use of Thermal Integrity Profiling (TIP) in Drilled Shaft Evaluation

January 2022
Final Report

Project number TR202015
MoDOT Research Report number cmr 22-002

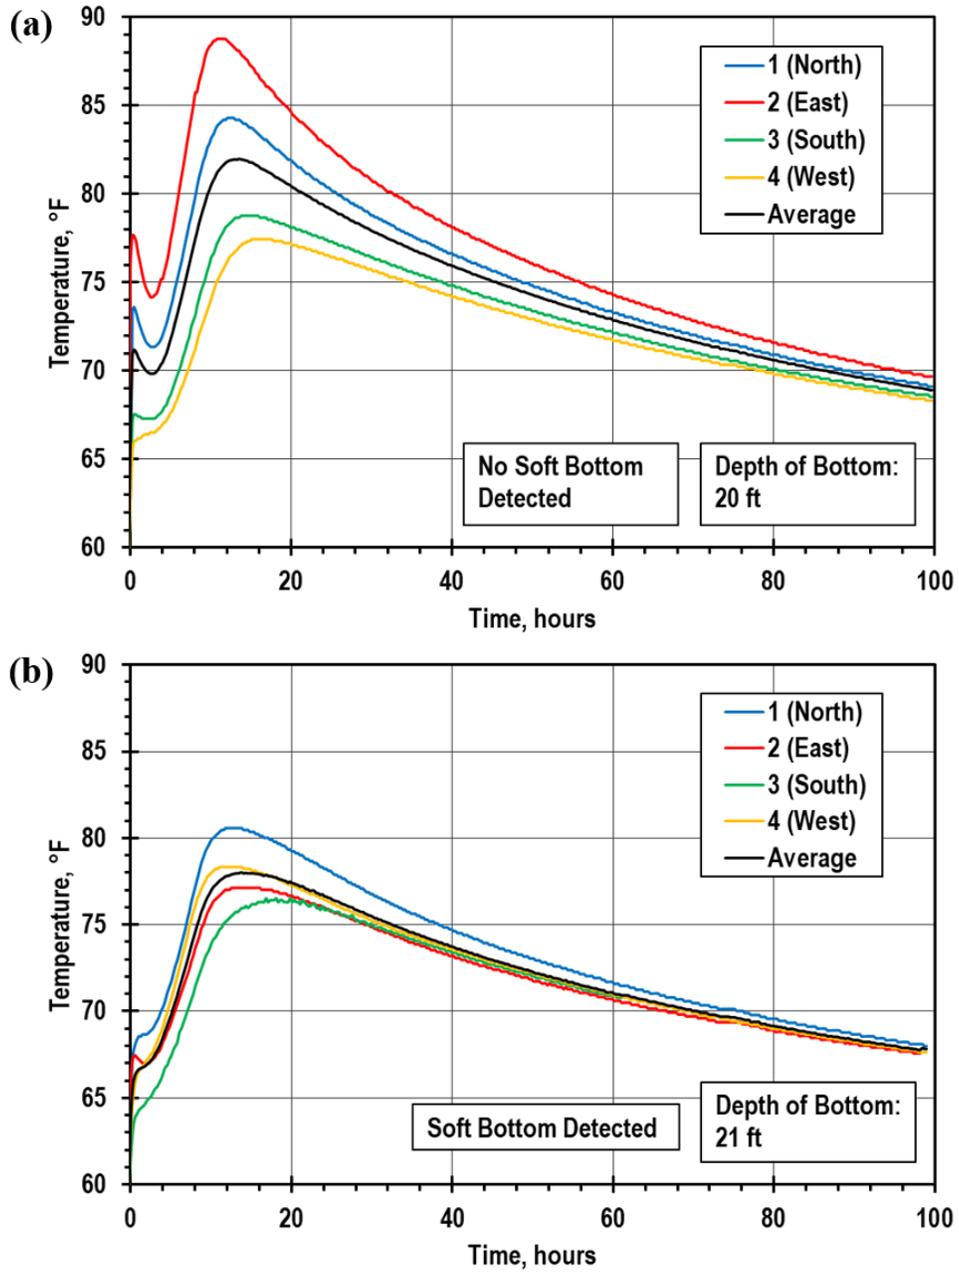
Figure 6-2: Temperature vs time at the bottom of shaft for Ewing Ave.: (a) Shaft 2 and (b) Shaft 3.

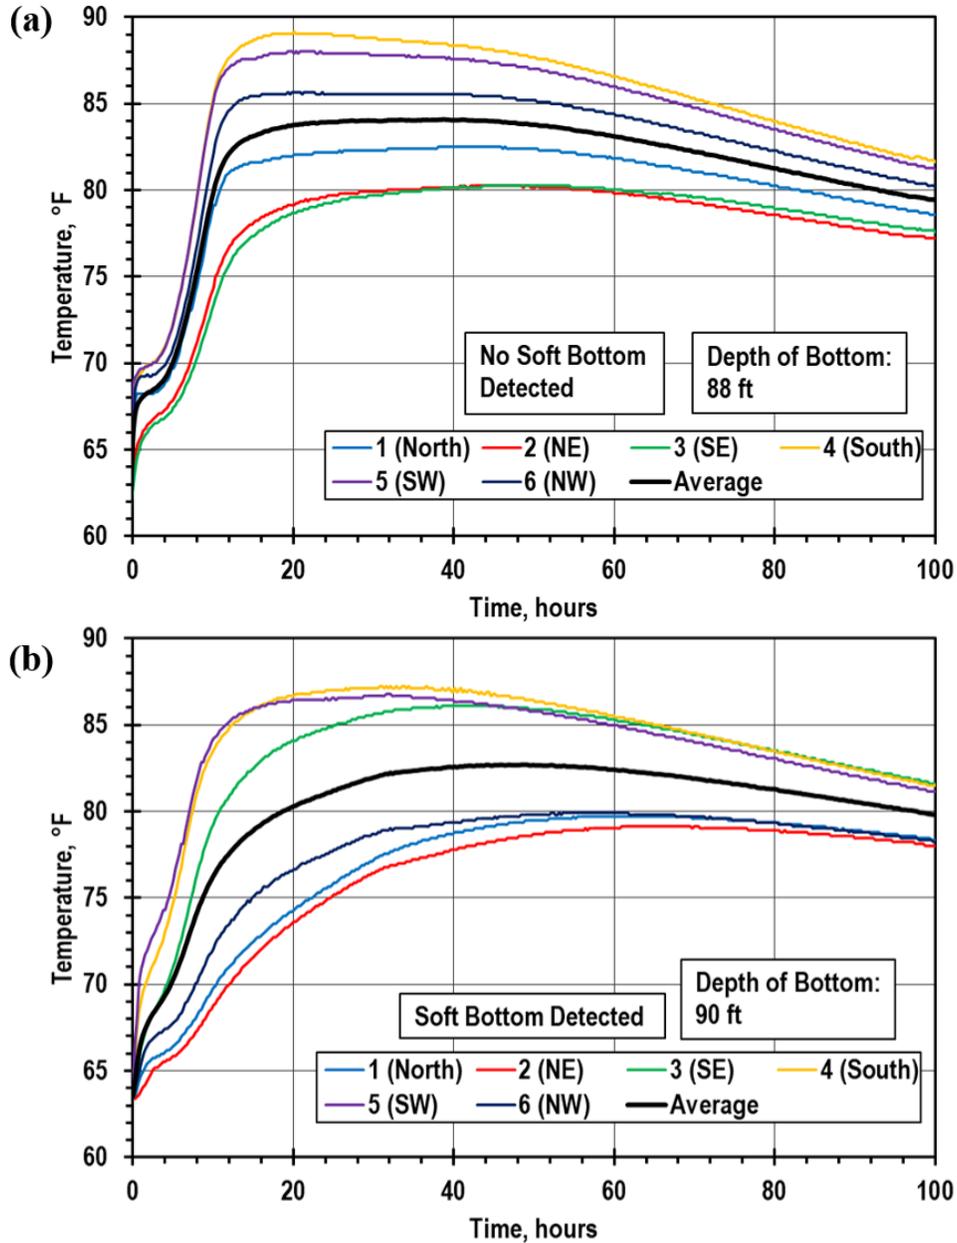
Figure 6-3: Temperature vs time at the bottom of shaft for Ramp F: (a) Bent 5 and (b) Bent 6.

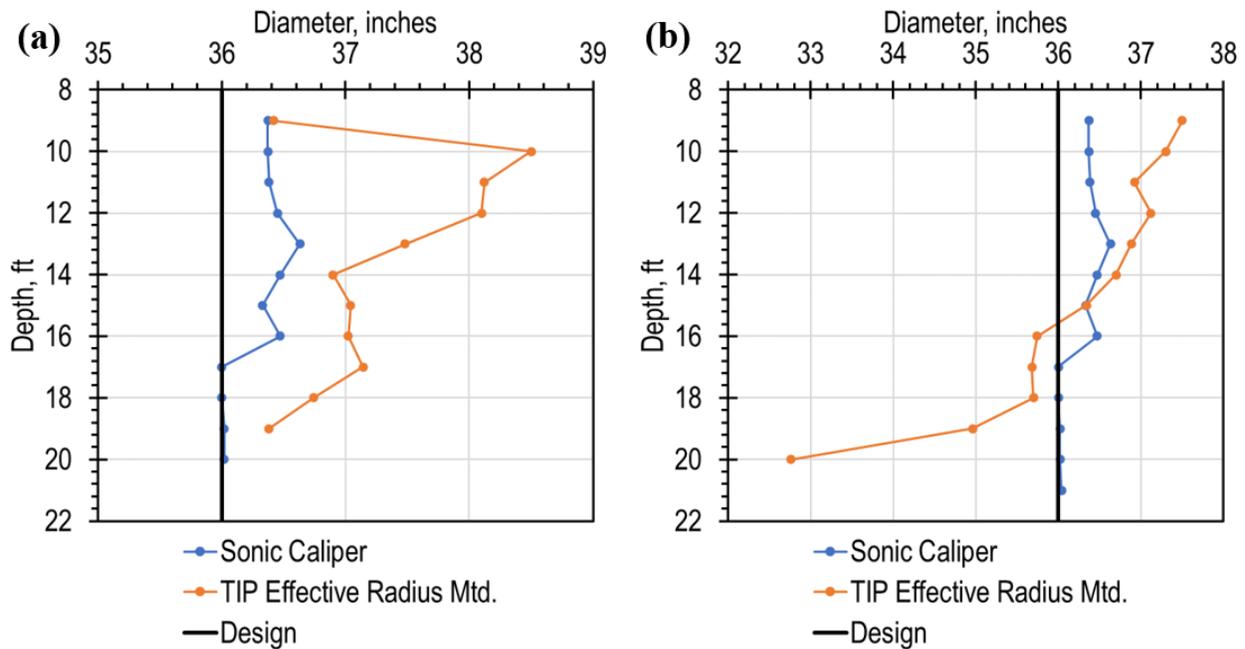
Figure 6-4: SONICaliper and TIP effective radius interpretations in Ewing Ave. rock sockets: (a) Shaft 2 and (b) Shaft 3.

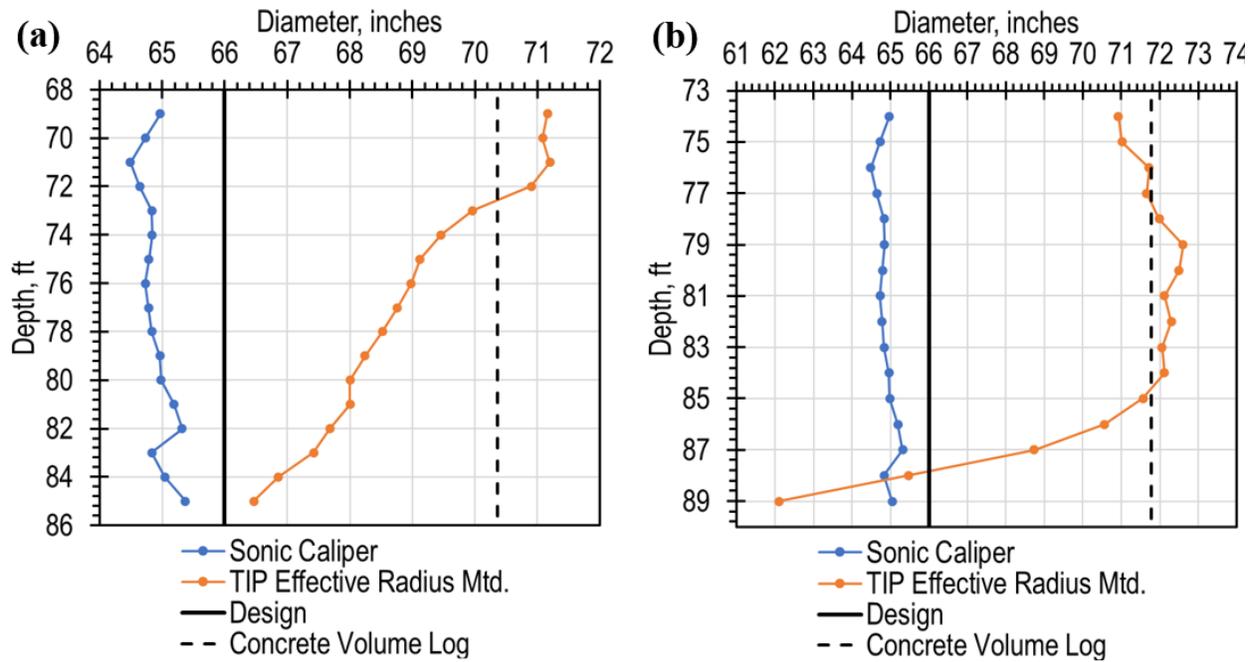
Figure 6-5: SONICaliper and TIP effective radius interpretations in Ramp F rock sockets: (a) Bent 5 and (b) Bent 6.
