Landslide Monitoring Methods: Application of Existing Technologies to Long-Term and Real-Time Monitoring of Slope Movements

February 2023
Final Report

Project number TR202016
MoDOT Research Report number cmr 23-002

Landslide Technology

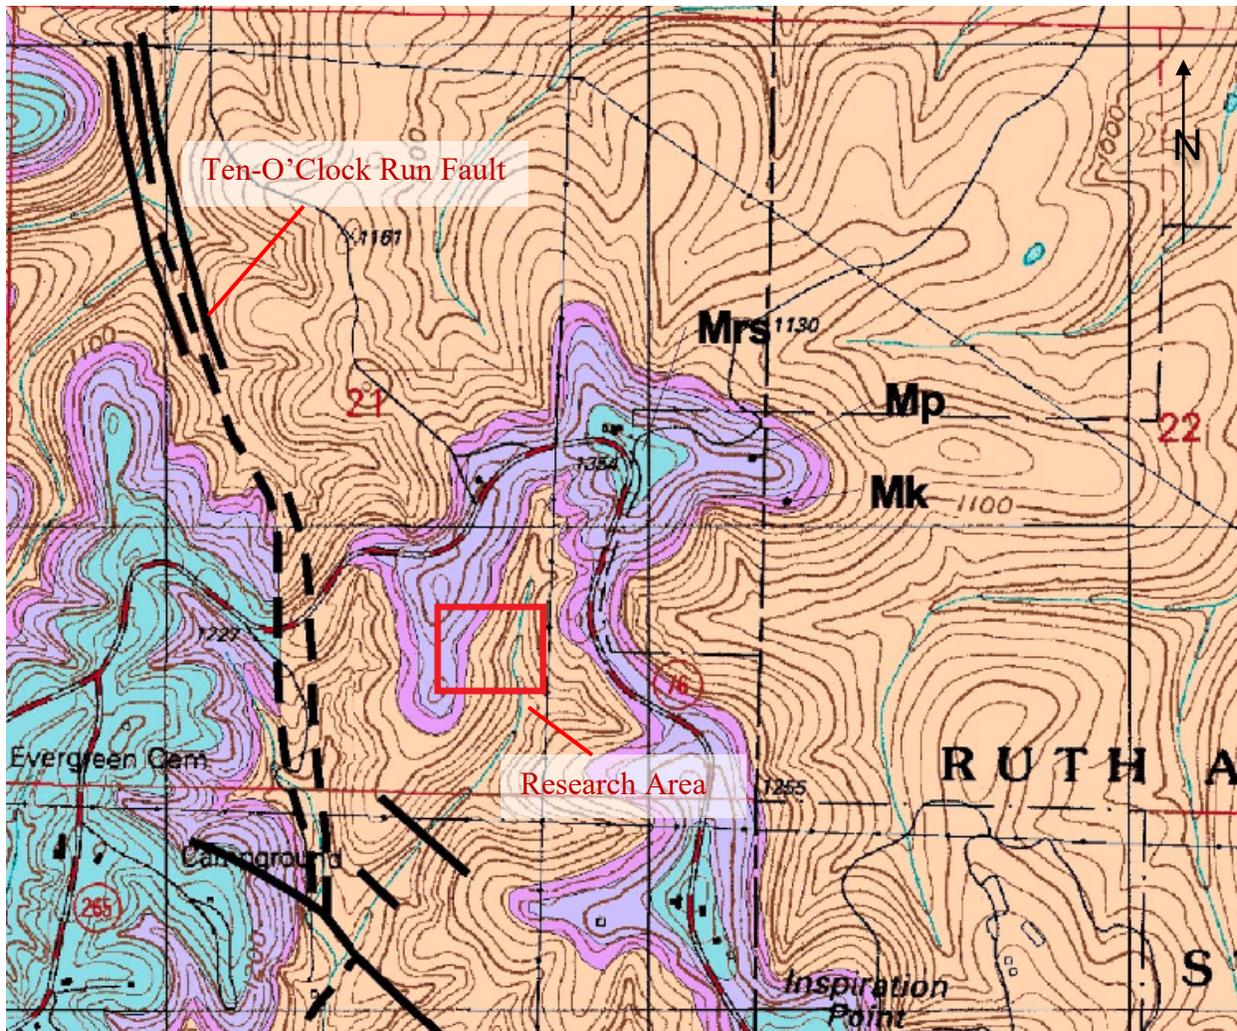
Figure 1: Segment of 2004 geologic map with the research area outlined in red. Scale of this excerpt is approximately 1in = 1,250ft. Pierson Limestone (Mp, light purple), Kinderhookian Series (Mk, purple), and Cotter Dolomite (Oc, beige) are expected to be encountered within the research area. (Whitfield, 2004).

The larger bedrock geologic map shows the Roark Creek Fault north of the project area and the Ten-O'Clock Run Fault to the south and west. The portion of the Ten-O'Clock Run Fault closest to the study area is shown in Figure 1. However, no faults are mapped within the project area that would have contributed to the observed slope instability.

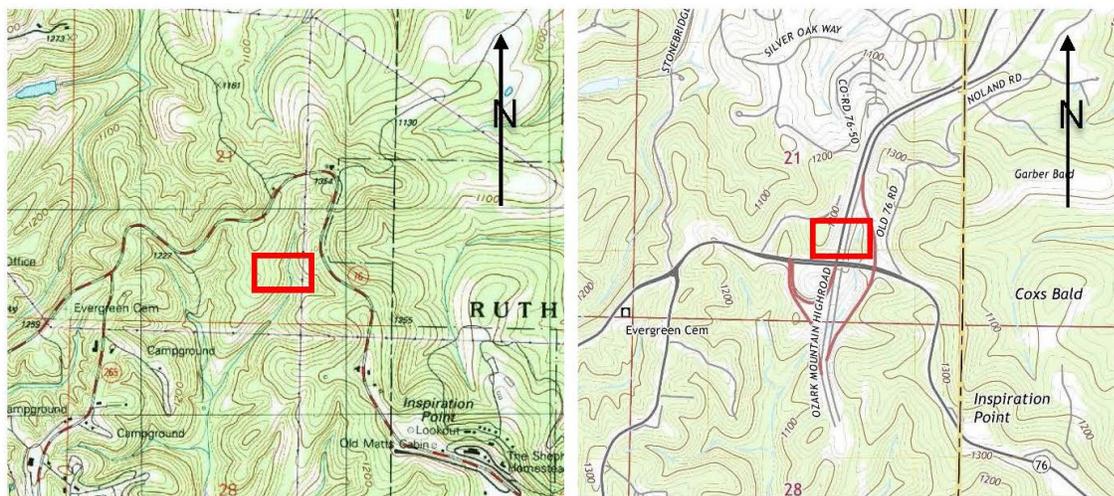
Figure 2: Excerpts from USGS topographic maps from 1989 (left) and 2021 (right) showing the project area (in red) before and after construction of the Ozark Mountain Highroad.

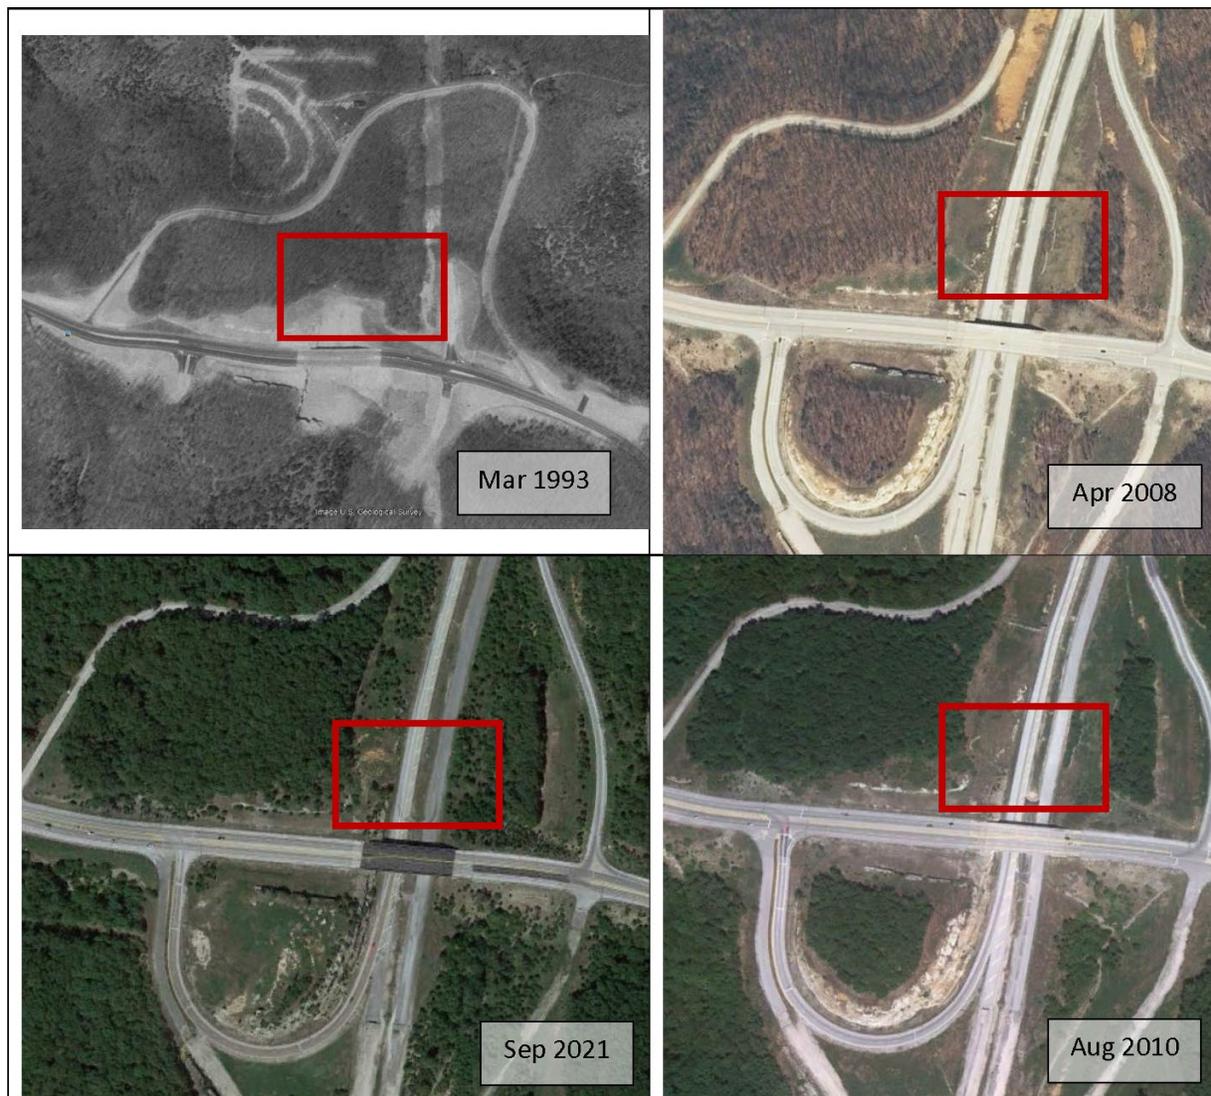
Figure 3: Selection of satellite images showing progression of slope instability at the study area over time. Movement appears to initiate between 2008 and 2010. All images courtesy of Google Earth.

Construction drawings and historical satellite images indicate that the cut slope was partially excavated in 1993 during the construction of the overpass that supported realignment of old Route 76, as shown in Figure 3. By 2001, final slope excavation was completed, and a set of nested gabion walls was constructed in the opposite embankment prior to the 2003 opening of the Ozark Mountain Highroad. A rockfill drain was constructed in the cut slope near the south end, aligned with a low spot in the ridge. No instability in the cut slope was noted at this time. The final cut slope in the study area was 2H:1V and approximately 75-feet tall, with height increasing from south to north. The site plans provided by MoDOT are included in Appendix A for reference.

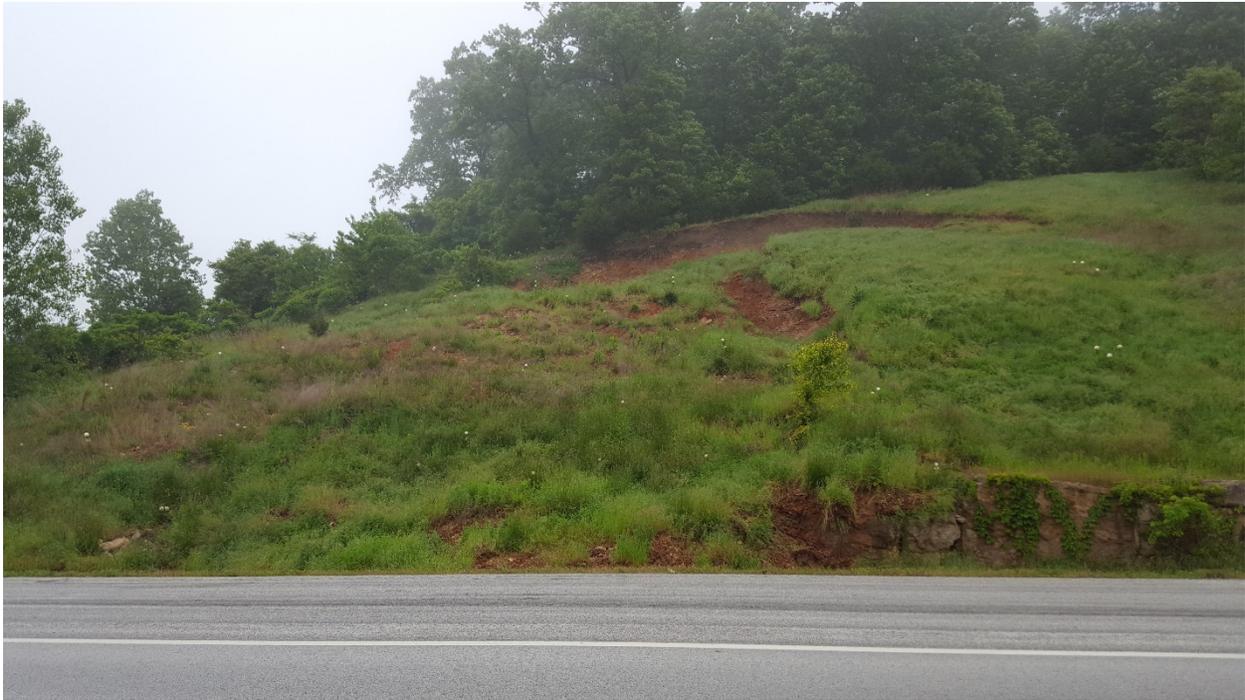
Figure 4: Reflective monitoring stations from previous research on the Ozark Mountain Highroad Slide in May 2020.

The reflective targets from the MST investigation remain onsite, as shown in Figure 4 below. Significant slide movement and growth occurred in May 2020 following an extended period of heavy precipitation. The landslide expanded to the north (right side of frame) and reflective targets that were previously intended to be control points are now within the slide mass.

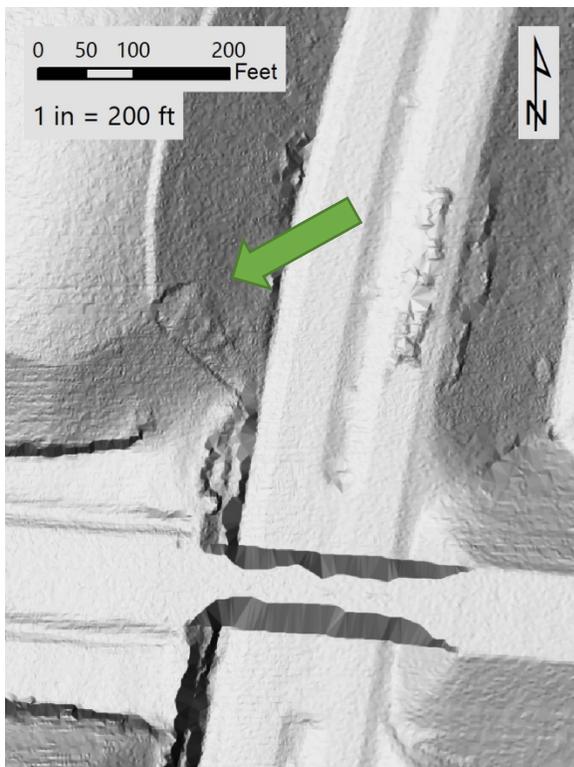
Figure 5: Bare earth LiDAR data from 2010 aerial LiDAR survey, with green arrow pointing to the landslide area.

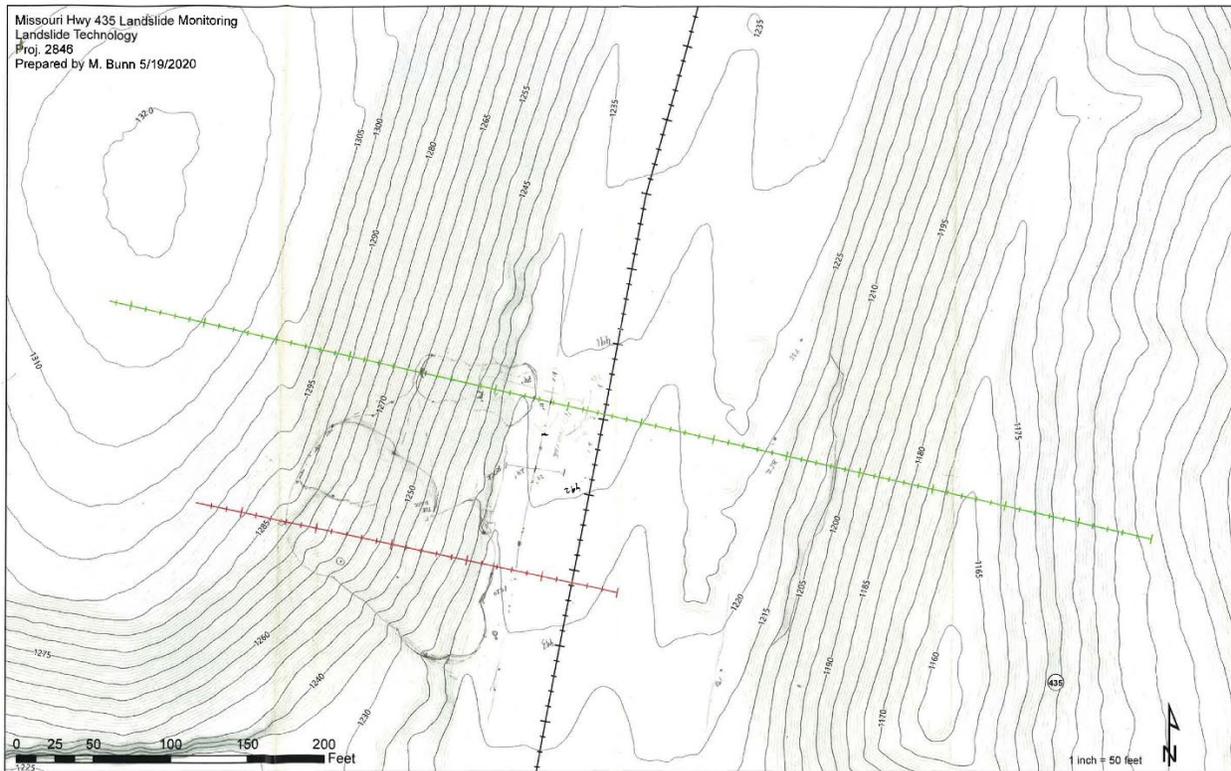
Figure 6: Site map with contours made from 2010 Stone County LiDAR data. This is a scan of the map was used during the field reconnaissance and includes notes taken in the field.

Although insufficiently detailed for long-term monitoring, the 2010 LIDAR was used to develop an initial site map with contours for field use, shown in Figure 6 below. The site map was created by processing the downloaded 2010 raster DEM with the ArcGIS Contour Tool. Extents of the final site map were based on an estimate of the likely area that would be covered during the site reconnaissance and a useful scale for field work.

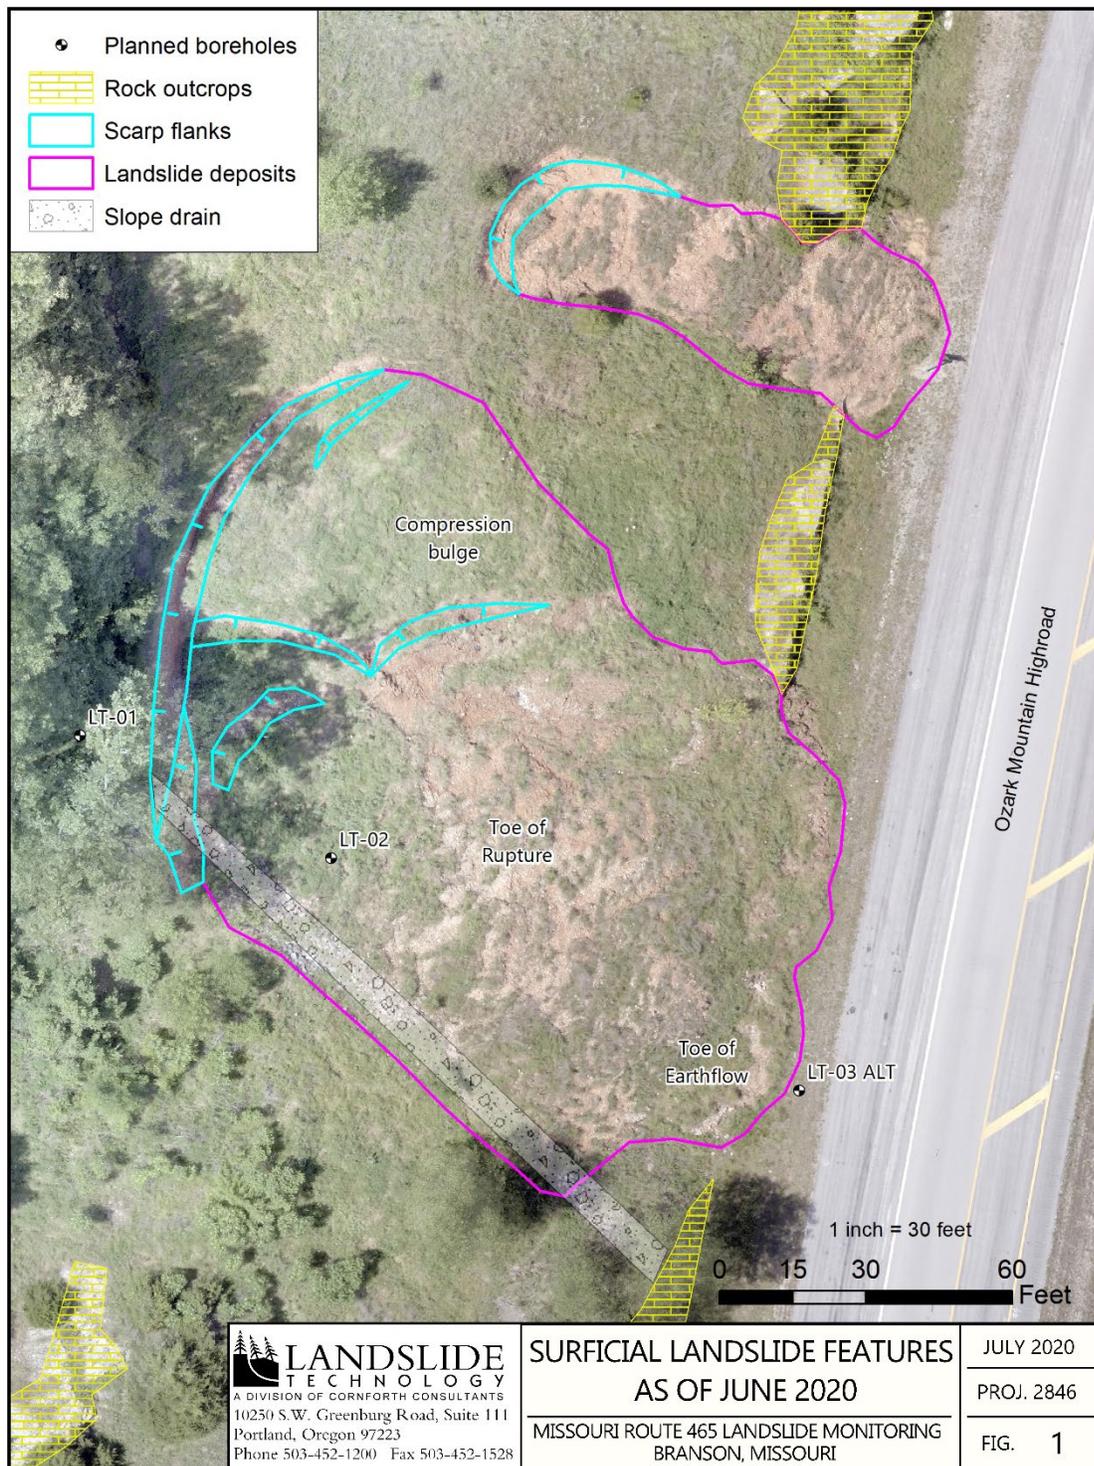
Figure 7: Finalized landslide map incorporating the site reconnaissance observations from May 2020, the LiDAR imagery from June 2020, and proposed boring locations.

Key features mapped during the 2020 field visit, and from high-resolution LIDAR data collected by Aerial Insights in June 2020, are displayed in Figure 7 on the following page.

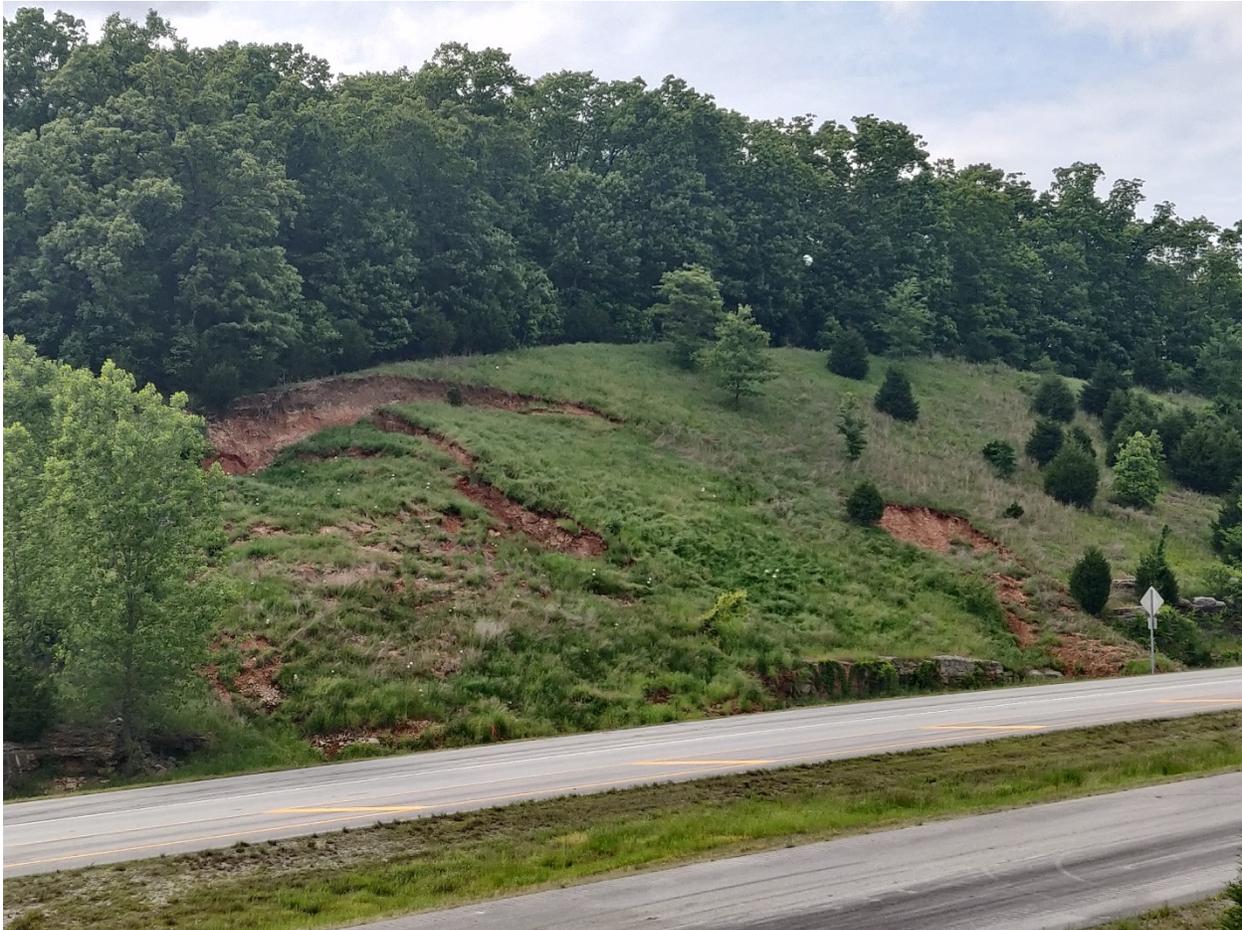
Figure 8: View of cut slope landslide complex taken from the Route 76 overpass May 2020.

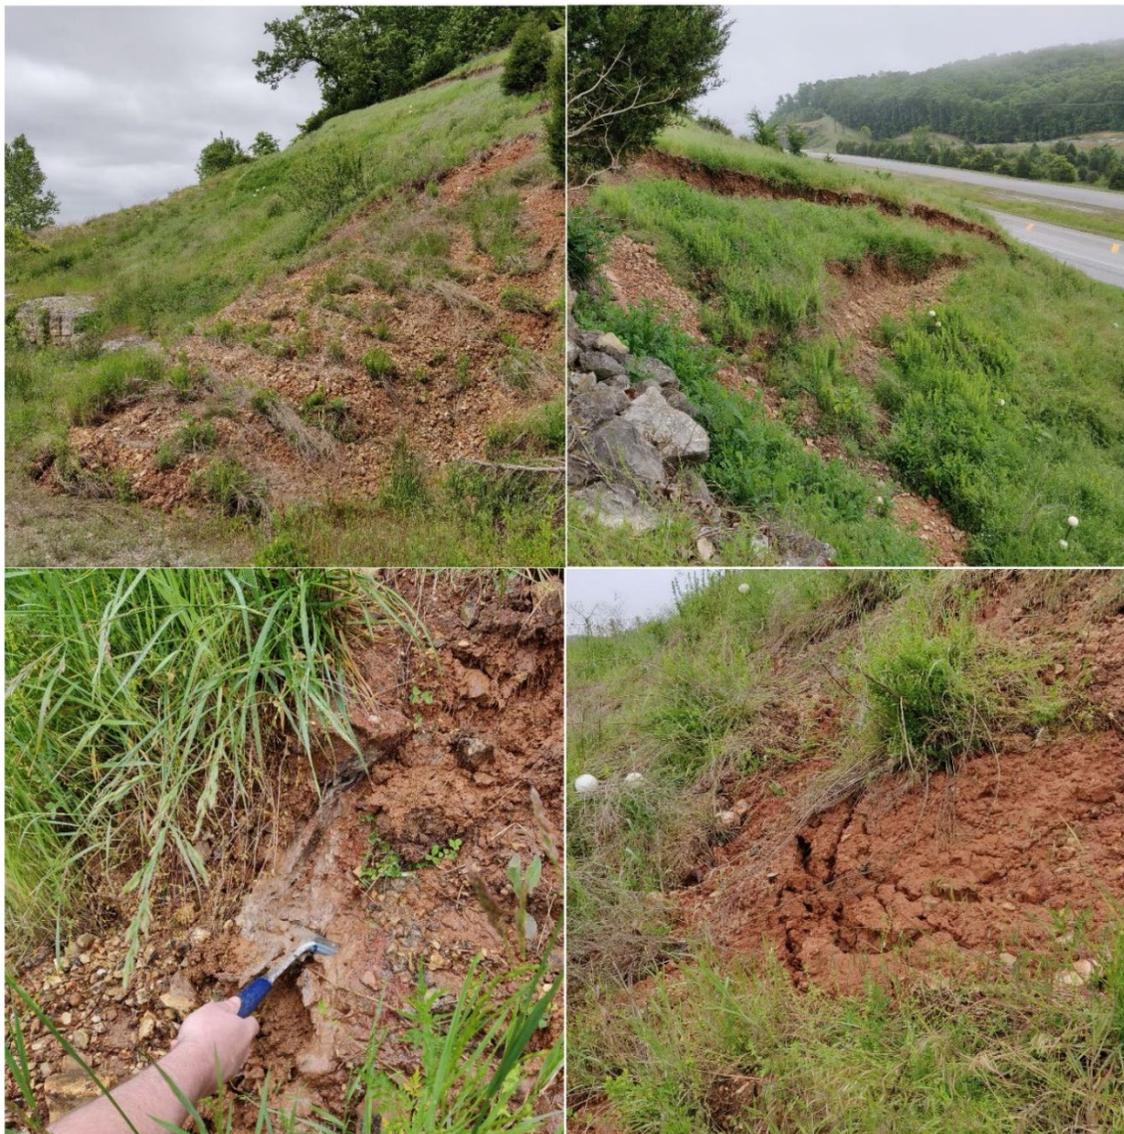
Figure 9: Slide features from May 2020. Clockwise from left, toe deposit in the roadway ditch, nested scarps at the head of the slide, an internal toe in the slide mass, and water seeping from the recently mobilized slide debris.

A selection of photos taken during the site reconnaissance are compiled in Figure 9. These photos show the nested head scarps associated with the slides, along with the landslide toes and internal deformation. The clay in the slide was saturated and moisture was actively seeping from the slide debris in multiple locations. Both slides appeared to have moved as saturated masses, with further internal deformation occurring as the slides moved downslope. No landslide movement was observed during the site visit.

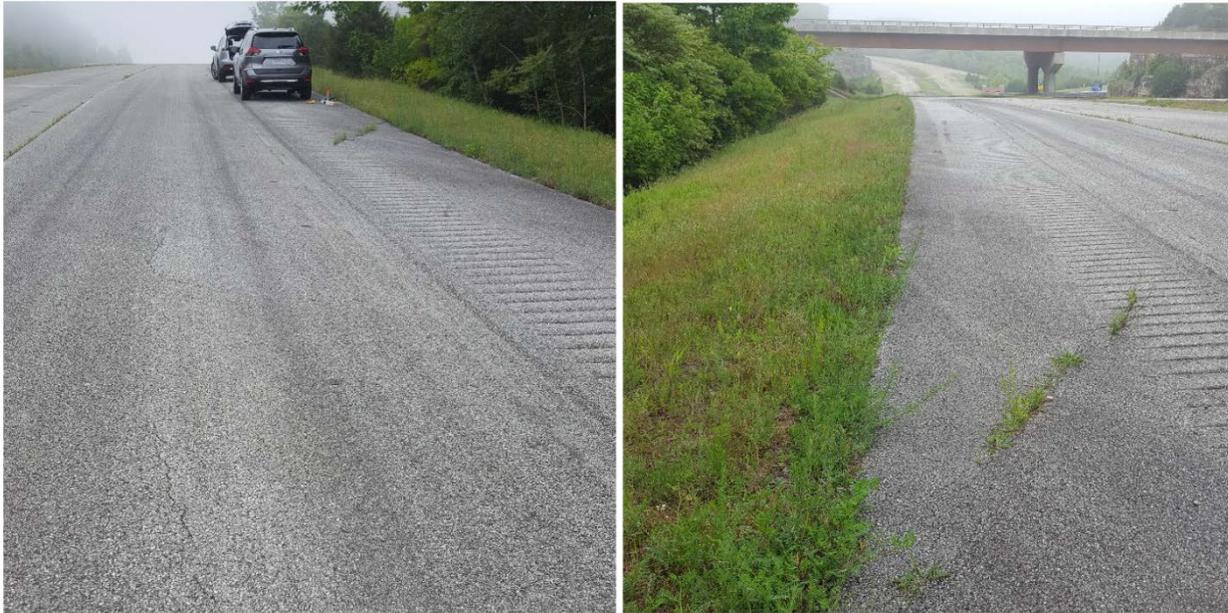
Figure 10: Arcuate cracking and minor deformation of the shoulder in the northbound lanes upslope from the gabion basket retaining wall system.

The first segment involved subsidence of the east lane and shoulder, located approximately 275 to 365 feet north of the Route 76 overpass bridge. A crescent shaped crack extended from the east shoulder at the south end of subsidence to 15 feet from the east shoulder, approximately 60 feet north of the starting point. A pair of photos of the pavement distress are shown in Figure 10.

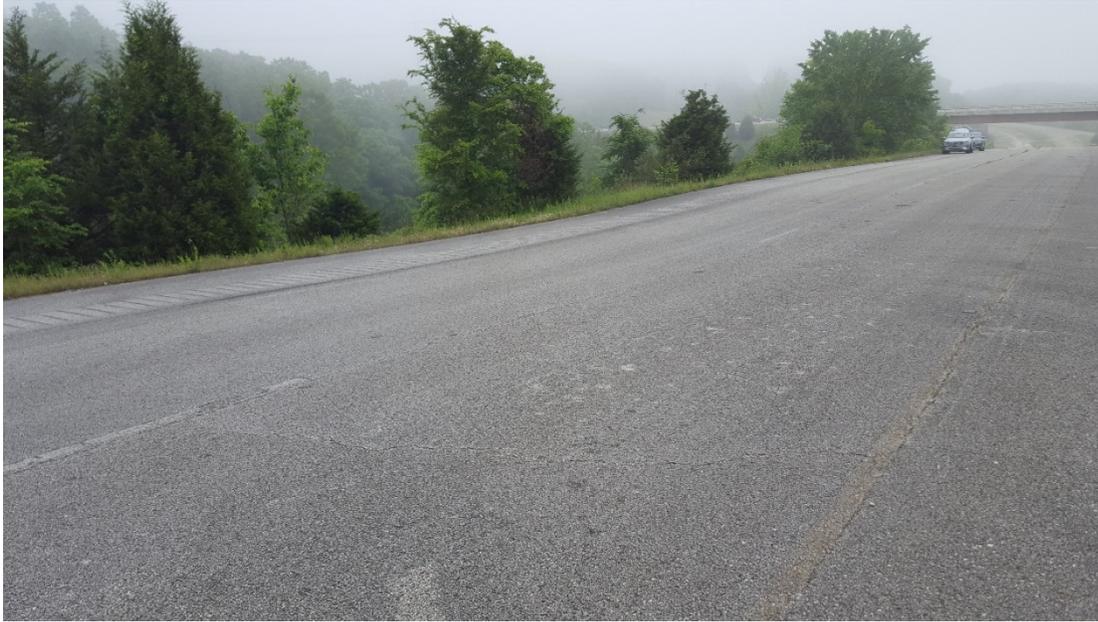
Figure 11: Deformation in shoulder of northbound lanes evidenced by the observed pavement down drop.

The second area of deformed pavement was located between 560 and 650 feet north of the Route 76 overpass bridge, north of the gabion wall system. It involved apparent subsidence of the entire paved northbound roadway, with increased subsidence to the east side of the embankment, as shown in Figure 11. No pavement damage or arcuate cracking was observed.

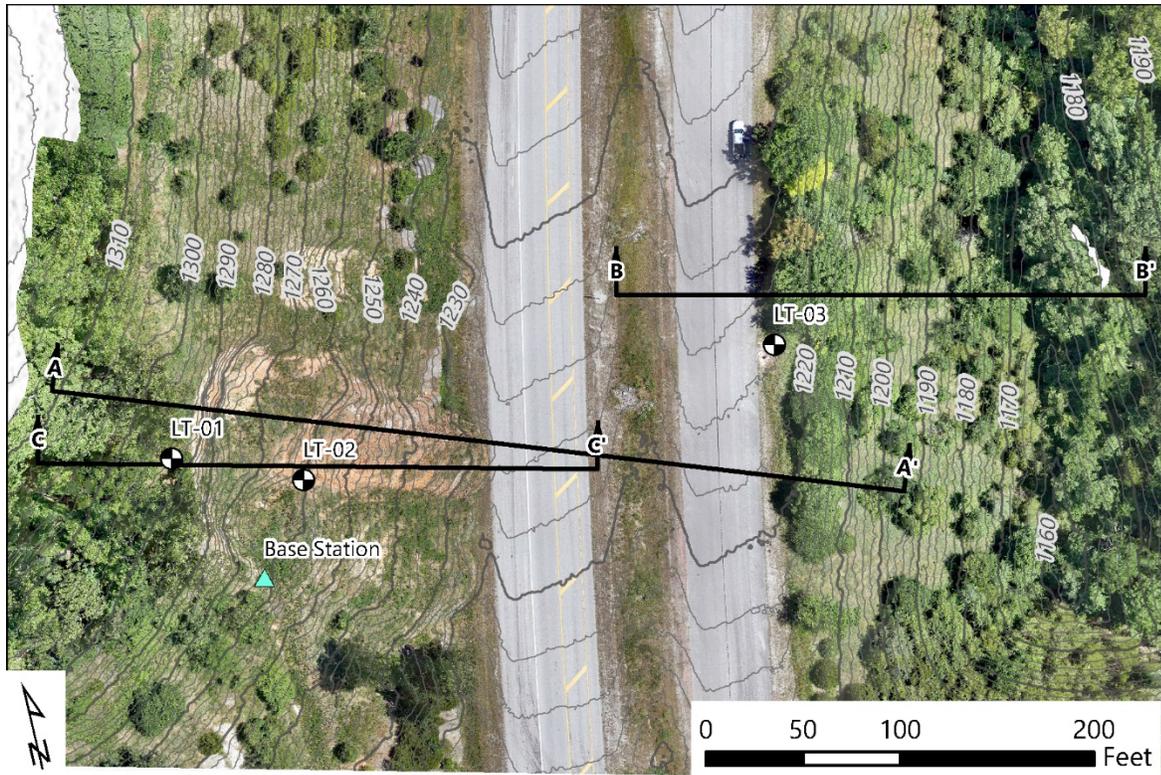
Figure 12: Site Plan showing location of borings and weather station installed at Ozark Mountain Highroad landslide.

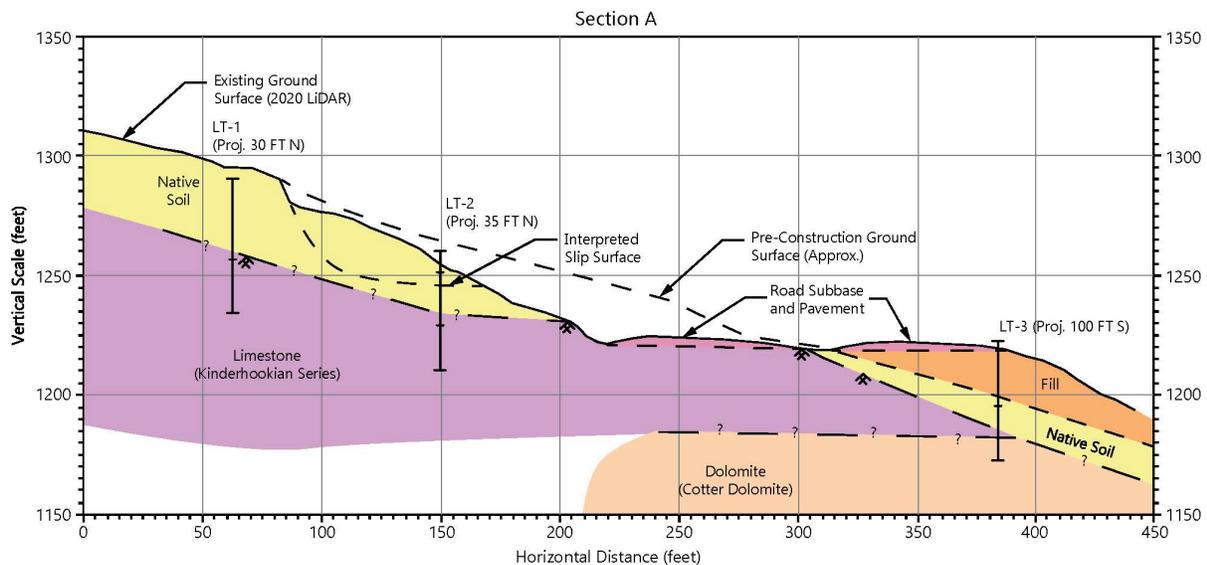
Figure 13: Geologic cross section through body of main slide showing cut-fill construction for this portion of the Ozark Mountain Highroad.

Broadly speaking, the soils on site consist of a clay colluvium overlying limestone and dolomite bedrocks. The embankment fill appears to have used the adjacent cut slope for borrow, because the native clay colluvium and the embankment fill are nearly identical in composition. Referring to the regional geologic map, the limestone encountered on site was interpreted to be part of the Kinderhookian Series, while the dolomite was interpreted as being part of the Cotter Dolomite. The contact between the two units was at a lower elevation than expected from the regional geologic map. Contact between the rock units did not appear to correlate with landslide location or activity.

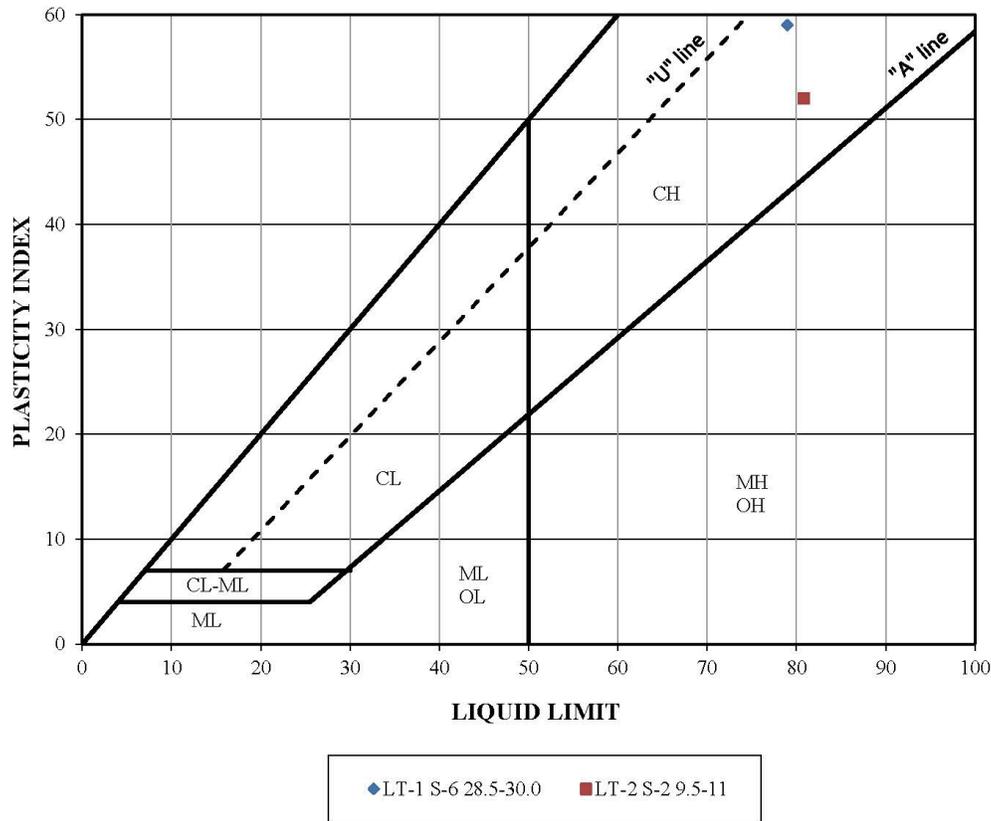
Figure 14: Plot of Atterberg Limit results for selected native soil samples.

Liquid and plastic limits (Atterberg limits) were determined for selected soil samples collected during the field investigations. Both samples were from the cut-slope soils. Test procedures were in general accordance with ASTM D4318-10. Results of this testing are summarized in Table 2 below and plotted graphically on the Plasticity Chart, Figure 14. Natural moisture contents determined from field samples during drilling was at or near the plastic limit.

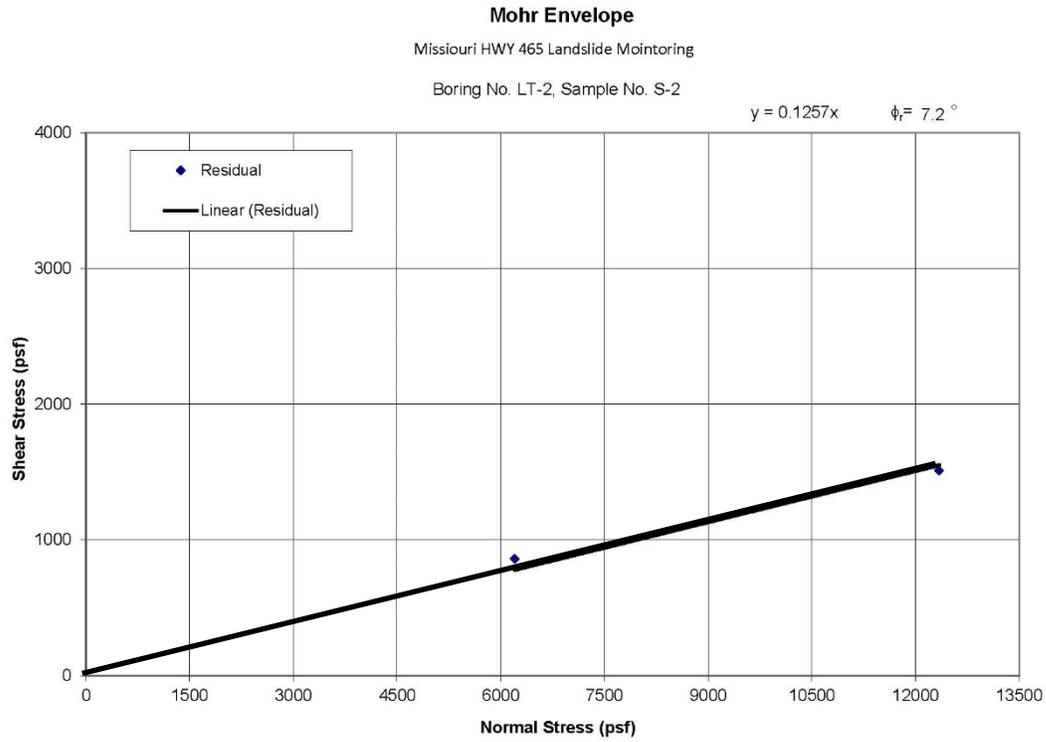
Figure 15: Plot showing the results of ring-shear testing on a sample of clay from LT-2, near the zone of maximum observed deformation.

A torsional ring shear strength test was conducted on sample S-2 from LT-2. This sample of red fat clay (CH) was collected between 9.5 and 11 feet below the ground surface, at the base of the observed slide movement. The test was performed in accordance with ASTM D 6467 standard testing procedure to determine the residual strength of the landslide shear zone materials. The soil was selected from sampled material and remolded into the ring-shear apparatus.

Plotted ring shear testing results are presented in Figure 15 below.

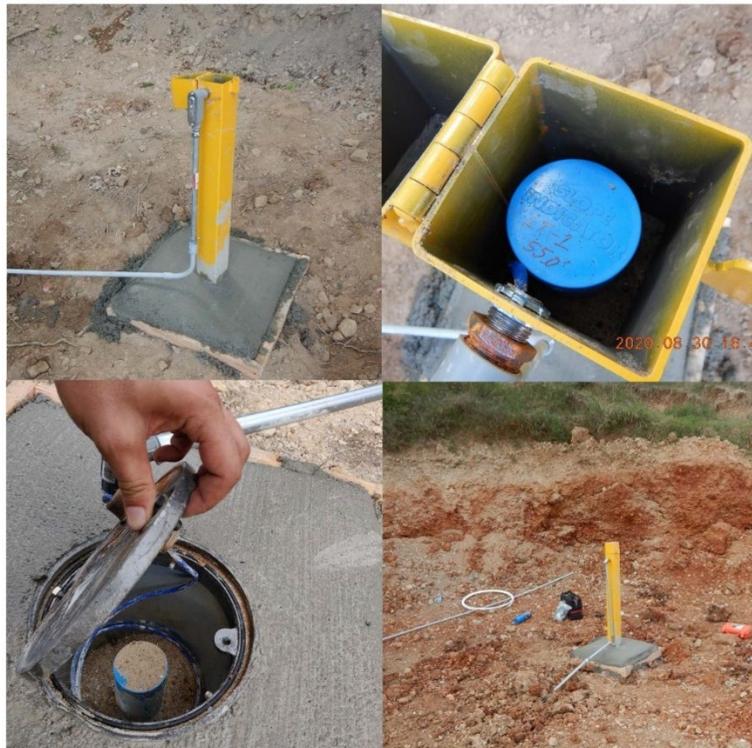
Figure 16: SI Monuments at Branson Landslide. Clockwise from top left: LT-1 above-ground monument, LT-1 open showing inclinometer pipe, LT-2 above-ground monument, and LT-3 flush mount.

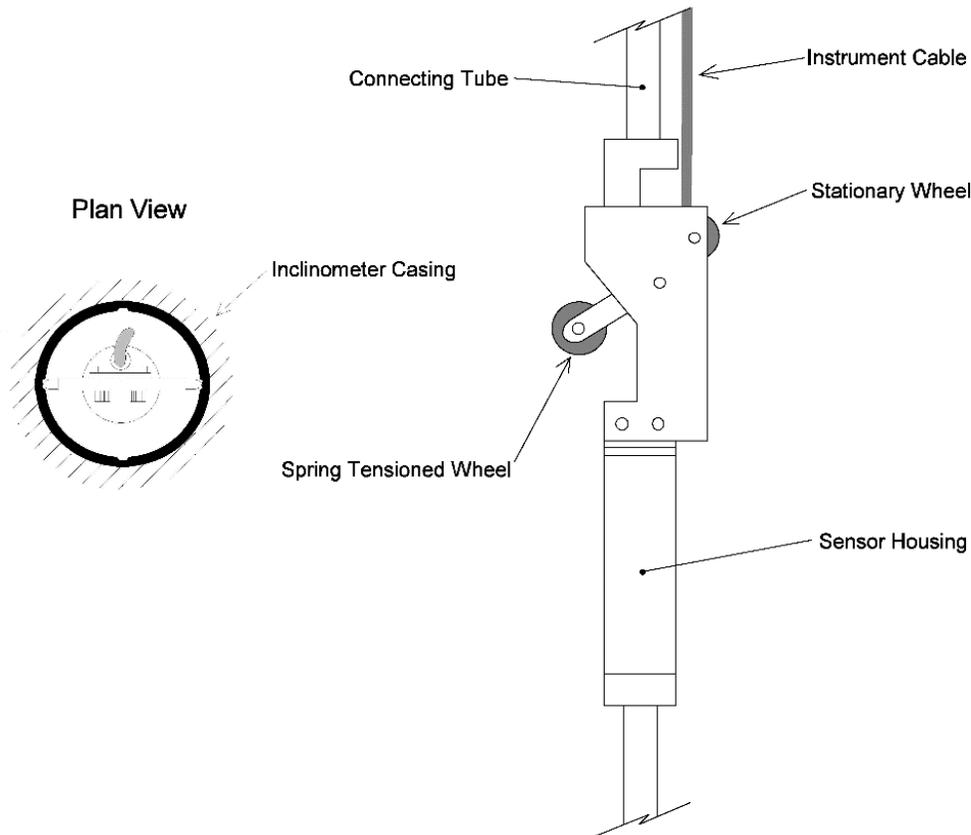
Figure 17: Schematic of GEOKON Modal 6300-1 In-Place Inclinometer (Courtesy of GEOKON).

6300-1 uniaxial in-place inclinometer produced by GEOKON. A schematic of an IPI is shown in Figure 17 below (Geokon, 2019). The instrument uses a tilt sensor to measure precise inclination of the instrument assembly within the SI casing, and when combined with the known gage length, this returns a net displacement over the shear zone from the date of IPI installation. Because it connects to a vibrating wire datalogger, tilt data can be collected at any time interval the datalogger will support. Instead of the weeks that typically pass between manual readings, the datalogger at Branson was programmed to collect data from the IPI at 10-minute intervals. This supported identification of triggering events and long-term slide behavior.

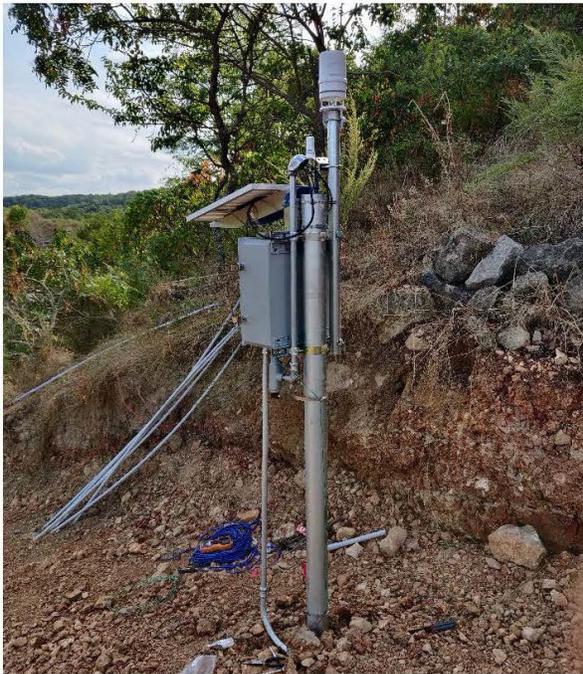
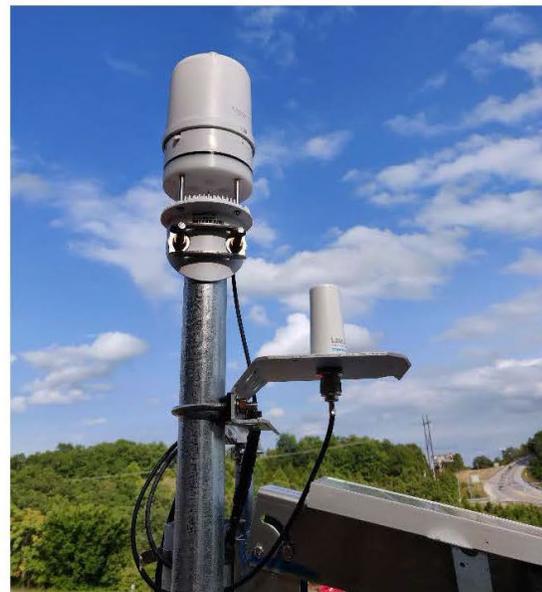
Figure 18: Pair of photos showing weather station as installed at base station (left) and a close up of the weather station and sensor (right).

Seasonal landslide movement typically correlates with precipitation and seasonal groundwater level fluctuations. The vibrating wire inclinometers collected groundwater data, but a weather station was required to collect precipitation data on site. The research team installed a ClimaVUE50 weather sensor, photos of which are shown in Figure 18 below. The station measures rainfall using a drip counter. Water collected in the funnel at the top of the weather sensor is released in drops of a known size, which generate an electrical pulse between a pair of pins as they exit the funnel. Although rainfall data was the primary data of interest for the research team, the weather station also collects temperature, relative humidity, solar radiation, and wind speed and directional data.

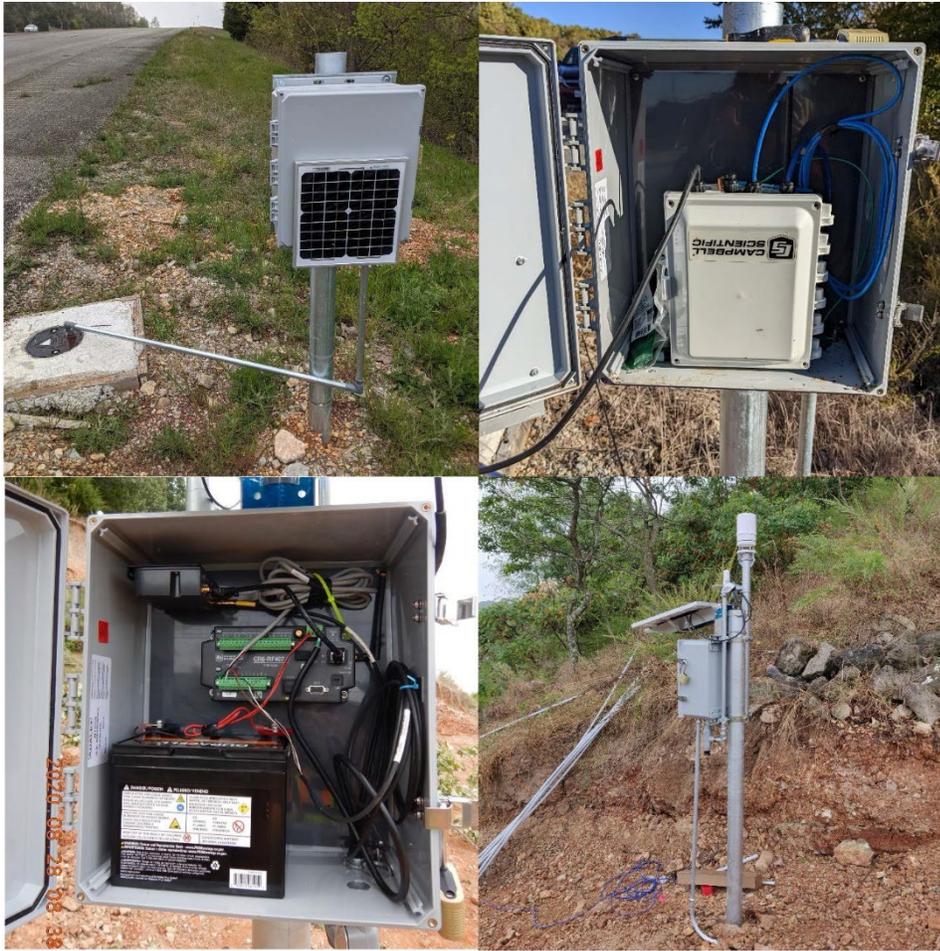
Figure 19: Clockwise from left: weatherproof box and solar panel at LT-3; enclosure with a CRVW3-407 datalogger at LT-3; weather station, solar panel, and weatherproof box at base station; and interior of base station with CR6 logger, peripherals, and rechargeable battery.

Base Station. The base station is built around CSI's CR6 datalogger with a built-in RF407 0.25W 900mHz radio to facilitate site communications. A Sierra Wireless Raven RV50 cellular gateway modem is connected to the CR6 via a short network cable for remote data collection. The modem's cellular connection was provisioned by CSI's subscription service with Verizon cellular service. The vibrating wire piezometers from LT-1 and LT-2 are connected directly to the CR6. The ClimaVUE50 weather station connected to the CR6. The CR6's solar controller manages the 20W 12V solar panel and 50ampHr battery. The modem's power was shut down via programming instructions at night to manage excess power drawdown while the site radio was always powered on. The site never lost power over the monitoring period with these power controls implemented. The code currently managing data collection and processing at the CR6 logger is included as Appendix C.

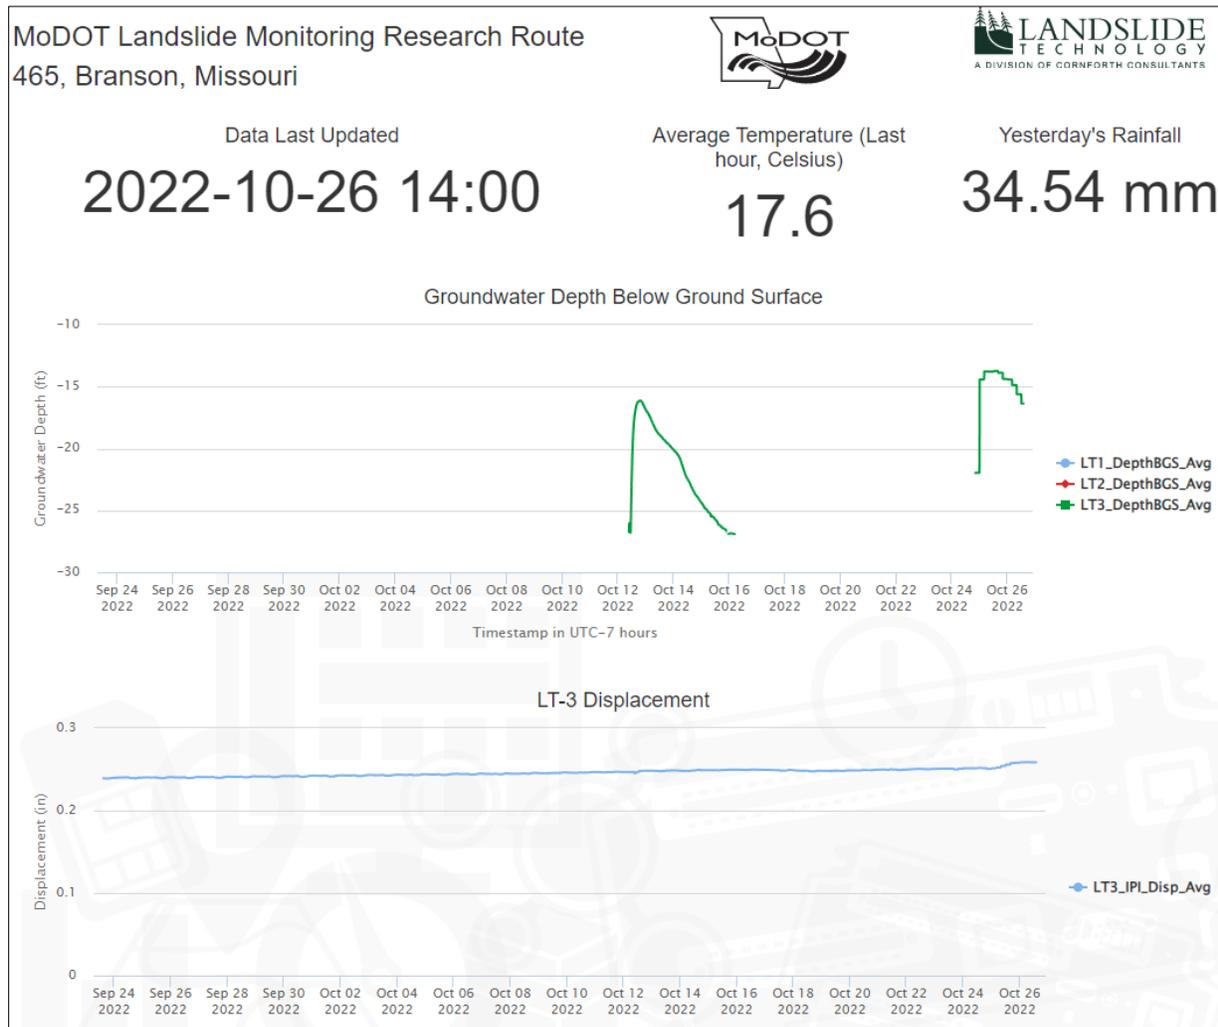
Figure 20: Konect GDS Data Management Website.

SIM card was provided by CSI and installed in the Sierra Wireless RV50 modem installed at the base station. A data management platform and website (Figure 20) was configured to obtain data on a daily basis and present plots of groundwater level and sensor temperatures, IPI displacement, and weather station values. The [website](#) is available at the time of writing, but communications were discontinued remotely October 26, 2022. No new data is being uploaded to the website, although the data loggers are continuing to collect and store data.

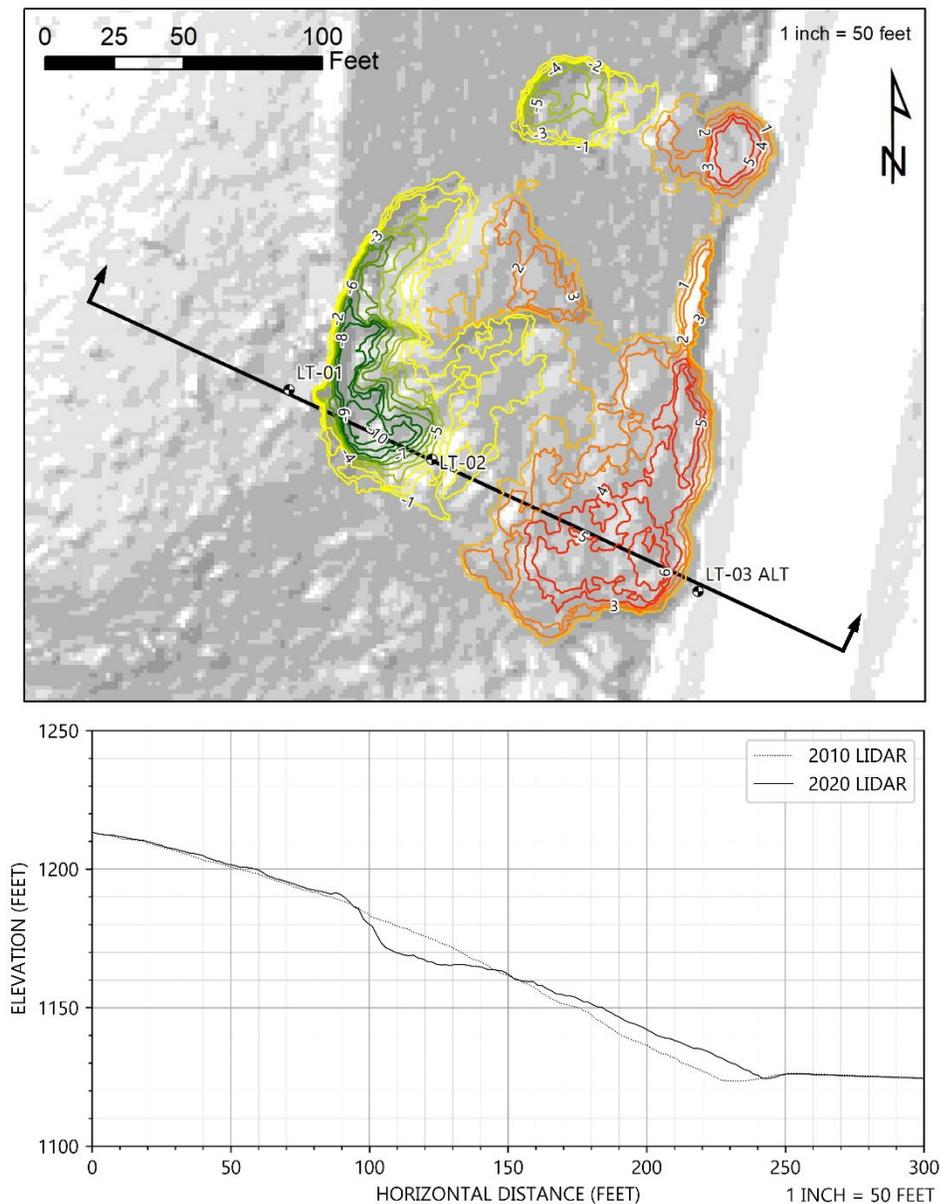
Figure 21: Comparison of 2010 Stone County LiDAR data with this project's initial dataset collected in June 2020. Contour intervals are 1-foot, with green indicating a decrease in surface elevation and red indicating an increase in surface elevation.

The change detection analysis shown in Figure 21, confirmed that Landslide Technology had sited borings LT-1 and LT-2 along the approximate center axis of the most active portion of the landslide. In the 1-foot contour intervals shown in the change detection map, green is areas of material loss at the head of the slides, while red shows areas of material deposition at the slide toes. The limited change in elevation in the main body of the slide, between the landslide head and toe, indicated that the main slide mass in this zone is moving parallel to the cut slope, with displaced material being deposited in the ditch. The cross-section comparison also shows the loss of ditch capacity since 2010, as the toe of the slide has deposited material in the ditch. The cross section also shows how much more fine resolution is available in the 2020 UAV survey, which has a more textured ground surface than the 2010 ground line.
