Landslide Monitoring Methods: Application of Existing Technologies to Long-Term and Real-Time Monitoring of Slope Movements

February 2023
Final Report

Project number TR202016
MoDOT Research Report number cmr 23-002

Landslide Technology

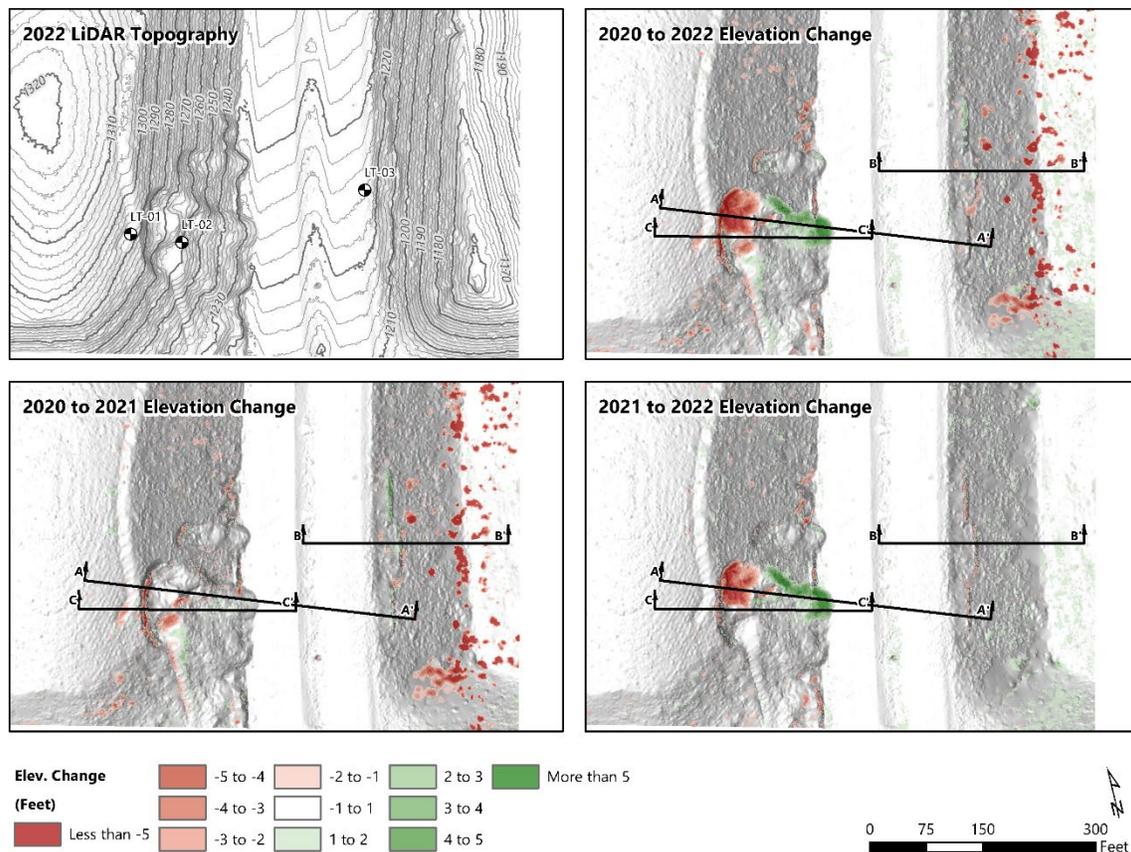
Figure 22: Change detection over the monitoring period using the three high-resolution LiDAR data sets. Red dots visible in the 2020 to 2021 and 2020 to 2022 images are caused by vegetation that was not removed from the 2020 dataset.

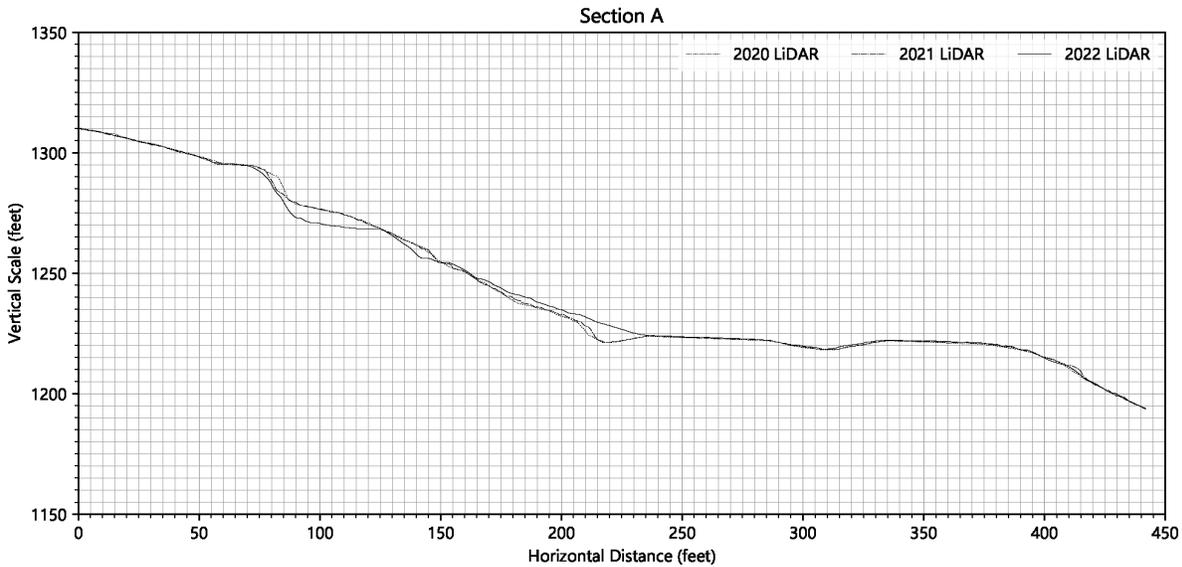
Figure 23: Cross section A-A' showing ground surfaces from 2020, 2021, and 2022 LiDAR surveys. Note encroachment of landslide deposits onto the edge of roadway.

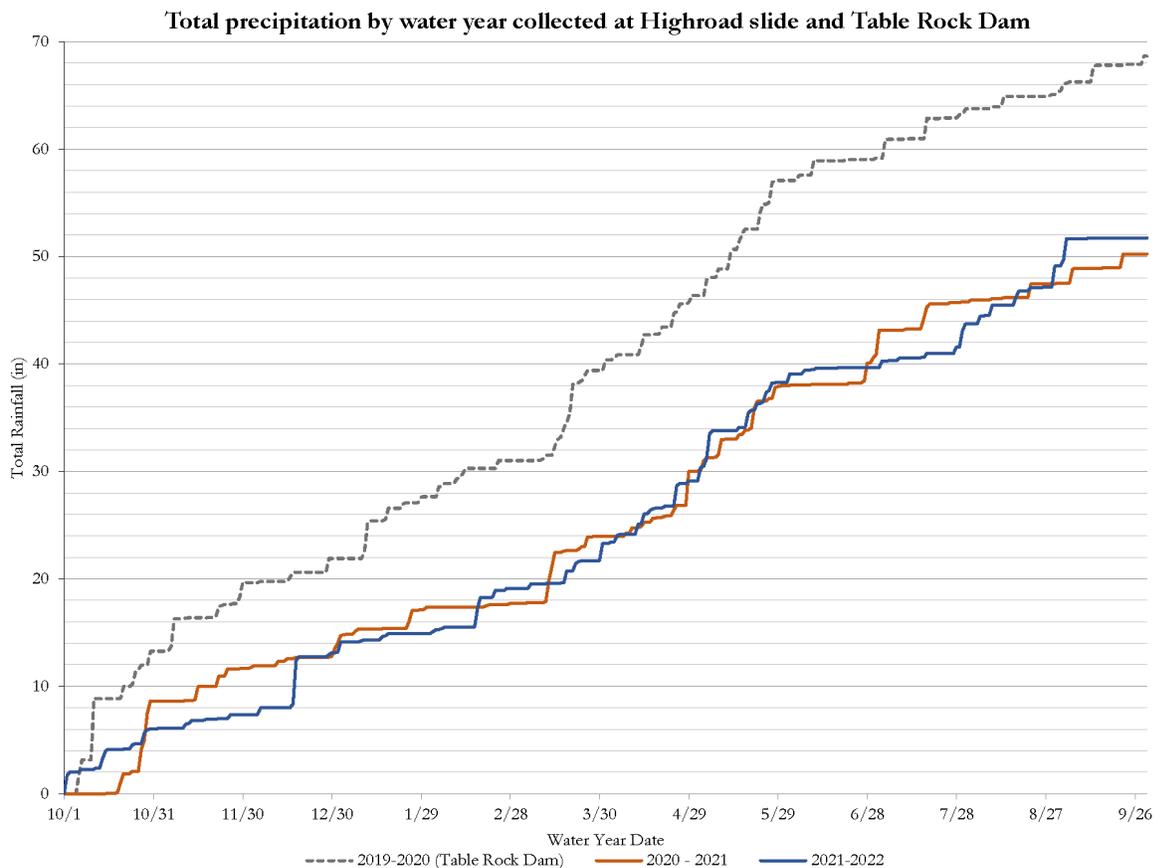
Figure 24: Cumulative precipitation collected in the project area and nearby Table Rock Dam during the study period.

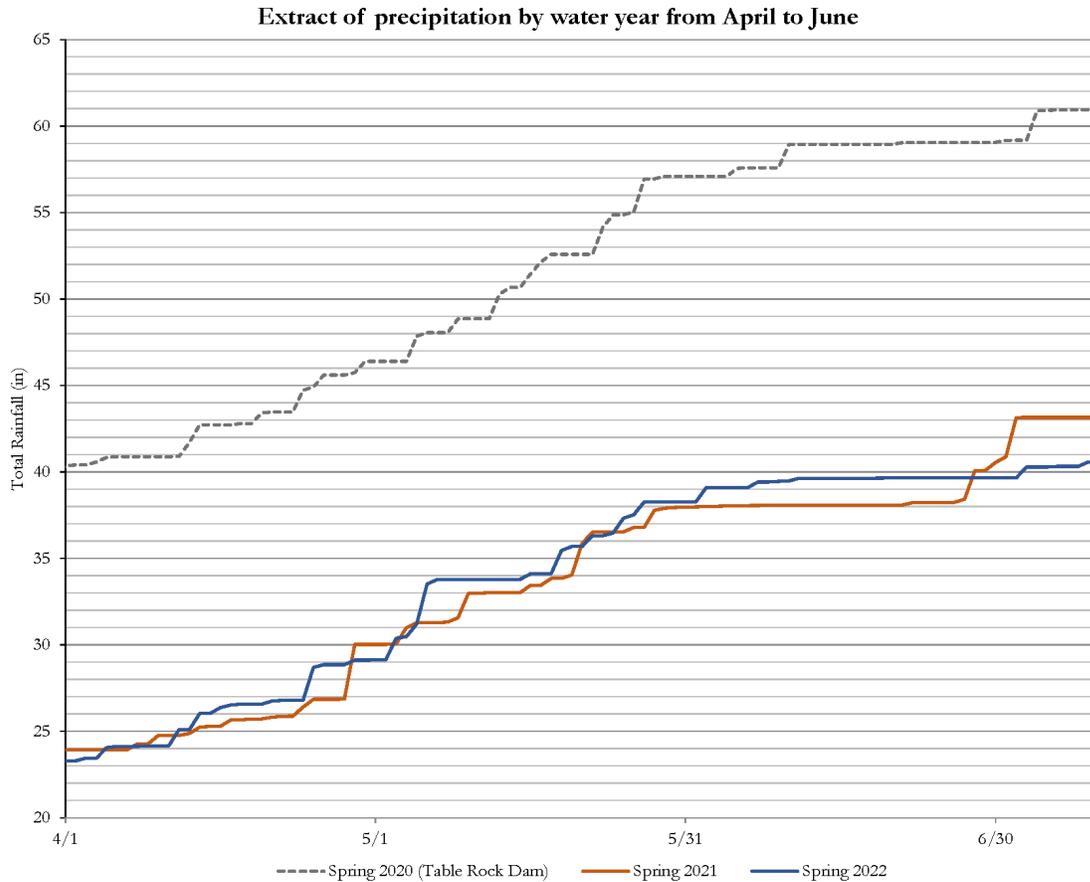
Figure 25: Extract of water year plot comparing April to June precipitation during the study period.

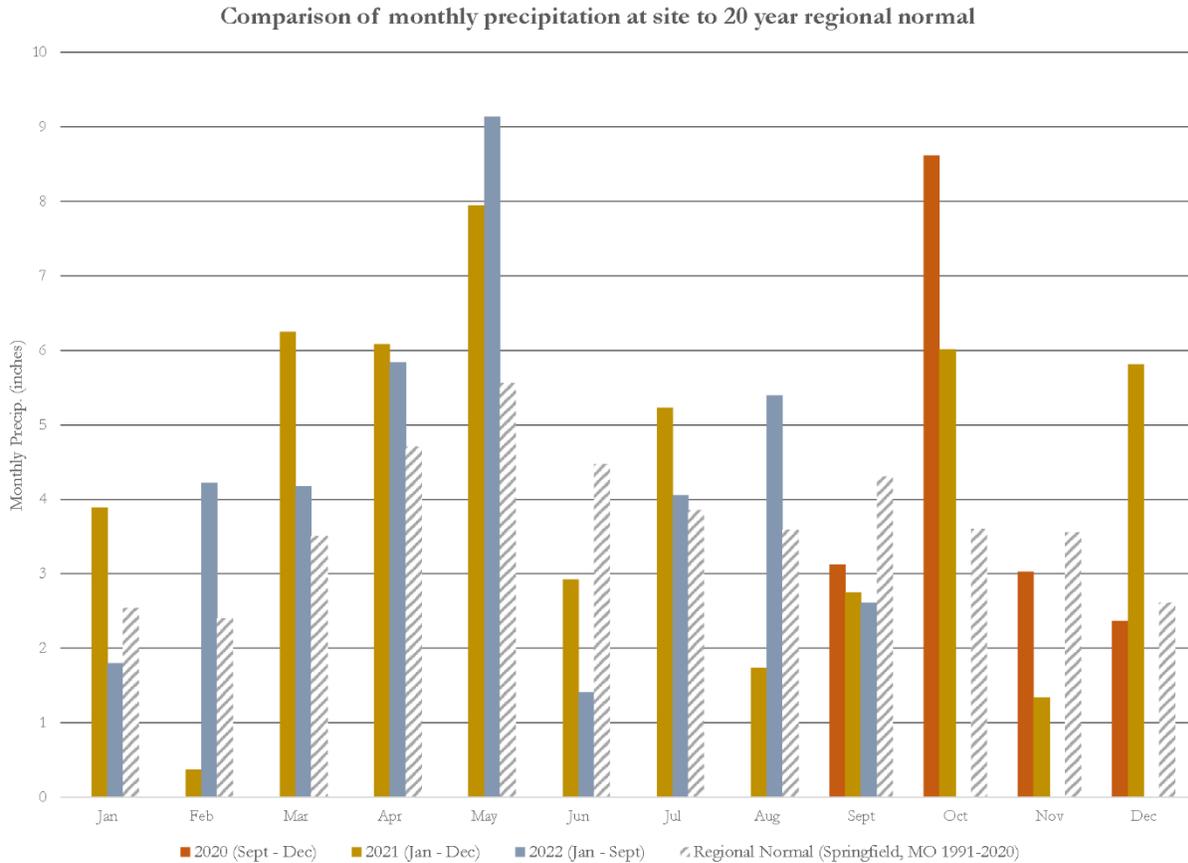
Figure 26: Monthly Precipitation collected at the project site compared to the 20-year normal from the Springfield, MO regional office for the National Weather Service for water years 2020 through 2022.

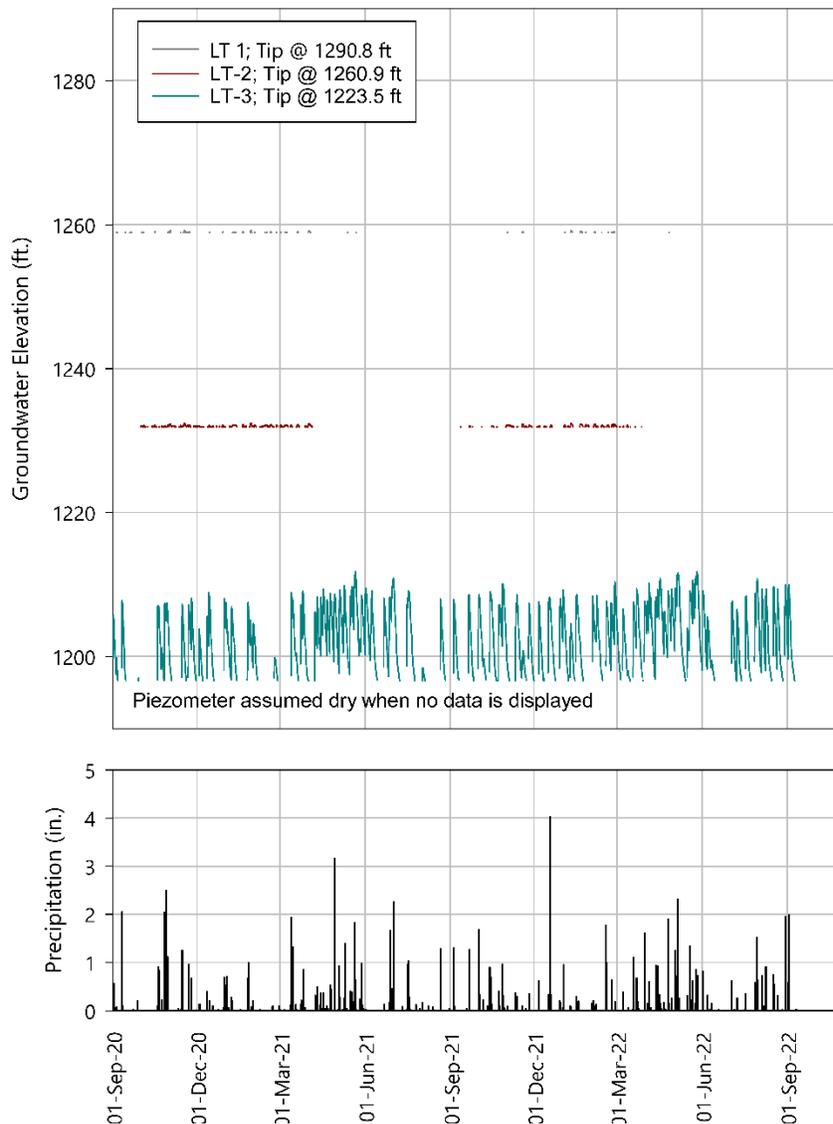
Figure 27: Summary of groundwater data collected at all three vibrating wire piezometers and daily precipitation collected by the weather station over the research project period.

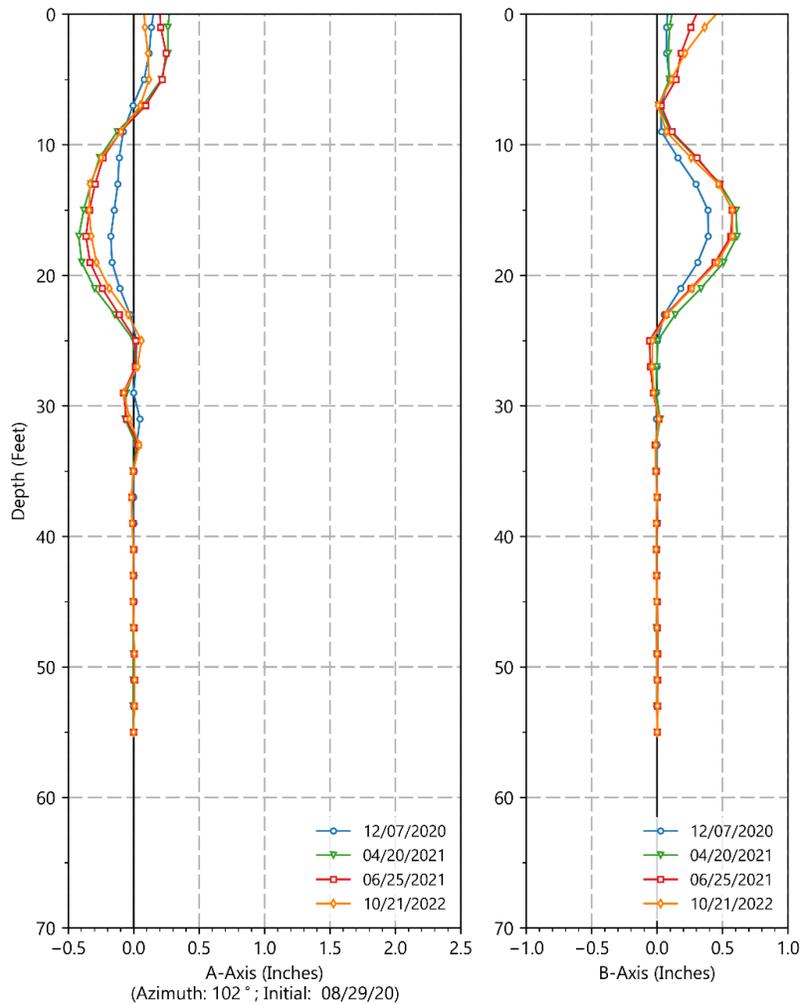
Figure 28: Cumulative displacement plot of LT-1 over the monitoring period, located on the natural slope above the cut.

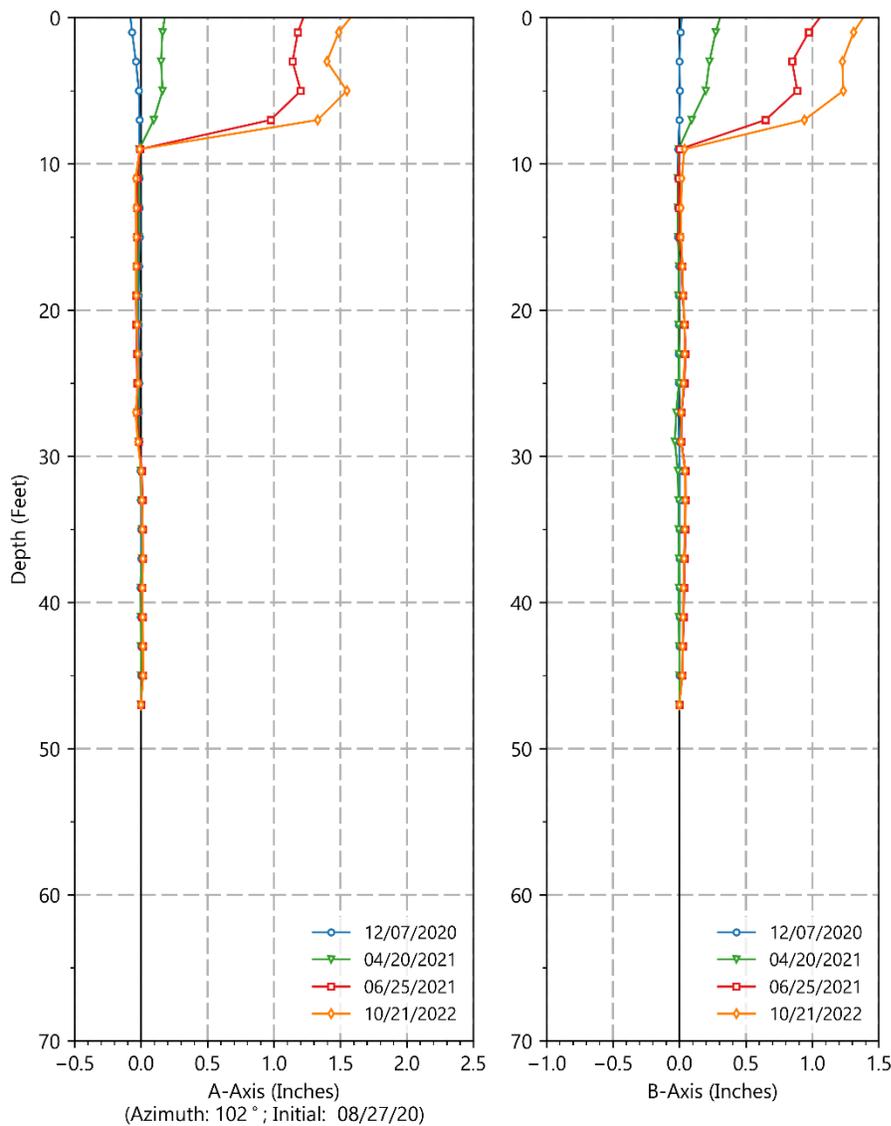
Figure 29: Cumulative displacement plot of LT-2, located in the cut slope instability, over the monitoring period.

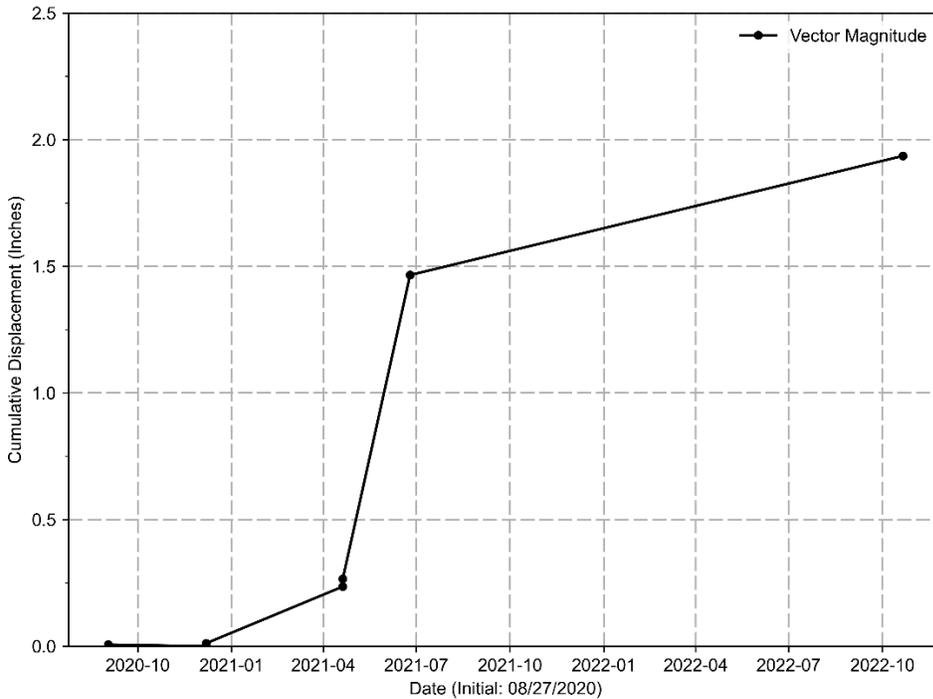
Figure 30: Time Displacement plot of observed displacement between 5 and 9.5 feet below ground surface in LT-2.

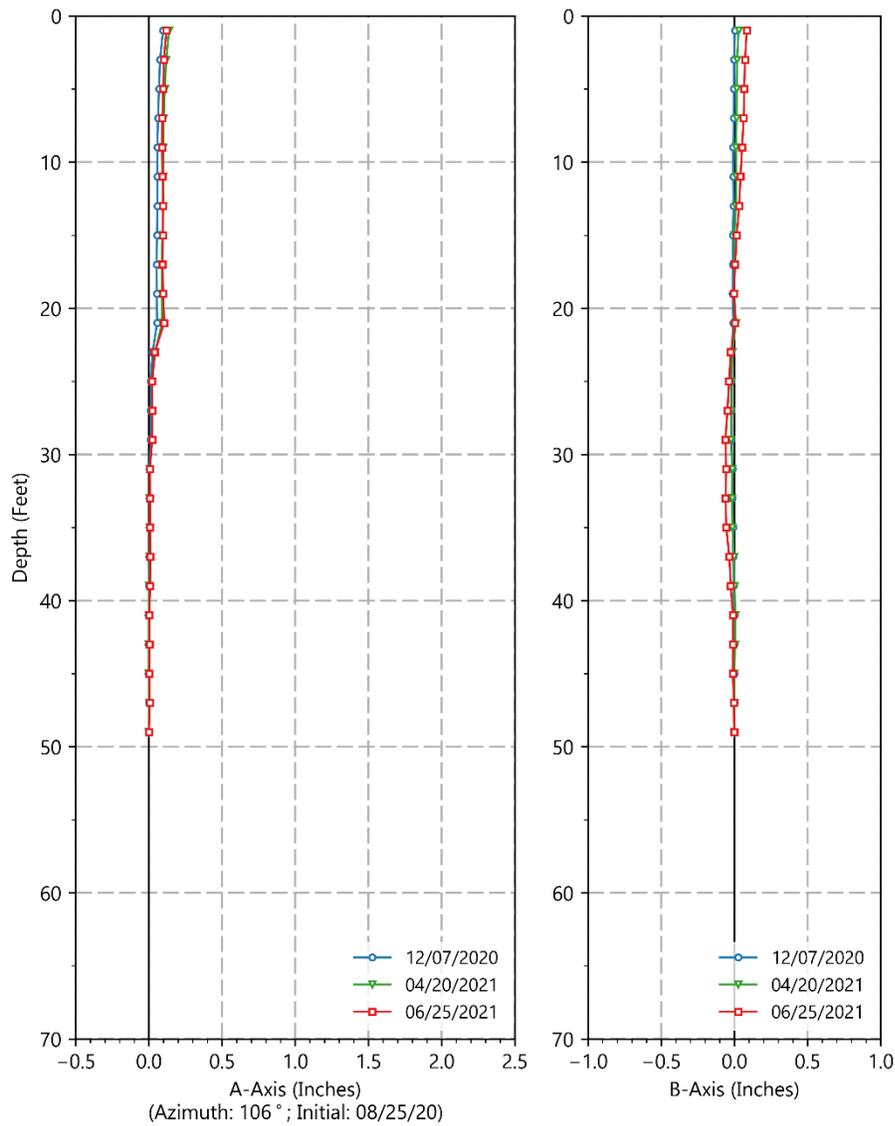
Figure 31: Cumulative displacement plot of LT-3, located in the observed northbound embankment slide, over the monitoring period.

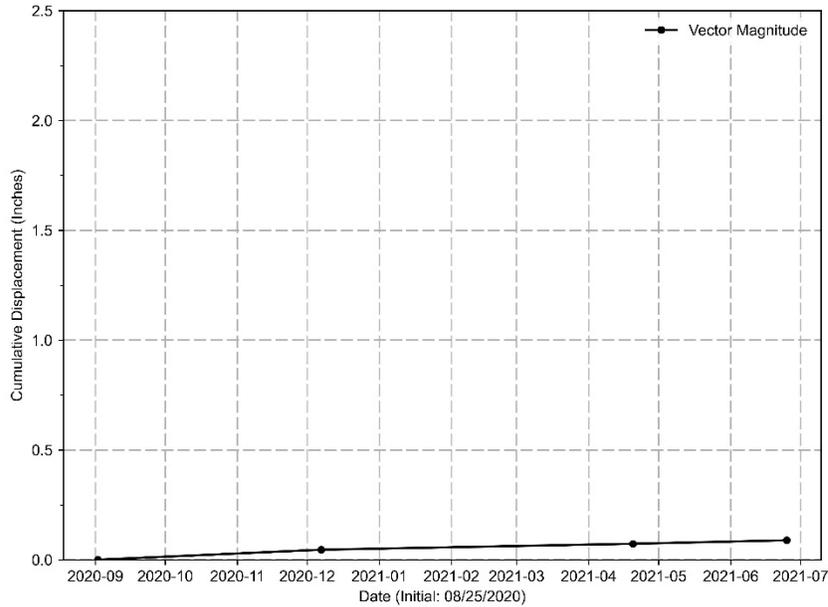
Figure 32: Time displacement plot for the upper shear zone of LT-3 between September 2020 and June 2021, prior to IPI placement.

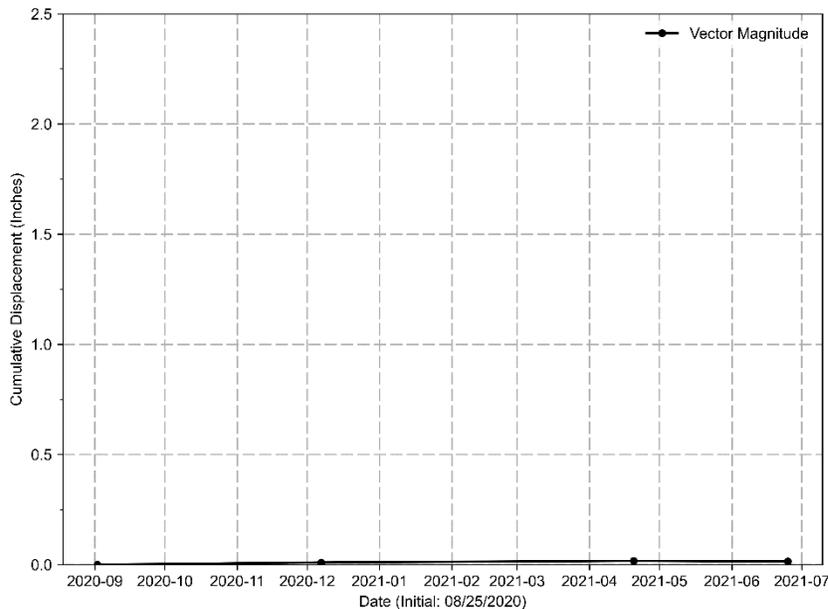
Figure 33: Time displacement plot for the lower shear zone of LT-3 between September 2020 and June 2021, prior to IPI placement.

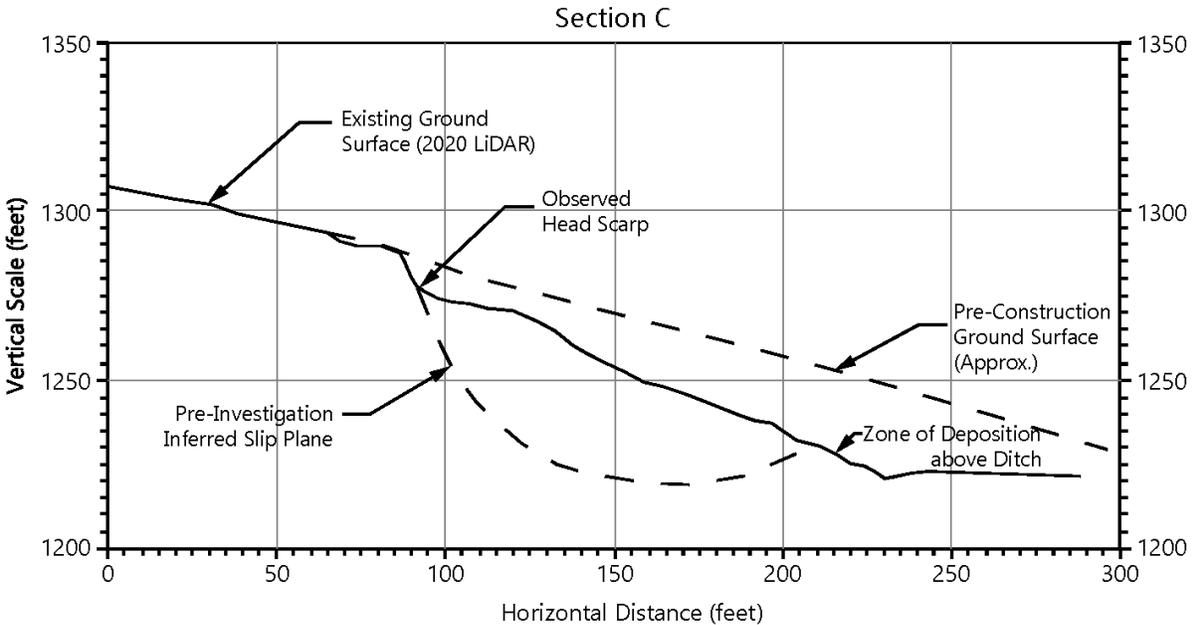
Figure 34: Estimate of slip surface geometry of the cut slope slide prior to subsurface investigation.

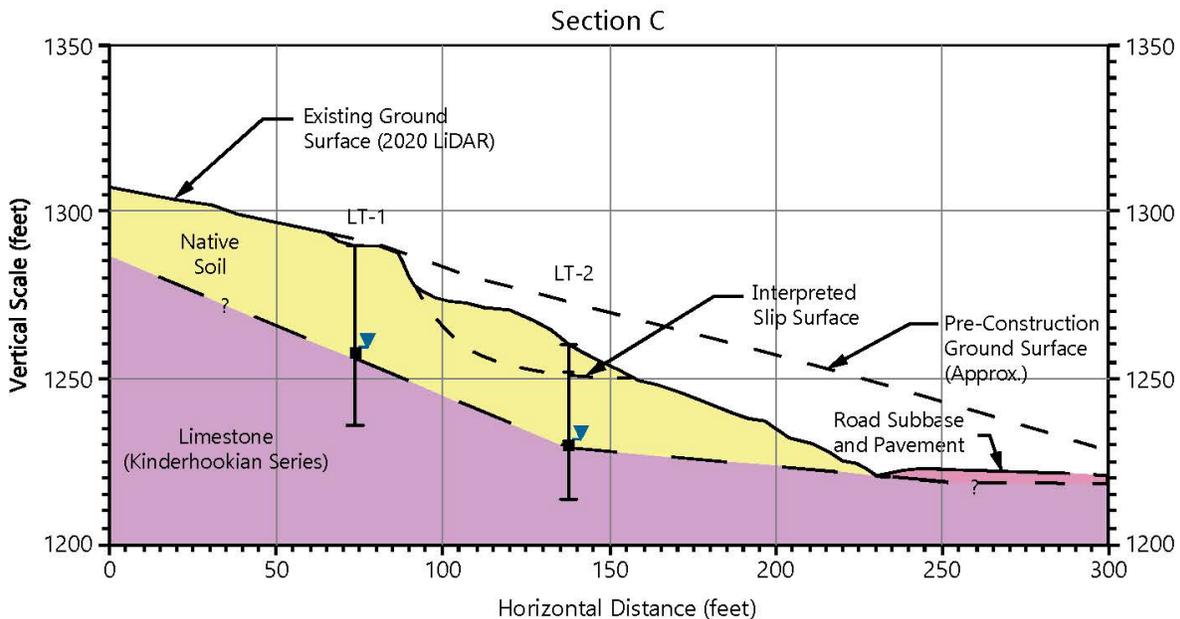
Figure 35: Geologic profile and subsurface geometry of the cut slope landslide based on subsurface samples and long-term monitoring.

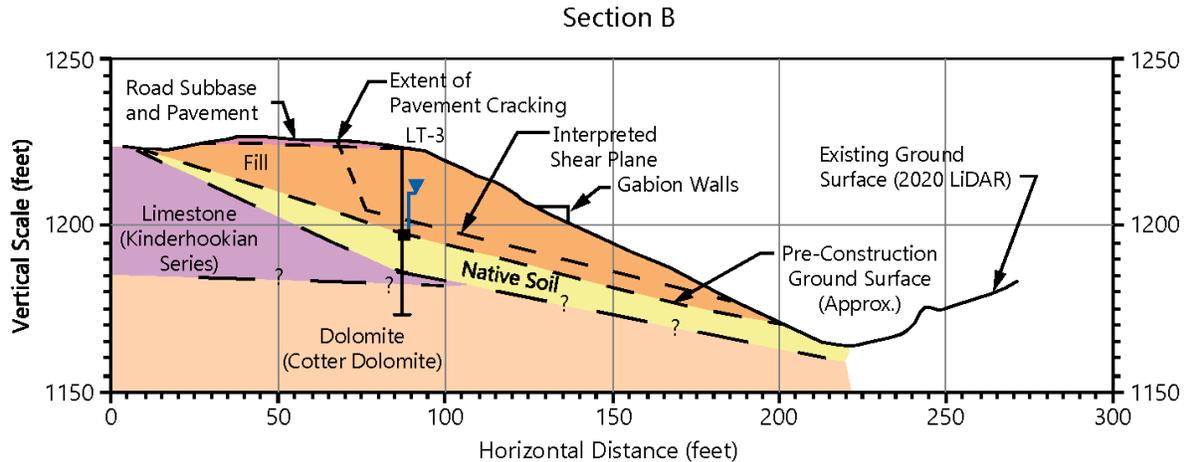
Figure 36: Geologic profile and subsurface geometry of the embankment fill landslide based on subsurface samples and long-term monitoring.

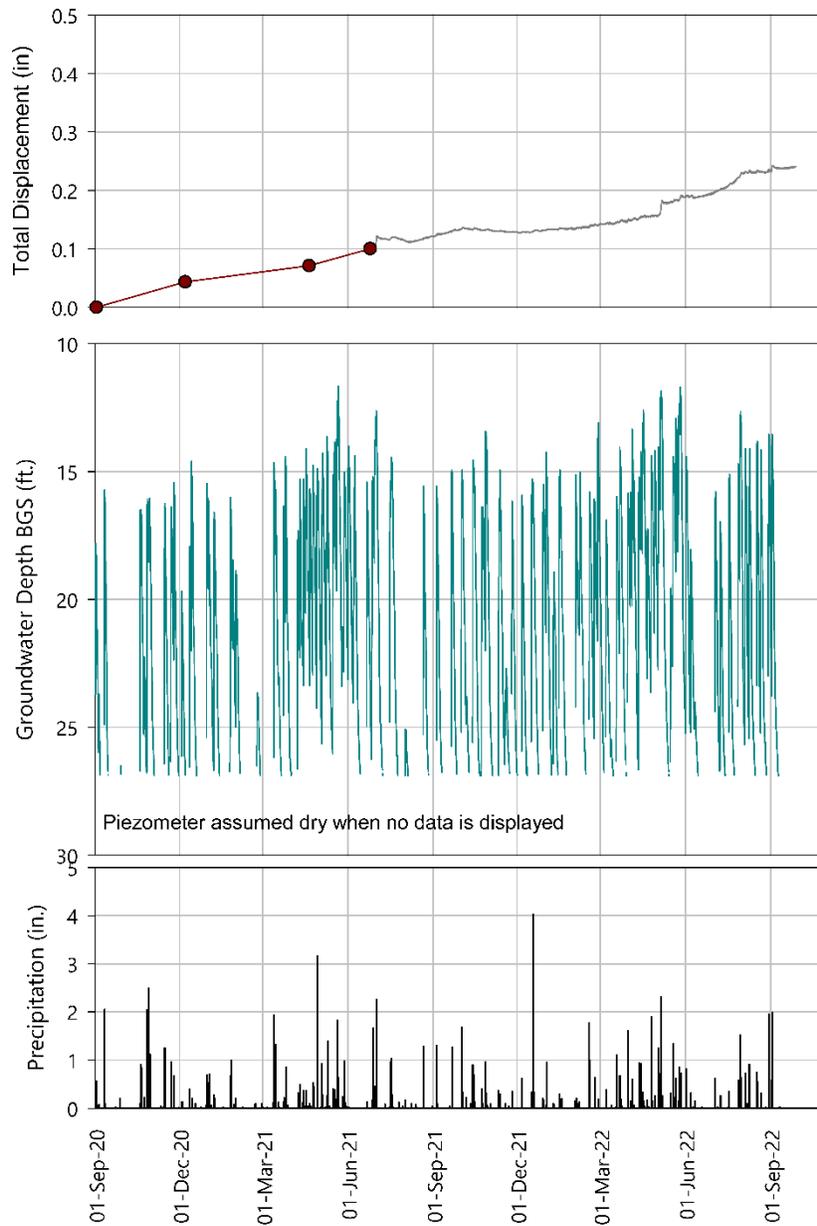
Figure 37: Plot summarizing all data collected at LT-3 - manual deflection measurements, IPI displacement, and groundwater elevation - combined with daily precipitation data collected at the weather station on the cut slope.

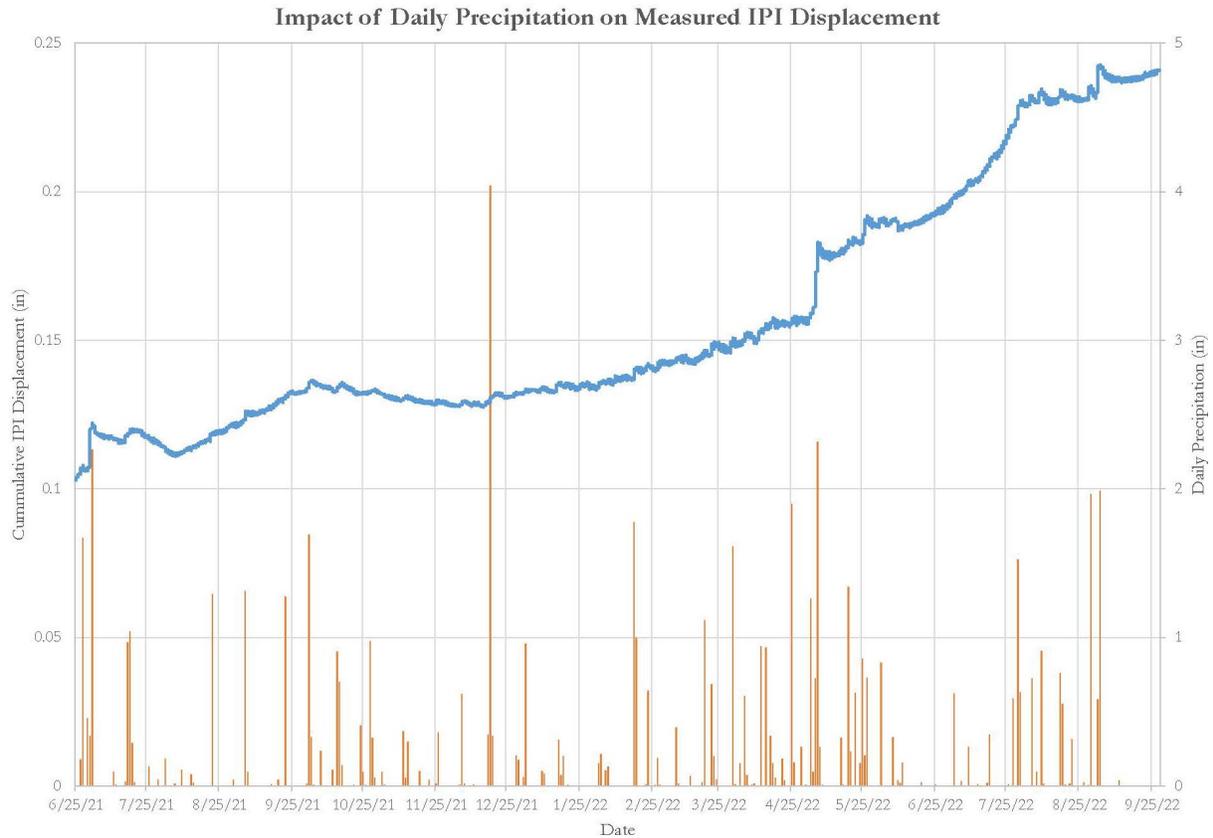
Figure 38: Comparison of IPI displacement and daily precipitation totals.

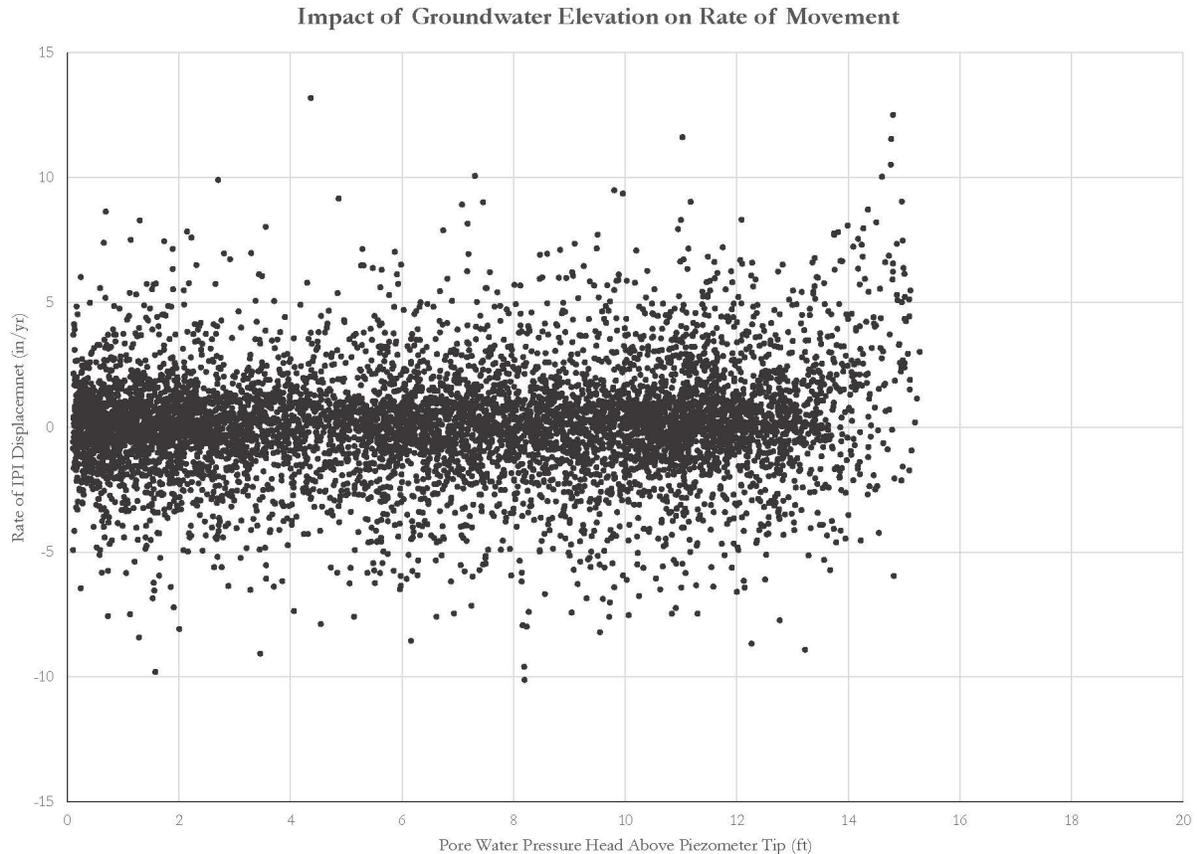
Figure 39: Rate of IPI displacement vs pore water pressure head measured at the piezometer tip.

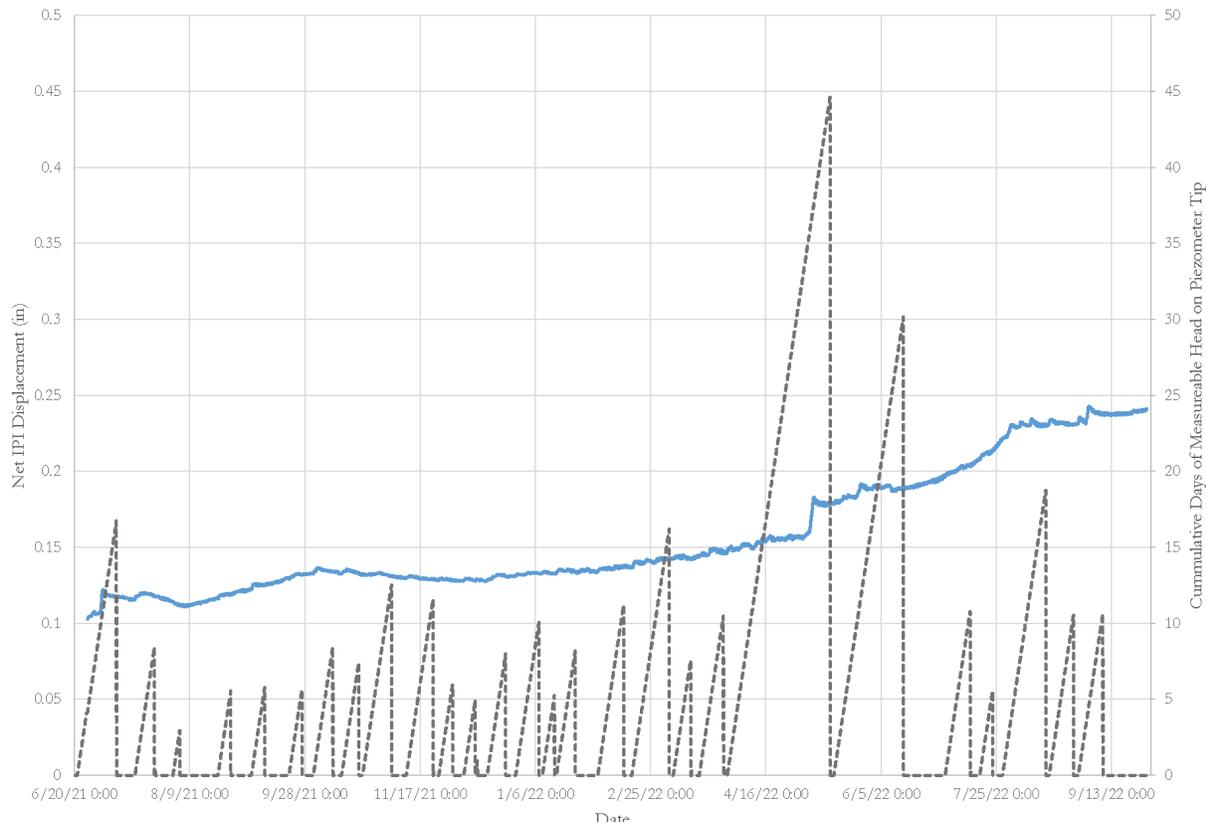
Figure 40: Net IPI displacement and the number of days of measurable groundwater.

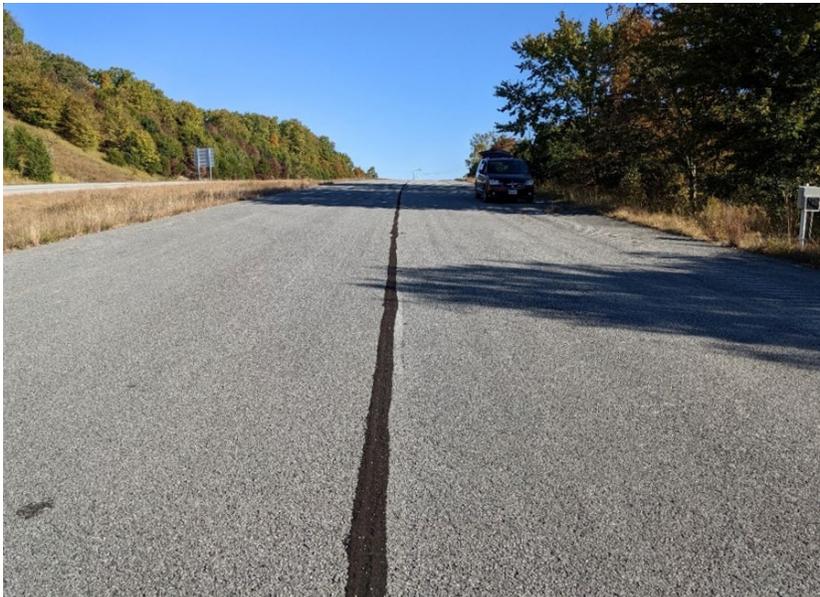
Figure 41: Crack sealing in northbound lane. Photo taken October 2022. LT-3 data logger is visible left of the shoulder.

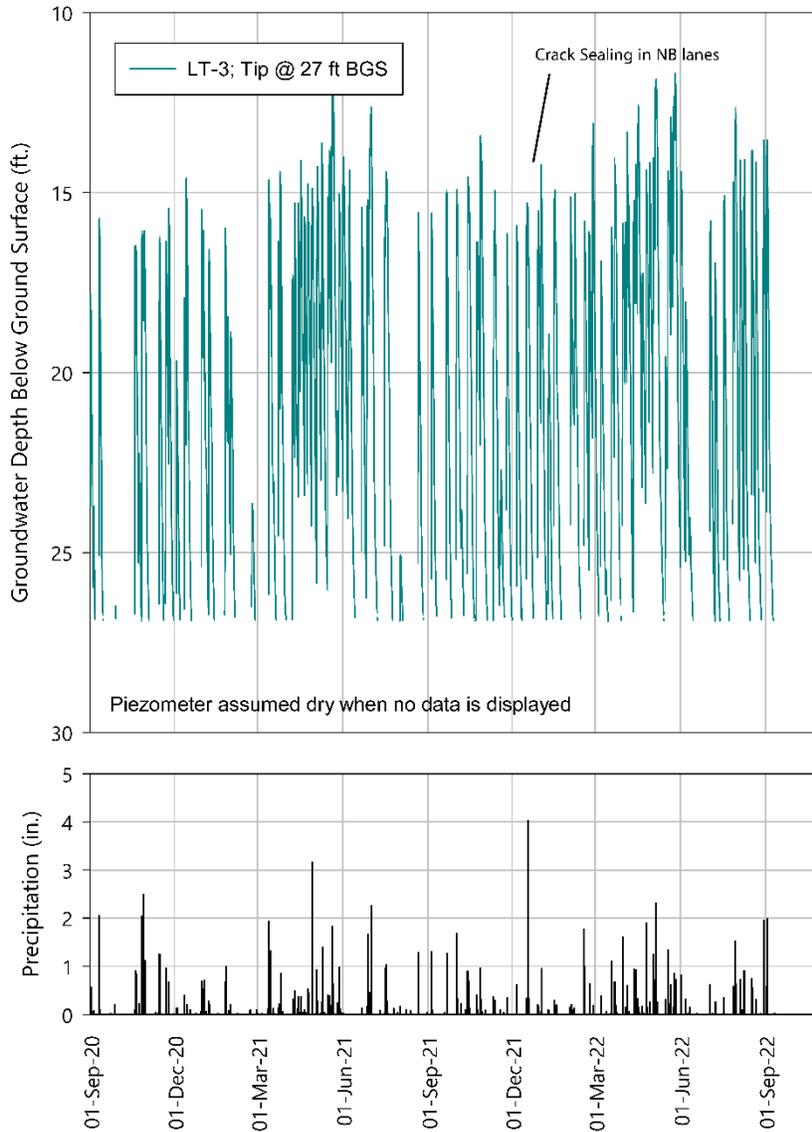
Figure 42: Pair of plots showing patterns of precipitation and groundwater elevation response before and after crack sealing.

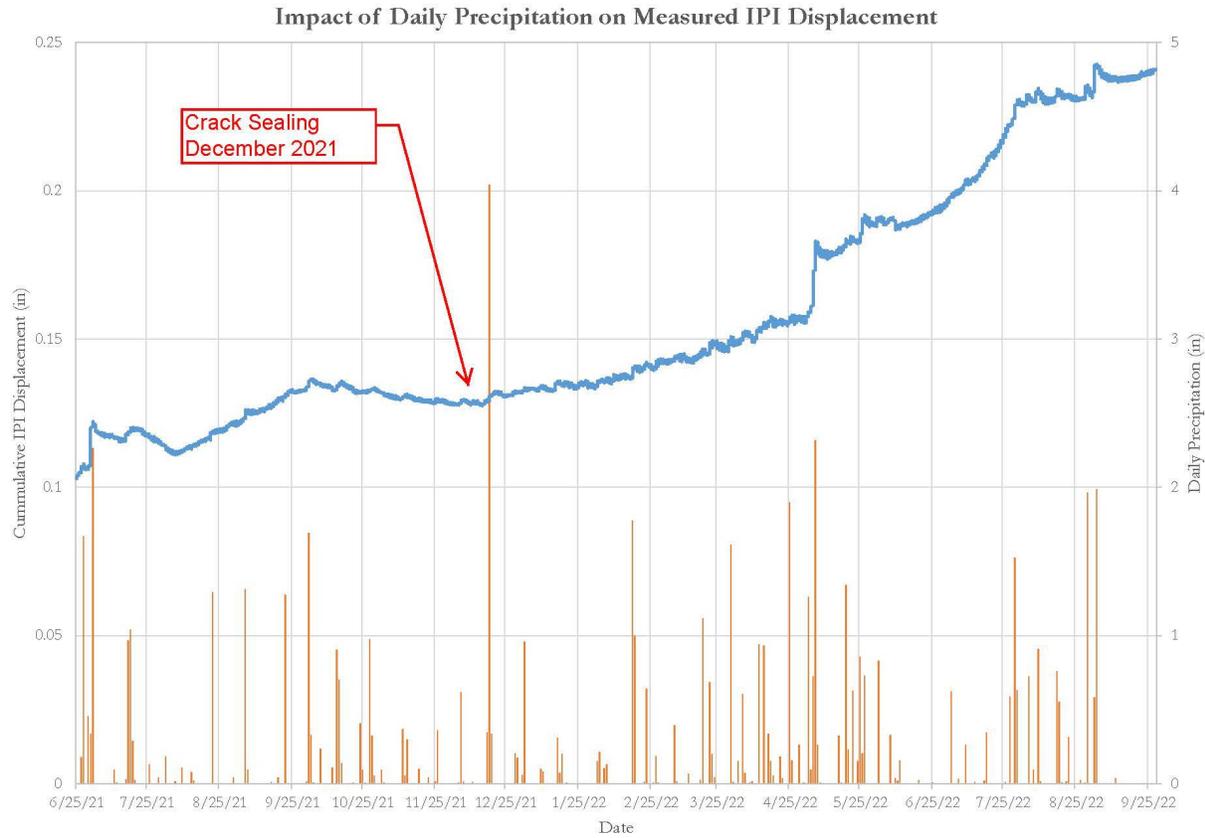
Figure 43: Comparison of precipitation and measured displacement at the LT-3 IPI.

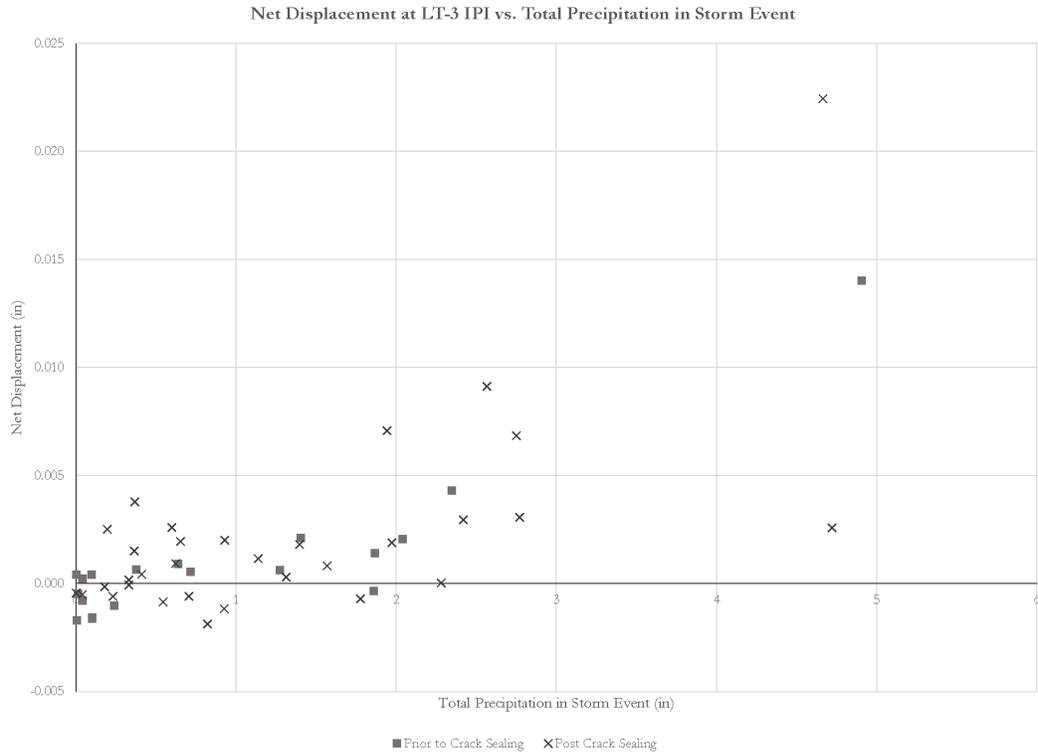
Figure 44: Comparison of measured net displacement and storm event size before and after crack sealing at LT-3.

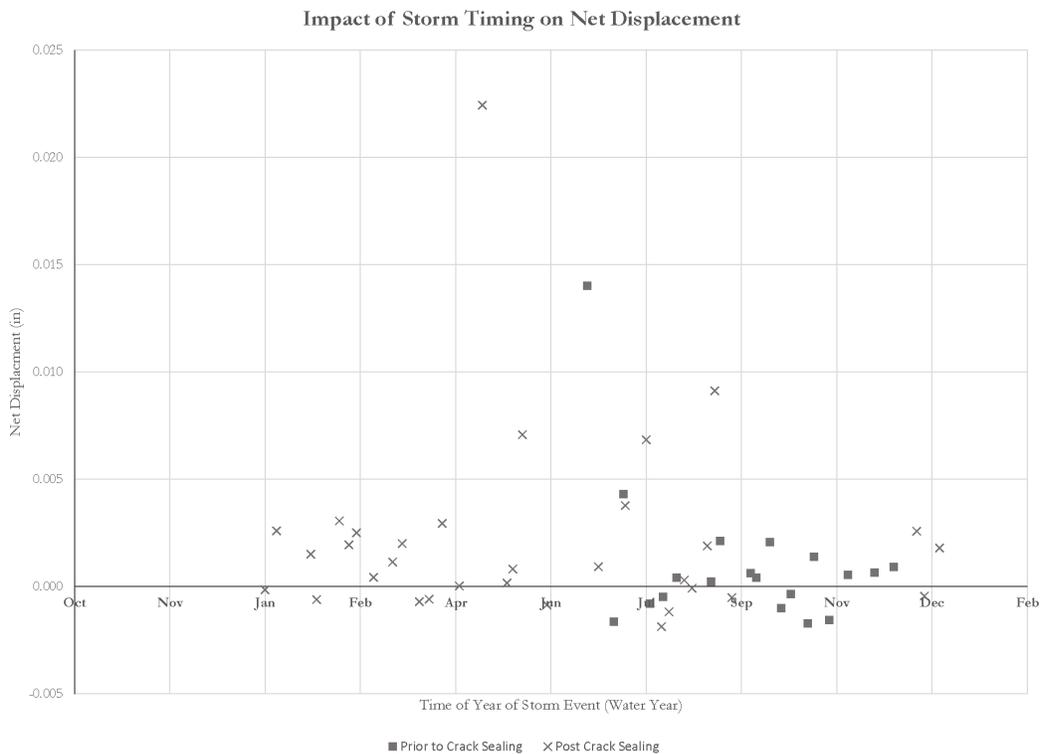
Figure 45: Impact of storm season on measured displacement, with data further sorted before and after crack sealing.
