# Slope Stabilization Using Recycled Plastic Pins Phase III

RI98-007D

by  
J. Erik Loehr, Ph.D.  
Assistant Professor of Civil Engineering  
and  
John J. Bowders, Ph.D., P.E.  
Professor of Civil Engineering

**January 2007**

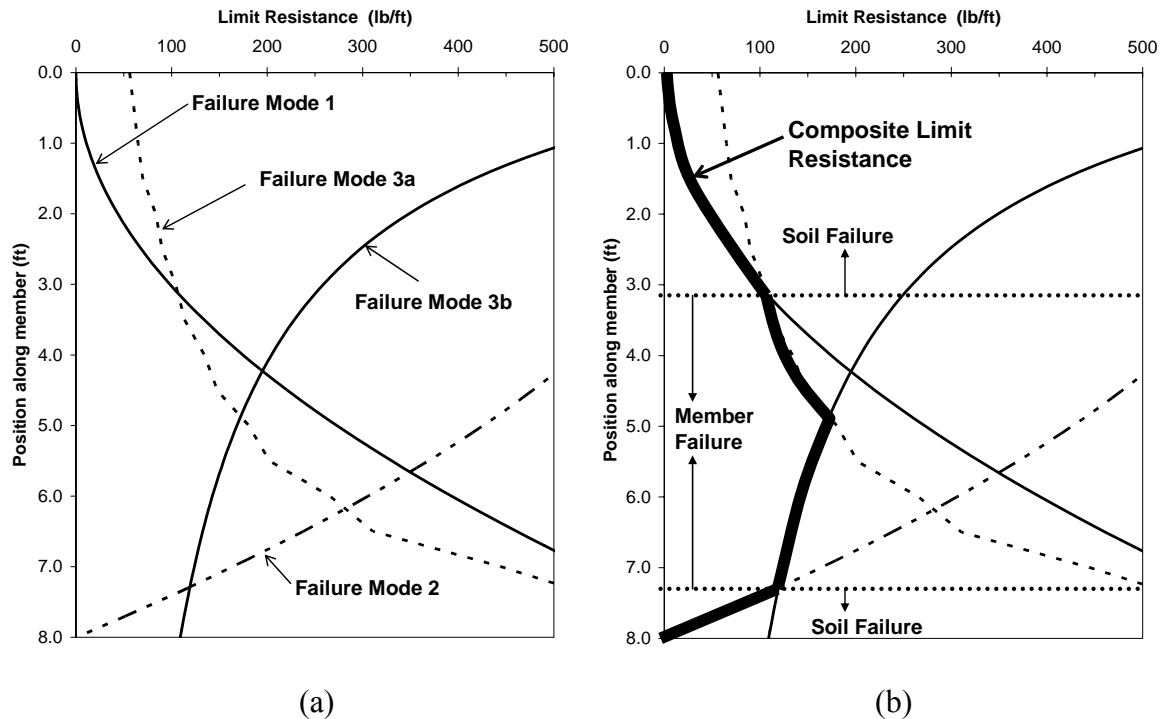
Figure 2.18 Determination of composite limit resistance curve for all failure modes: (a) limit resistance curves for Failure Modes 1, 2, and 3 and (b) Composite limit resistance curve

be established, as shown in Figure 2.18. The controlling failure mode is dependent on the depth of sliding. For sliding surfaces passing through the upper 2- to 3-ft. of the reinforcing member, Failure Mode 1 typically controls. Failure Mode 3 controls for sliding surfaces passing through depths of 3- to 7.5-ft. along the reinforcing member. Below that depth, Failure Mode 2 typically controls. These depths are approximate and vary with the properties of the reinforcing members, the spacing of the members, and the soil properties.

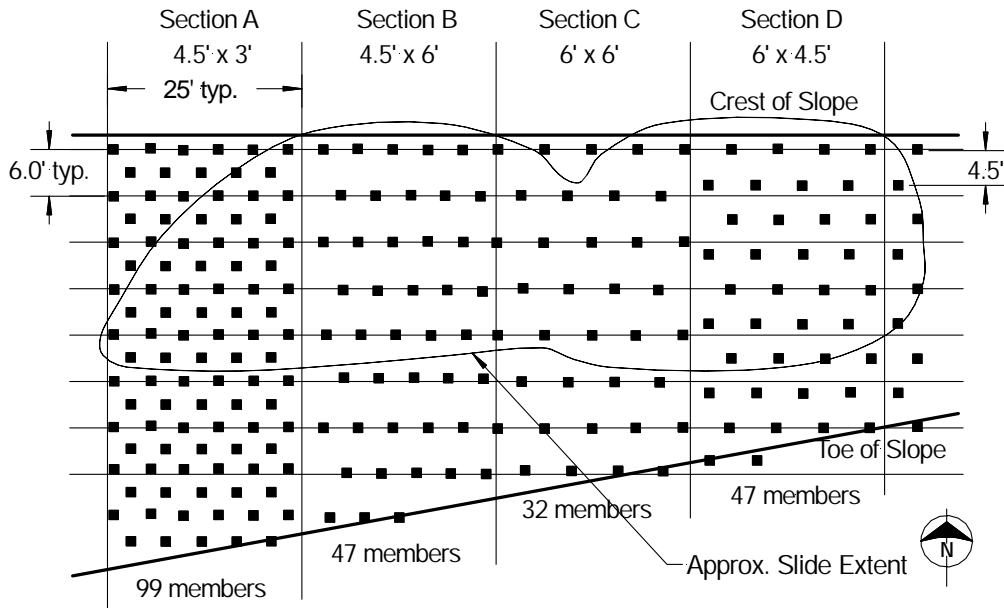
Figure 6.7 Plan view of selected stabilization schemes for slide area S3 at the I70-Emma test site.

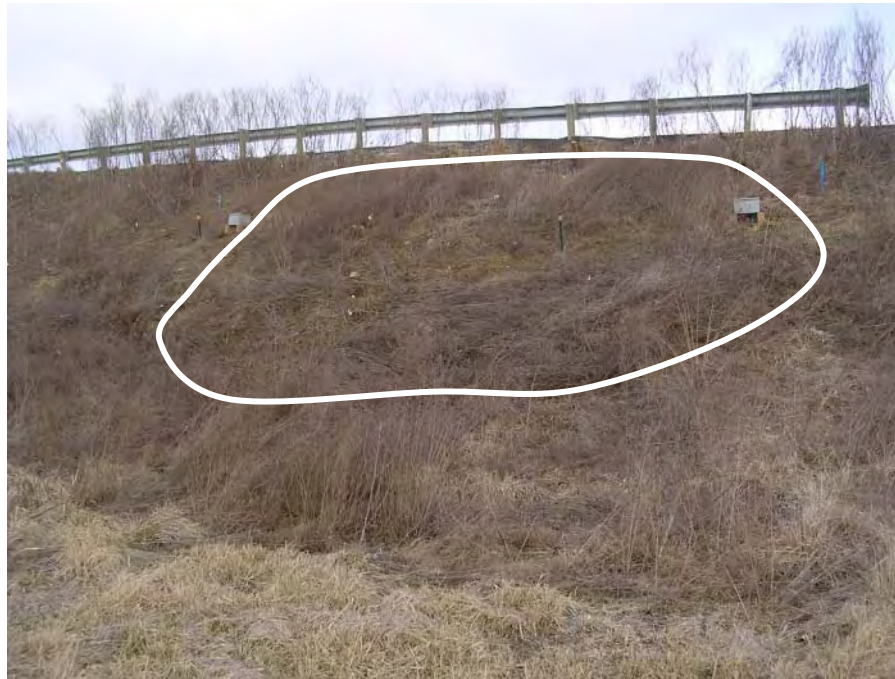
Figure 6.23 Observed failure in slide area S3 at I70-Emma site on January 27, 2005.

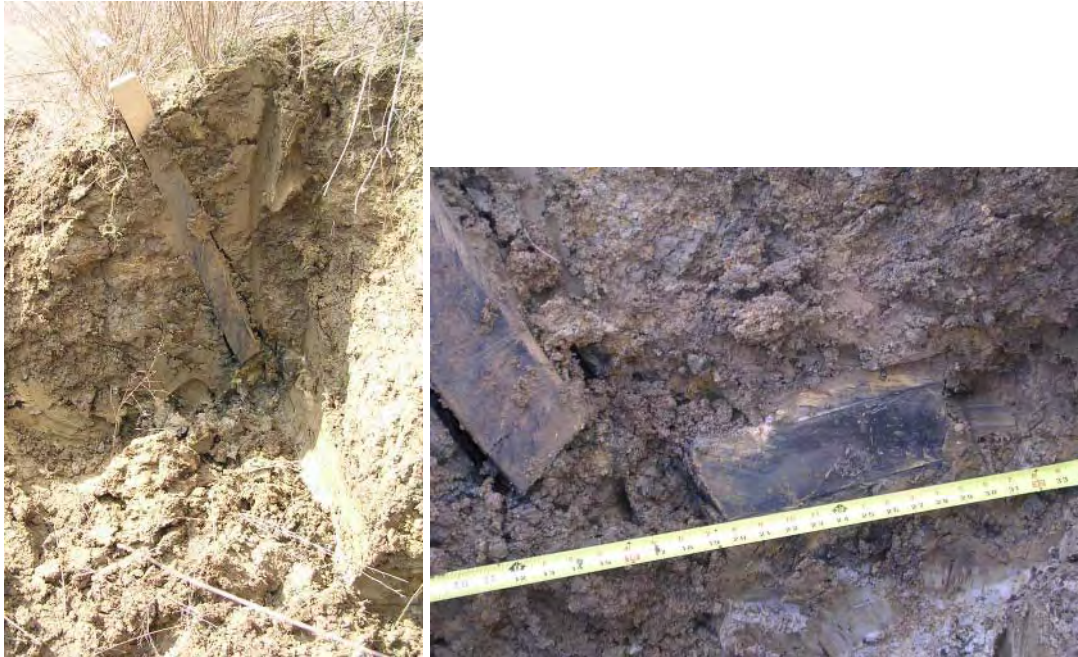
Figure 6.27 Photograph of member M-1 in slope during excavation: (a) entire members and (b) close up of fractured section.

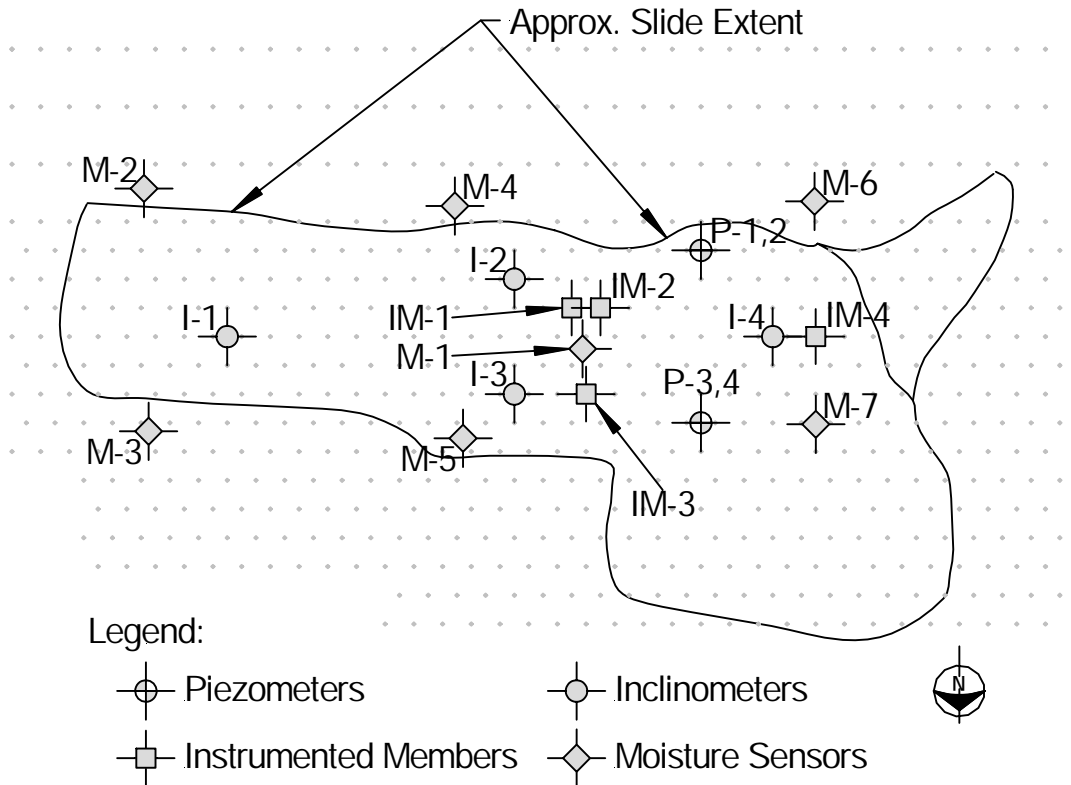
Figure 7.10 Instrumentation layout for I435-Wornall Road site.

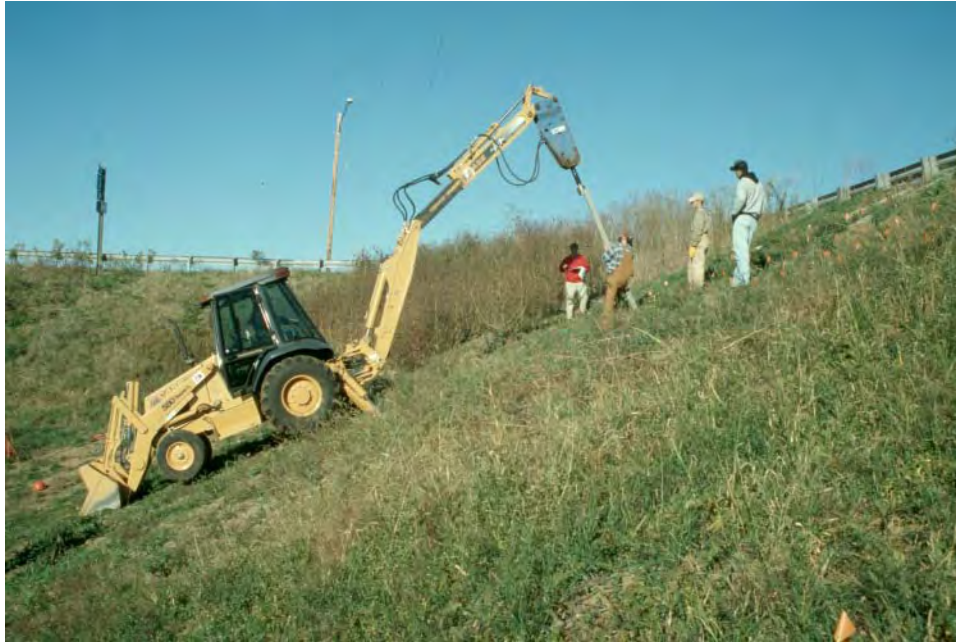
Figure 10.1 Backhoe mounted hammer used for initial installation attempts at the I70-Emma test site during Phase I.

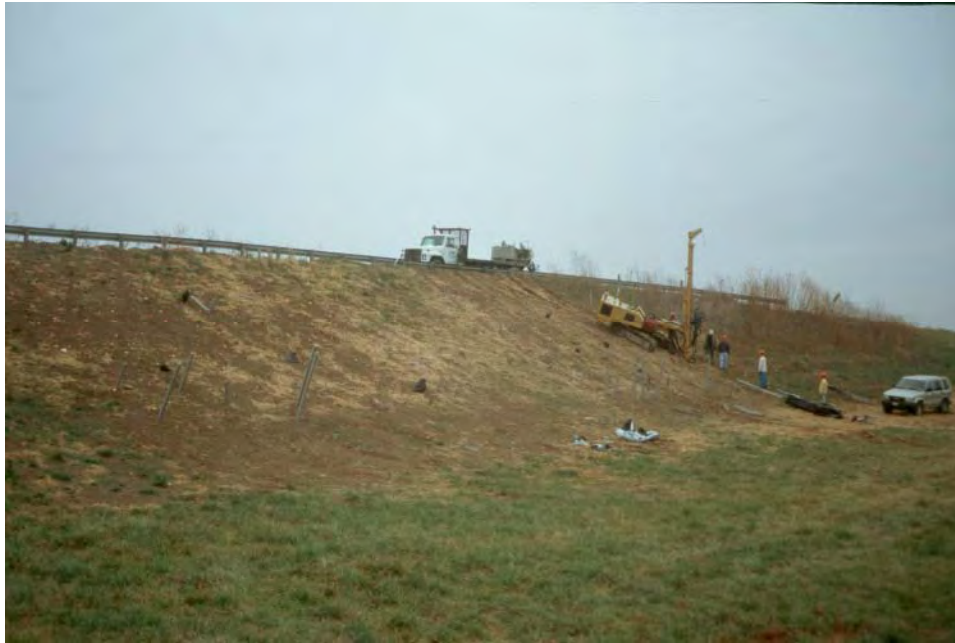
Figure 10.3 Photograph of I70-Emma test set near the end of installation activities for slide areas S1 and S2.
