Preservation of Missouri Transportation Infrastructures: Validation of FRP Composite Technology

Volume 1 of 5

In-Situ Load Testing of Bridges

P-962, T-530, X-495, X-596 and Y-298

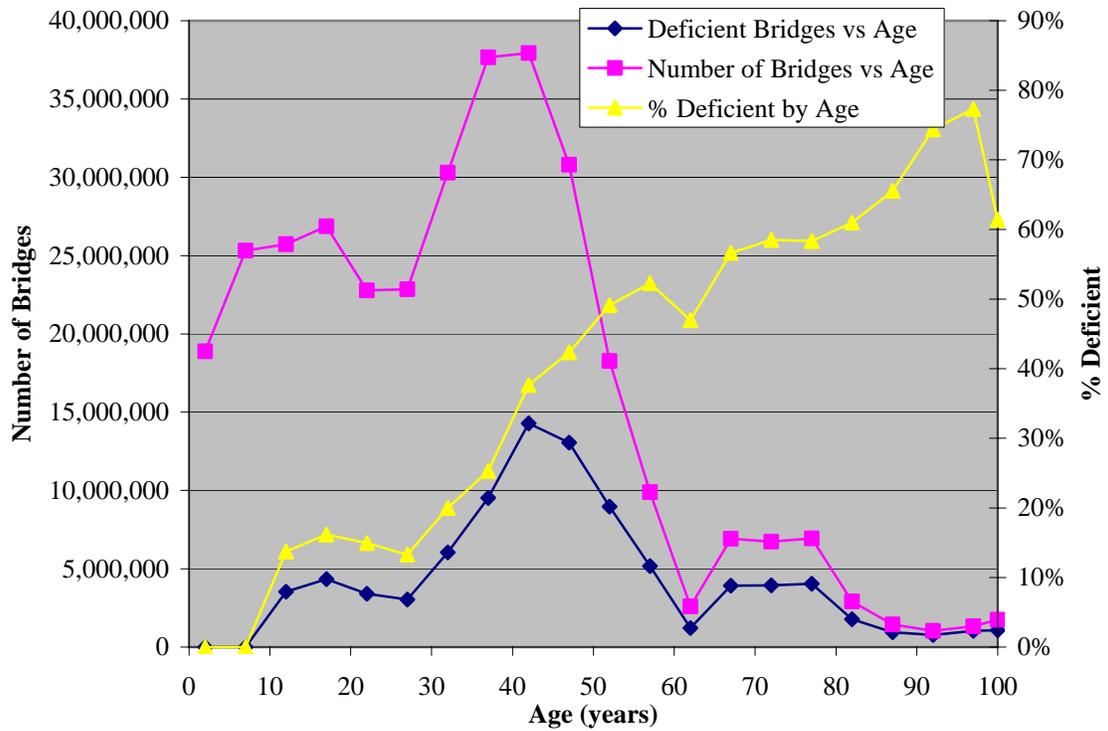
Figure 1.1. 2007 Age and Deficiency of USA Bridges (National Bridge Inventory, 2007)

The number of deficient bridges appears to be on the rise, creating concern for future years. Figure 1.1 shows the number of bridges of certain ages and the number of deficient bridges associated with each age. Additionally, the percentage of deficient bridges at each age level has been plotted. According to the trend of Figure 1.1 (National Bridge Inventory 2007) as the bridges built under the Federal Highway Act of 1956 become older, the number of deficient bridges will dramatically increase.

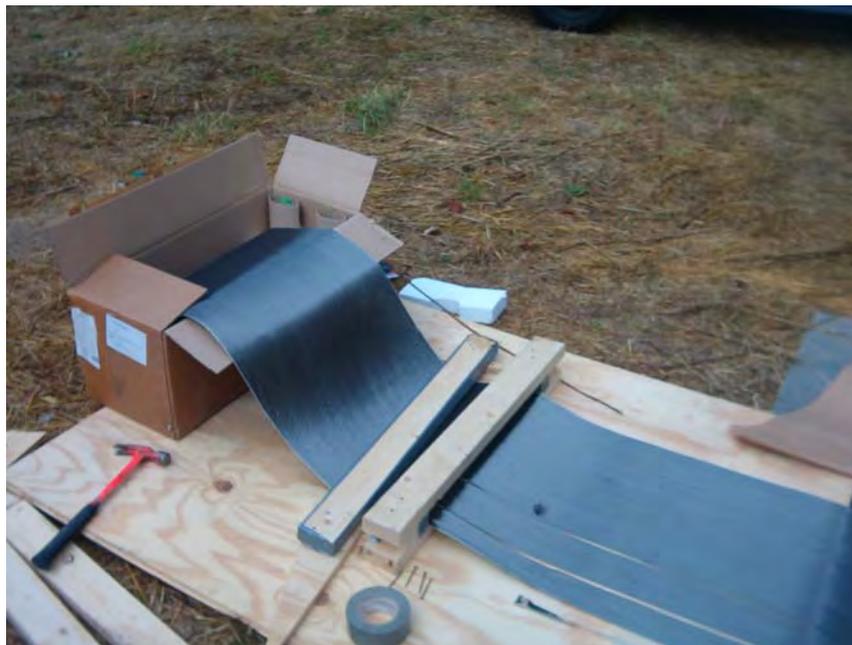
Manual FRP lay-up is the process of adhering rolled sheets (see Figure 2.1) of FRP to concrete with two-part resin. The types of FRP include Glass (GFRP), Aramid (AFRP) and, the most common for structural applications, Carbon (CFRP). To ensure a good bond the existing concrete surface must be roughened with sandblasting and then smoothed and leveled with putty. Corners must be rounded in the case of shear strengthening with U-wraps to prevent localized stresses in the FRP (ACI Committee 440).

Figure 2.1. Sheets of FRP for Manual Lay-Up

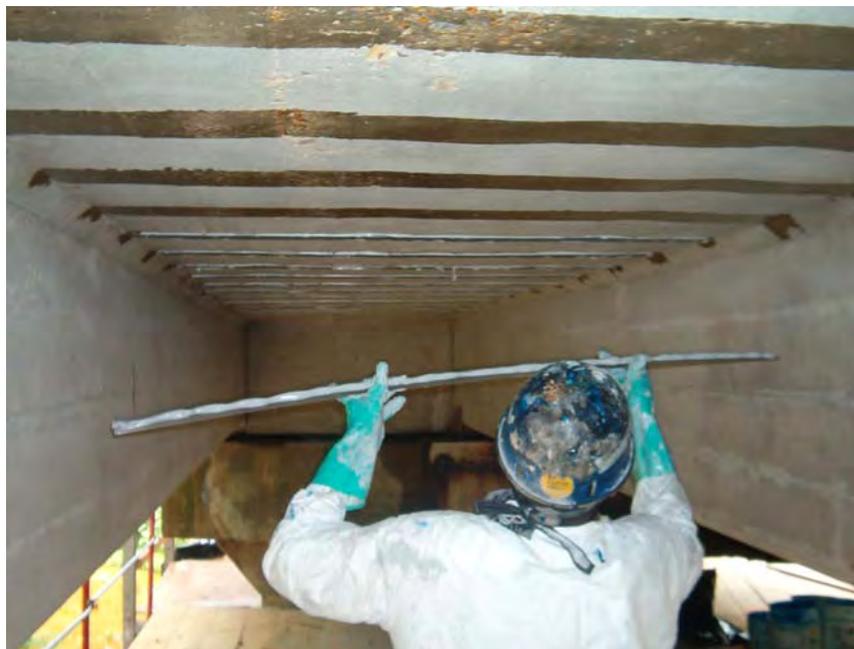
Pre-cured laminates are plates of the resin and fiber matrix that have been cured prior to application. These plates are applied to the prepared concrete surface with a two-part epoxy similarly to the FRP sheets, as illustrated in Figure 2.2. However, pre-cured laminates need to be properly supported to a soffit during installation to ensure there is a solid bond.

Figure 2.2. Pre-cured Laminate FRP Installation

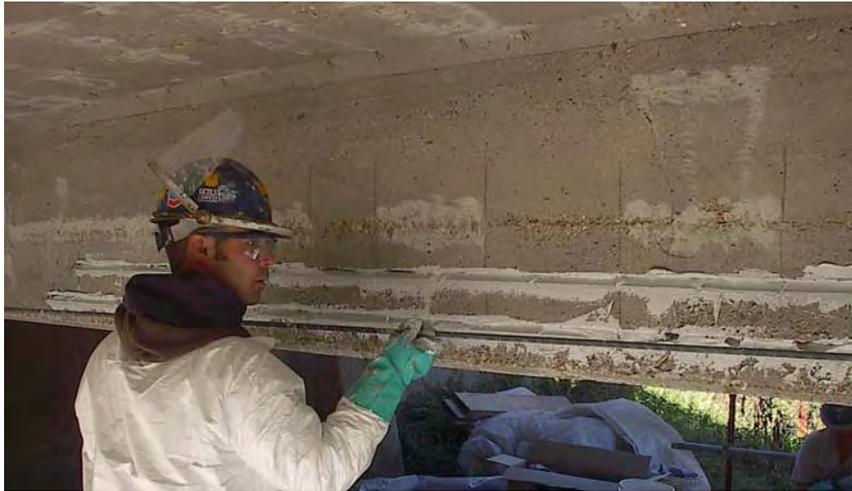
Near surface mounted (NSM) bars are rectangular or circular bars applied by cutting grooves into the existing concrete surface where an increase in moment capacity is required. The grooves are filled with epoxy and the bars are pushed into the grooves, causing excess epoxy to seep out. Additional epoxy is then applied over the bars where needed and the surface is finished. See Figure 2.3 for a picture of the installation of NSM bars.

Figure 2.3. NSM Bar Installation

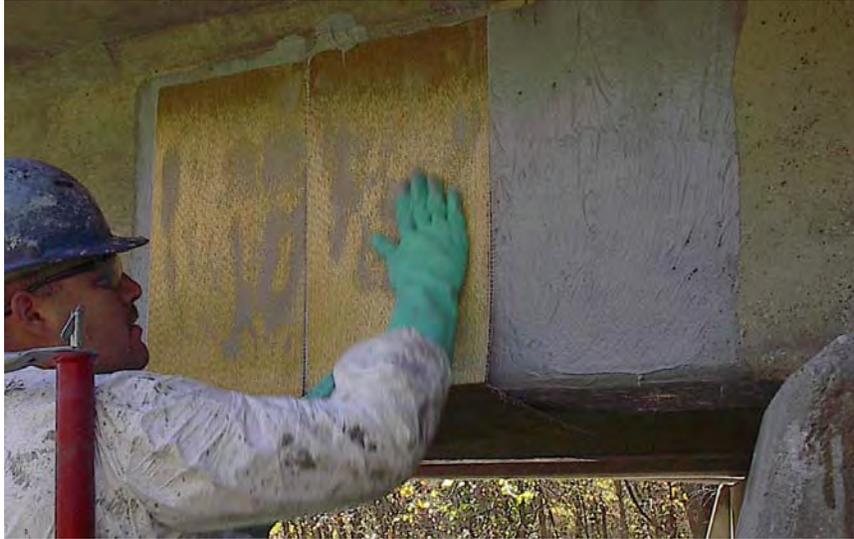
Steel reinforced polymer (SRP) is very similar to FRP; the primary difference being that SRP contains high strength steel wires instead of carbon, glass or aramid fibers. SRP is applied in the same way as FRP sheets; it is impregnated with resin and applied to the prepared concrete surface. See Figure 2.4 depicts the installation of SRP shear strengthening on Bridge P-962.

Figure 2.4. SRP Installation Bridge P-962

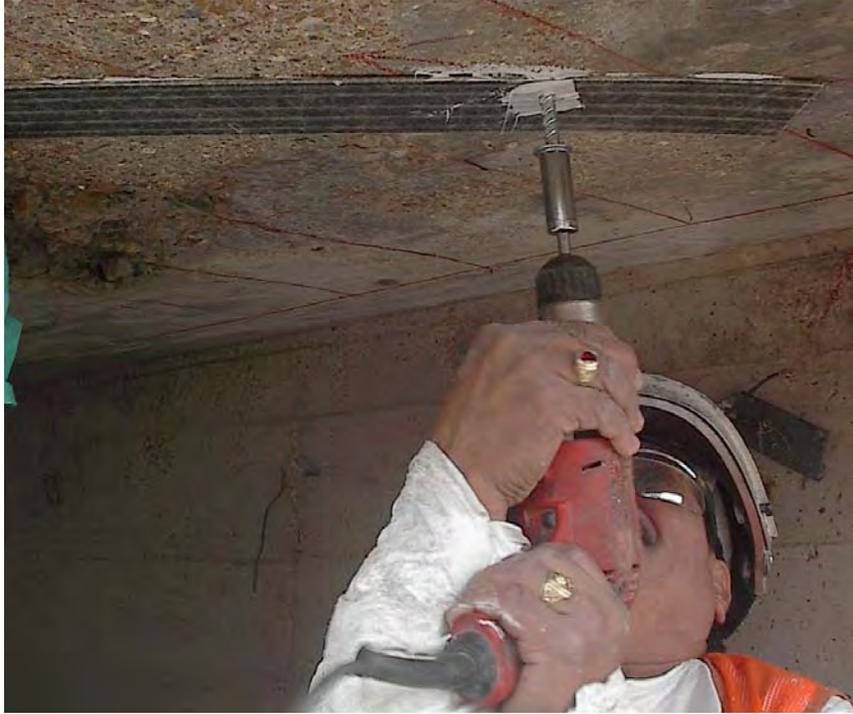
The final technology associated with bridge strengthening is mechanically fastened fiber reinforced polymer (MF FRP). MF FRP is essentially pre-cured laminate plates with predrilled holes which are fastened to the concrete surface with mechanical bolts (see Figure 2.5). Because the concrete surface does not need to be prepared, this technique offers a faster installation process.

Figure 2.5. MF FRP Installation

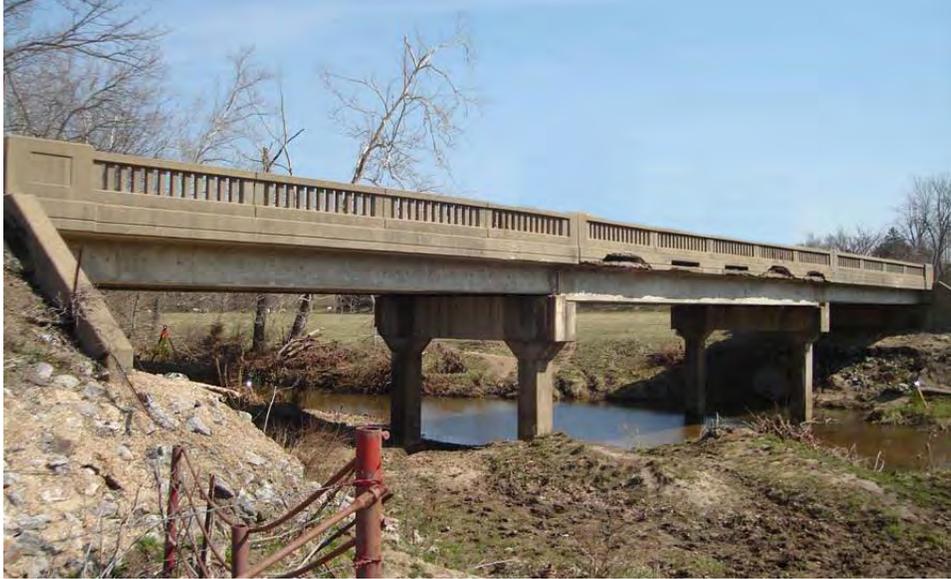
Figure 3.2. Bridge X-596

The condition of X-596 prior to strengthening was such that there were cracks in the exterior girders with exposed reinforcement. Figure 3.2 depicts the bridge and Figure 3.3 shows the condition of the superstructure. In addition, there were cracks at the connections between girders and the intermediate diaphragms and bents. The end bents were in overall good condition aside from rusty steel bearing plates.

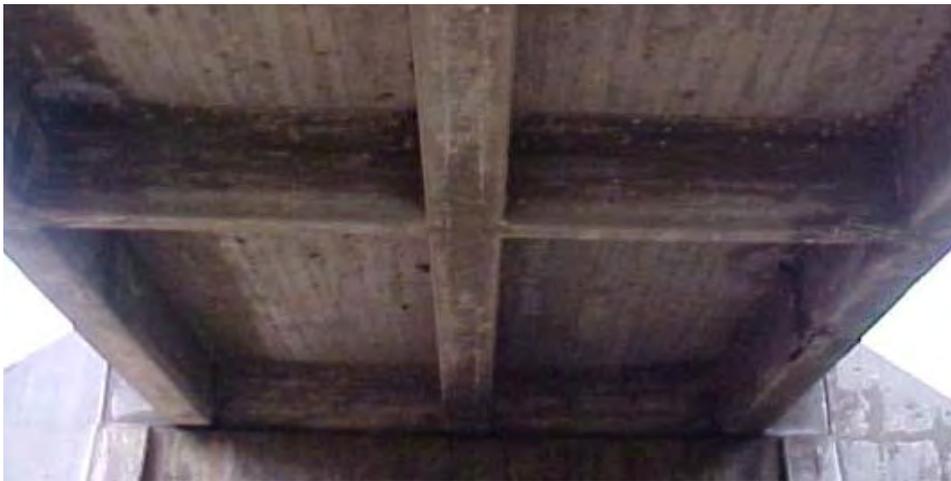
Figure 3.3. Bridge X-596 Superstructure

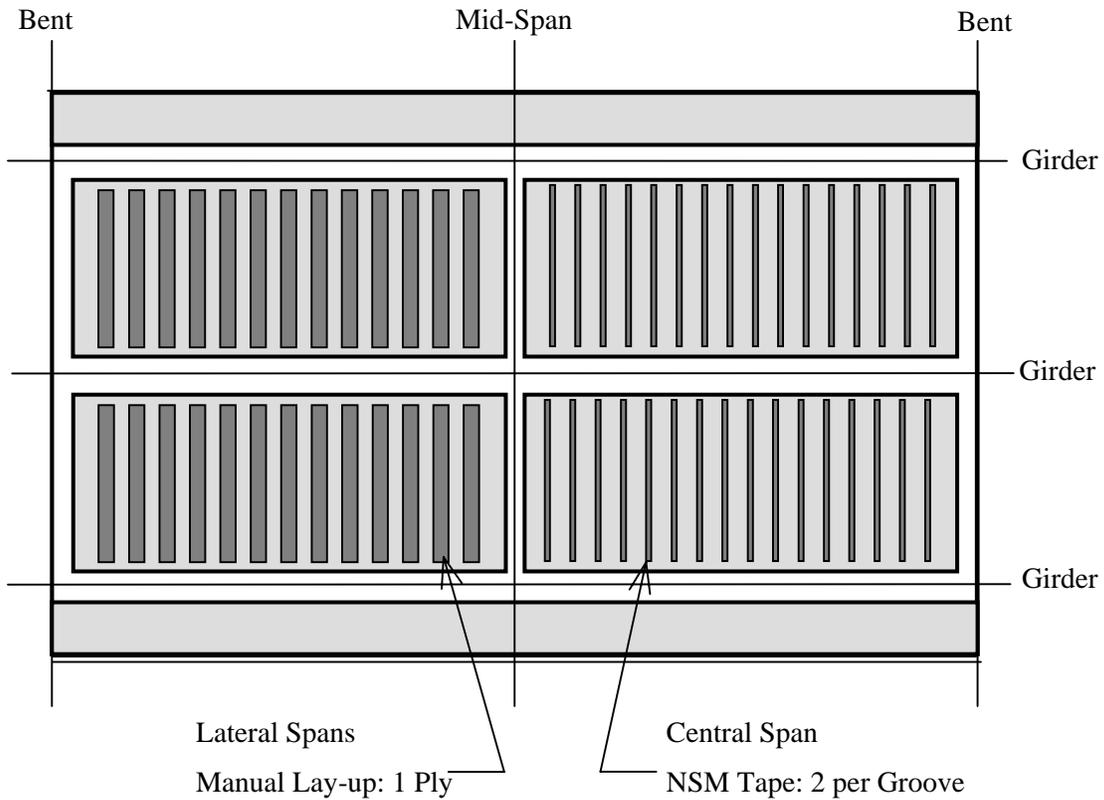
Figure 3.4. Bridge X-596 Plan View Strengthening Detail

In order to install these composites, 116-ft³ (3.285m³) of deteriorating concrete was removed and the new surface was cleaned. The surface was then prepared for the placement of FRP via manual lay-up by rounding corners and roughening with sandblasting. The installation

details for Bridge X-596 are provided in Figures 3.4, 3.5 and 3.6. These strengthening details were typical for Bridges T-530, X-495 and P-962.

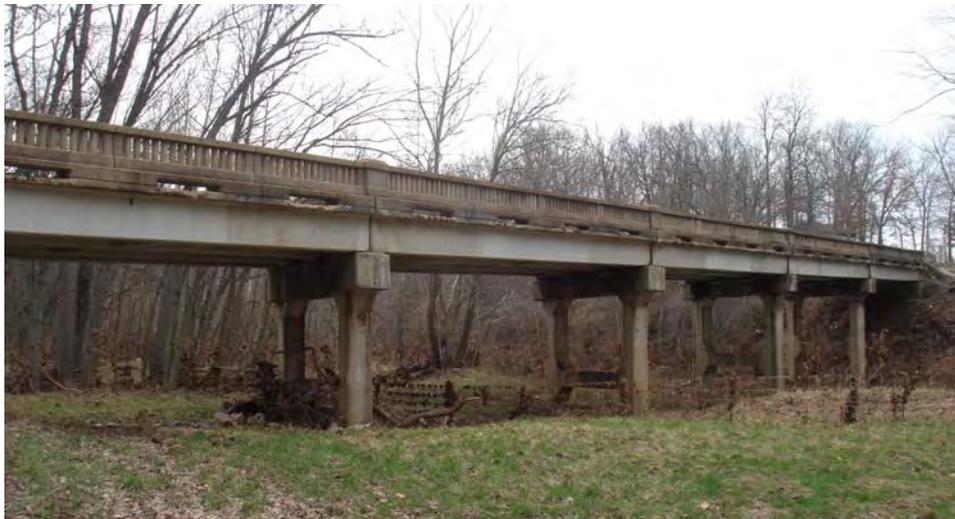
Figure 3.7. Bridge T-530

Bridge T-530 before strengthening is shown in Figures 3.7 and 3.8. Prior to strengthening, the concrete exhibited some spalling along the bridge edges. The concrete in the deck and beams was noted to be in good condition, with only minor cracks that required no injection. The piers and abutments were in good condition also, but the bents showed some deterioration due to steel corrosion.

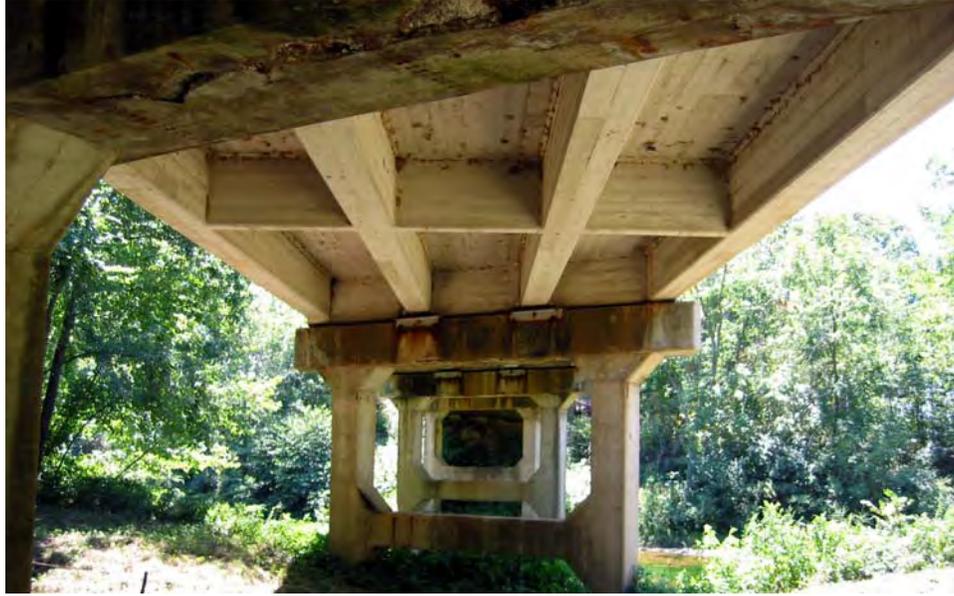
Figure 3.8. Bridge T-530 Substructure

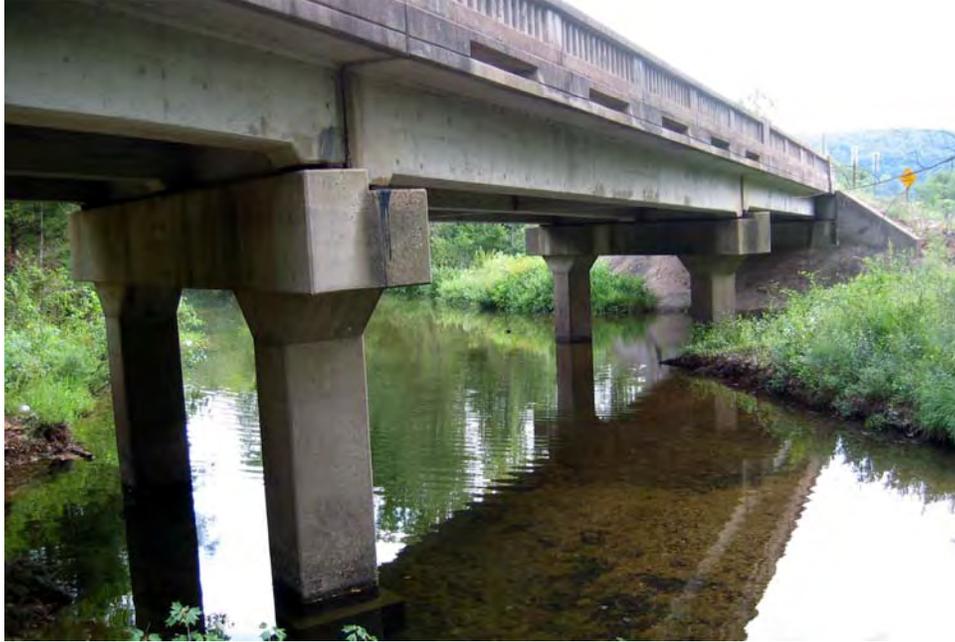
Figure 3.9. Bridge X-495

Prior to strengthening, the condition of the beams, abutments and piers were noted to be in good condition. Of the bridges tested in this project, bridge X-495 was in the best condition considering its overall age and average rating. See Figures 3.9 and 3.10 for visual details of the bridge prior to strengthening.

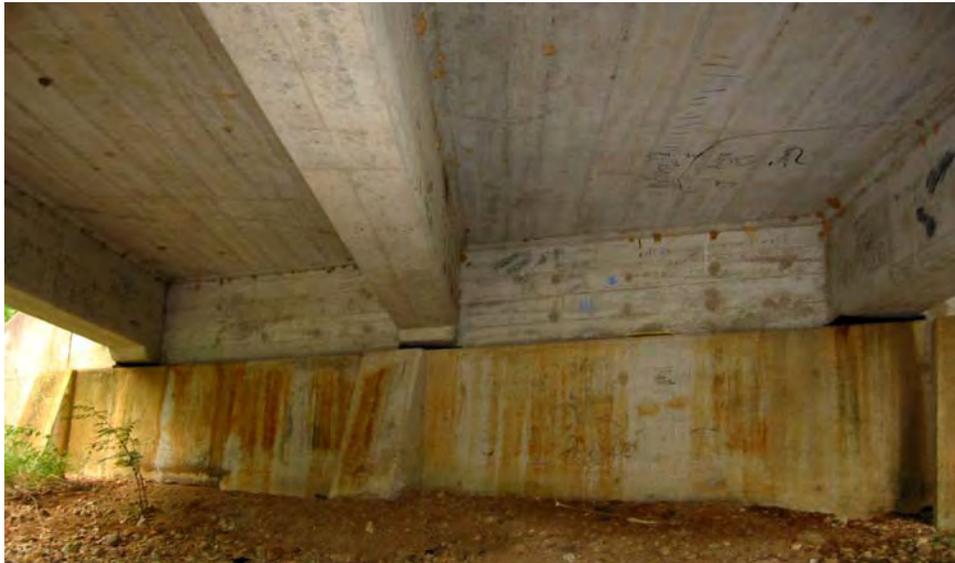
Figure 3.10. Bridge X-495 Substructure

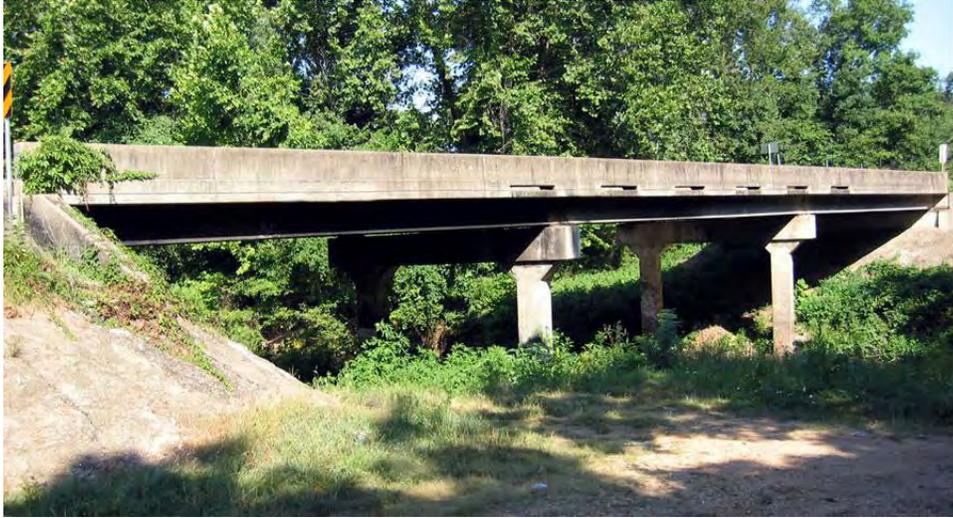
Figure 3.11. Bridge P-962

Prior to strengthening, the bridge beams and piers were noted to be in good condition; see Figures 3.11 and 3.12. The abutments were not in good condition and the deck required some repairs.

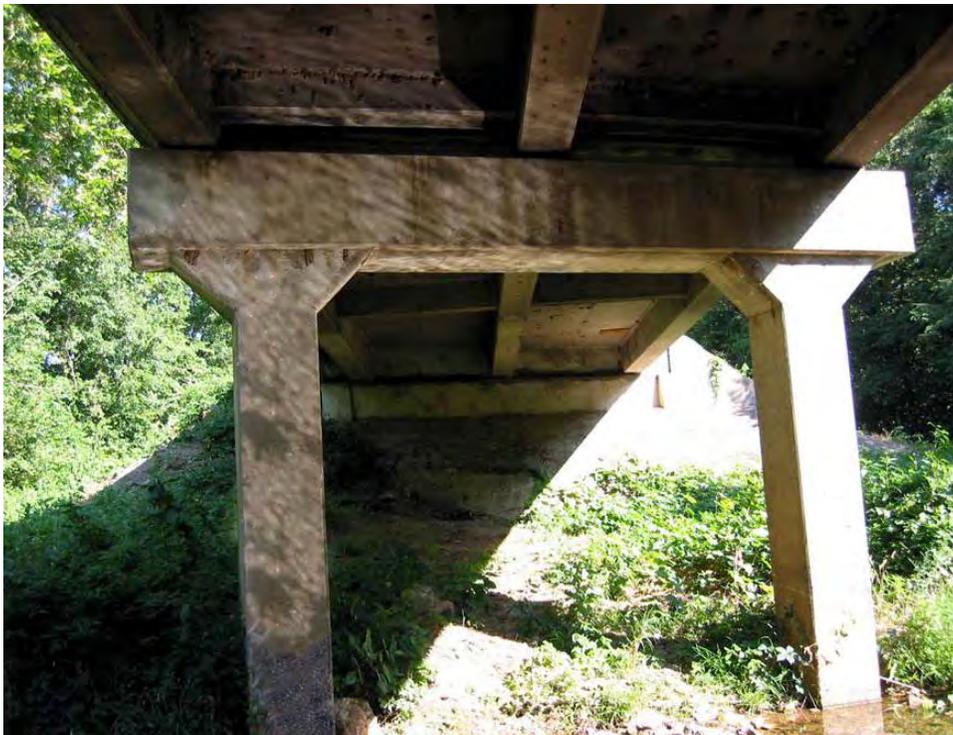
Figure 3.12. Bridge P-962 Substructure

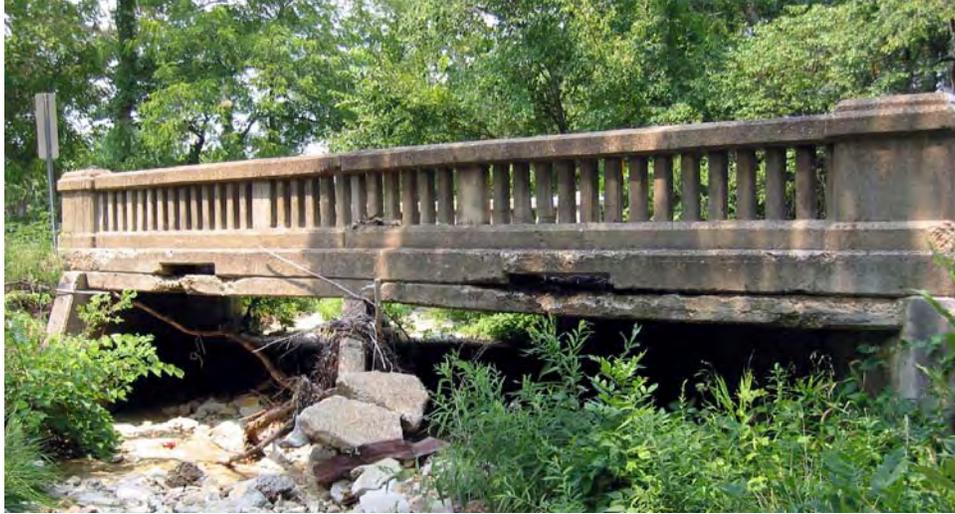
Figure 3.13. Bridge Y-298

Prior to strengthening, it was noted that the east span was in poor condition due to poor drainage, especially close to the edge of the bridge. Also, upon visual inspection the east span showed permanent deflection. The west span concrete was sound, but, due to improper concrete cover, had some exposed reinforcement. See Figures 3.13 and 3.14 for the visual appearance of Y-298 before strengthening.

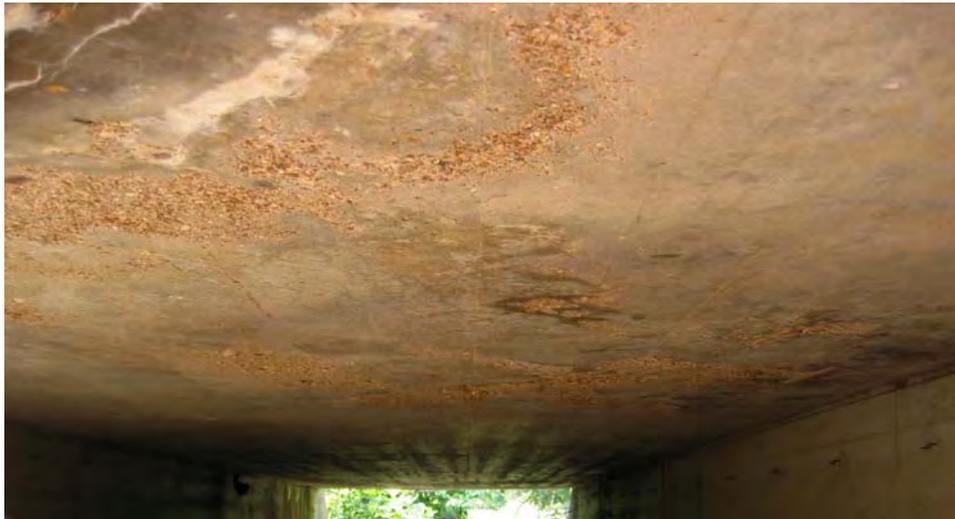
Figure 3.14. Bridge Y-298 Substructure

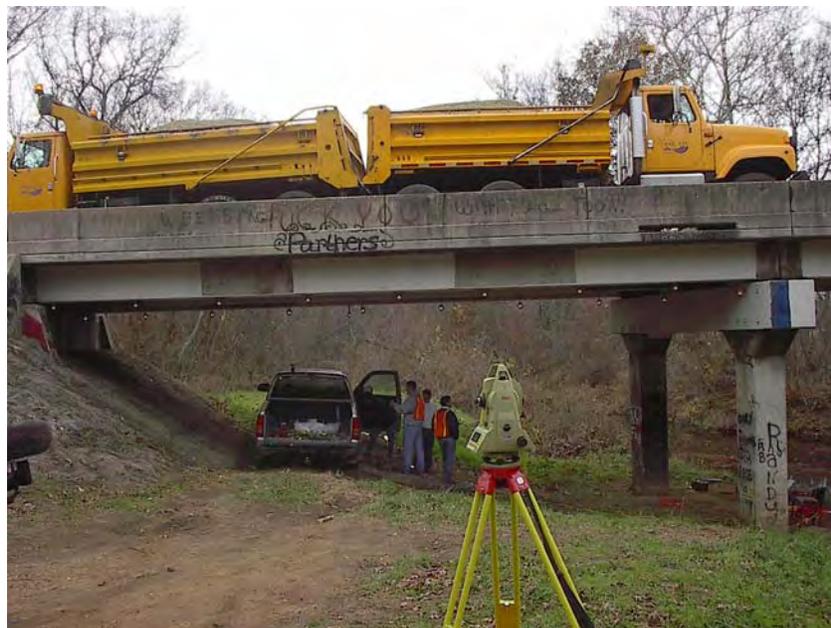
Figure 4.1. Loaded Trucks Used to Test a Bridge

method of testing real structures (Figure 4.1). Dynamic load tests use moving loads to induce vibrations and find the very rapid loading response of the structure. These tests allow for the analysis of dynamic load allowance, frequency, vibration, and a stress range for fatigue evaluation (AASHTO 2003). Driving loaded trucks over pre-determined locations at given speeds is the easiest method of testing dynamic loading.

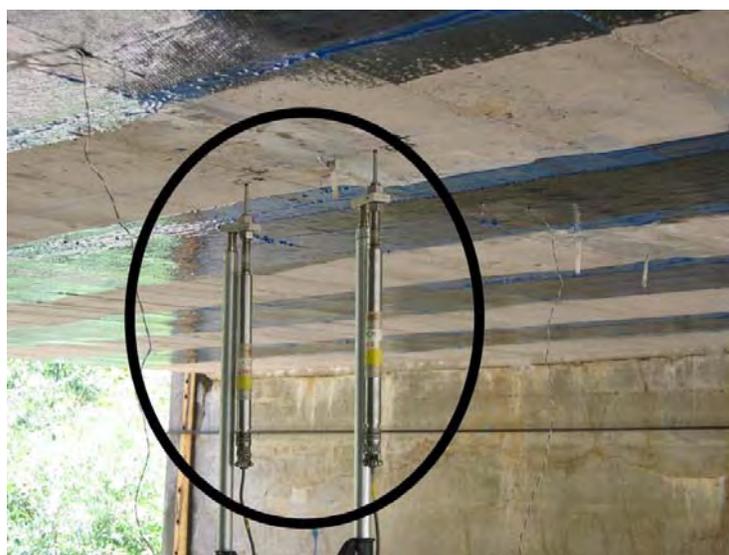
Figure 4.2. Two LVDT's Measuring Deflection

4.1.3. Measurements and Instrumentation. A variety of measurements can be made during the load test. Strain gauges are commonly applied to structural components at critical locations. Measuring strain allows engineers to evaluate stress distribution and contribution of members. Typically, electrical resistance gauges are used; however, other methods of measuring strain are also used. Displacement is another common measurement. Linear Variable Displacement Transducers (LVDT's – see Figure 4.2) are popular tools because they can measure both static and dynamic loads. LVDT and dial gauges both require stable support assemblies and recommended accuracies of 0.0001 and 0.001 inches respectively (ACI Committee 437). Without stable support the accuracy is greatly reduced. Other measurements include rotation and acceleration; rotation is critical for torsional effects and finding fixity levels in a structure. Table 4.1 lists a summary of the measurements made and devices used for load testing.

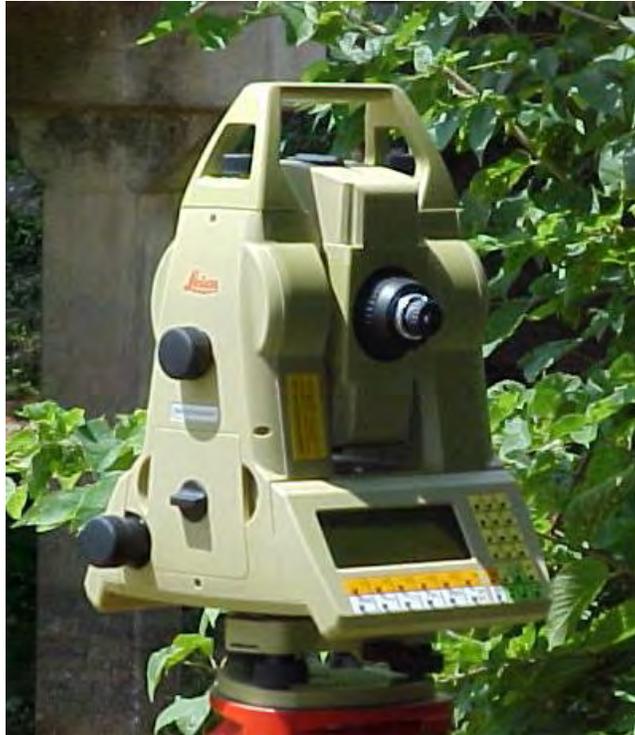
4.2.1. Understanding Surveying Equipment. Traditional land surveying techniques use many components, with the total station as the principal device. The total station (Figure 4.3) was set atop a secure tripod in a location with an unobstructed view of the field targets. Reference points (Figure 4.4), or backsites, were set in place to transfer a horizontal angle or an elevation from the reference point to the total station, and then from the total station to the target prisms (Figure 4.5). The reference points also served to check that the total station had not moved. The reference point was a prism mounted atop a secure tripod and the targets were prisms fixed atop a metal rod (range pole). In the case of load testing, the prisms were fixed to points on the tested structure.

Figure 4.3. Leica TCA 2003

The total station obtained three-dimensional coordinates of every target by measuring a horizontal angle, vertical angle, and the distance between points. The instrument was automatically set to take four angle readings per recorded shot (measurement); this was done internally by four diodes optically reading a fine bar code set on a glass ring inside the instrument. During operation, the instrument continuously read the bar codes on the horizontal and vertical planes. This “electronic protractor” inside the Leica TCA 2003 (Leica 2003) was accurately read to 0.5 arc-seconds ($1/7200$ degrees).

The total station measured distance by using an EDM (Electronic Distance Meter); the EDM sent a laser signal to the glass prism target, which reflected the signal back to the total station. The time taken for the signal to return to its origin was multiplied by the signal speed to obtain the target distance. The total station adjusted the signal speed based on field conditions (temperature, pressure, etc.), so that the instrument could measure a distance accurate to 1 mm plus 1 ppm (1-in. = 25.4mm). The EDM could be set to measure distance using one of several measuring programs. The programs took multiple distance readings and recorded the average distance for each recorded shot (measurement); some programs took less time but were also less

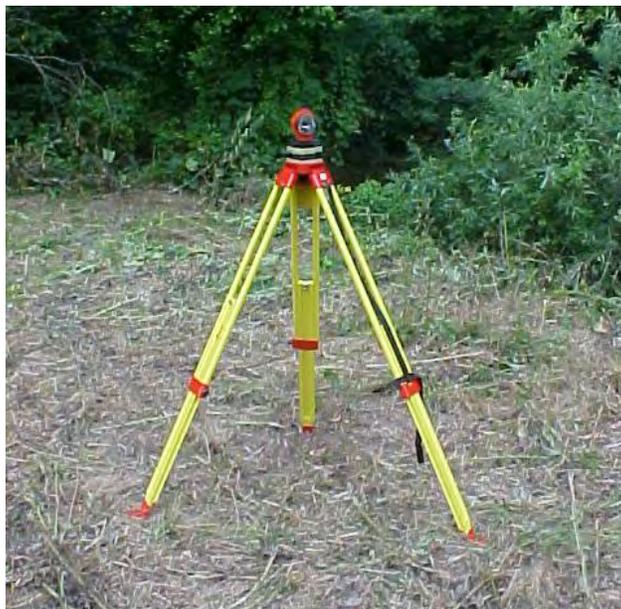
Figure 4.4. Reference Point

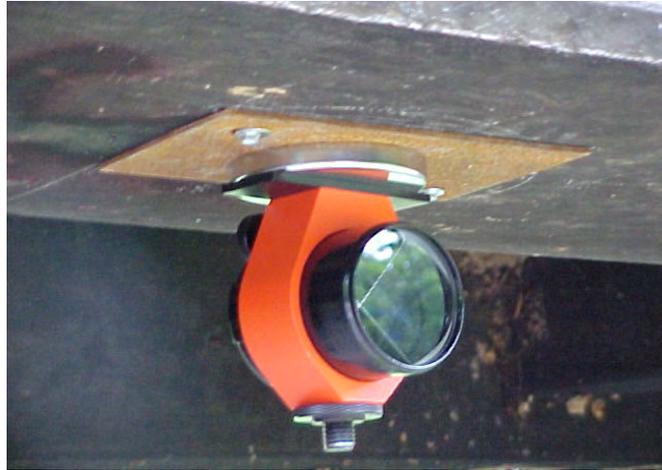
Figure 4.5. Target Prism

The targets were glass prisms in enclosed cases. The glass prism was designed to reflect the laser signal back to the total station without interference from other nearby objects. Moisture, dirt, and surface scratches on the prisms could obstruct the signal, so the prisms must be well kept.

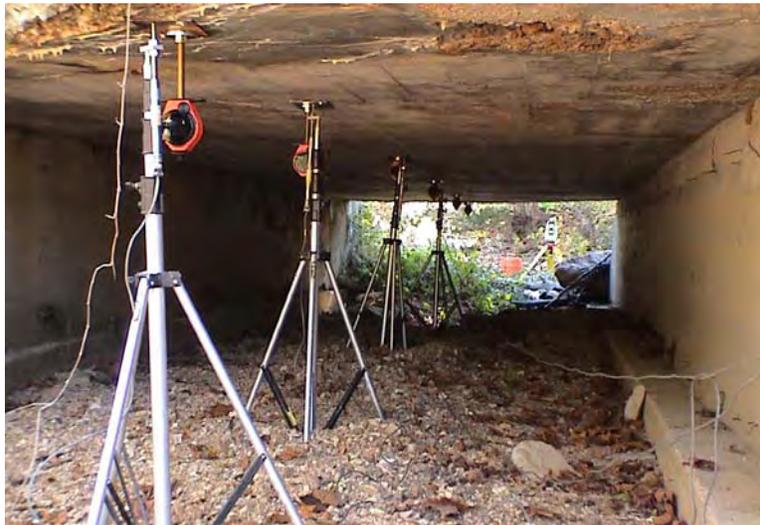
4.2.3.1 Case Study 1: Field Test. The first test took place at Bridge Y-298 in Pulaski County, Missouri. This bridge was chosen for a comparison study because the area underneath the structure is easily accessible, making setup of the LVDT system relatively easy. Figure 4.6 and Figure 4.7 show the low clearance of the substructure, as well as the setup of the LVDT and

Figure 4.6. LVDTs and Target Prisms

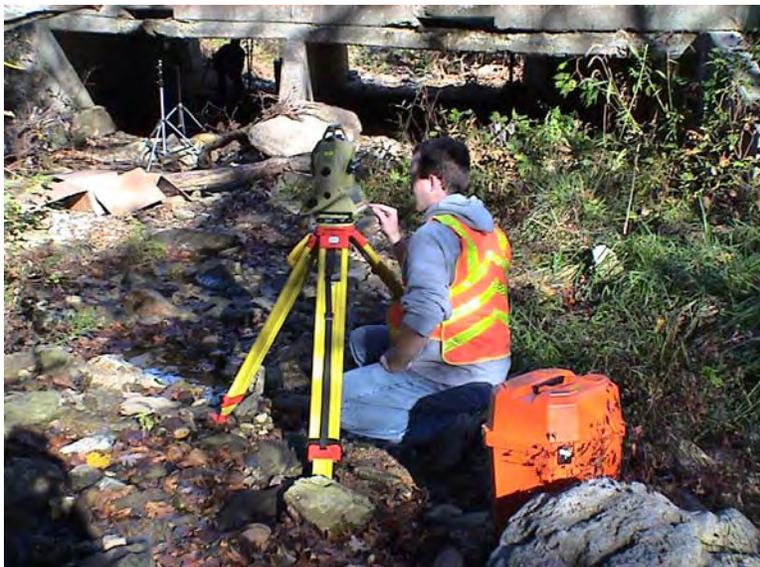
Figure 4.7. Total Station Setup

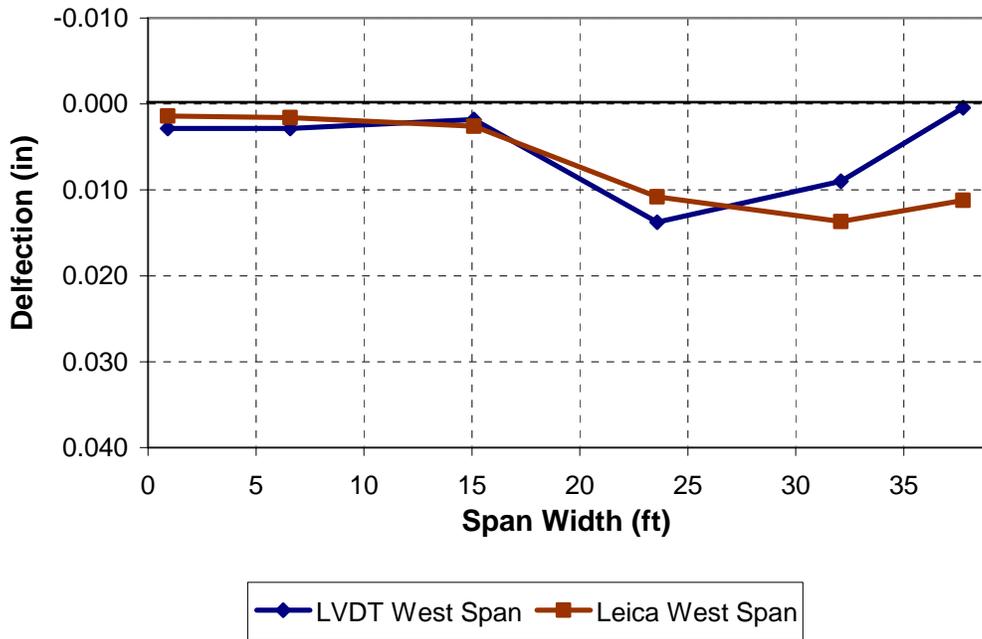
Figure 4.9. Stop 3 – West Span Deflection

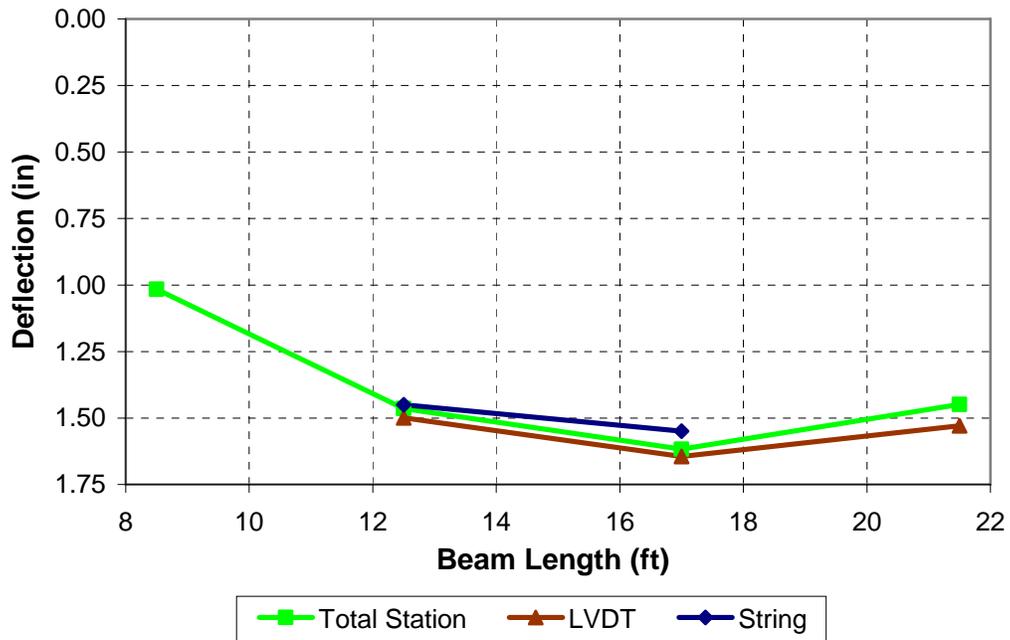
Figure 4.12. Laboratory Test Results

Error could most likely be due to several sources. First, the string transducers, LVDTs, and prisms were not mounted as close to each other as possible, at a given location. If the instrumentation was not located in the same proximity, torsion/rotation effects could influence the readings. Second, during testing when the load was held constant, it was noted that the hydraulic jacks do not actually hold a constant load. This was plotted (Load versus Deformation via LVDTs and String Transducers) after testing, which automatically sets the surveying equipment at a disadvantage. However, this does not account for the difference between string transducer and LVDT readings. Compared to the variances between these two systems, internal error of the Total Station was negligible.

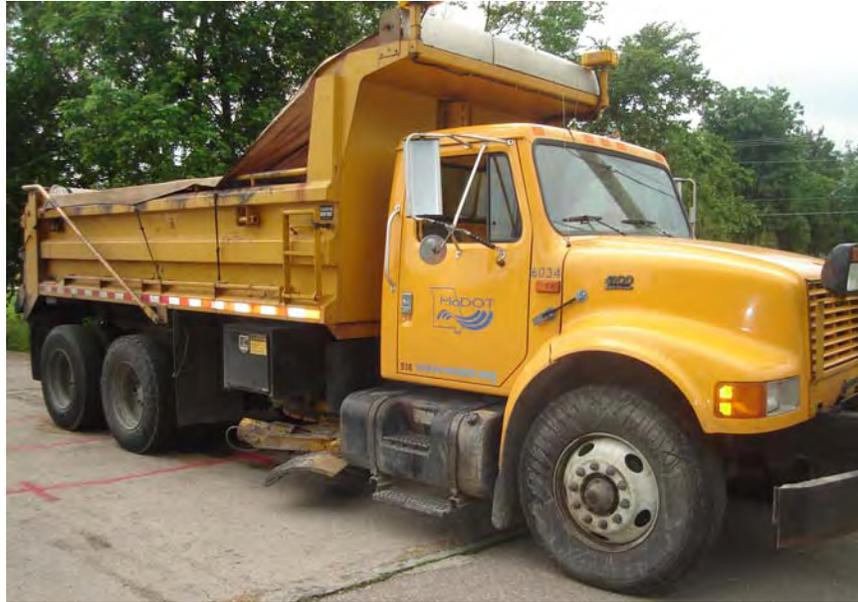
The load testing procedure for the Five Bridges Project involved the static placement of two loaded H20 dump trucks provided by MoDOT (Figure 5.1). Load tests utilizing loaded dump trucks have been conducted in the past and are an effective and simple means to evaluate bridges (Stone, 2002). The weight of the trucks was recorded to account for any large variances in weight between load tests and the potential of a considerable difference in deflection. The weights of both the front and rear tandem axles were recorded. For modeling purposes and to assist in the normalization of the load test deflection data, the dimensions of the truck axles and distances to the centerline of each tire were recorded as well.

Figure 5.1. MoDOT Provided H20 Truck

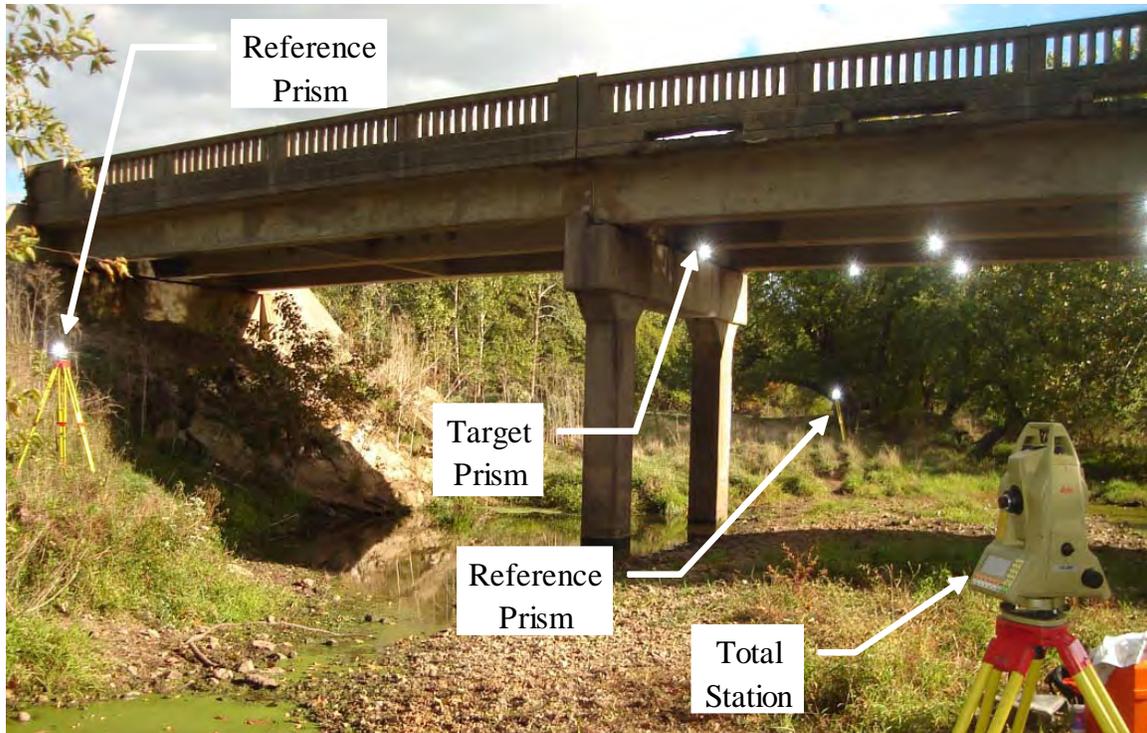
Figure 5.2. Total Station Test Setup

As indicated, testing utilized a Leica TCA 2003 Total Station and optical surveying prisms for targets located on the bridge and reference points; see Figure 5.2 for a load test setup example.

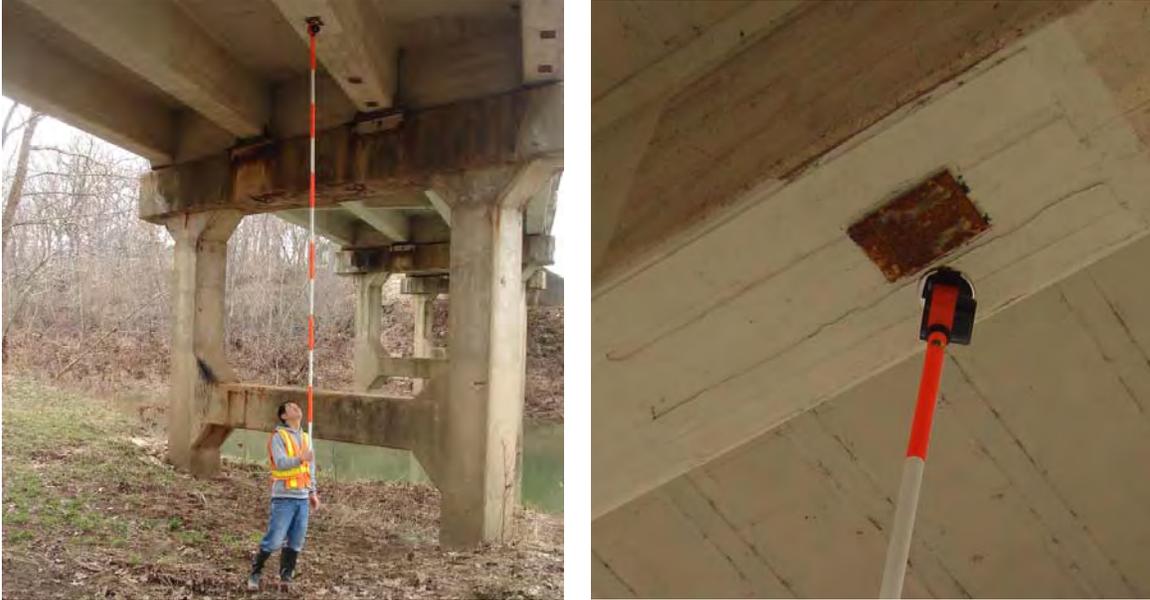
Figure 5.3. Attaching Target Prisms with Range Pole

Iron plates were epoxied to the underside of the bridges at predetermined locations along the span and given time to cure prior to load testing. The plates remained for future load tests. Magnetized target prisms were then attached to the plates using a range pole. Figure 5.3 shows the attachment of the magnetized target prisms to the soffit of the bridge girders.

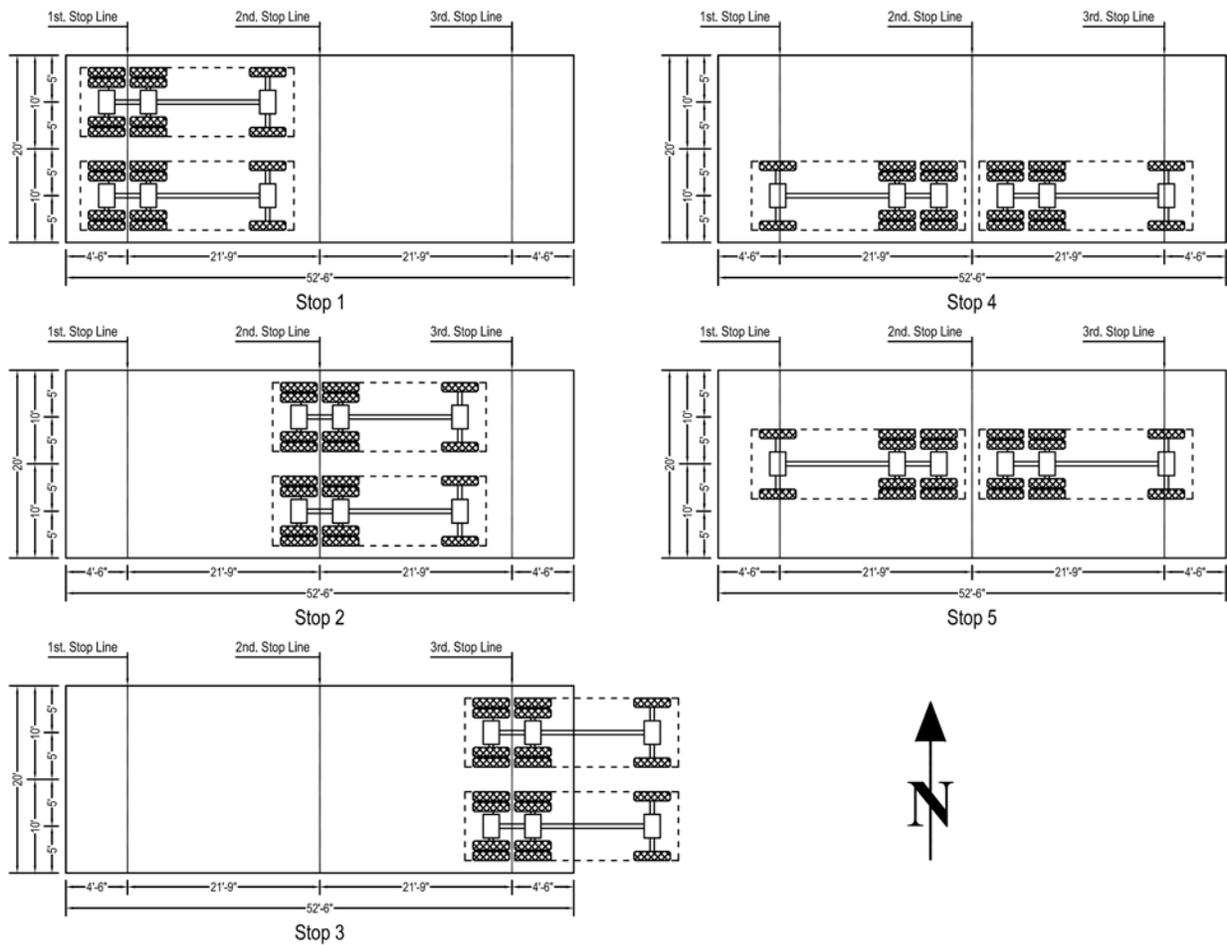
Figure 5.4. Bridge X-596 Truck Stops

stops used on bridge X-59; similar stops were used on the other bridges, though that additional presence of a skew angle should be noted. The stops and exact locations of the target prisms have been provided in Appendix B.

The first three stops were conducted with both trucks side-by-side driving down the length of the bridge. Stop 1 was conducted with both rear axles near the edge of the span to induce a maximum shear case. Stop 2 was conducted with both trucks side by side at midspan; this was a maximum moment configuration. Stop 3 was similar to stop 1 in that it produced a large shear case, only on the opposite side of the bridge. Stop 4 and 5 were overload conditions intended to produce maximum moments and, therefore, deflections on the exterior girder (Stop 4) and interior girder (Stop 5).

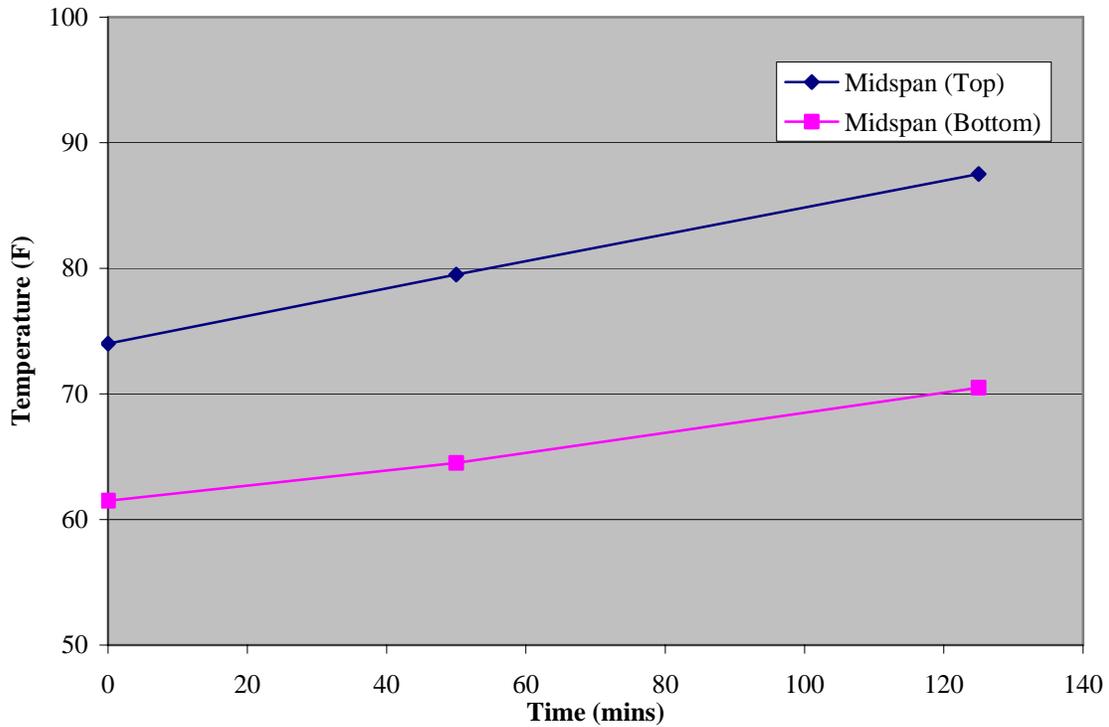
Figure 6.1. Bridge X-596 Temperature Over time of Midspan Interior Girder

Temperature readings were recorded with a temperature gun on the top deck and at the bottom of the girders three times during testing in order to quantify thermal effects. Figure 6.1 shows the temperature variance over time for Bridge X-596 at midspan of the interior girder. This test was conducted in the morning and an increasing temperature gradient was observed. A similar temperature rise was common for most conducted tests. The temperature variance shown in Figure 6.2 is one of the more extreme cases in temperature fluctuation observed during testing. During overcast days, the temperature variance was observed to be much lower.

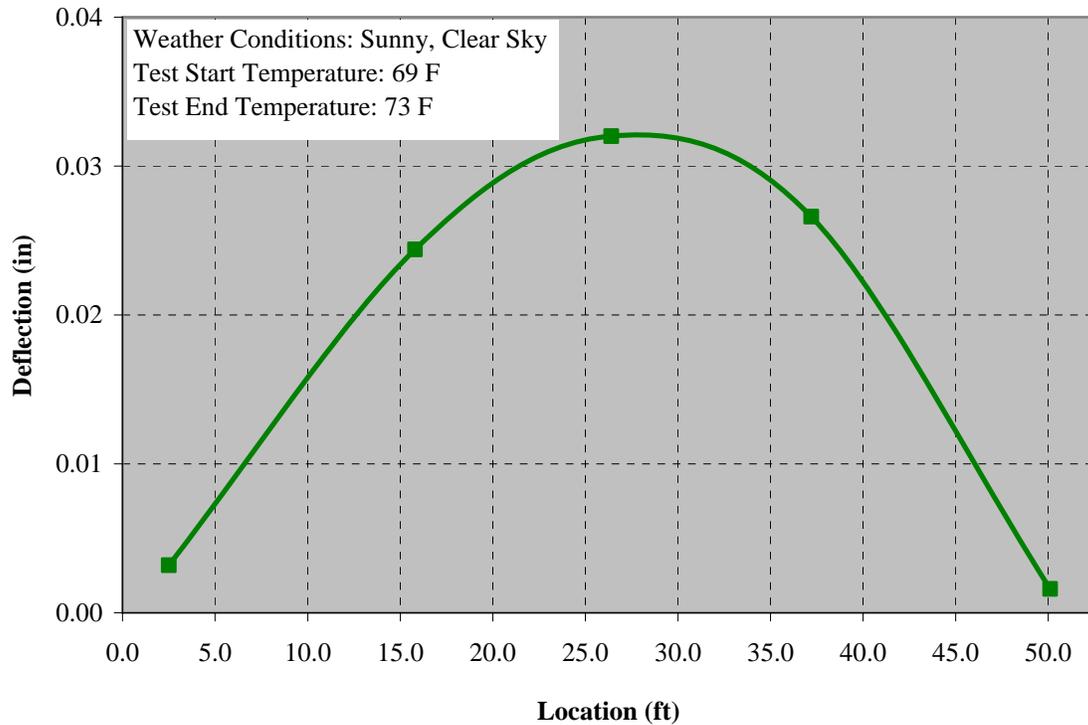
Figure 6.2. Bridge X-596 Thermal Camber

The temperature increase resulted in a thermal camber of the bridge, which was apparent in subtracting the elevation of the final no load test from the initial no load test. For the temperature increase shown in Figure 6.1, the camber was calculated and is graphically represented in Figure 6.2. Figure 6.2 also has the weather conditions and air temperatures at both the test start and end.
