Preservation of Missouri Transportation Infrastructures: Validation of FRP Composite Technology

Volume 1 of 5

In-Situ Load Testing of Bridges

P-962, T-530, X-495, X-596 and Y-298

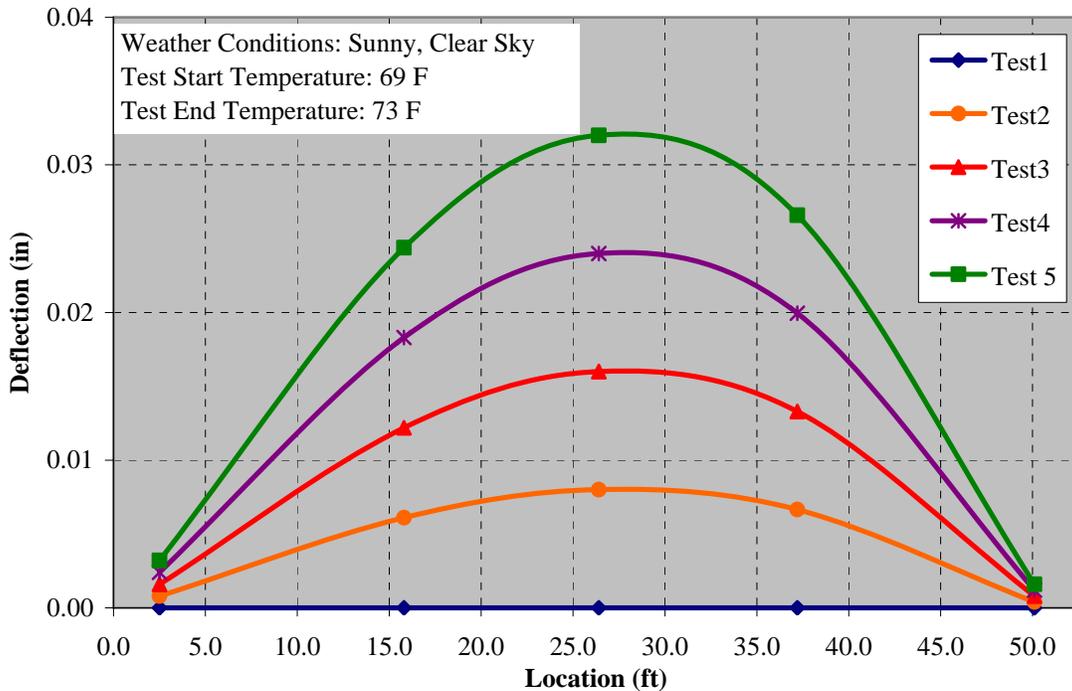
Figure 6.3. Bridge X-596 Adjustment of Baseline Due to Thermal Effects

In order to appropriately account for the camber of the bridge due to thermal effects during testing, an appropriate baseline was established for each stop during testing. For most of the bridges (excluding Y-298) 5 truck positions, or stops, were conducted during testing. The thermal effects were accounted for by taking a weighted average of the first no load stop and the final no load stop based upon when the stop occurred. Figure 6.3 shows the linearly adjusted baselines for the camber effects.

Test 1 occurred closest to the first no load test and therefore used the first no load as a baseline. Test 2 utilized a weighted average of 75 percent camber from the first no load and 25 percent from the second no load and so forth. A linear relationship was the most appropriate way to account for thermal deflections because quantifying the exact temperature throughout the cross section would have been very difficult. In addition, for some bridges portions of the deck could be shaded during the test whereas other spots remained in the sunlight and recorded much larger temperature values. This meant the temperature was not only varying throughout the depth of the bridge section, but over the entire deck surface. Figure 6.4 shows the shading of Bridge X-495 during Stop 3, which was the halfway point of testing. Testing of the bridge began in the early morning with the entire deck shaded; when testing was completed, the entire deck surface was sunlit.

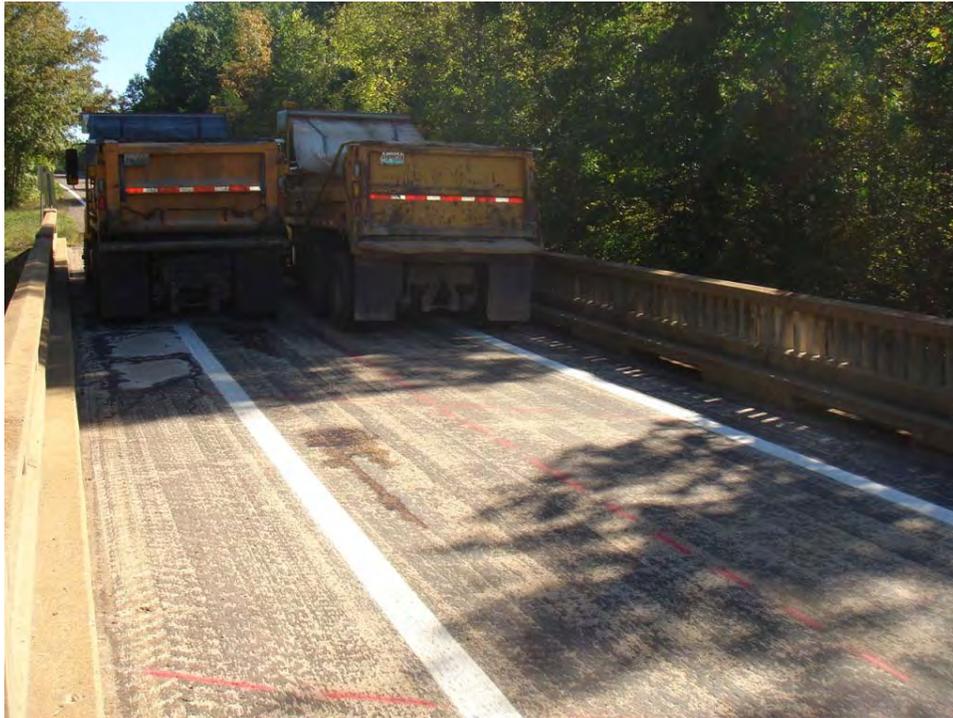
Figure 6.4. Bridge X-495 Shading of Deck During Testing

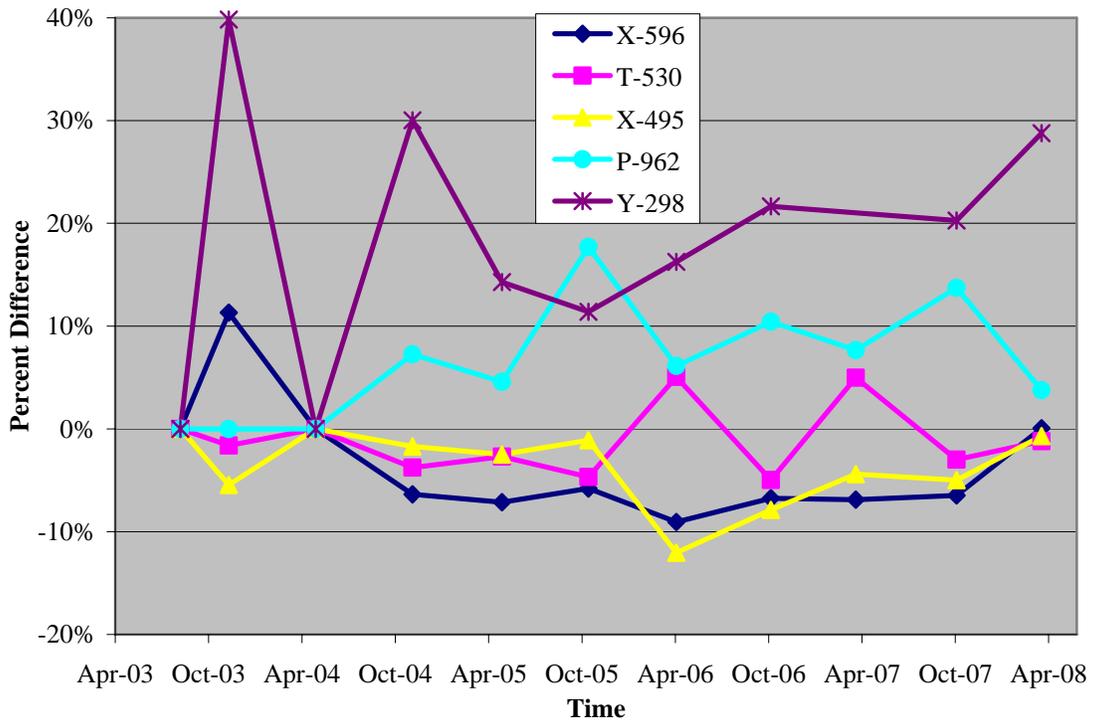
Figure 6.5. Percent Difference of Total Truck Weight over Time

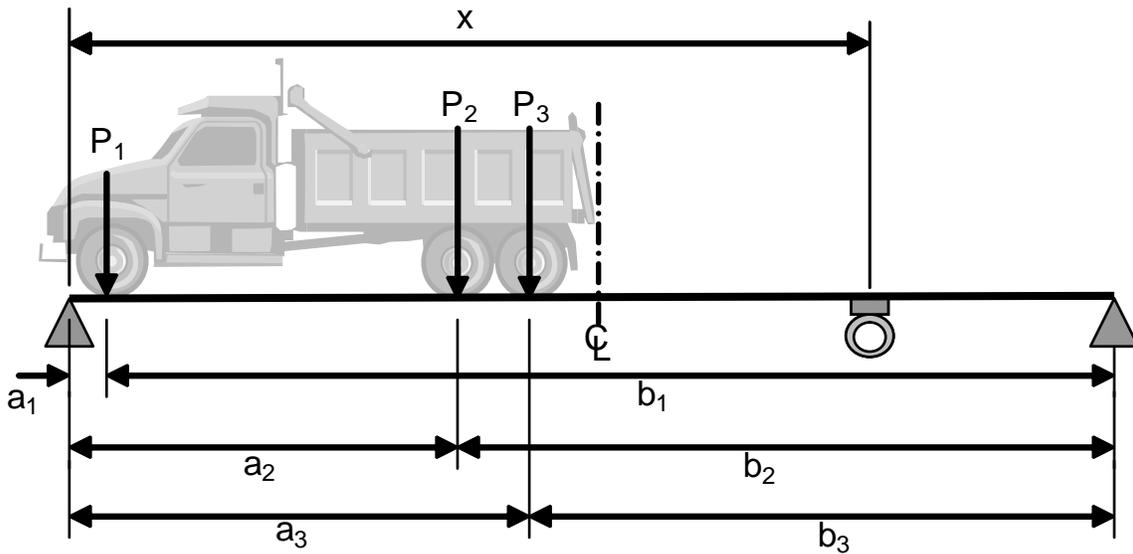
Figure 6.8. Step 2 Sketch for Theoretical Deflection Terms

$$\frac{\text{Theoretical } \Delta_{\text{Test 1}}}{\text{Theoretical } \Delta_{\text{Test } i}} = \frac{\sum_1^j P_{1j} b_{1j} (L^2 - b_{1j}^2 - x^2)}{\sum_1^j P_{ij} b_{ij} (L^2 - b_{ij}^2 - x^2)} \quad (3)$$

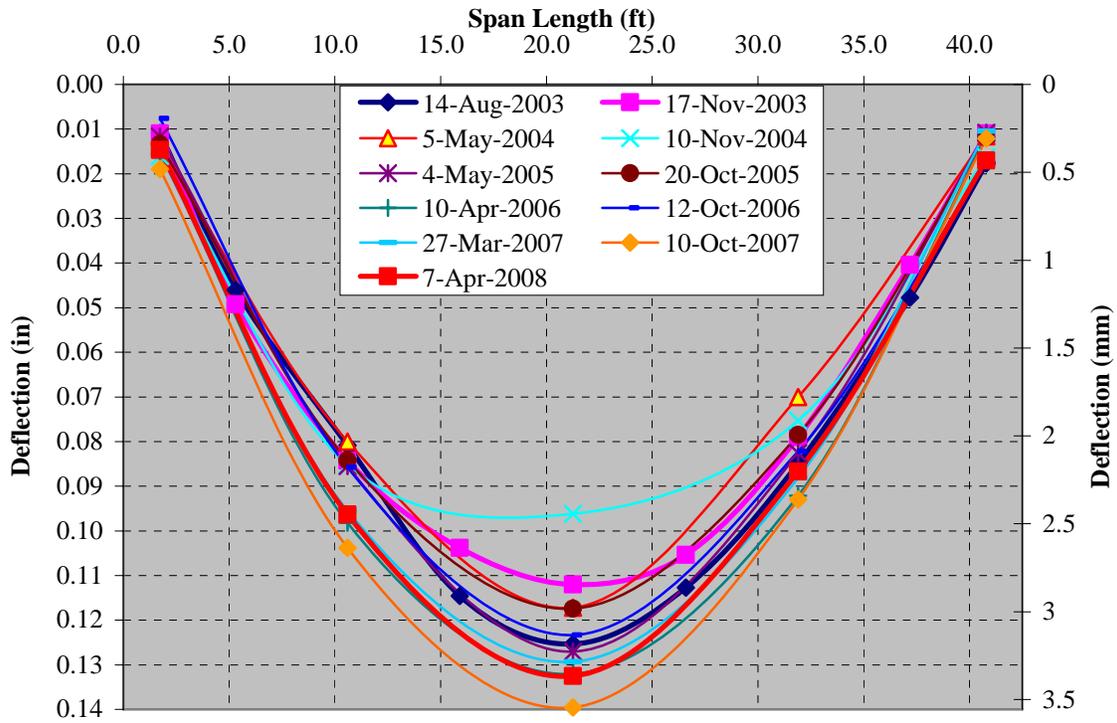
Figure 6.9. Recorded Deflection Bridge P-962 - Stop 2, Exterior Girder

Stop 2, the exterior girder of the bridge, for all 11 tests conducted on bridge P-962. Figure 6.10 shows the data after normalization.

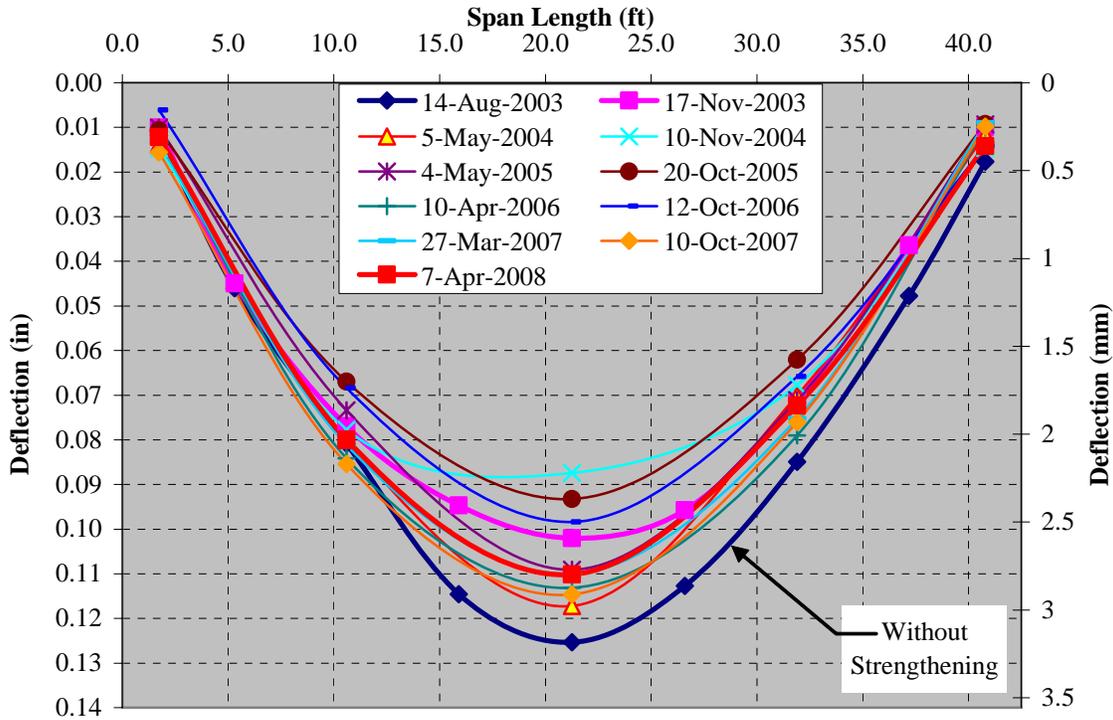
Figure 6.10. Normalized Deflection Bridge P-962 - Stop 2, Exterior Girder

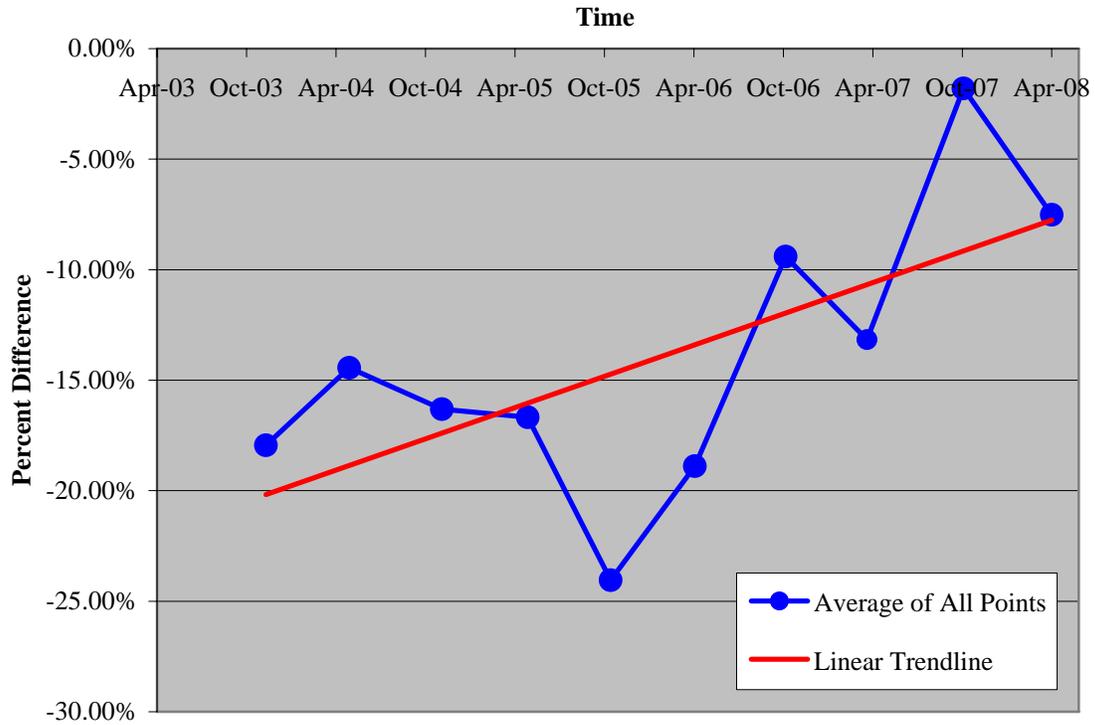
Figure 7.1. Average Deflection Percent Difference Bridge P-962

In order to better graphically present this change, the average of all deflected points was calculated for each test and a percent difference was then computed based upon the original Test 1 data. The results are presented in Figure 7.1 and Figure 7.2 for Bridge P-962 and Bridge T-530, respectively. A linearly trend line was plotted and displays a line that approaches the original deflection of the bridge. The apparent increase in deflection could be attributed to a softening of the FRP material utilized during strengthening or to the deterioration of other bridge components as the bridge aged. The varying thermal effects also may have impacted this apparent loss in stiffness, though bond softening at the interface of the FRP composites and the concrete substrate over the observed time could have been a factor as well.

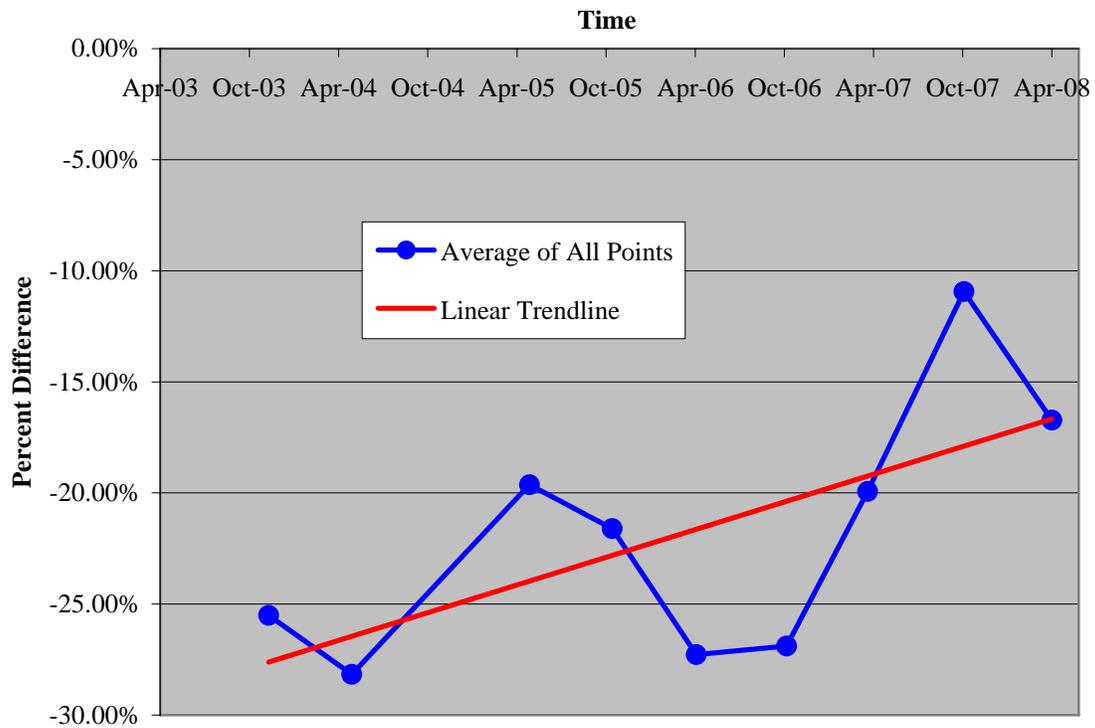
Figure 7.2. Average Deflection Percent Difference Bridge T-530

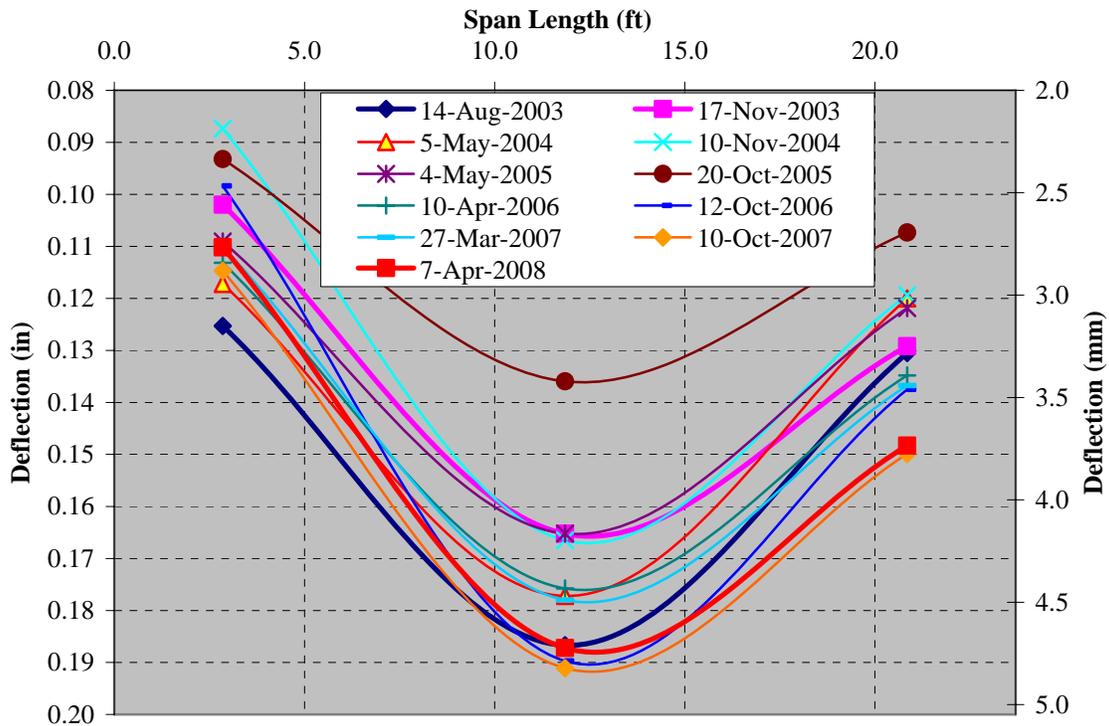
Figure 7.3. Bridge P-962 Span 1, Stop 2 Midspan Transverse Normalized Deflection

The normalized transverse girder deflection at midspan was plotted to gain an understanding of girder deflections relative to each other. The transverse deflection has been plotted below for span 1 of bridge P-962 in Figure 7.3. The results indicate an increased deflection on the western exterior girder.

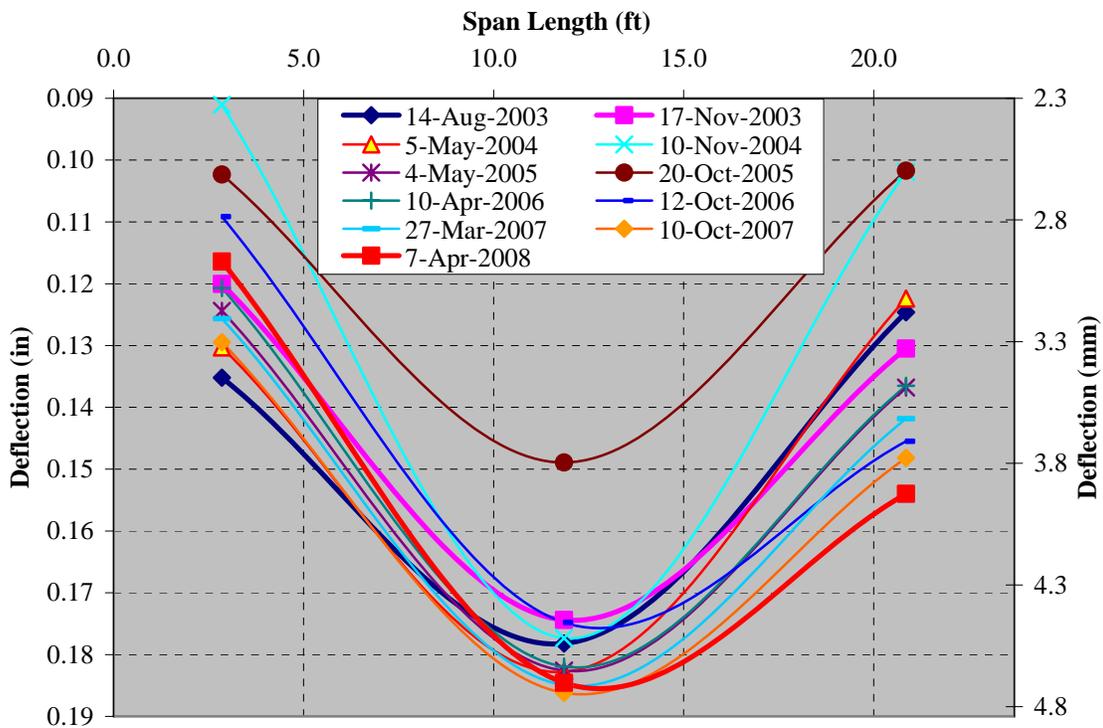
Figure 7.4. Bridge P-962 Span 2, Stop 2 Midspan Transverse Normalized Deflection

Additionally, spans 2 and 3 were monitored for bridge P-962 under Stop 2 loading configuration. The midspan girder deflections (Figures 7.4 and 7.5) display a similar trend of an increased deflection of the western exterior girders. Note that span 3 was strengthened with SRP reinforcement which upon visual inspection exhibited localized signs of rusting. The deflection data for span 3 does not show larger deflections over time or larger deflections than span 1 or 2. The SRP is therefore still performing adequately with no appreciable loss in steel area due to rusting.

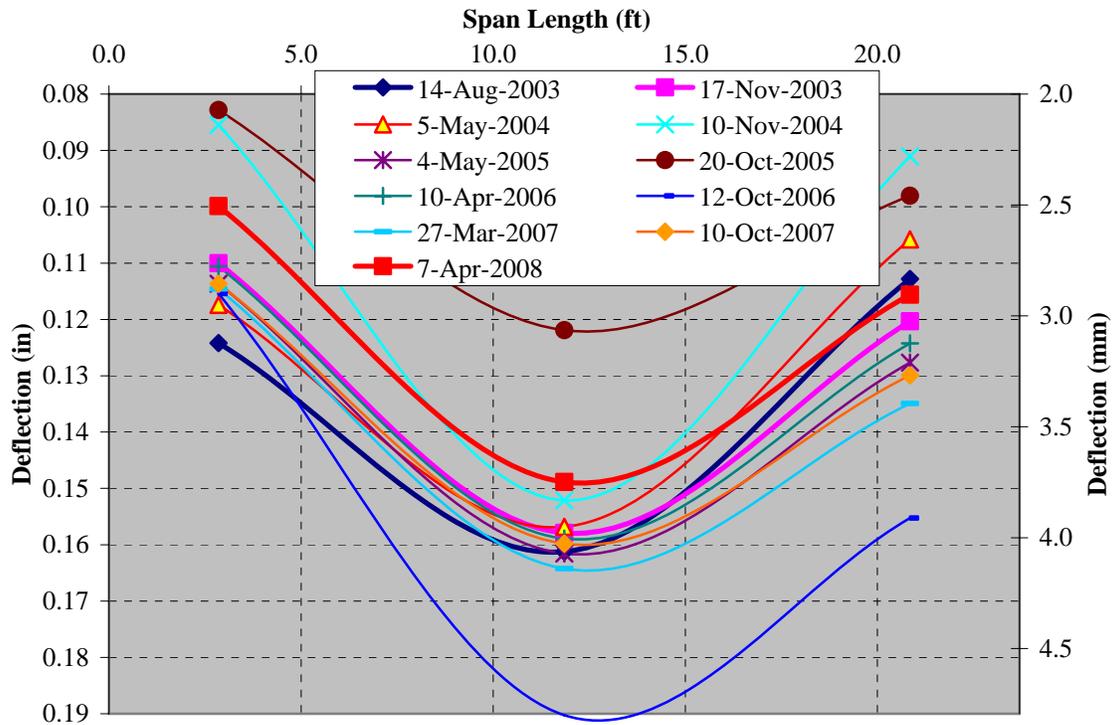
Figure 7.5. Bridge P-962 Span 3, Stop 2 Midspan Transverse Normalized Deflection

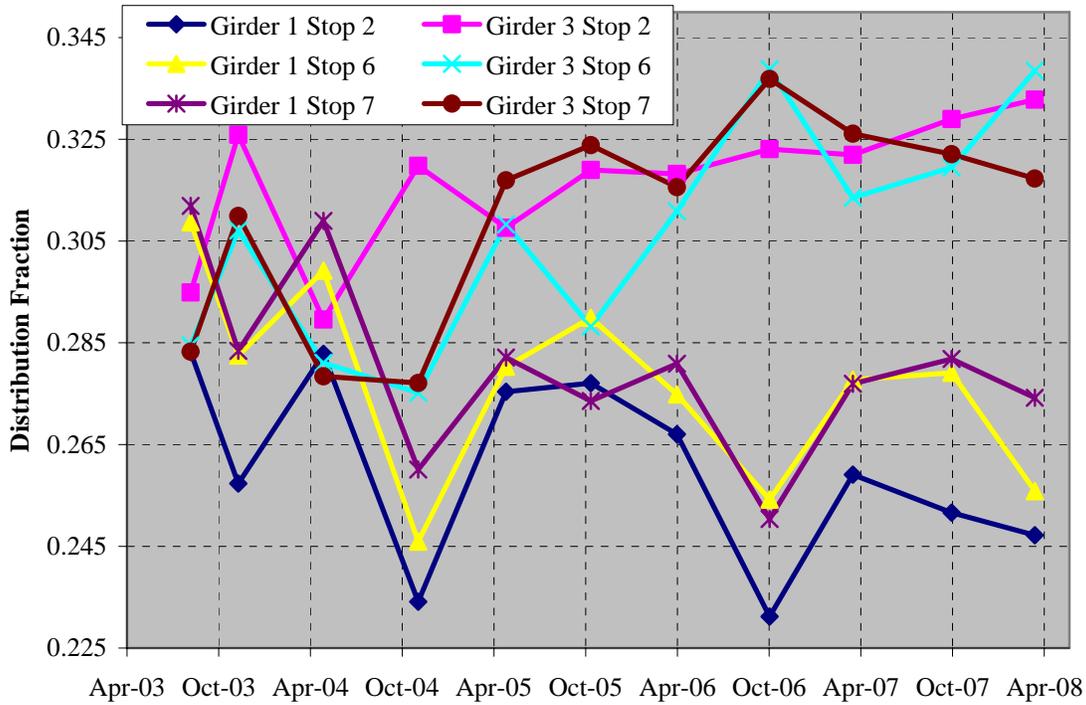
Figure 7.6. Bridge P-962 Stops 2, 6 and 7 Distribution Fraction

These fractions can also be displayed over time to identify any changes that may occur from test to test. The fractions for Stops 2, 6 and 7 have been plotted for bridge P-962 in Figure 7.6. Stops 2, 6 and 7 configured the trucks side by side at midspan for each of the three spans.

Figure 7.6 clearly shows that the western exterior girders (denoted as girder 1 for all stops) took more of the load as testing progressed through time. The strengthening on the exterior girders of each individual span was the same. Therefore, this increase in distribution could have been caused by inconsistencies in the installation of the FRP material. Another possibility is lateral misplacement of the trucks during testing.

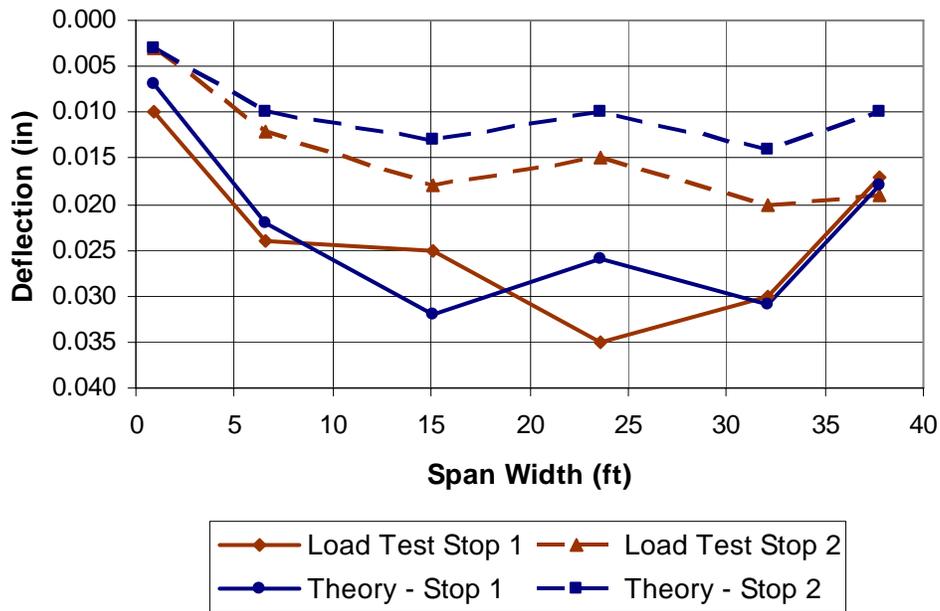
Figure 7.10. Bridge Y-298 West Span

due to overloaded conditions, and the actual continuity of the spans would have therefore be small. The resulting FEM models were compared to the load testing results, shown in Figures 7.10 and 7.11. Average theoretical error values were computed similarly to the other four bridges, except only one model (shown in Figures 7.10 and 7.11) was used.

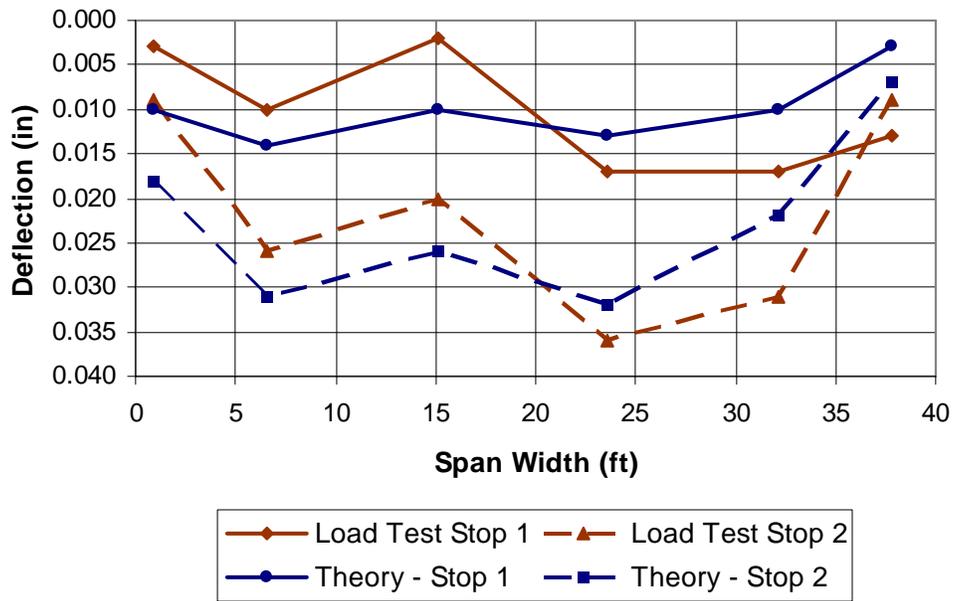
Figure 7.11. Bridge Y-298 East Span

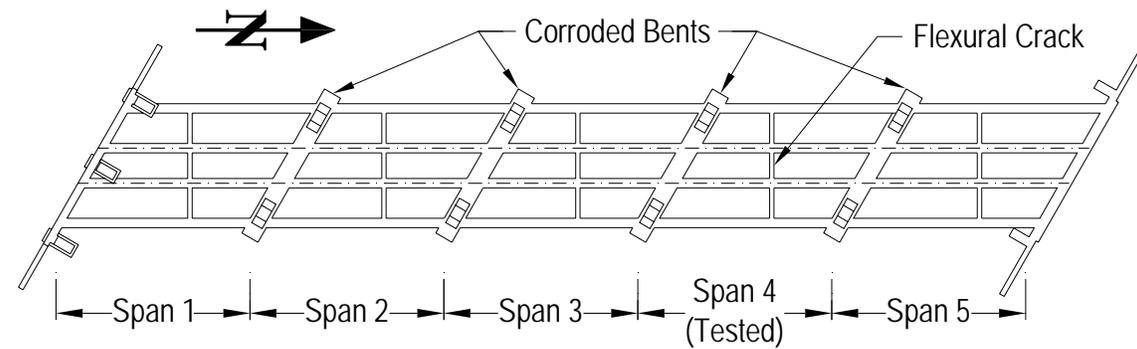
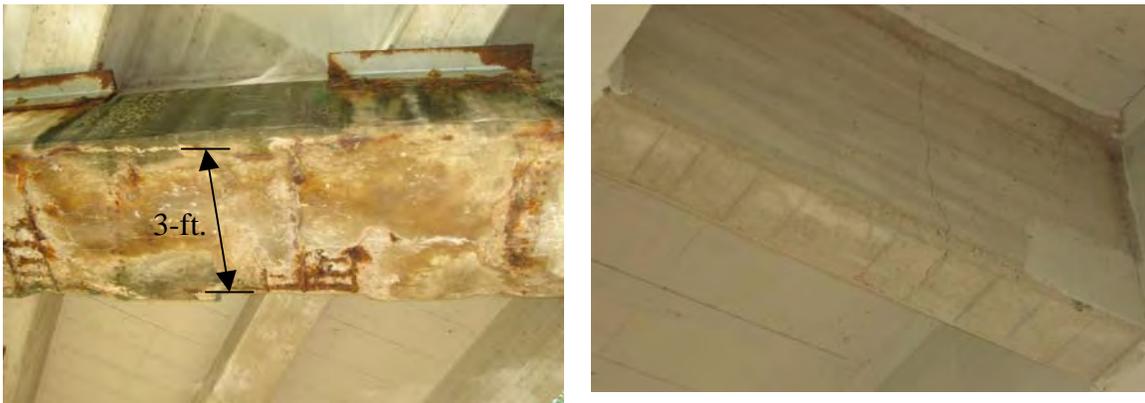
7.6.1. Bridge T-530. Bridge T-530 showed signs of severe corrosion of the bents due to the propagation of water from the deck surface. These bents were corroded before the bridge was strengthened and need to be monitored in the future to ensure structural integrity. The presence of a flexural crack was also noted on the midspan transverse beam of the tested span. The size of the crack was noted, and did not noticeably increase in size when testing under truck load. Figure 7.12 shows the location and a depiction of the corrosion of the bents and the flexural crack of the transverse girder.

Figure 7.12. Bridge T-530 Corrosion of Bents and Cracked Transverse Beam

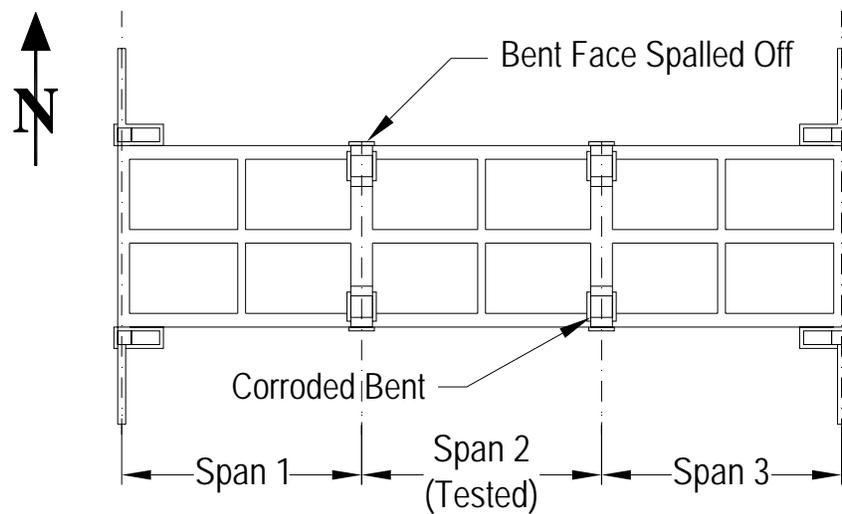
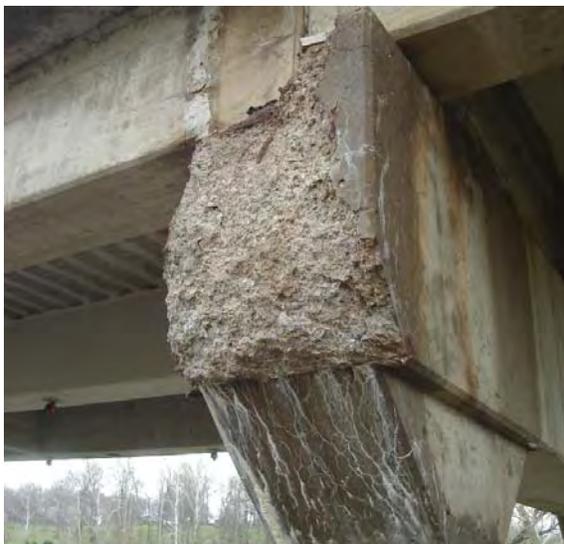
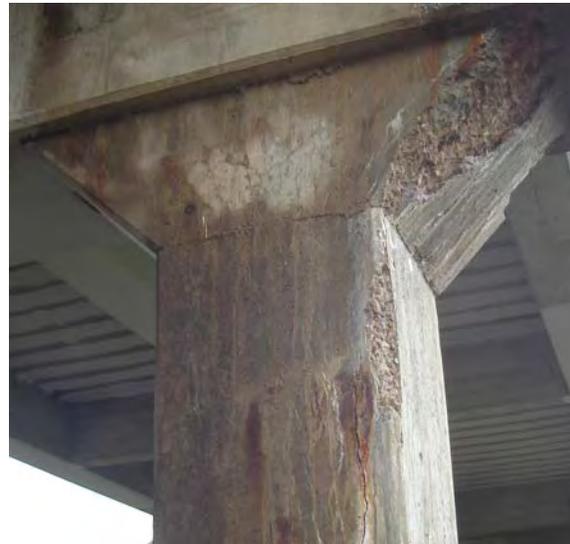
7.6.2. Bridge X-596. Bridge X-596 also exhibited bent corrosion. The exterior face of one bent had spalled off, exposing the reinforcement. This occurred between tests 8 and 9 and was not present prior to construction. In addition, another bent exhibited corrosion at the intersection of the transverse beam with the column. The locations and a picture of each decayed bent are shown in Figure 7.13. Additional corrosion was also observed on the barrier walls in the form of exposed reinforcement and deteriorated concrete.

Figure 7.13. Bridge X-596 Corrosion of Bents

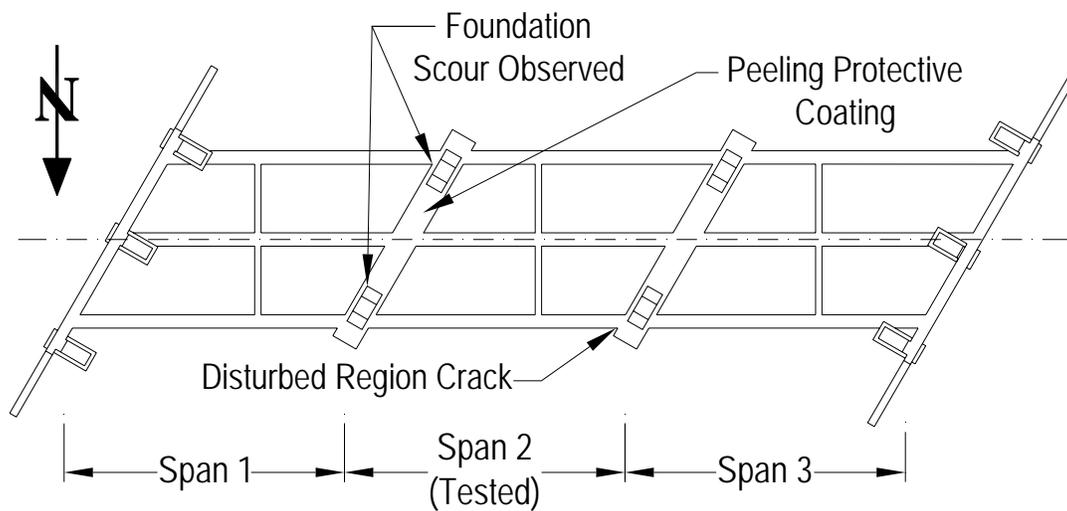
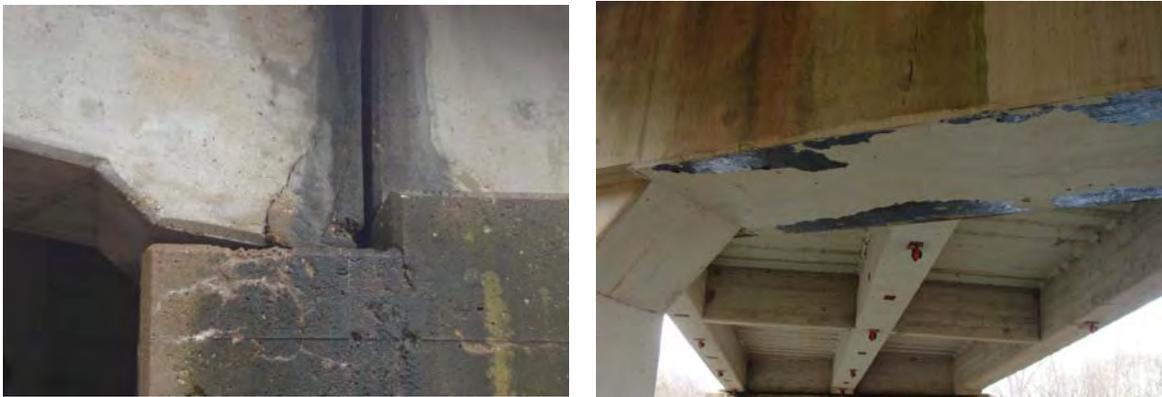
7.6.3. Bridge X-495. The presence of an endspan crack in the disturbed region was noted during the 8th series of tests. This crack did not propagate further when observed during later tests. Additionally, the protective coating on the FRP applied to one bent via manual lay-up is peeling from the bent soffit. This may be due to poor installation or water drainage from the deck. This phenomenon was not observed on the other bent, which was in good condition. The disturbed region crack and protective layer peeling is shown in Figure 7.14 along with the locations of the occurrences. Lastly, there is an appreciable amount of scour around the foundations of one of the bents. This is in the deeper part of the creek and was observed during the 8th test when the water visibility was fairly clear.

Figure 7.14. Bridge X-495 Disturbed Region Crack and Peeling of Protective Coating

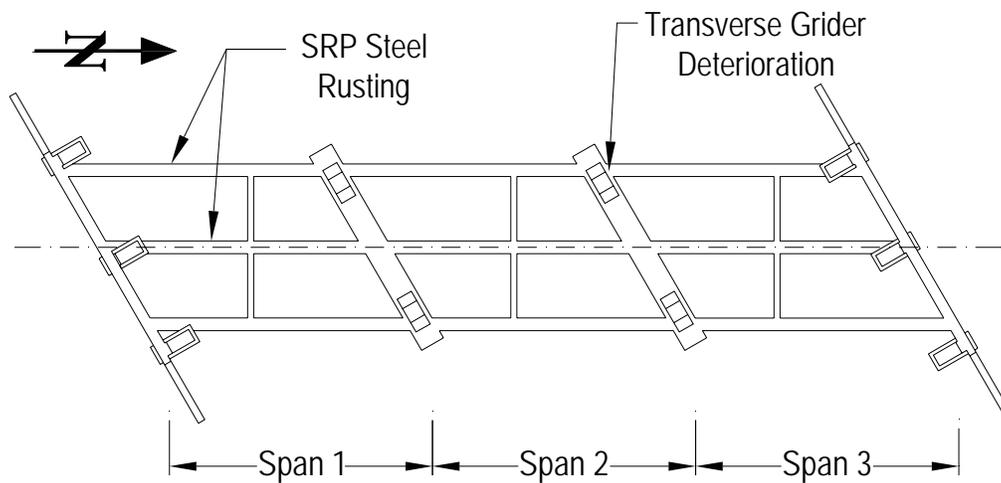
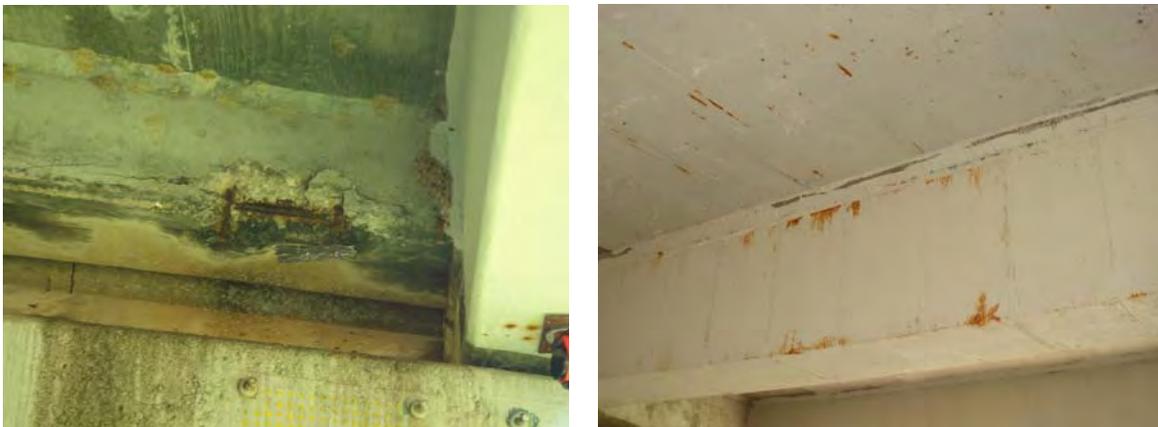
7.6.4. Bridge P-962. The transverse girder at one of the bents showed signs of corrosion in the form of exposed and rusted rebar from spalled concrete. Also, the SRP utilized to strengthen the third span showed signs of rust in many places. This was especially prevalent in locations where water was able to drain from the deck to the girders or bents. The transverse girder corrosion and rusting of SRP can be observed in Figure 7.15 along with the locations of the occurrences.

Figure 7.15. Bridge P-962 Corrosion of Transverse Girder and SRP Reinforcement

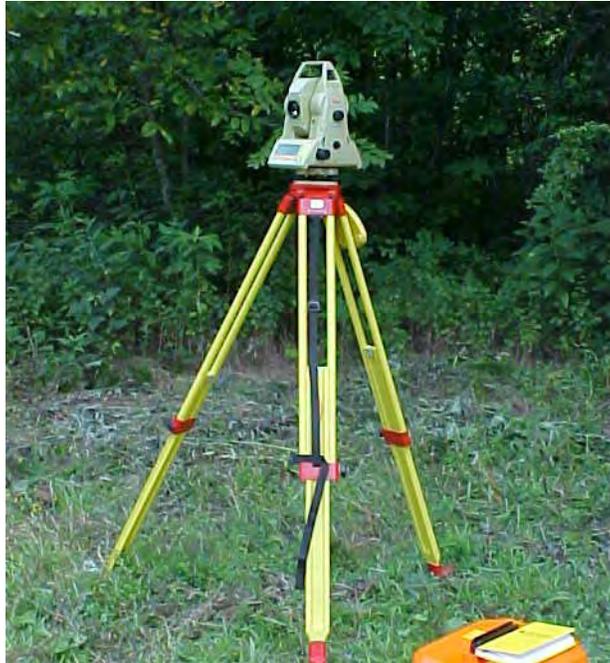
The rest of the site setup took place underneath the structure. The Total Station was placed approximately 50 to 100 feet away from and nearly perpendicular to the tested span, in a shady location, and with an unobstructed view of the tested span. A position in clear sight of all prisms was chosen to maximize the angle between the prism targets on the bridge.. The soil under the Total Station had to be firm and stable. The tripod was first set up: first, the legs were unfastened, released to a desired length, and tightened. The bases of the tripod legs should be approximately equidistant from each other and about three feet apart. Each leg base was then stepped on with enough weight to drive the leg firmly into the soil. The Total Station (instrument) was taken out of its case and secured to the tripod (see Figure C.1). The instrument case was closed to keep it clean and dry. The base of each leg was firmly stood on again. At this point, the legs should not be able to move much in the soil. If movement occurred, the soil would not be considered stable enough and the Total Station would be moved. While looking at the leveling bubble on the instrument, each leg was released, adjusted, and tightened to balance the bubble in the center ring. Next, the “ON” button was pressed followed by the electronic level button to display the fine-adjustments needed to perfectly level the instrument. Using the finger screws at the base of the instrument, the instrument was leveled so that each tilt direction measured 0°00’00”. “CONT” was pressed to return to the main menu.

Figure C.1. Total Station and Tripod

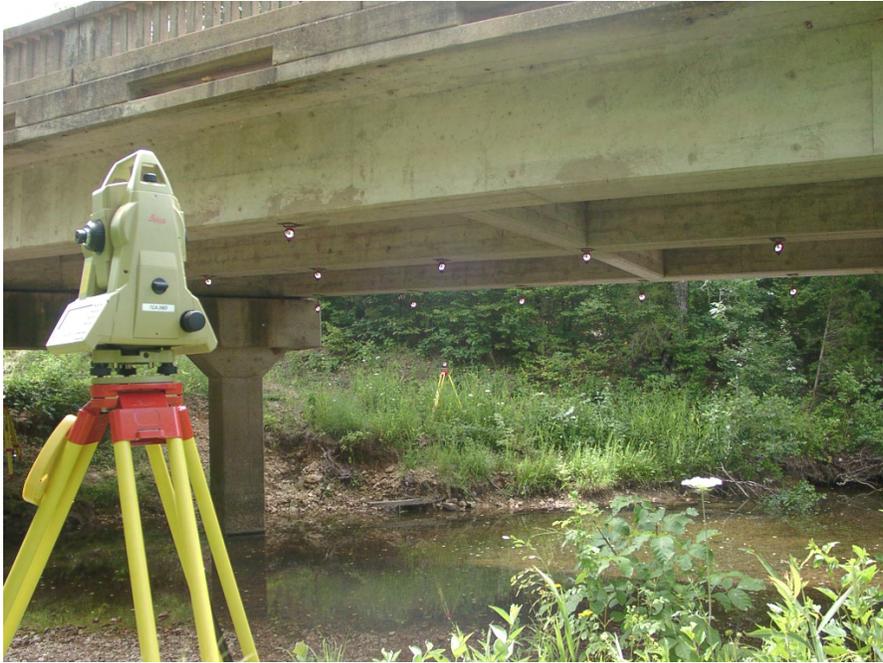
Figure C.2. Site Setup

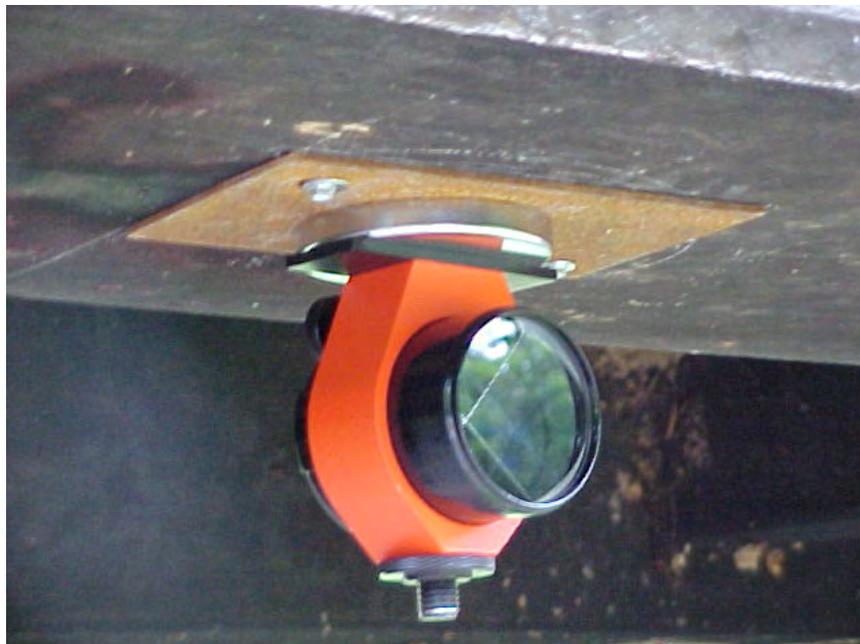
Figure C.3. Short Magnet Mount and Prism

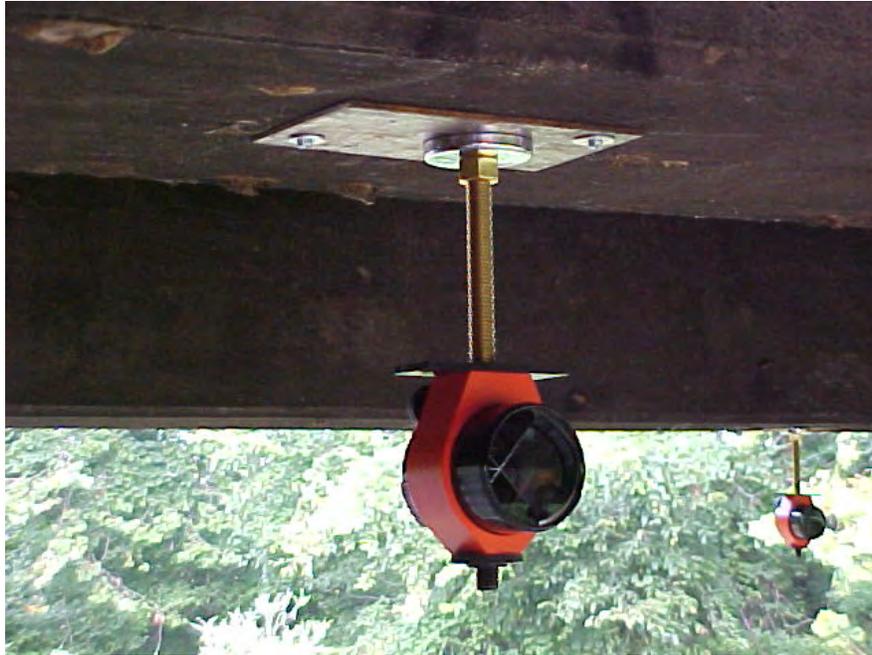
Figure C.4. Long Magnet Mount and Prism

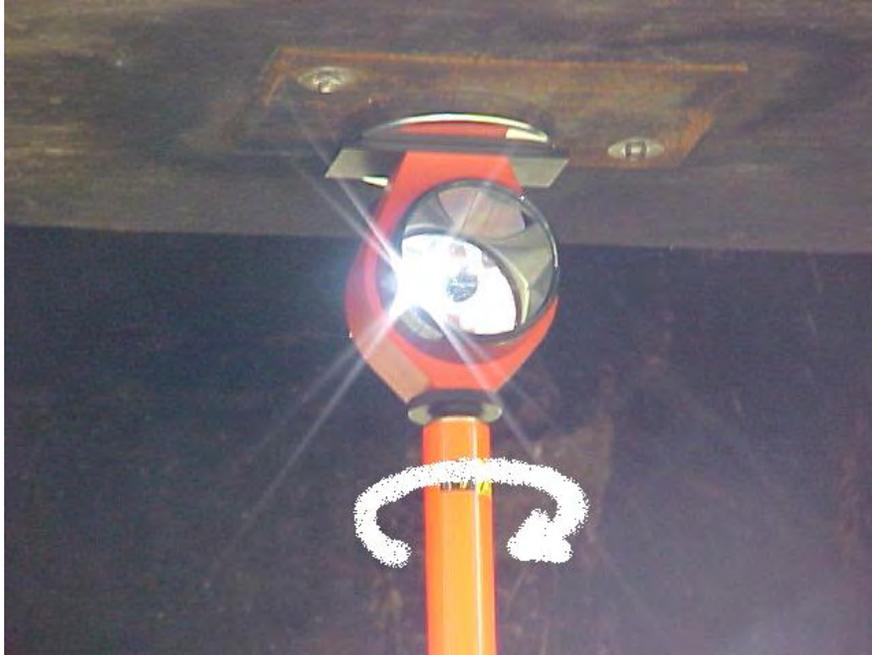
Figure C.5. Screw Range Pole onto Prism

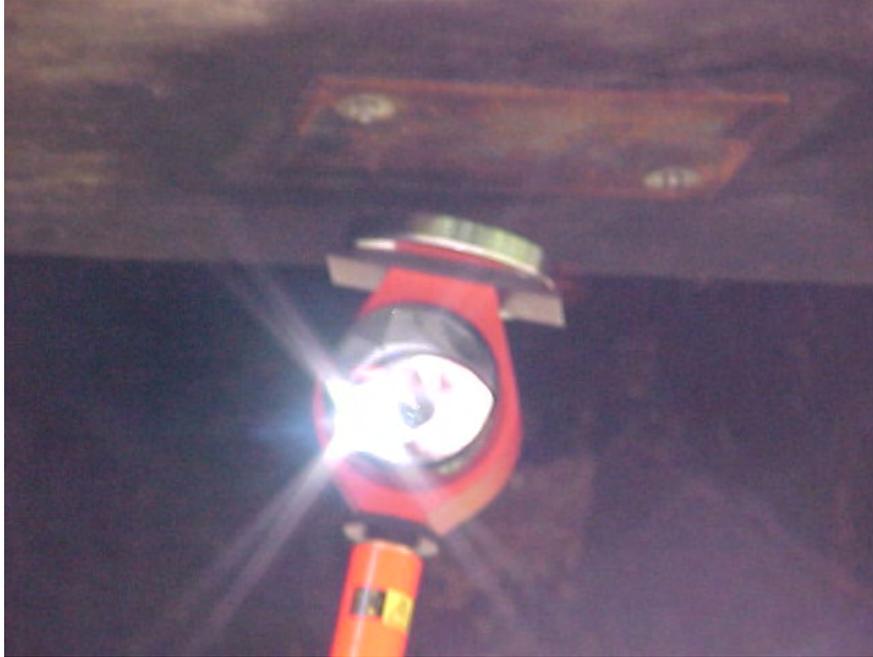
Figure C.6. Pull Down the Prism

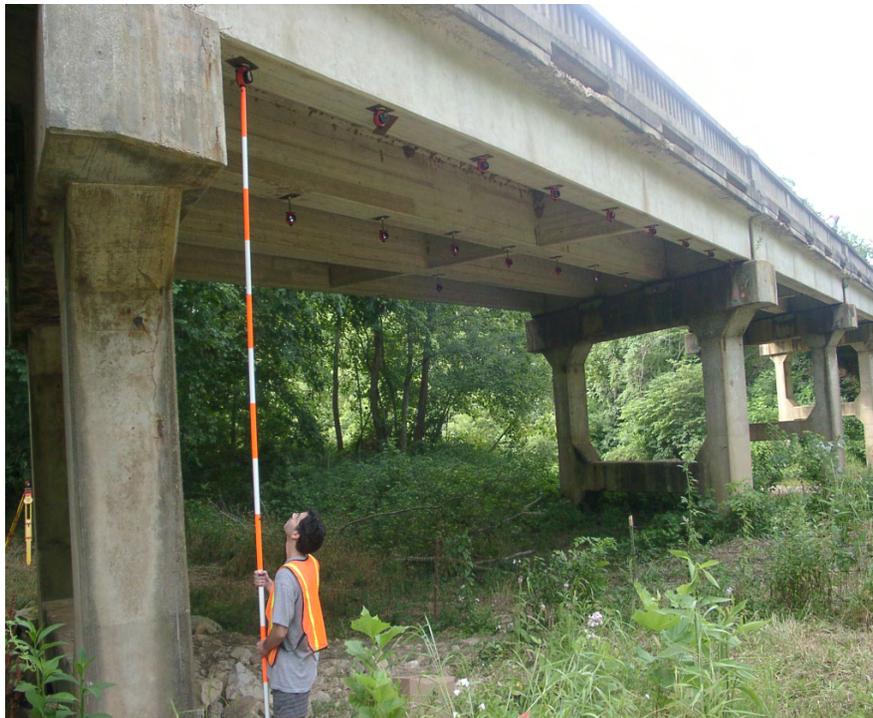
Figure C.7. Range Pole Assembly

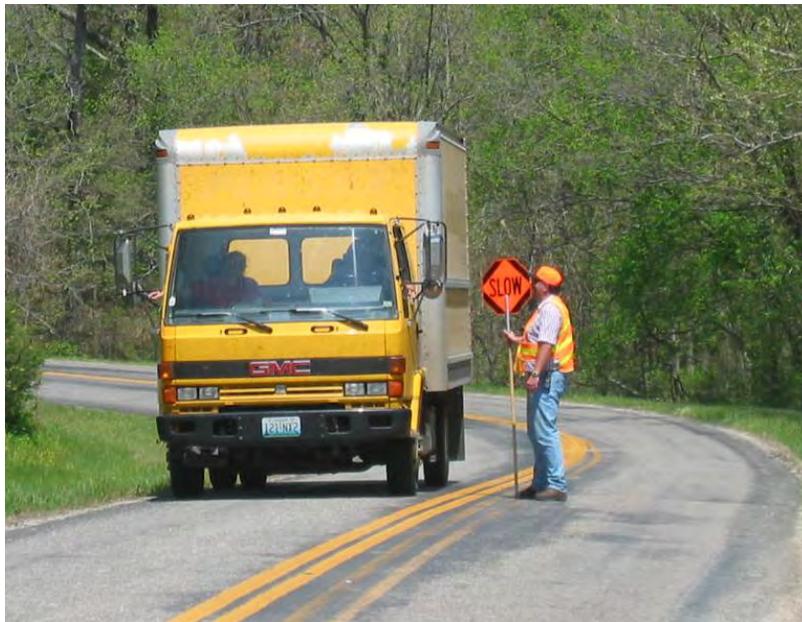
Figure C.8. Traffic Control During Testing
