**Organizational Results Research Report**

# **Coated Steel Rebar for Enhanced Concrete-Steel Bond Strength and Corrosion Resistance**

**Final Report**

September 2010

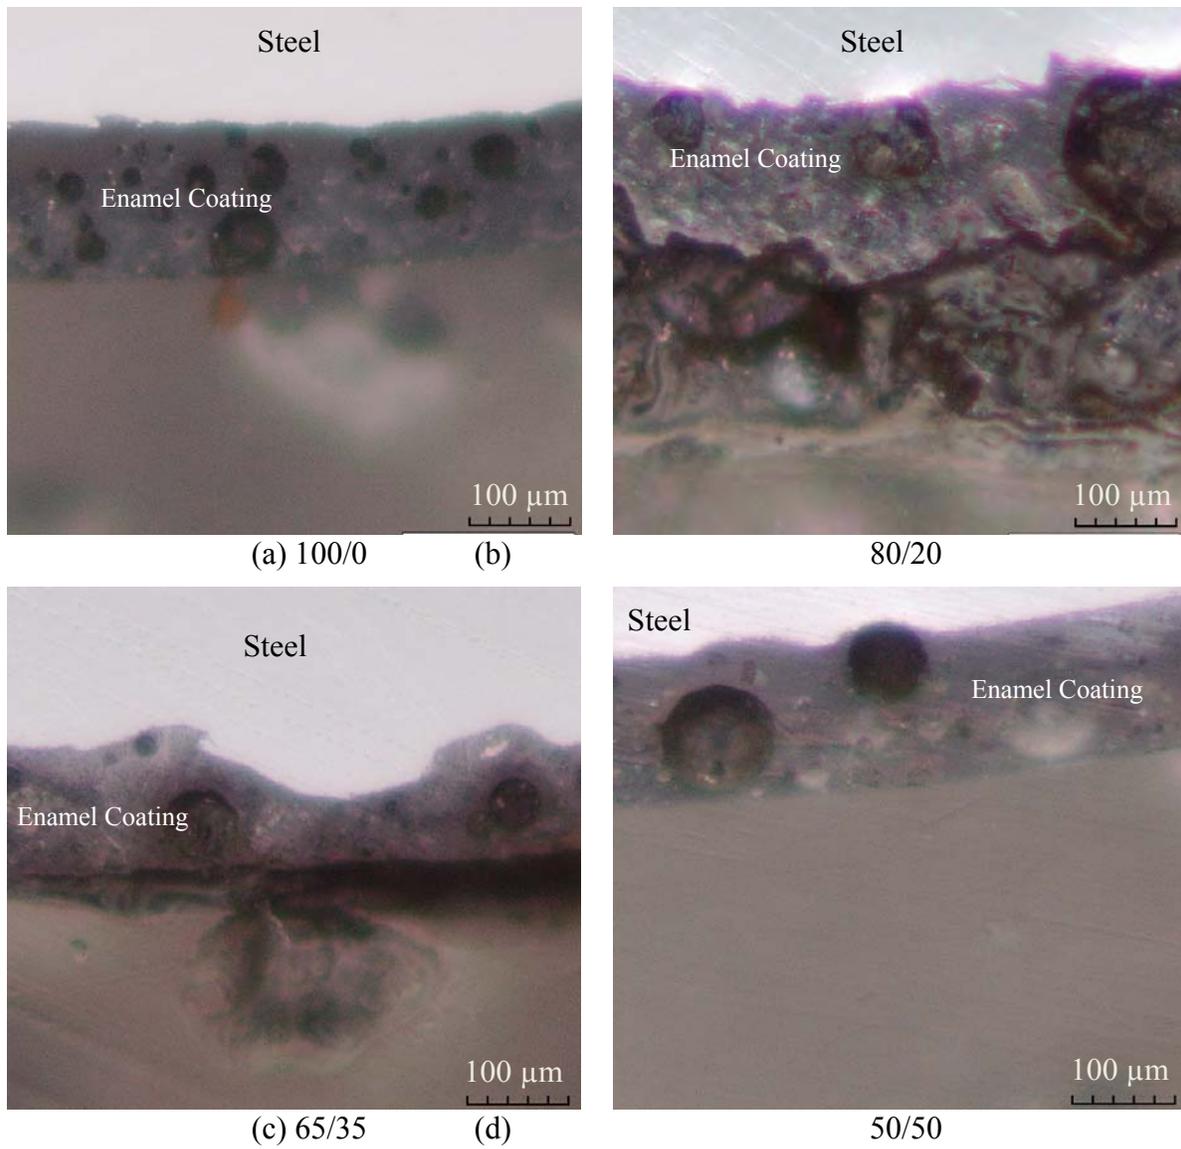
Figure 4.2 Microstructures of various enamel coatings.

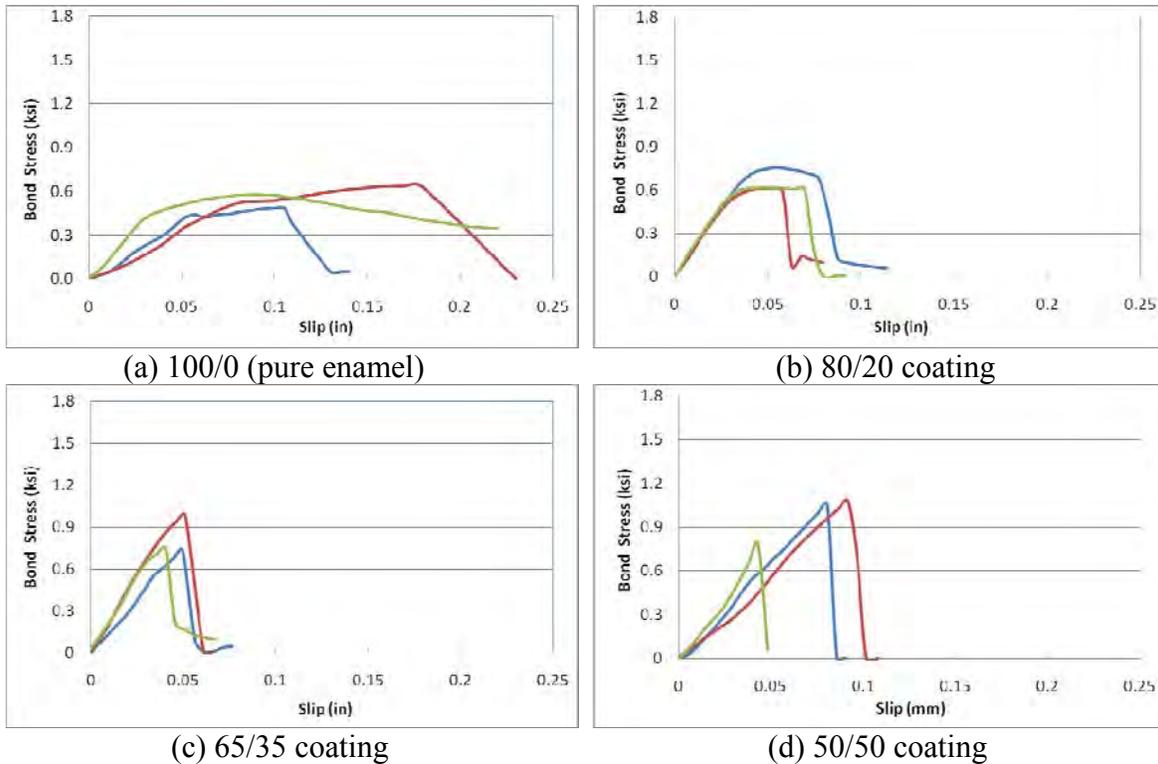
Figure 4.8 Stress-slip curves of specimens with various coatings at curing age of 14 days.

The bond stress-slip curves are depicted in Figures 4.8 through 4.10. They indicated that the rods coated with pure enamel experienced much larger slippage and their corresponding specimens have a more ductile bond behavior than the remaining specimens. Rods coated with enamels with 20% calcium silicate also exhibited a greater degree of slipping, particularly at early curing ages. These results reflect the difference in failure modes between the samples. As shown in Figure 4.11, the steel rods coated with pure enamel were consistently pulled out of the mortar cylinders due to low surface roughness and no chemical reaction with the mortar. When rods coated with the reactive enamel were pulled out, the mortar cylinders often split. The slip between a rod and mortar before the applied load reached its peak decreased with increased curing age for the pure enamel coating and increased for the 65/35 enamel coating. This was also related to the switch in failure modes, but attributable to the fact that mortar becomes stronger with curing time. Stronger mortar becomes more brittle at the mortar-steel interface with pure enamel but delays the splitting failure that controls the slip in the 65/35 coating. The change from ductile to brittle bond behavior of mortar cylinders reinforced with the 80/20 coating was observed as the curing age increased, indicative of the switch from a rod pullout failure to concrete splitting failure. Although the specimens with 50/50 coating consistently failed by the concrete splitting mode, the level of slips before failure follows no consistent pattern, and is most likely due to inconsistent mortar and casting conditions for various specimens. At 28 days of curing, one 65/35 specimen and one 50/50 specimen were damaged during the tests.

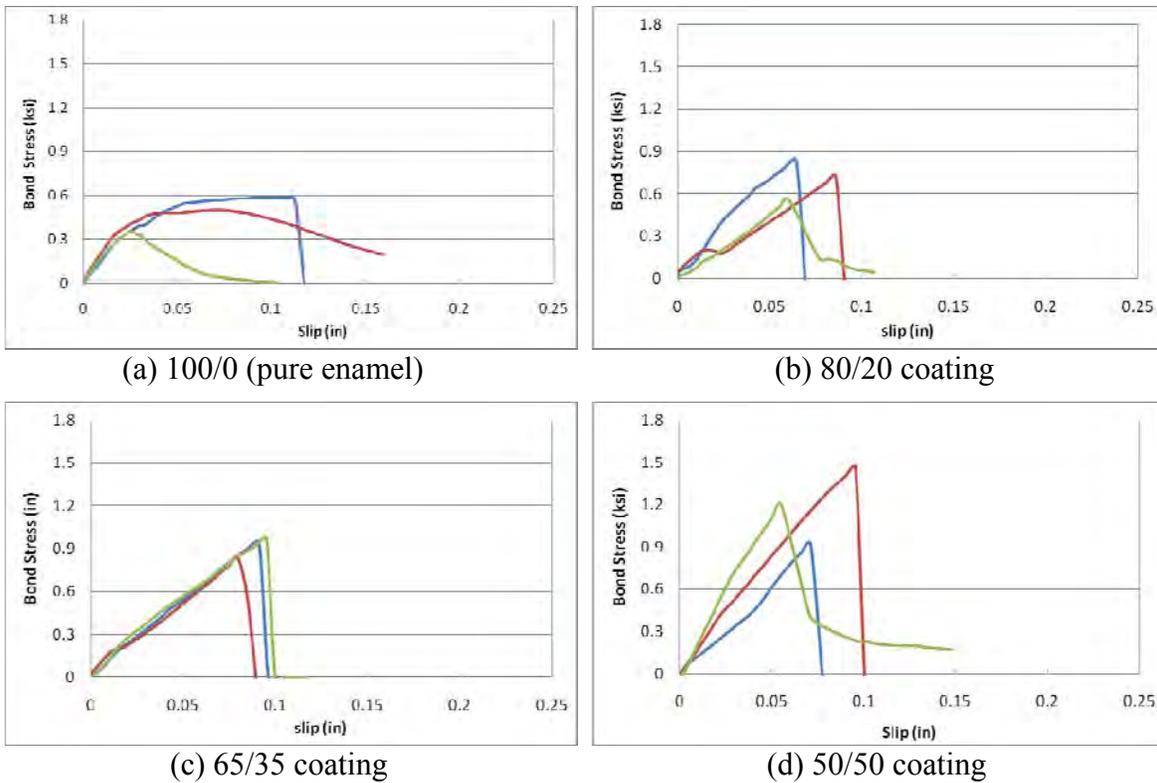
Figure 4.10 Stress-slip curves of specimens with various coatings at curing age of 60 days.

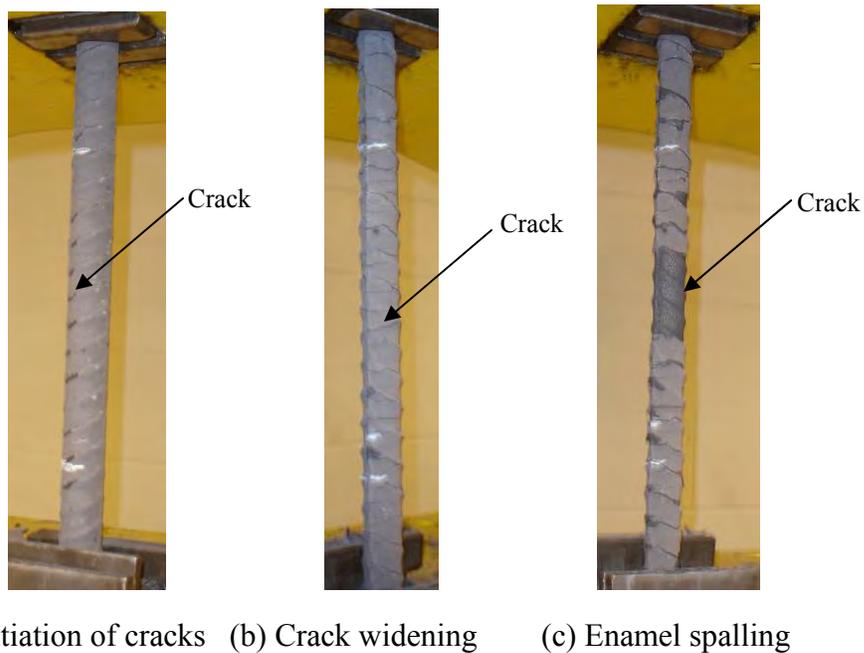
(a) Initiation of cracks (b) Crack widening (c) Enamel spalling

The loading protocol for the tensile tests met the requirements of ASTM A370 (2005). The average load rate was kept at 0.5 in. per minute throughout each test. Crack initiation of the enamel coating was observed at an average strain of  $3000 \mu\epsilon$ . As the load continued to increase, the cracks on the coating surface widened until spalling occurred at the necking portion as illustrated in Figure 5.6.

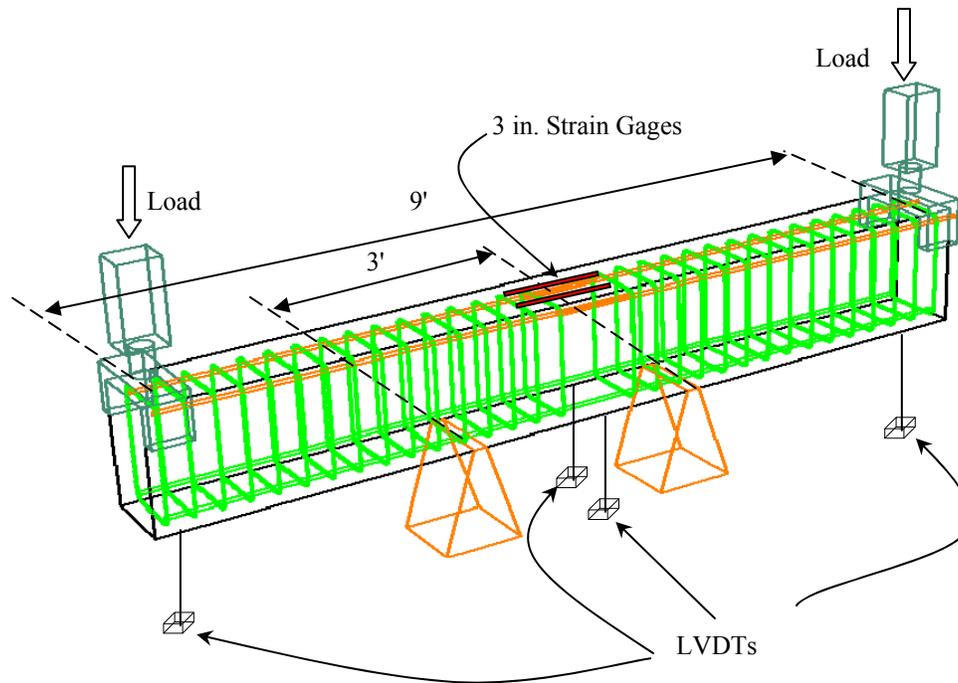
Figure 5.11 Illustration of sensor distribution (excluding embedded sensors).

As illustrated in Figure 5.9, four LVDTs were used to monitor the deflections of a specimen during each test. Two LVDTs were located at the ends of the specimens. The other two were placed at each side of the beam at mid-span to obtain an average value of the mid-span deflection. Two 200-kip capacity load cells were mounted on top of the hydraulic jacks to monitor the load applied during the test. An overall view of external sensors is presented in Figure 5.11.

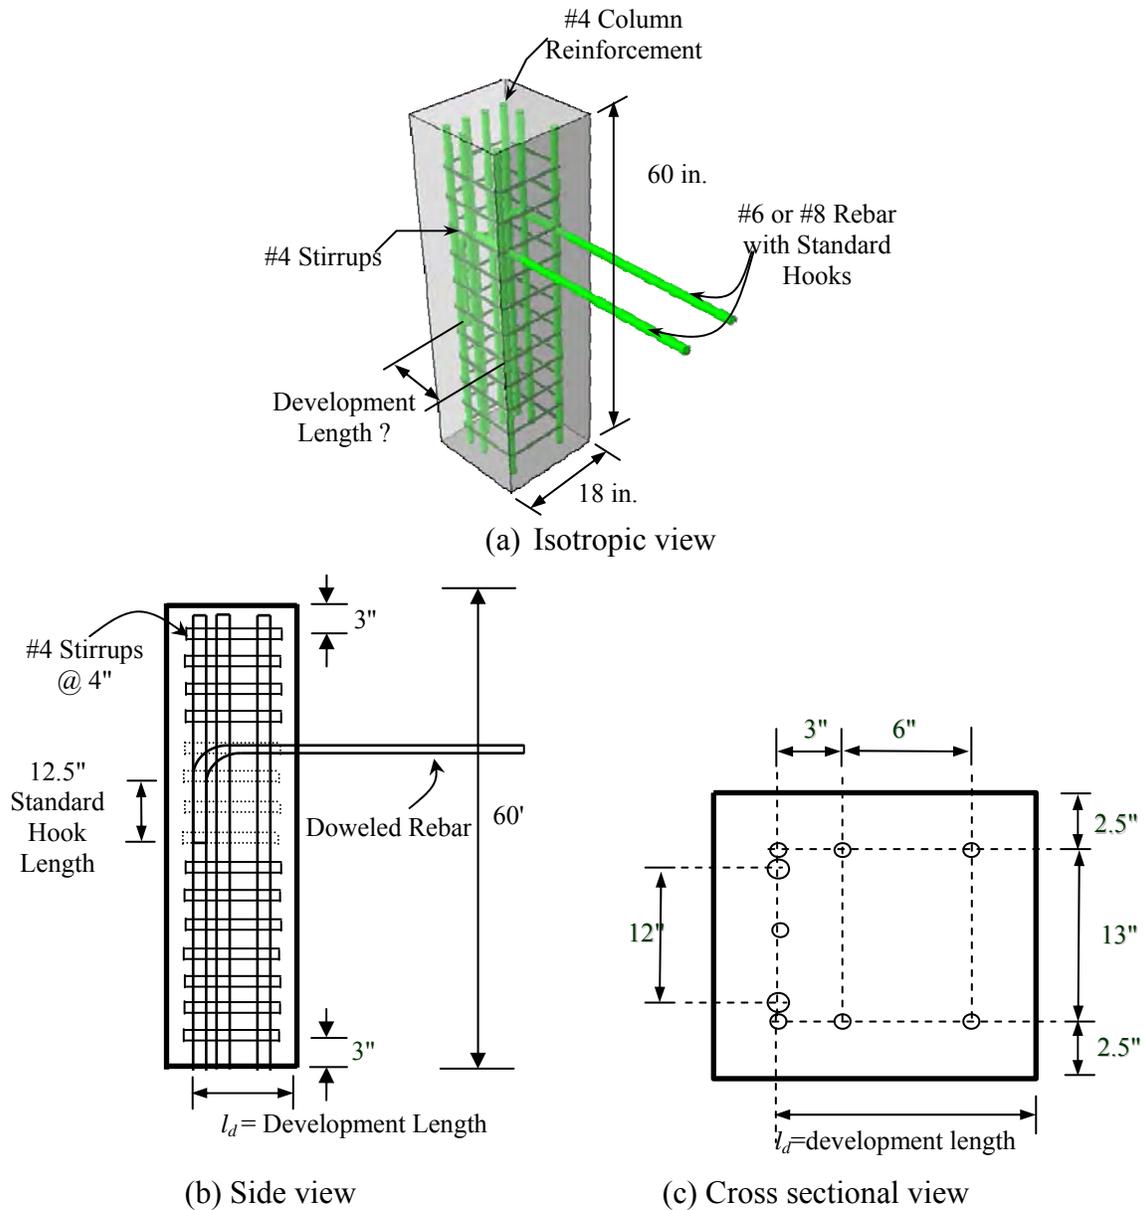
Figure 5.22 Isotropic view of a column specimen.

where  $l_{hb}$  is the required development length,  $d_b$  is the rebar diameter, and  $f'_c$  is the compressive strength of concrete. Figure 5.22(a) shows an isometric view of a short column specimen with a height of 60 in. and a width of 18 in. Each specimen is reinforced with two #6 or #8 rebar with standard 90° hooks to simulate a typical beam-column connection. The dimensions and reinforcement details are presented in Figure 5.22(b, c).

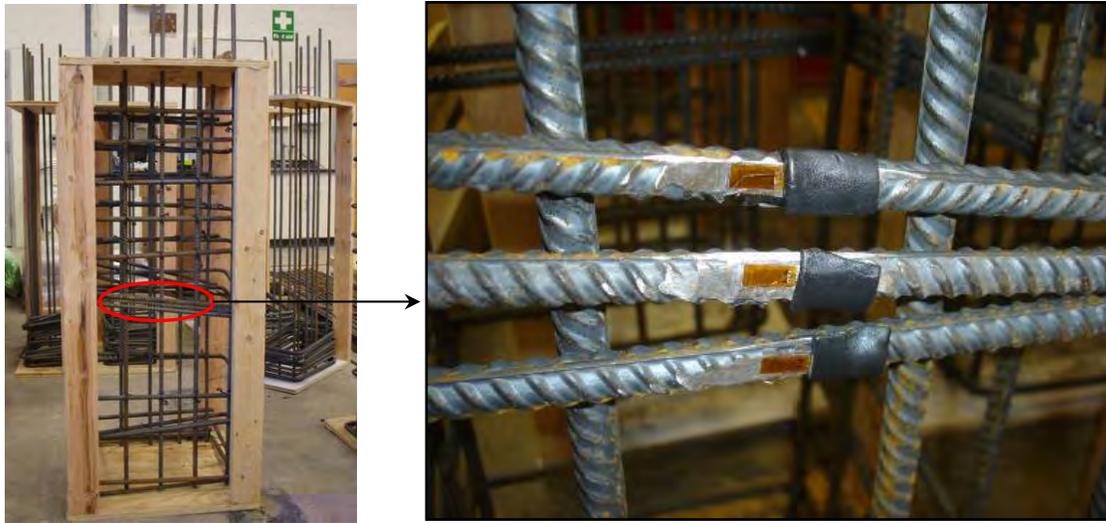
(a) Location of instrumented bars

The displacements at the ends of both dowel bars were measured with two linear motion transducers. The rebar slips against concrete were measured on the top surface of the column near the dowel bars with two LVDTs. The third LVDT was placed on the floor to measure the tilt of the column at the location of the dowel bars. Three strain gages were installed at the middle of the stirrups on one side of the tested specimen, as seen in Figure 5.25. Another three strain gages were installed on one of the two dowel bars in each specimen at locations as illustrated in Figure 5.26.

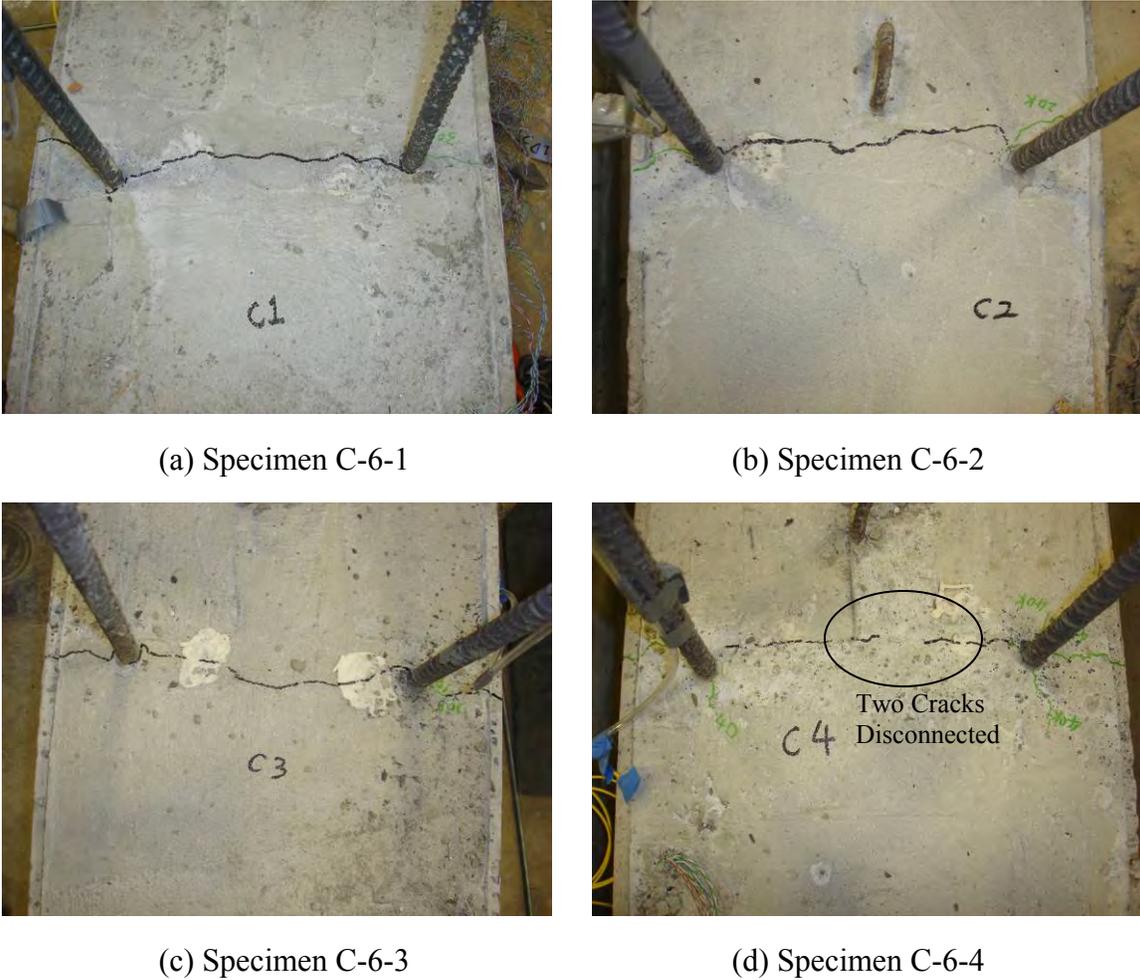
Figure 5.31 Top views of various tested specimens in Group I.

Group I consisted of four reinforced concrete (RC) column specimens with two #6 Grade 60 dowel bars embedded in each column. The 28-day concrete compressive strength for Group I was 4.37 ksi. The top views of the failed specimens are shown in Figure 5.31. Cracks near the two dowel bars of each specimen were initiated from their side covers and propagated toward each other across the top surface. A cross-over crack was finally formed on the top surface as seen in Figure 5.31. The exception to this observation was the crack pattern on the top surface of Specimen C-6-4. As can be clearly observed in Figure 5.31(d), the two cracks initiated around the dowel bars of Specimen C-6-4 were not connected together though the development length of these dowel bars is equal to that of dowel bars in Specimen C-6-1. The only difference between the two specimens is the presence of enamel coating in Specimen C-6-4. This comparison indicates a better bond performance of dowel bars in concrete when coated with reactive enamel. As a result, the coated dowel bars engaged more concrete as they were pulled out of the concrete column, leading to less stress concentrations in the concrete around the dowel bars.

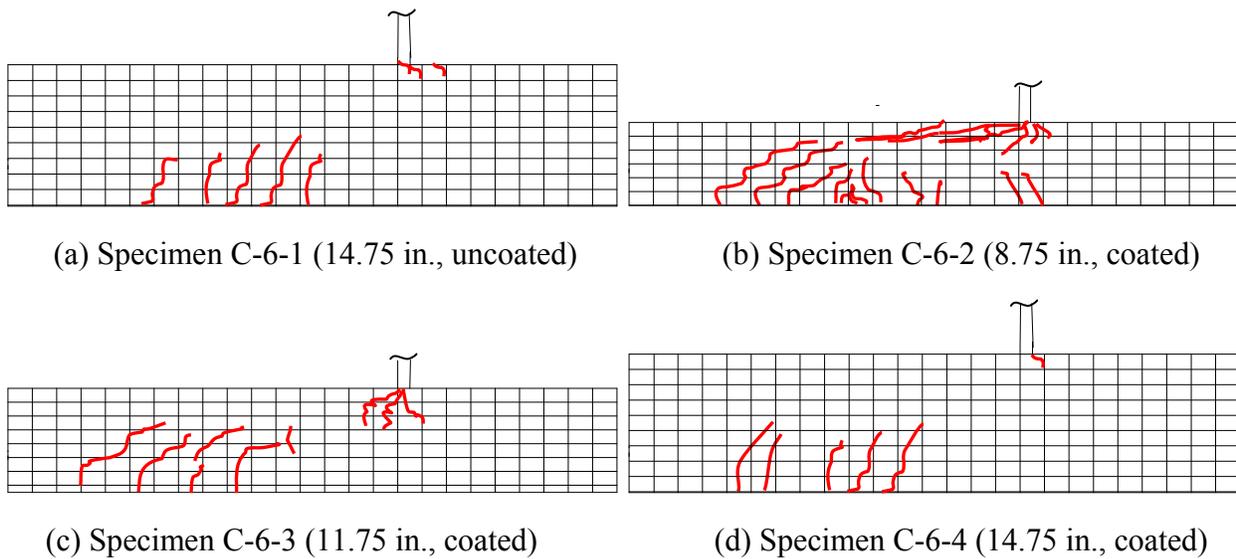
Figure 5.32 Crack patterns on the side of various specimens in Group I (marks traced on the pictures in B&W).

Cracks on the sides of Specimens C-6-1 to C-6-4 were mapped and illustrated in Figure 5.32. It is clearly seen from Figure 5.32 that less cracks in number were observed as the development lengths increased from Specimen C-6-2 to C-6-4. With equal development lengths, Specimen C-6-4 and C-6-1 experienced similar cracks. The former appeared to have less cracks near the dowel bar, which is likely related to the use of enamel coating in Specimen C-6-4. It was interesting to note that severe cracks occurred but no concrete spalling was observed on Specimen C-6-2 even though only 60% of the required length for uncoated bars was considered. Due to the strong bond between enamel-coated rebar and concrete, the cracked concrete pieces most likely remained attached to the rebar in Specimen C-6-2.

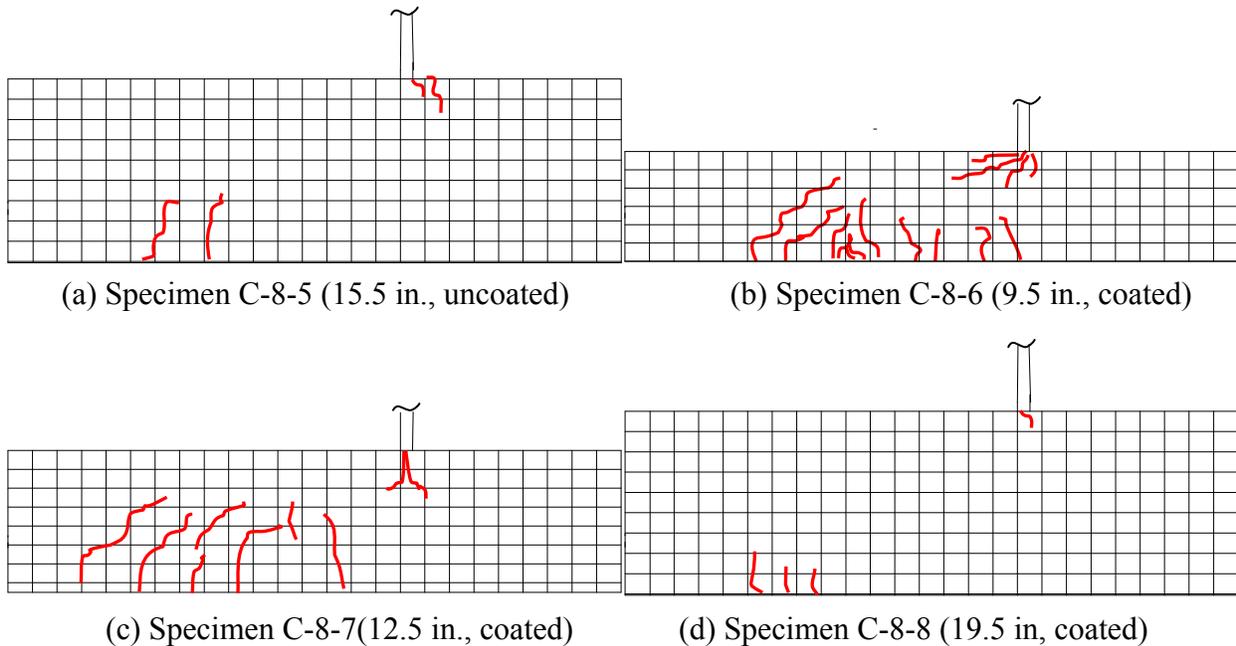
Figure 5.34 Crack patterns on the side of various specimens in Group IV (marks traced on the pictures in B&W).

In comparison with Group I specimens, Group IV specimens experienced much less cracks both in number and length. This result is due to the use of higher concrete strength in Group IV specimens.

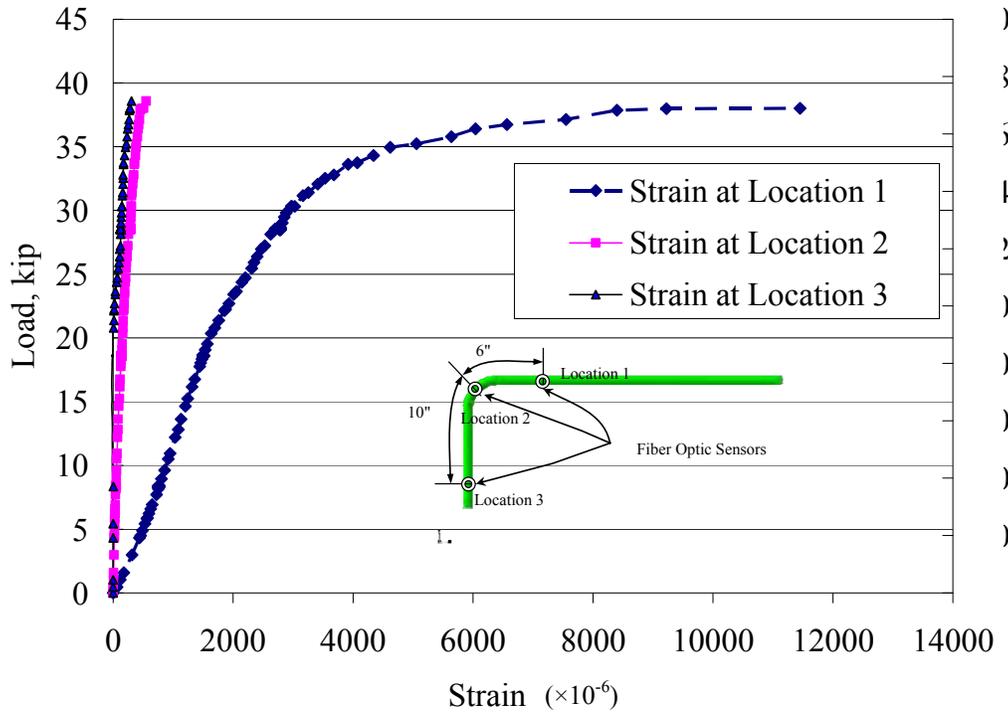
Figure 5.37 Measured strains at three locations by FBG sensors.

with what was observed from the load-slip curves in Figure 5.30(b). Note that the maximum load in Figure 5.37 is smaller than that in Figure 5.30(b) since the FBG sensors began to malfunction at approximately 38.5 kips.

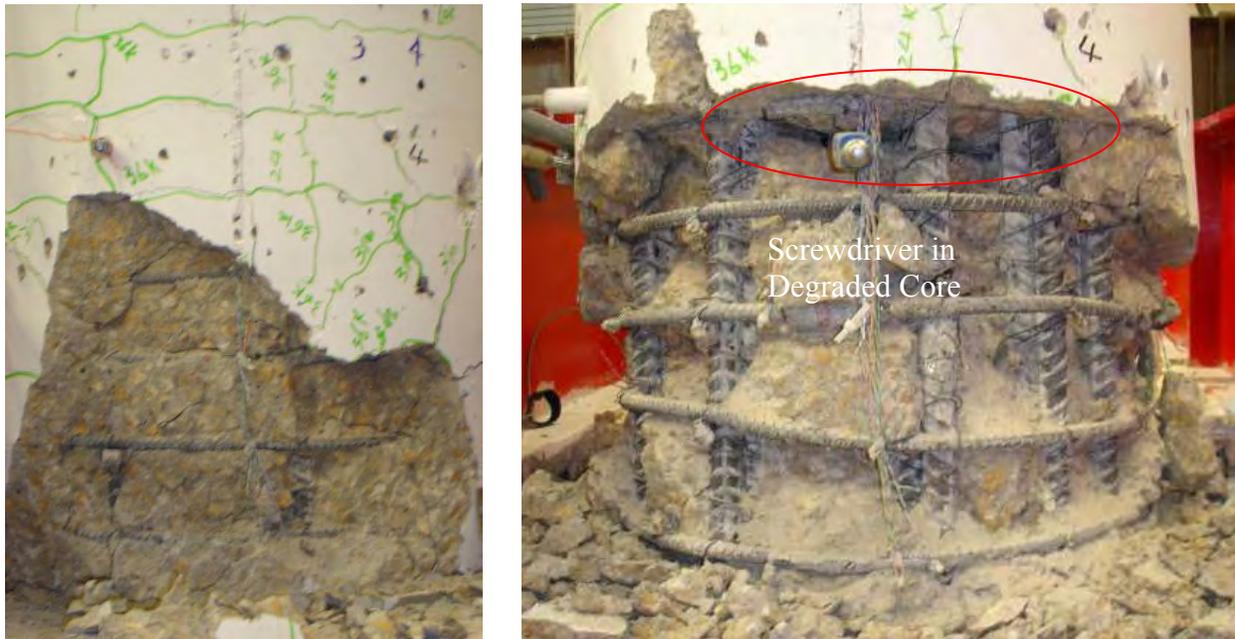
(a) At 6 in. displacement

concrete core near the end of spliced rebar as indicated in Figure 5.48(b). The presence of the hollow concrete core was a strong indication of the column failure at the spliced joint.

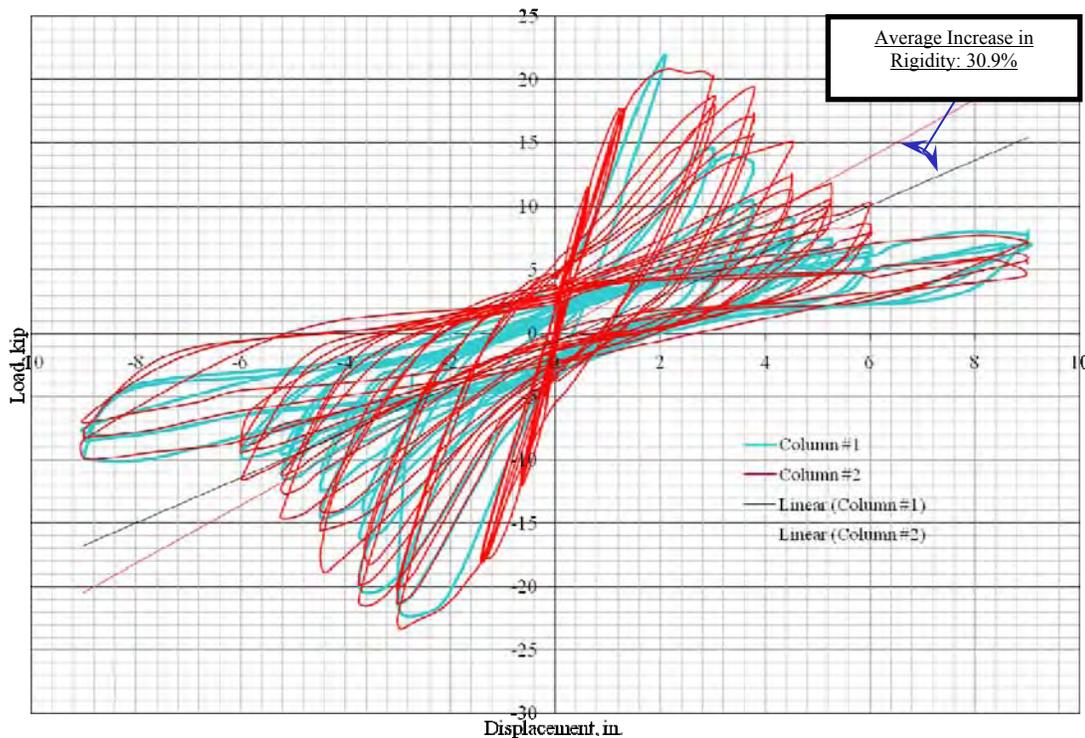
Figure 5.51 Load-displacement curves of two columns.

The load-displacement curves of two columns are compared in Figure 5.51. In this report, an average tangential stiffness of a column was introduced to measure the overall rigidity of the column over a displacement range. It is defined as the arithmetic average of tangential stiffness at all measured displacement points. Figure 5.51 indicates that the increase in tangential stiffness from Column #1 to Column #2 is approximately 30.9%. The stiffness increase is consistent with the change in damaged area as shown in Figure 5.50.

It can also be observed from Figure 5.51 that the envelope of the load-displacement curves of Column #2 basically covers that of Column #1. In two consecutive cycles, Column #1 suddenly experienced a maximum drop of 35.2% in load capacity whereas Column #2 gradually dropped a maximum of 11.6% in load capacity. In comparison with Column #1, Column #2 can dissipate 30.8% more energy over a range of the test displacement, as illustrated and evaluated in Figure 5.52. Here, the energy dissipated is measured by the shaded area in Figure 5.52.

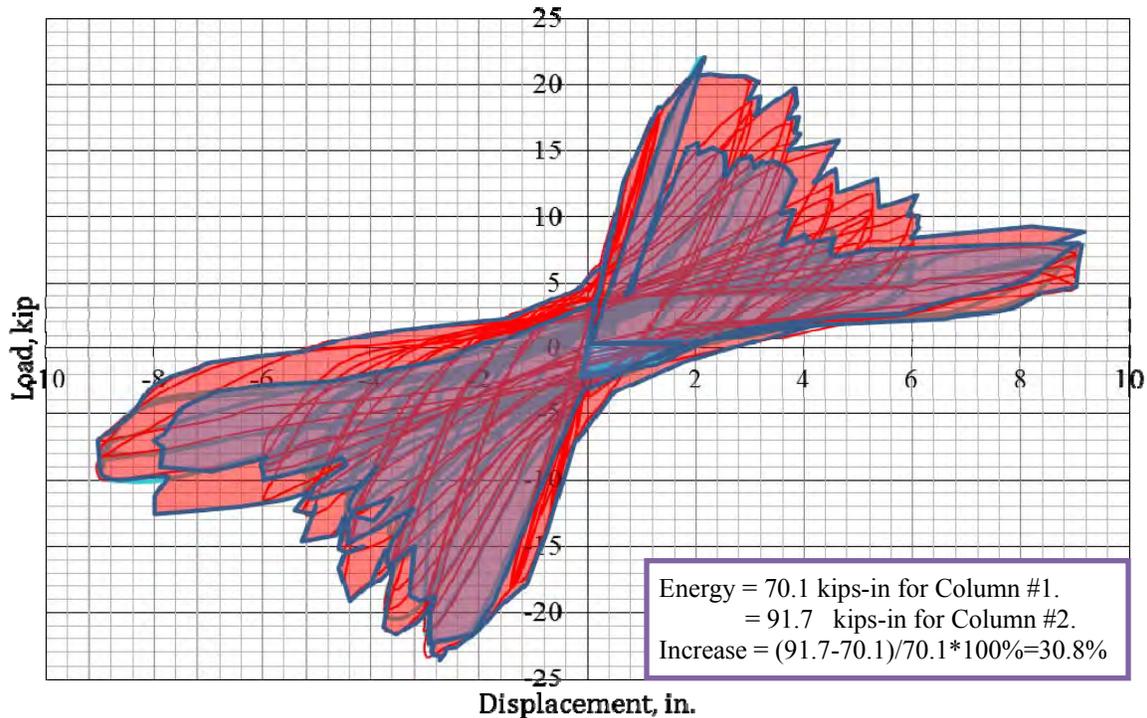
Figure 5.52 Dissipated energy in two columns.

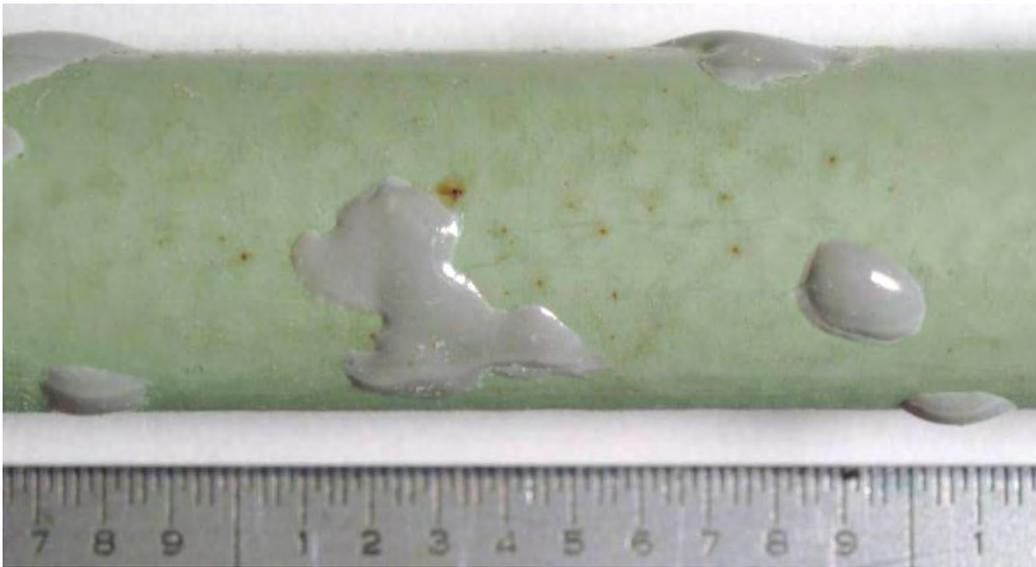
(a) Typical spots of corrosion in a deformed and a smooth bar after testing

(b) Sign of degradation of an epoxy-coated smooth bar

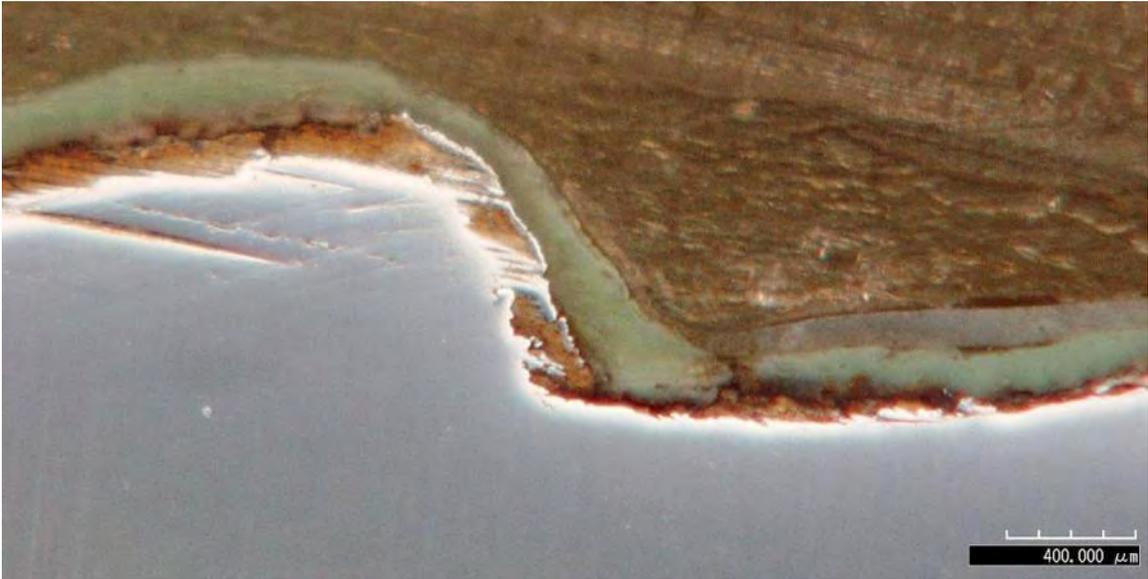
(a) Longitudinal view of a deformed bar

(b) Steel corroding underneath a slightly damaged section of epoxy coating after testing

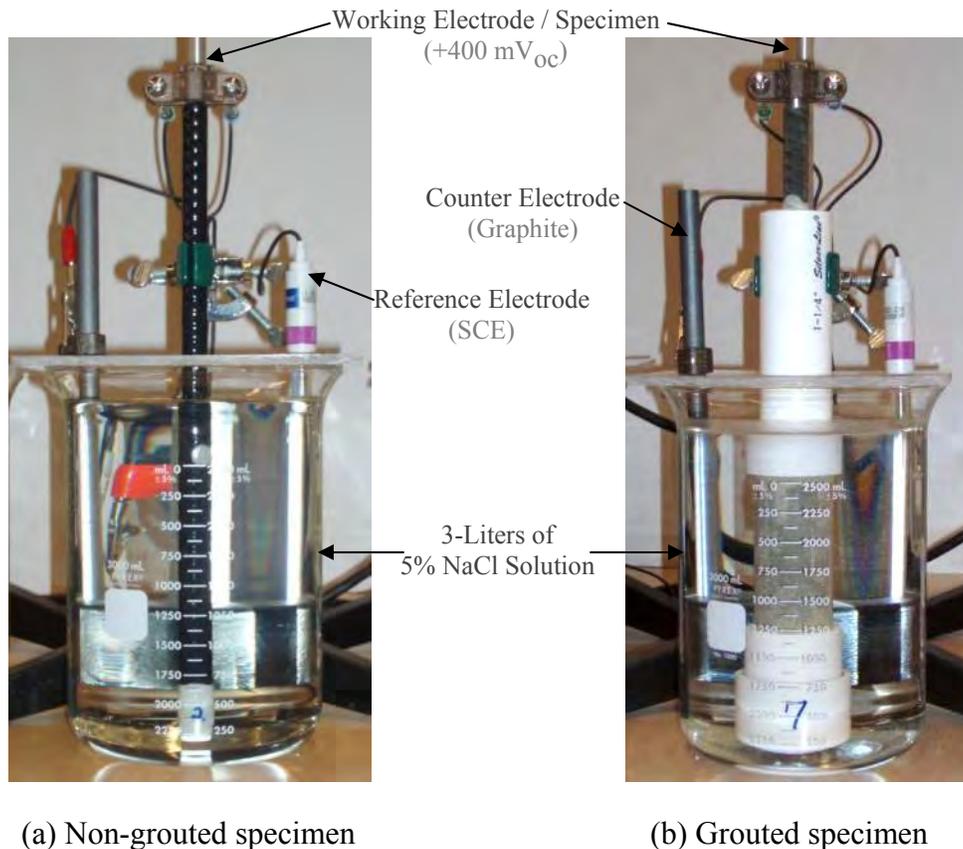
Figure 6.20 Test setup of a typical specimen in a beaker.

After prepping a set of specimens, each specimen was then placed within a corrosion cell, as shown in Figure 6.20. The corrosion cell consisted of a glass beaker that contained approximately 0.8 gallons (3 liters) of electrolyte. The electrolyte was composed of deionized water and 5 percent ACS grade sodium chloride (NaCl) by weight. Before batching the solution, the deionized water was given a minimum of 24 hours to reach an ambient temperature of approximately 68°F (20°C). Once a specimen was positioned within the solution, a plexiglass top was placed over the beaker. A brass grounding clamp was then attached to the exposed steel located at the top of the specimen. Both the counter and reference electrodes were then partially inserted into the solution. The centroids of the counter and reference electrodes were equally spaced at a distance of approximately 2.4 in. (60 mm) from the center of the specimen (the working electrode). As shown in Figure 6.20, the counter and reference electrodes were supported by the plexiglass top and were located on opposite sides of the specimen. The counter electrode, supported approximately ½ in. (13 mm) above the bottom of the beaker, was made of a graphite rod that was ½ in. (13 mm) in diameter and 12 in. (305 mm) in length. The graphite rod, manufactured by Graphtek LLC, was a grade GM-10. A gel-filled saturated calomel electrode (SCE), manufactured by Fisher Scientific, was used as the reference electrode and was positioned at a depth of approximately 3½ in. (89 mm) within the solution. After the electrodes were partially immersed within the solution, they were then individually connected to an eight-channel ECM8 multiplexer which was attached to a Series G300 potentiostat. Both the multiplexer and the potentiostat were manufactured by Gamry Instruments.

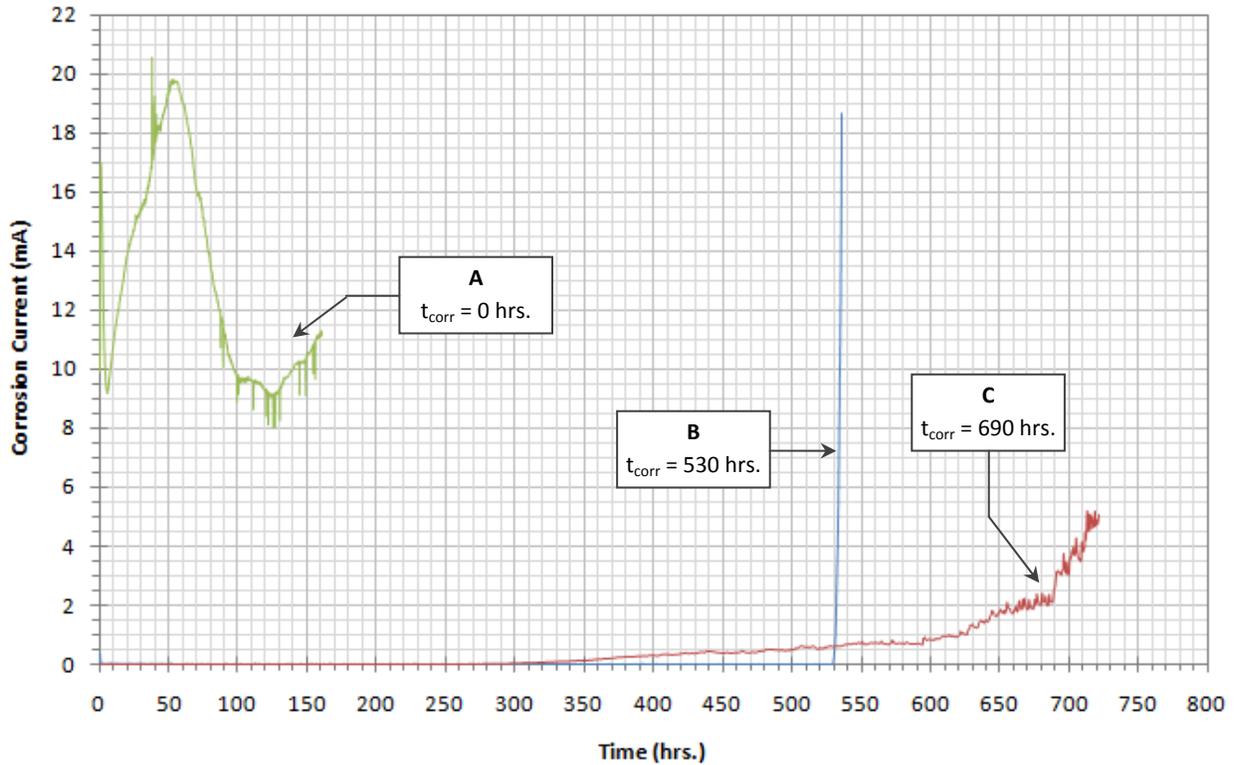
Figure 6.25 Three test results commonly seen during the ACT phase.

value that was measured from the start of the test to the moment when the well defined spike in corrosion current first appeared. For example, the specimen that produced the result labeled “B” in Figure 5.25 received a  $t_{\text{corr}}$  value of 530 hours. If a specimen exhibited a minor increase in corrosion current over a long period of time that was then followed by a more significant increase in corrosion current, the  $t_{\text{corr}}$  value for that specimen would have been measured from the start of testing to the point at which the first significant increase in corrosion current was first detected. For instance, the specimen that produced the result labeled “C” in Figure 5.25 was assigned a  $t_{\text{corr}}$  value of 690 hours.

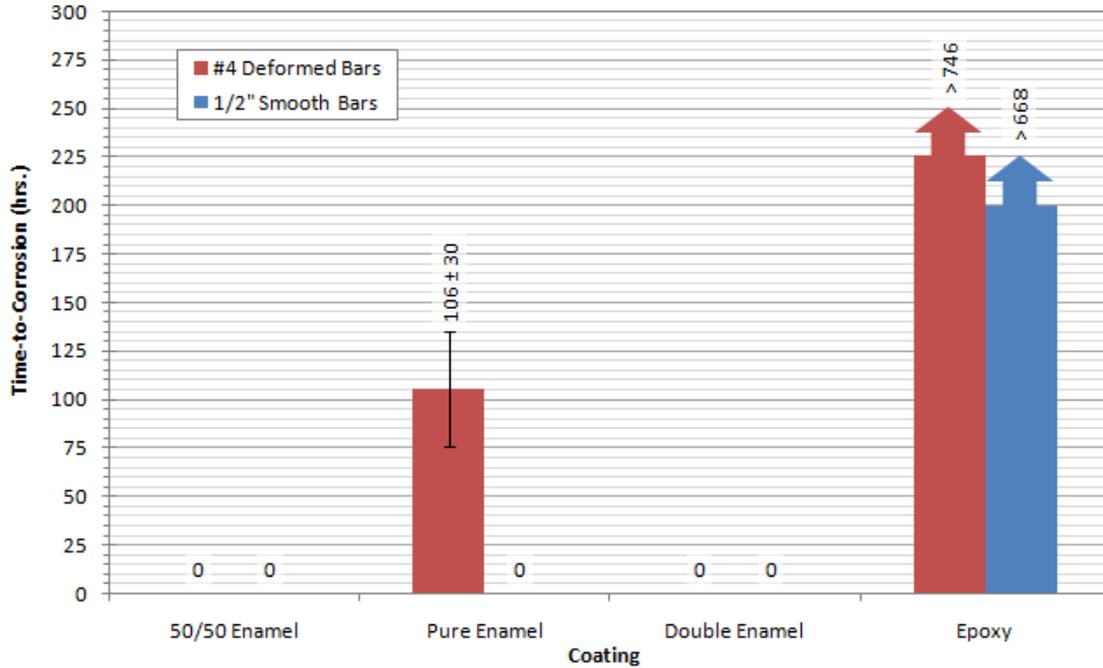
Figure 6.26 Test result summary for the non-grouted specimens.

A summary of the ACT results for the non-grouted specimens is shown in Figure 6.26. The 95 percent confidence interval for each set’s average  $t_{\text{corr}}$  is also included in Figure 6.26. A set’s confidence interval was developed using the standard error of a set’s mean value (SEM). The SEM for a set of specimens was calculated by dividing the standard deviation of the sample set by the square root of the number of specimens used in deriving the set’s average  $t_{\text{corr}}$  value.

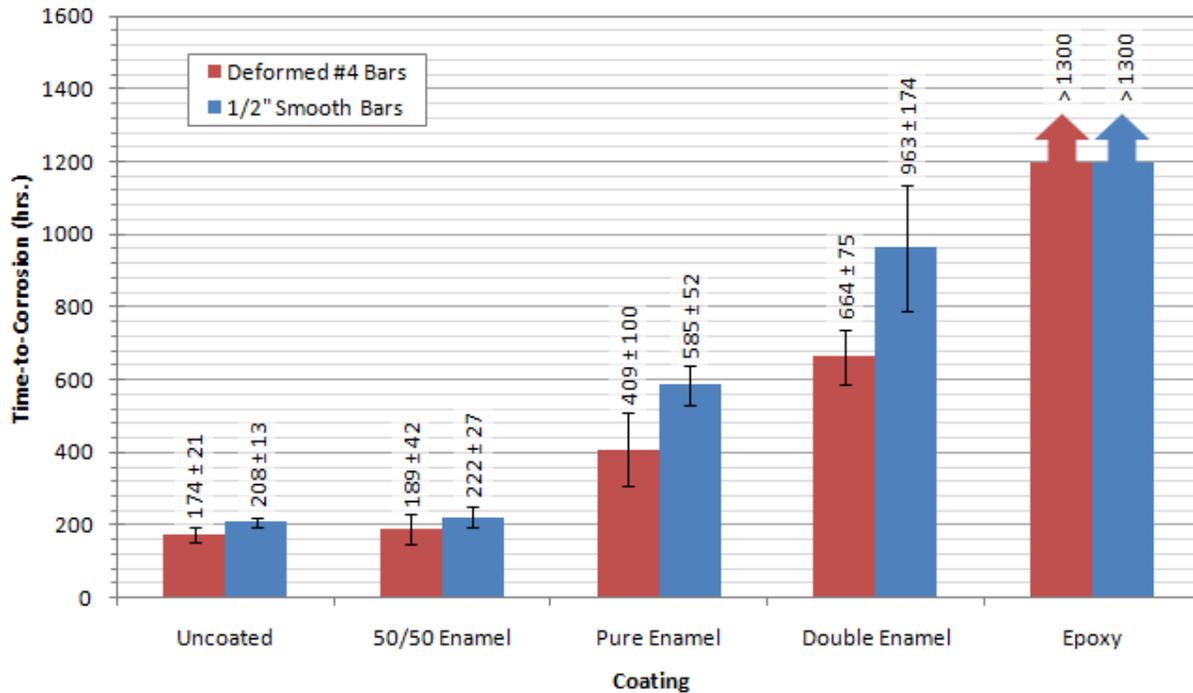
Figure 6.27 Test result summary for the grouted specimens.

A summary of the ACT results for the grouted specimens is shown in Figure 6.27. The 95 percent confidence interval for each set's average  $t_{\text{corr}}$  is also included in the figure. A set's confidence interval was developed using the standard error of a set's mean value (SEM). The SEM for a set of specimens was calculated by dividing the standard deviation of the sample set by the square root of the number of specimens used in deriving the set's average  $t_{\text{corr}}$  value.

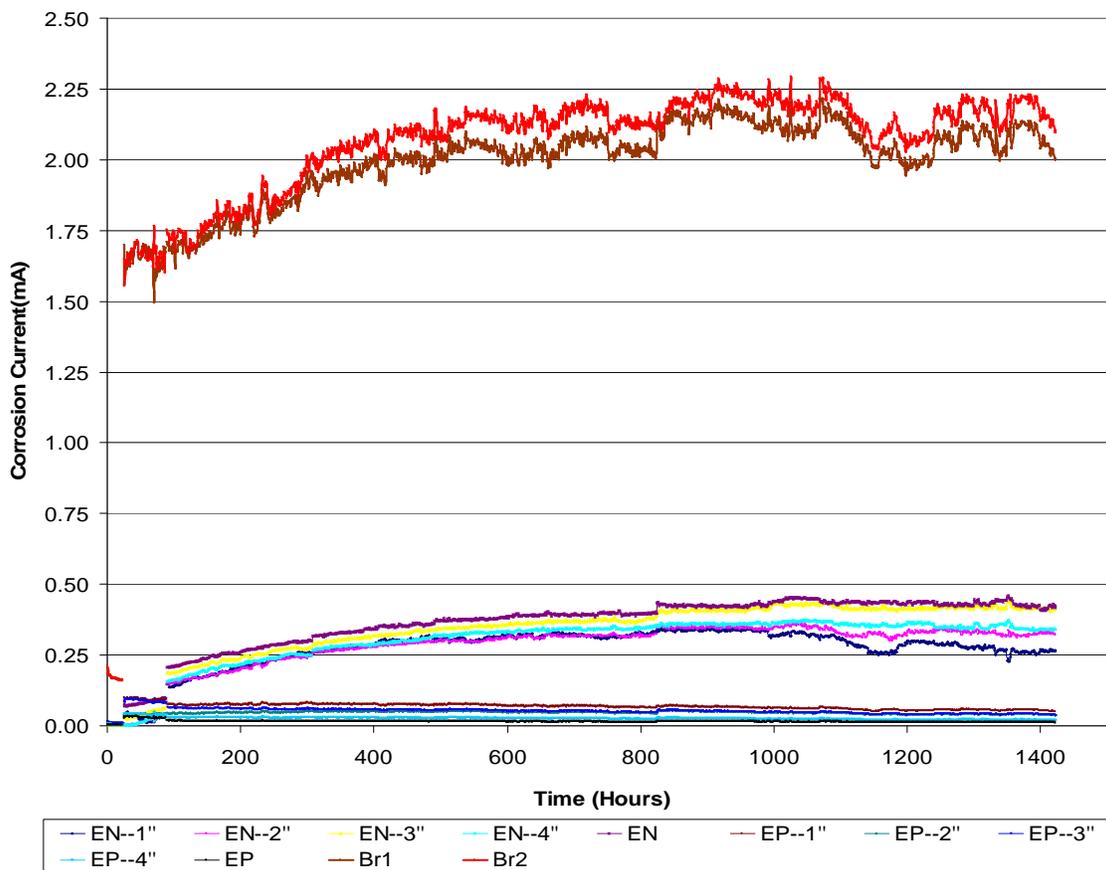
Figure 6.28 Corrosion currents of the 12 tested bars.

Figure 6.28 presents the recorded corrosion currents from all specimens as a function of time. For uncoated (Br) and for enamel-coated (EN) rebar, the corrosion current increased with time and approached a nearly constant value after 600 hours. The asymptotic corrosion current is between 2.00 mA and 2.25 mA for uncoated rebar, and between 0.25 mA and 0.50 mA for enamel-coated rebar. The corrosion current for epoxy-coated (EP) bars are always less than 0.1 mA. The corrosion current densities for all the tested rebar are listed in Table 6.2. The corrosion current of enamel-coated steel bars lies between those of uncoated bars and epoxy-coated bars. The corrosion current density is approximately  $77.4 \text{ uA/in}^2$  ( $12 \text{ uA/cm}^2$ ) for uncoated rebar,  $12.9 \text{ uA/in}^2$  ( $2.00 \text{ uA/cm}^2$ ) for enamel-coated rebar, and  $0.3 \text{ uA/cm}^2$  for epoxy-coated rebar. Note EN-1" in Figure 6.28 and Table 6.2 means an enamel-coated specimen with damage at 1 in. interval.

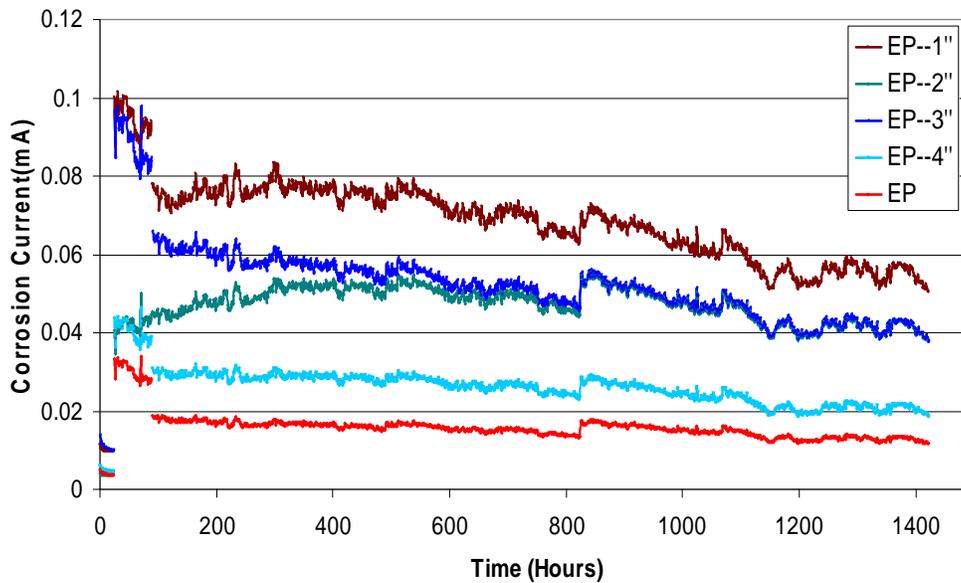
Figure 6.30 Corrosion current of epoxy-coated rebar.

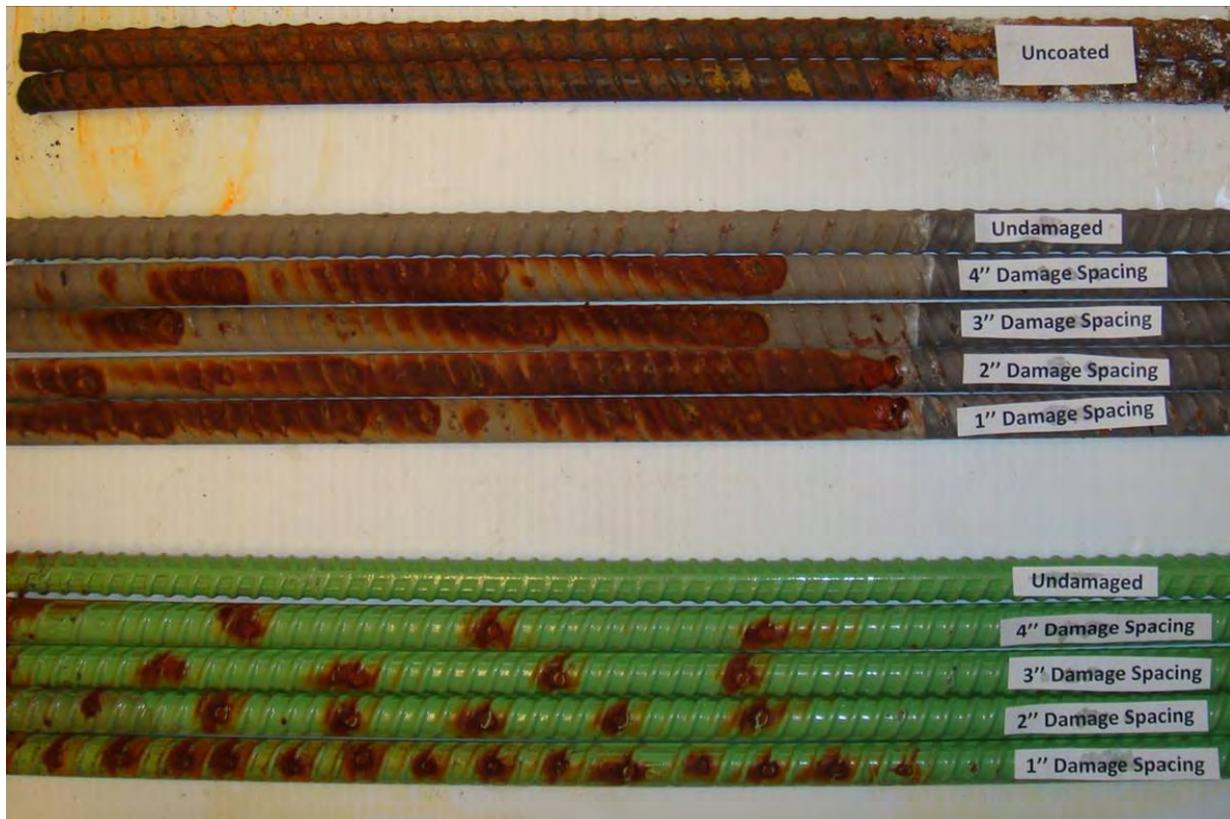
Figure 6.31 Surface conditions of all tested rebar after testing
