**Organizational Results Research Report**

# **Coated Steel Rebar for Enhanced Concrete-Steel Bond Strength and Corrosion Resistance**

**Final Report**

September 2010

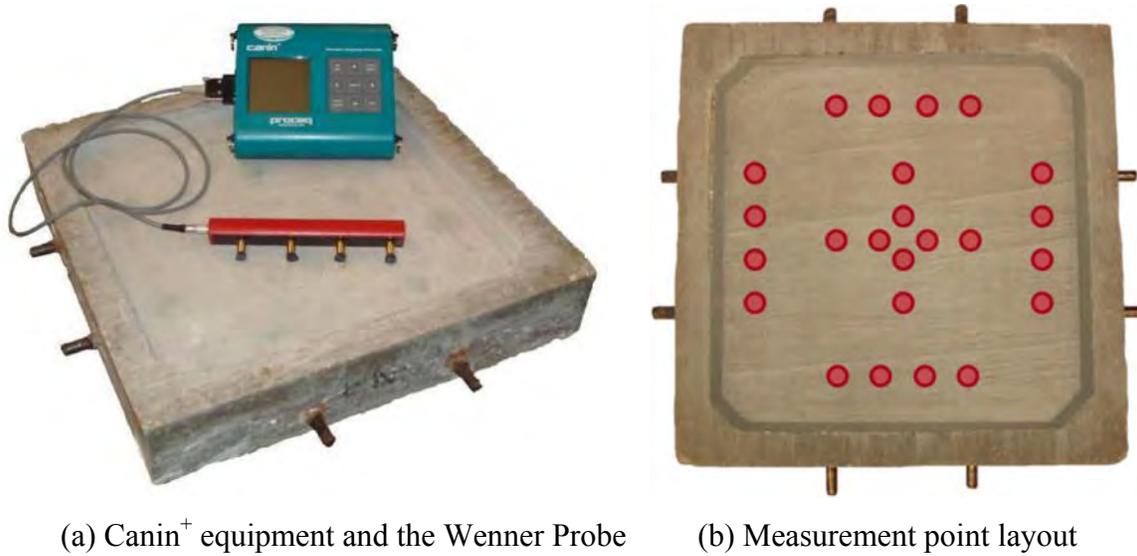
(a) Canin<sup>+</sup> equipment and the Wenner Probe      (b) Measurement point layout

The resistivity of each specimen was measured every six weeks with the use of a Canin<sup>+</sup>, a corrosion analyzing instrument manufactured by Proceq. Canin<sup>+</sup> incorporated the use of a Wenner Probe, also known as a four probe resistivity meter, which has a fixed electrode spacing of 2 in. (51 mm) and a nominal alternating current (AC) output of 180  $\mu$ A at a frequency of 72 Hz. The equipment had an impedance of 10 M $\Omega$  and an operating range of 0 to 99 k $\Omega$ cm. The Canin<sup>+</sup> along with the Wenner Probe may be seen in Figure 6.36(a).

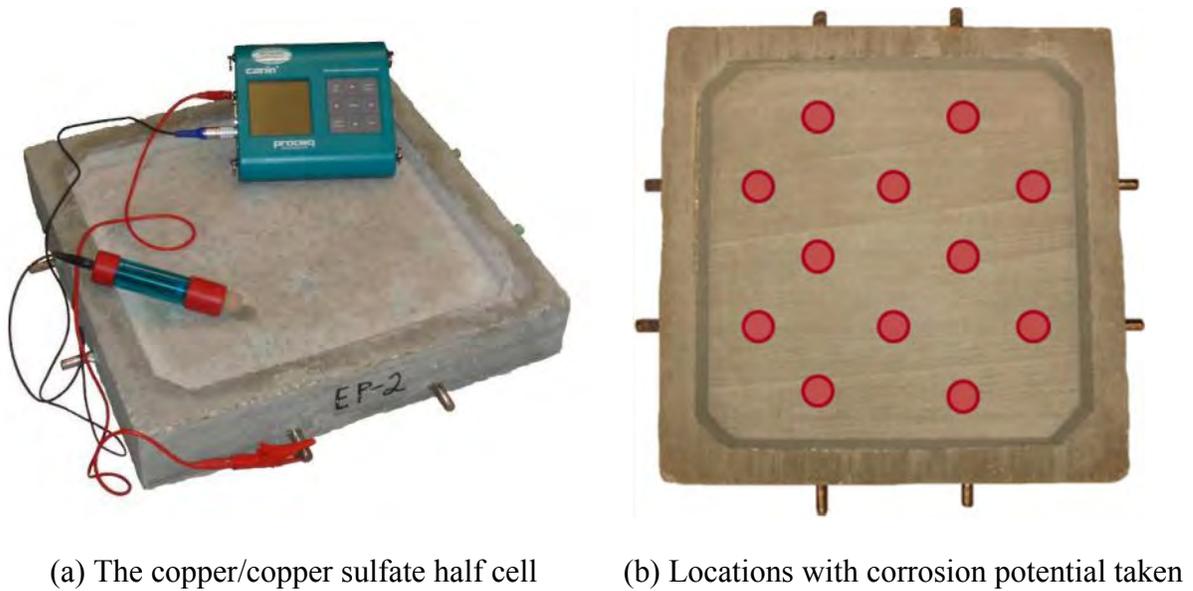
Figure 6.37 Half cell measurements

The corrosion potential of the rebar embedded within a specimen was measured immediately after the specimen's resistivity readings were recorded. Using the Canin<sup>+</sup> equipment, which had an operating range of  $\pm 999$  mV and incorporated a copper/copper sulfate half-cell, the corrosion potentials at three locations along the length of each embedded bar were measured. The three locations were spaced 6 in. (152 mm) on center and were offset a distance 3 in. (76 mm) from a specimen's side. A schematic layout of the locations in which potential readings were taken along the surface of a specimen may be seen in Figure 6.37(b).

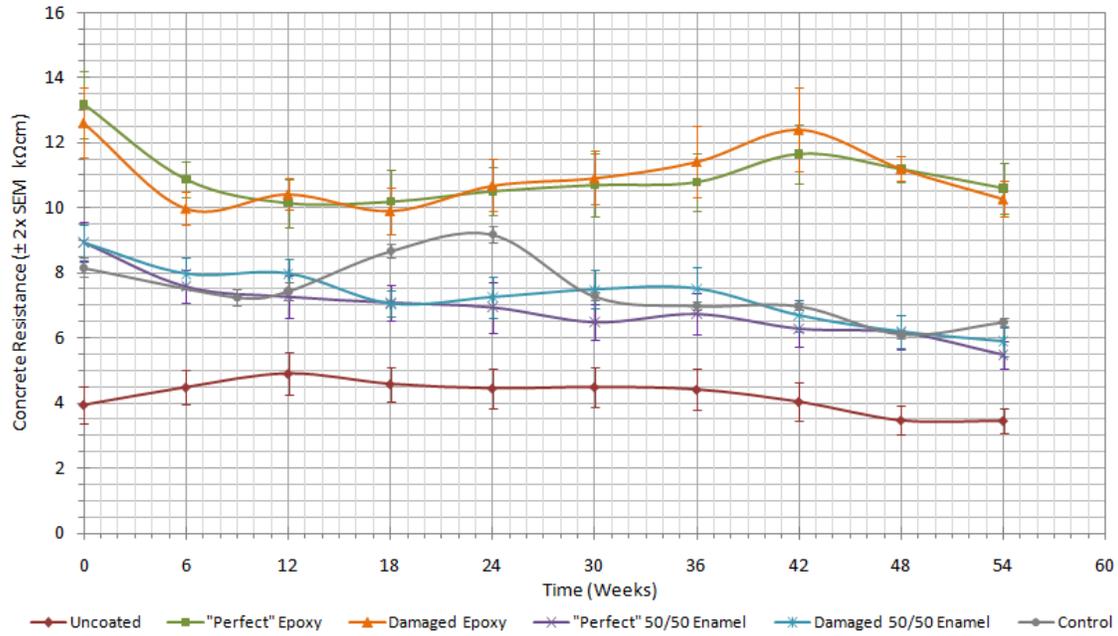
Figure 6.39 Average resistance of each specimen type during the 54 weeks of testing.

As shown in Figure 6.39, the resistivity for each group of specimens remained relatively constant during the testing period. Both the "perfect" and damaged 50/50 enamel specimens have approximately the same resistance throughout the 54 weeks of testing. Similarly, both the "perfect" and damaged epoxy groups have the overall resistance values of 11.0 kΩcm. A specimen group's overall resistance was calculated by averaging the group's ten data points shown within Figure 6.39. The overall resistance for each of the six groups of specimens, along with the 95% confidence interval corresponding to each value, is shown in Figure 6.40.

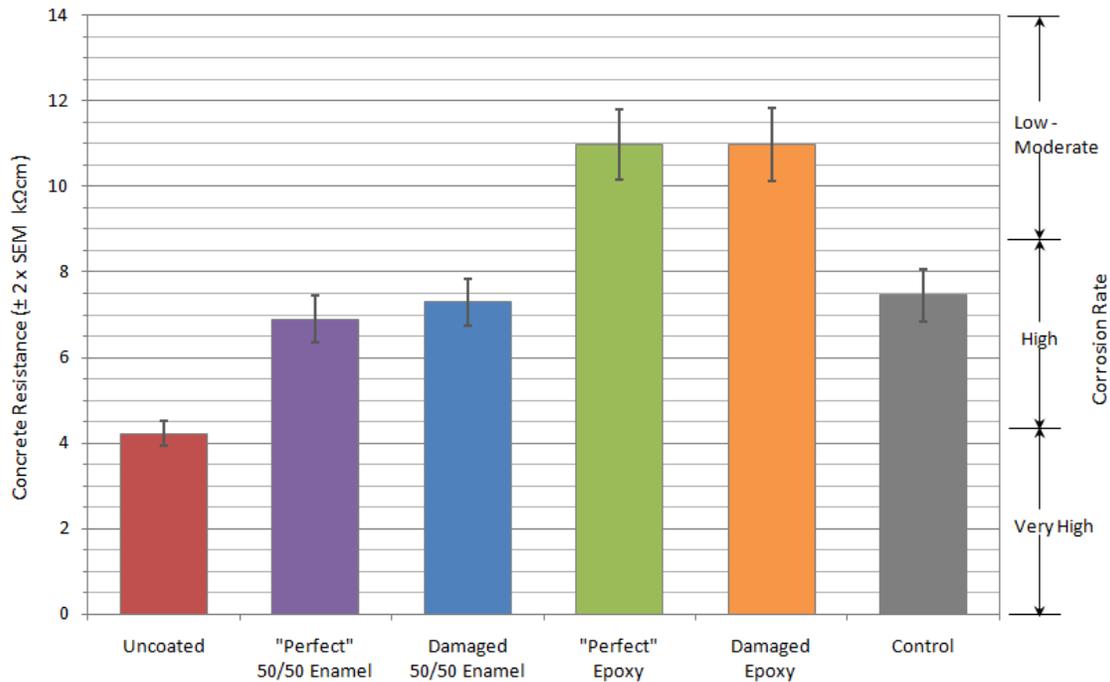
Figure 6.40 Average resistance of each specimen type.

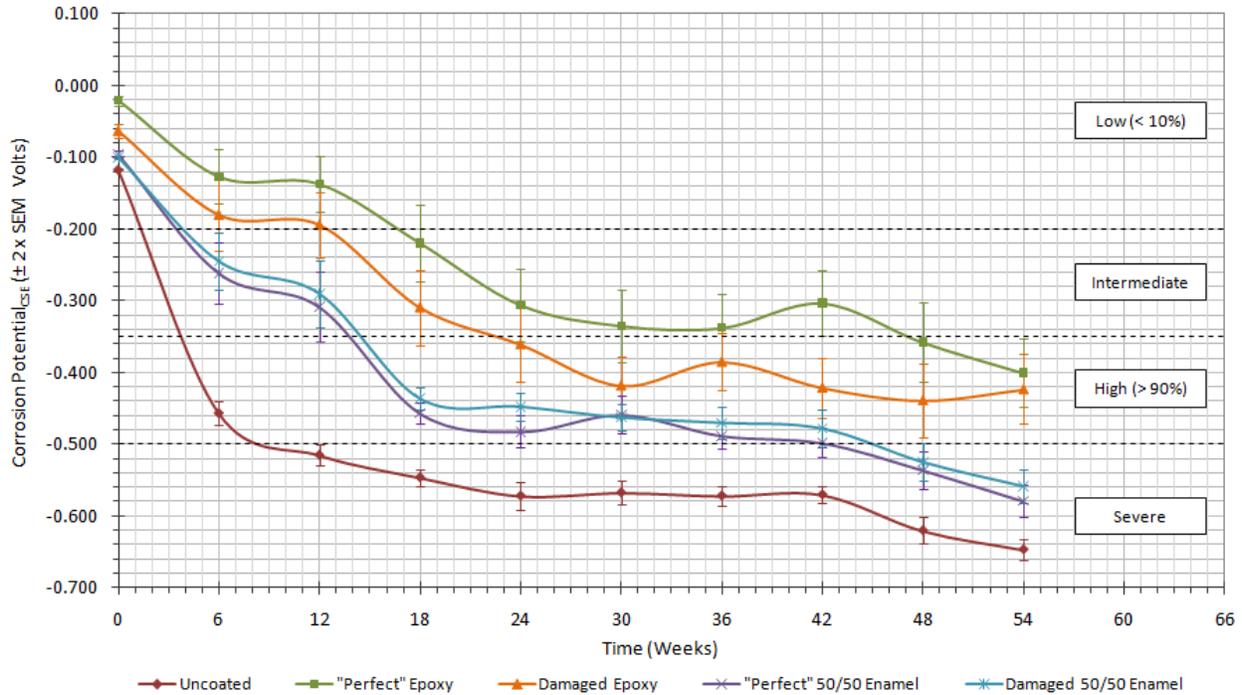
Figure 6.41 Average corrosion potential of each specimen group during the 54 weeks of testing.

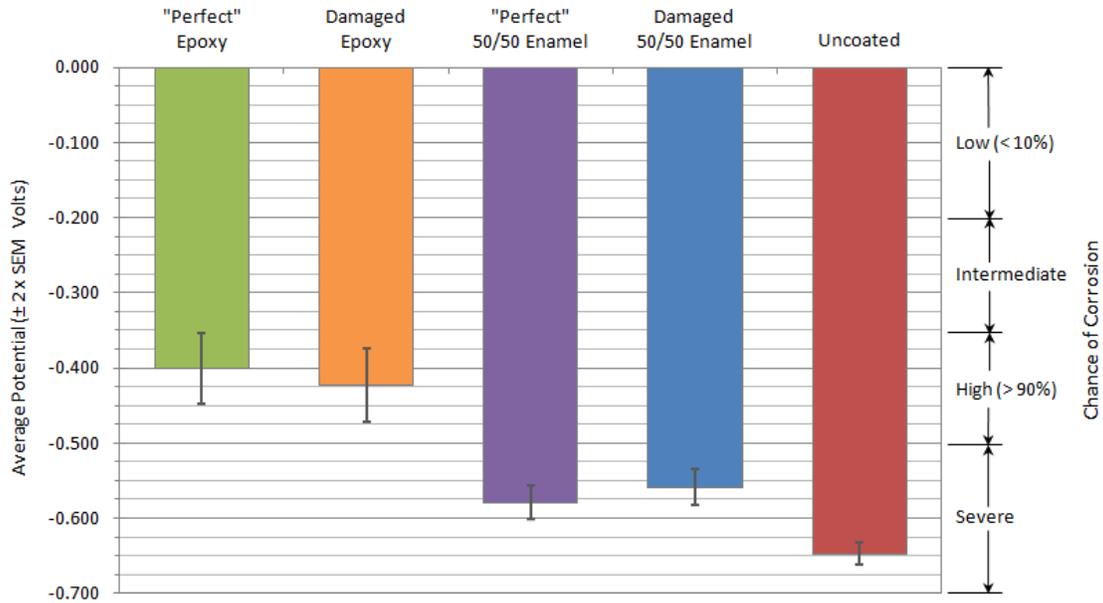
Figure 6.42 Average corrosion potential of each specimen group at the end of testing in week 54.

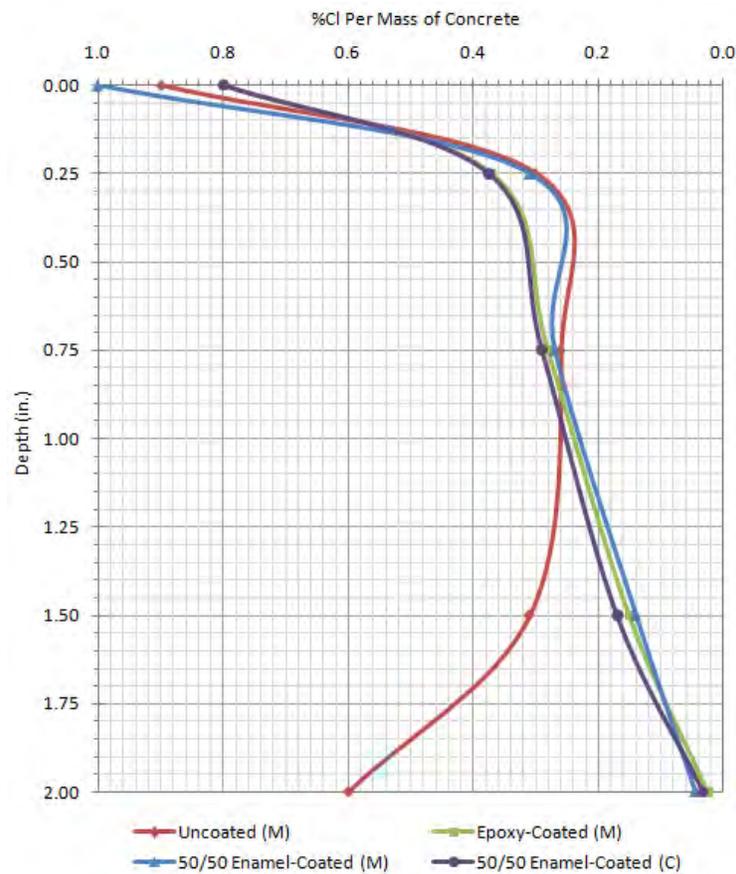
Figure 6.43 Typical chloride profiles for the 25 ponding specimens.

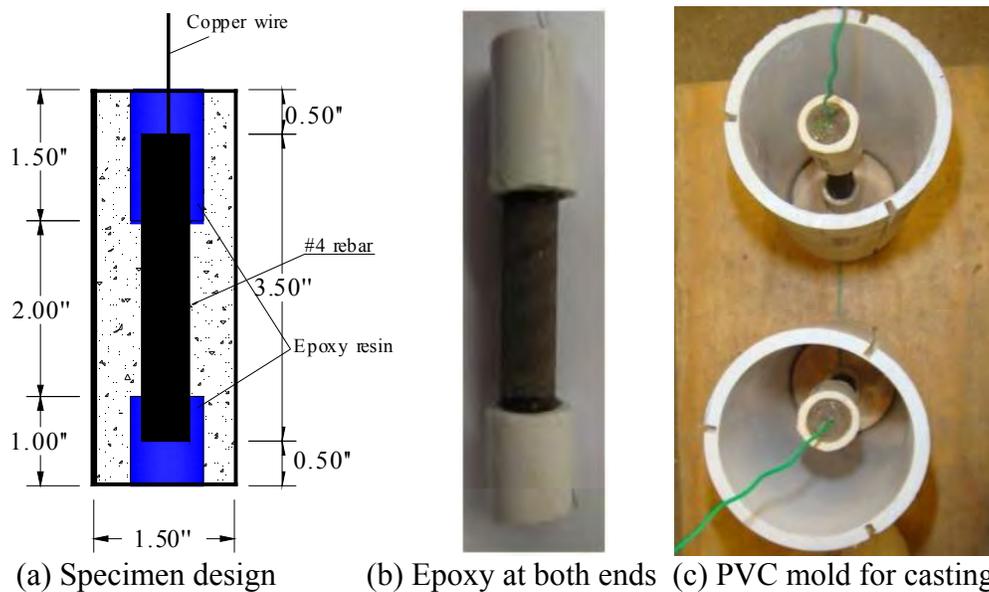
Figure 6.54 Mortar cylinder specimen and casting

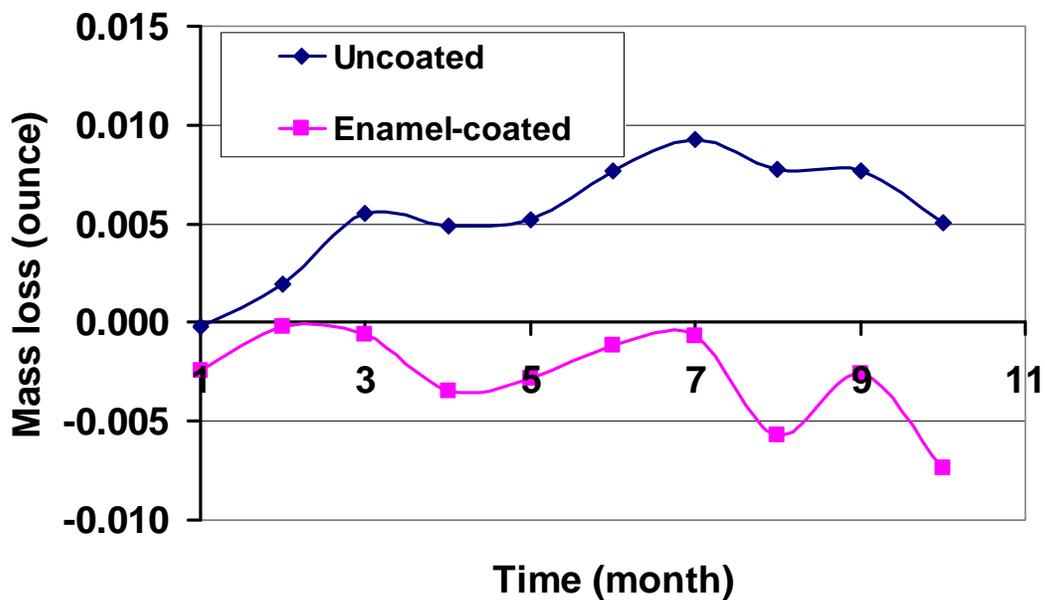
Figure 6.57 Mass loss of steel disc samples with time.

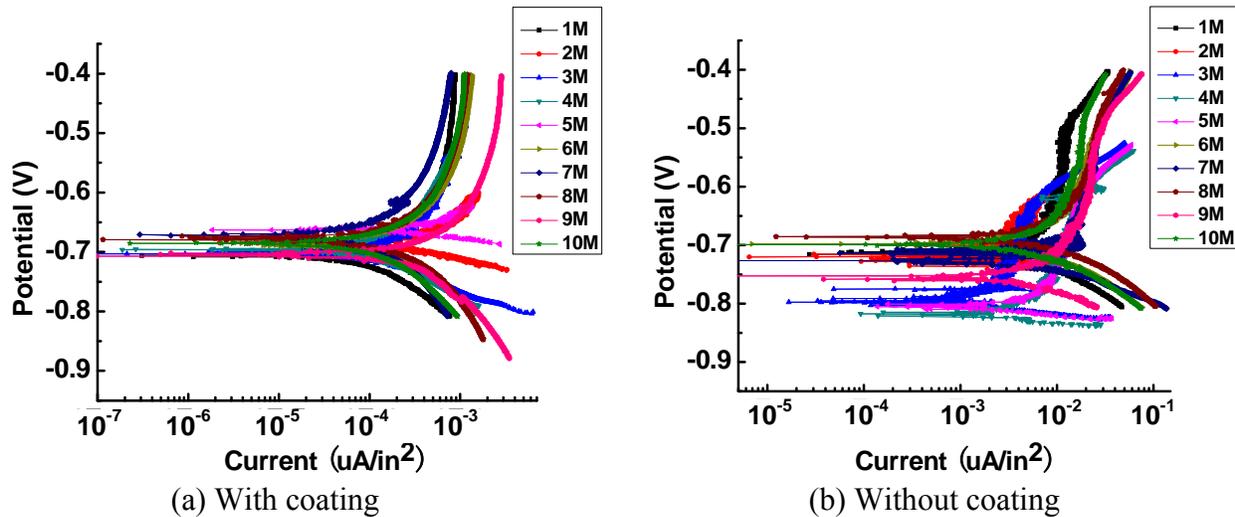
Figure 6.58 Tafel plots of steel disc samples

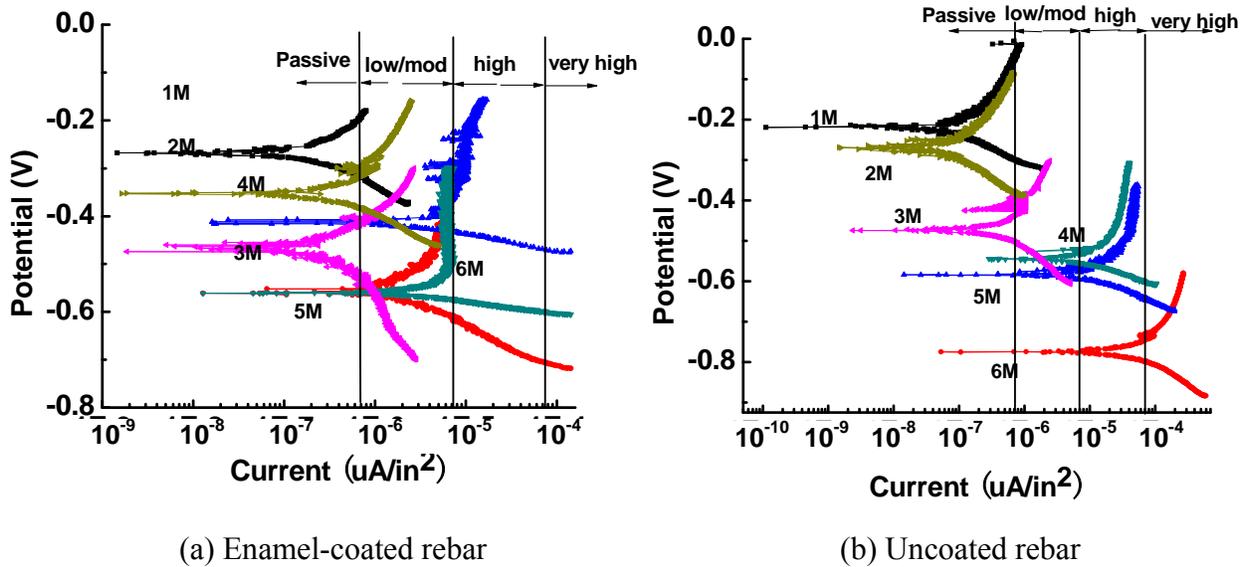
Figure 6.60 Tafel plots of mortar cylinder samples.

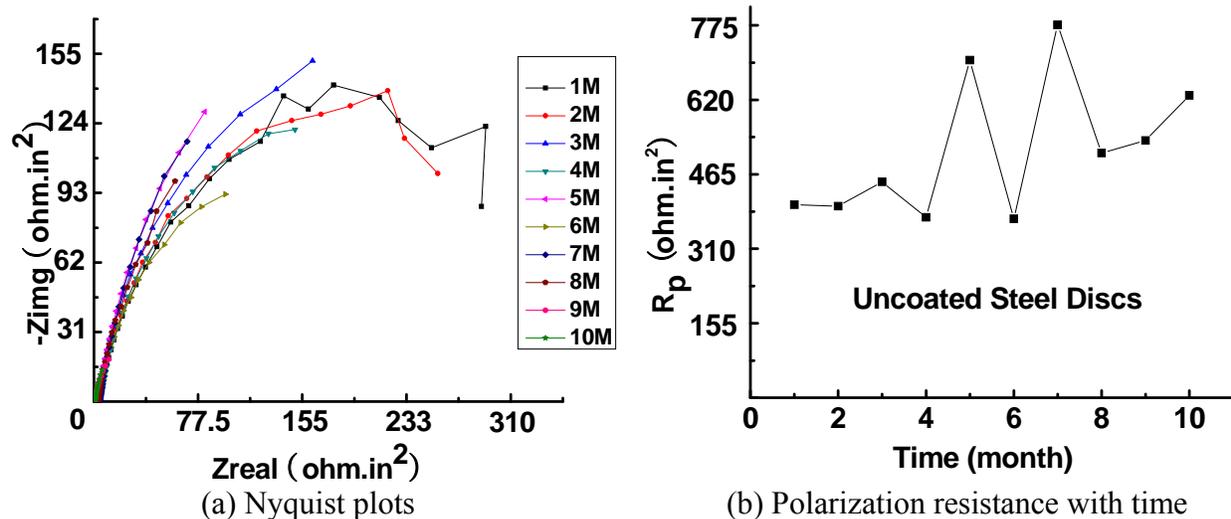
Figure 6.61 EIS test results from uncoated steel disc samples.

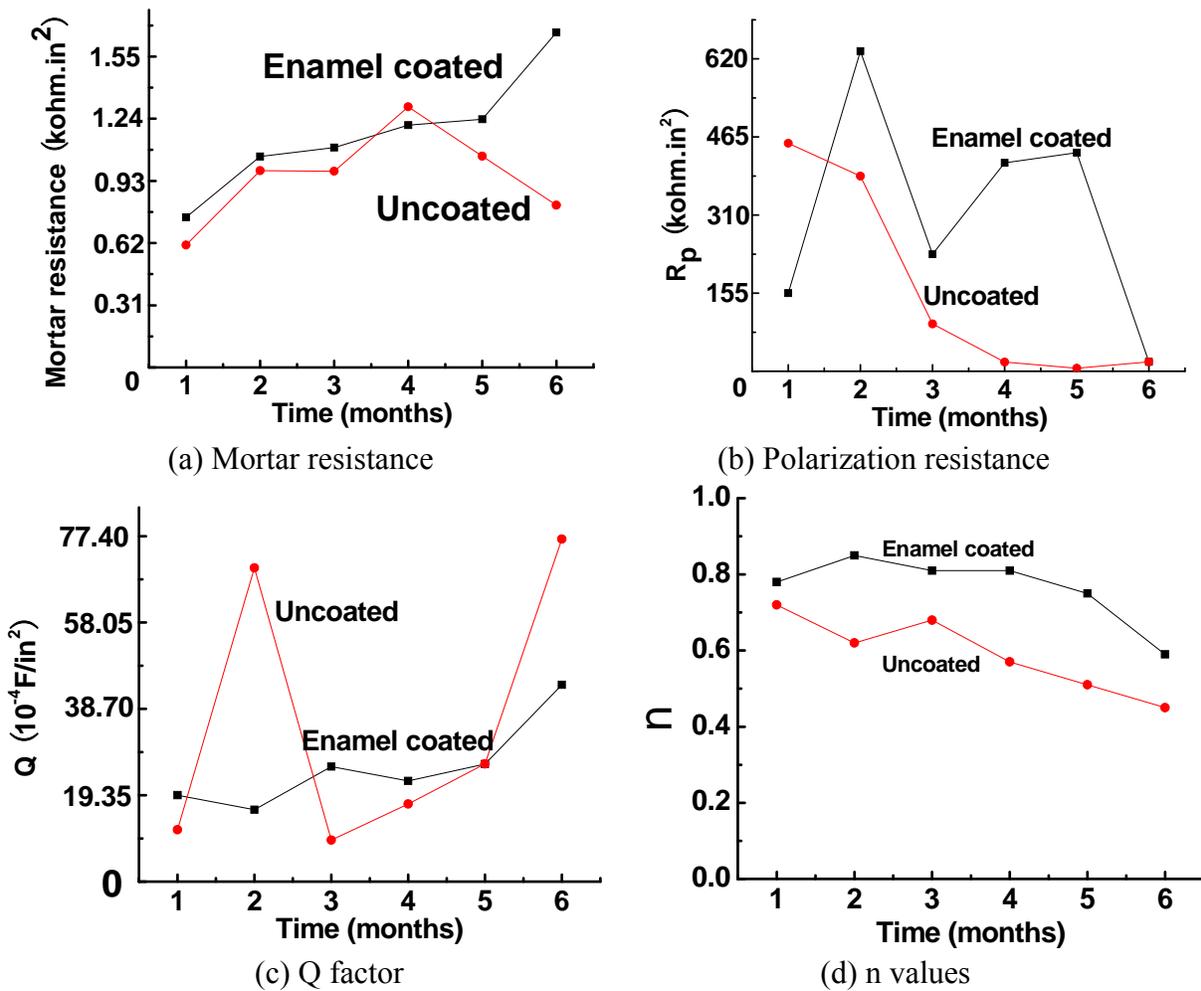
Figure 6.66 EEC model parameters changes over time.

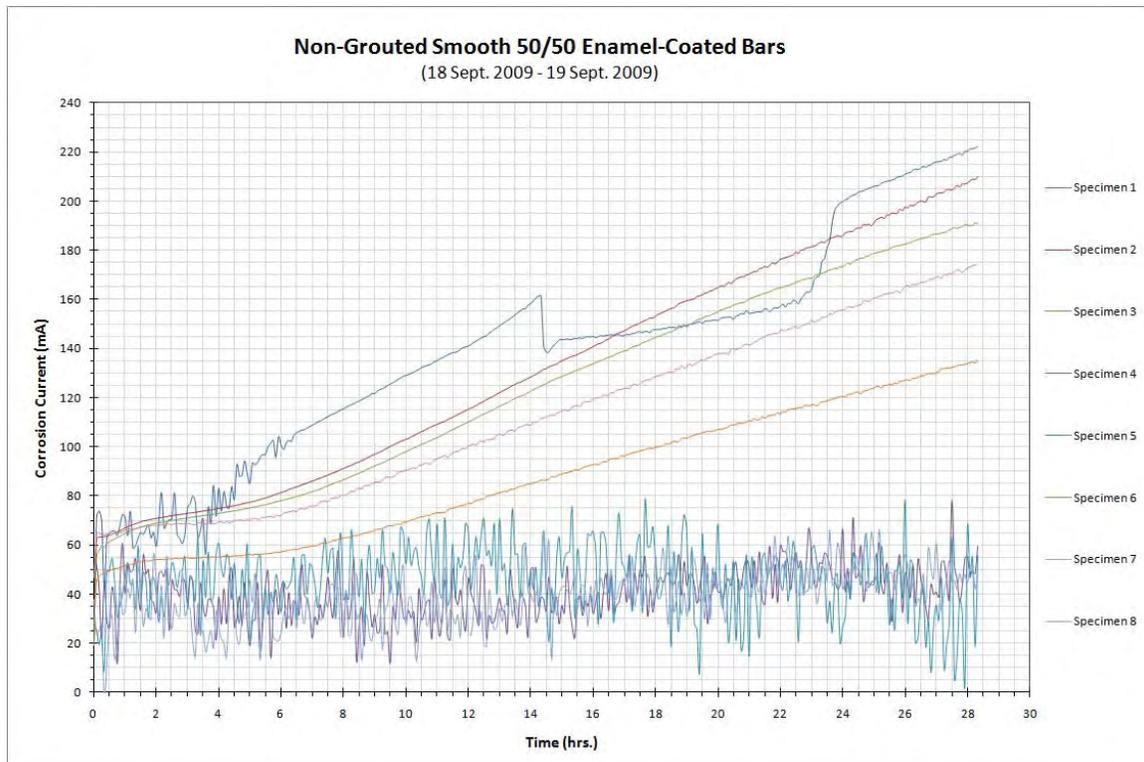
**Figure B - 1:** Corrosion current versus time plot for the non-grouted smooth 50/50 enamel-coated ACT specimens.

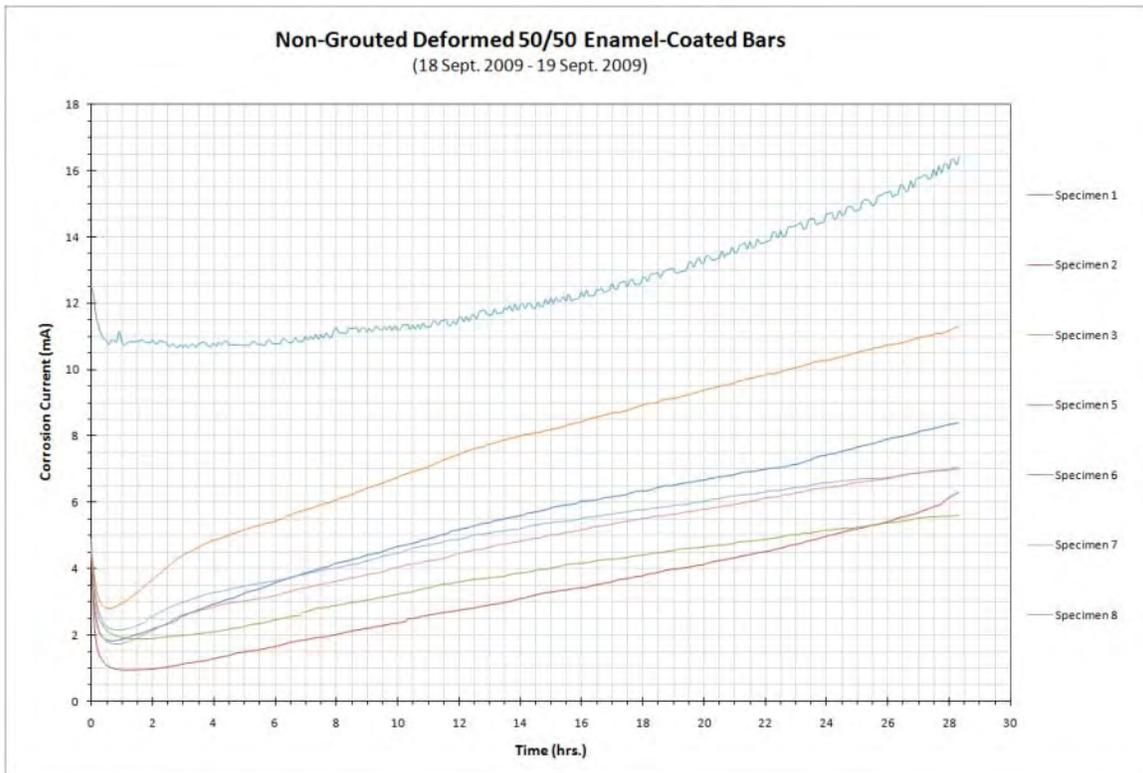
**Figure B - 2:** Corrosion current versus time plot for the non-grouted deformed 50/50 enamel-coated ACT specimens.

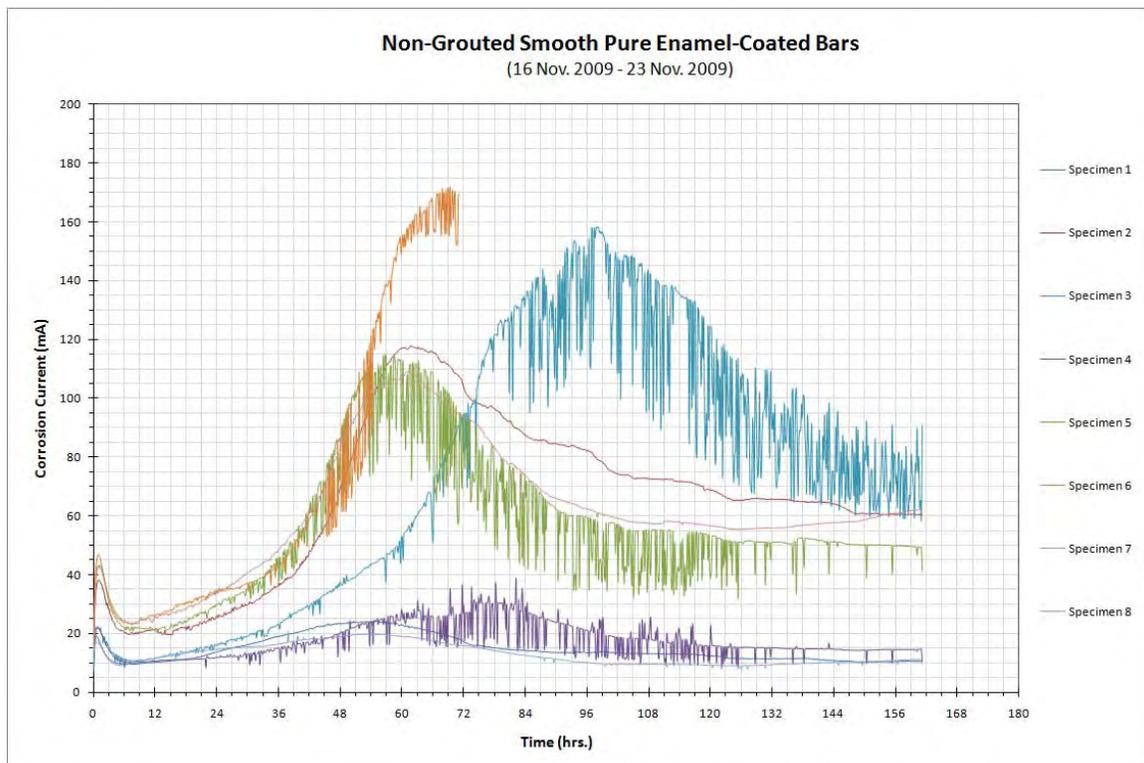
**Figure B - 3:** Corrosion current versus time plot for the non-grouted smooth pure enamel-coated ACT specimens.

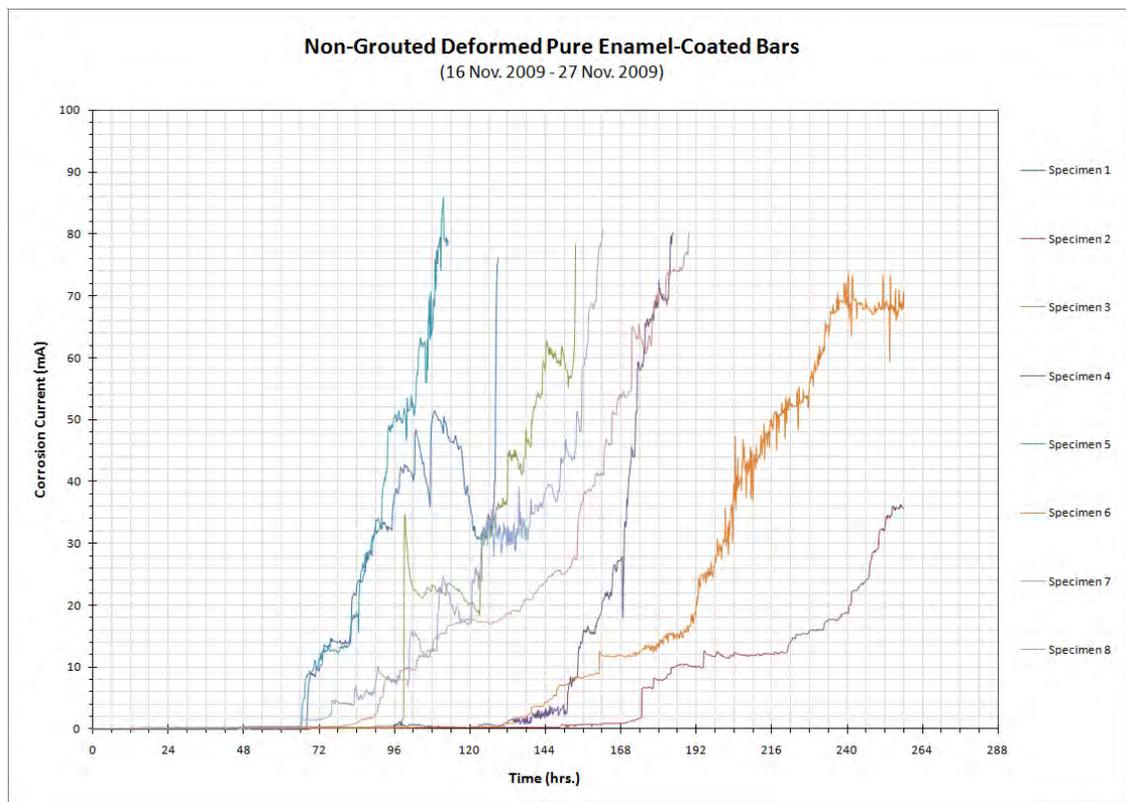
**Figure B - 4:** Corrosion current versus time plot for the non-grouted deformed pure enamel-coated ACT specimens.

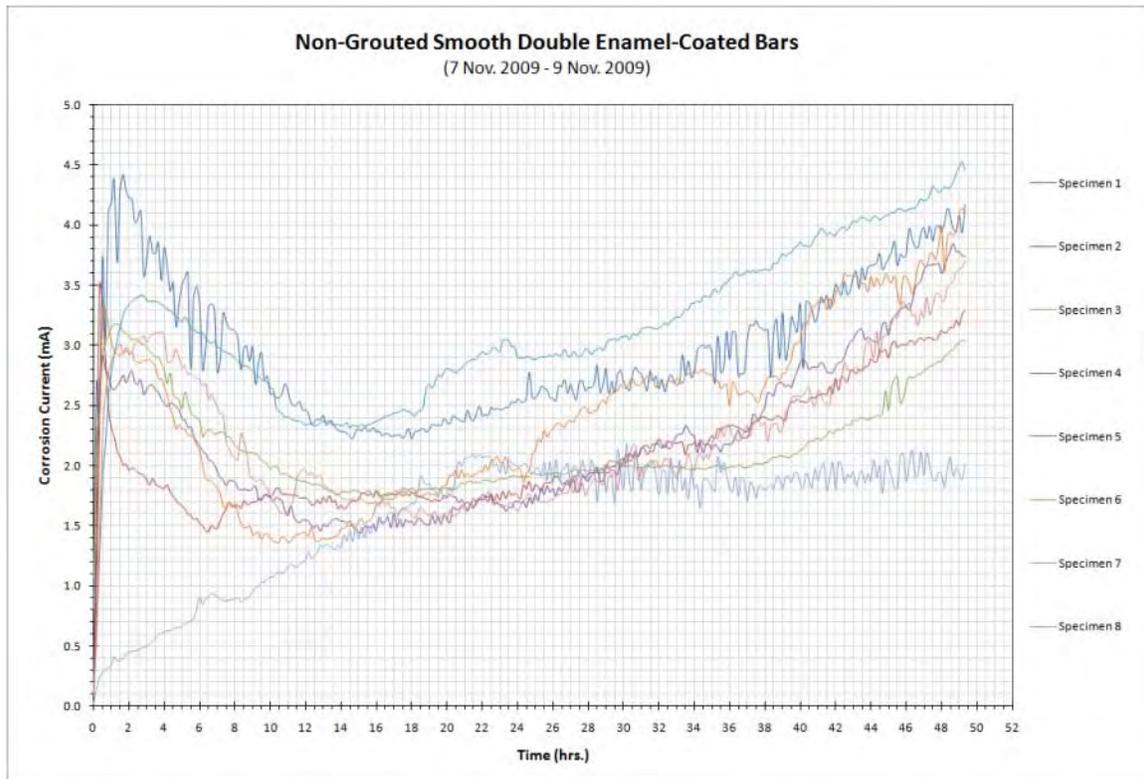
**Figure B - 5:** Corrosion current versus time plot for the non-grouted smooth double enamel-coated ACT specimens.

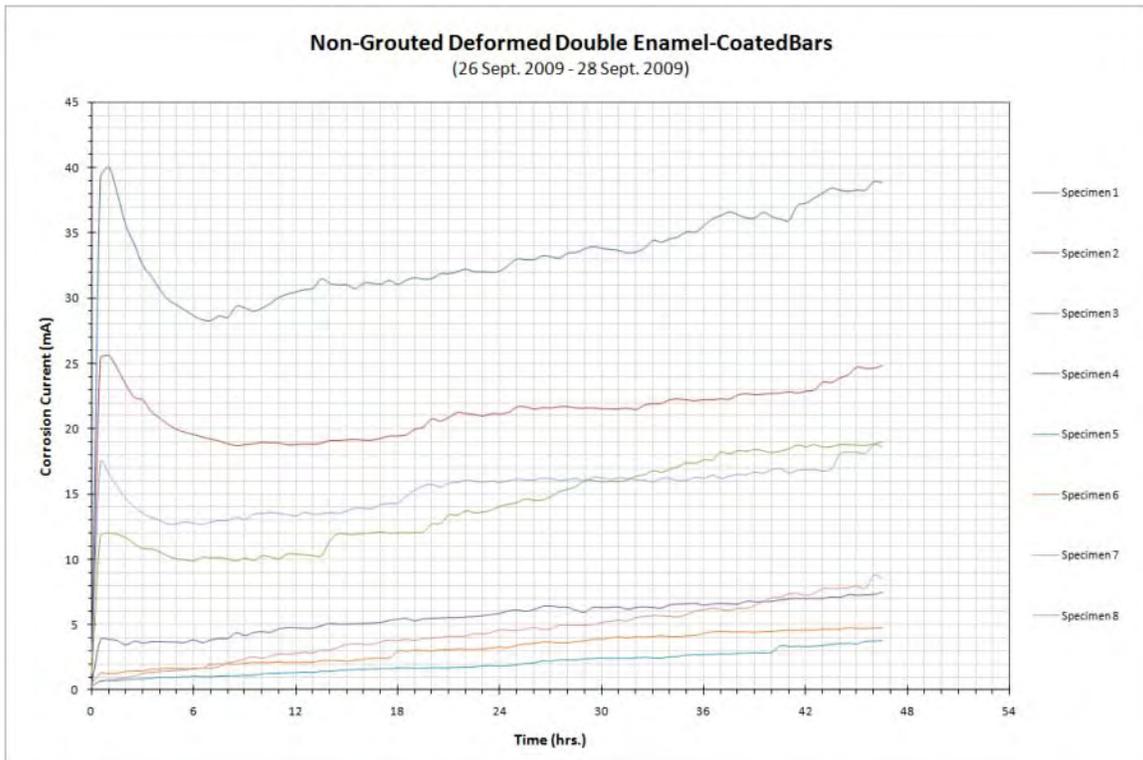
**Figure B - 6:** Corrosion current versus time plot for the non-grouted deformed double enamel-coated ACT specimens.

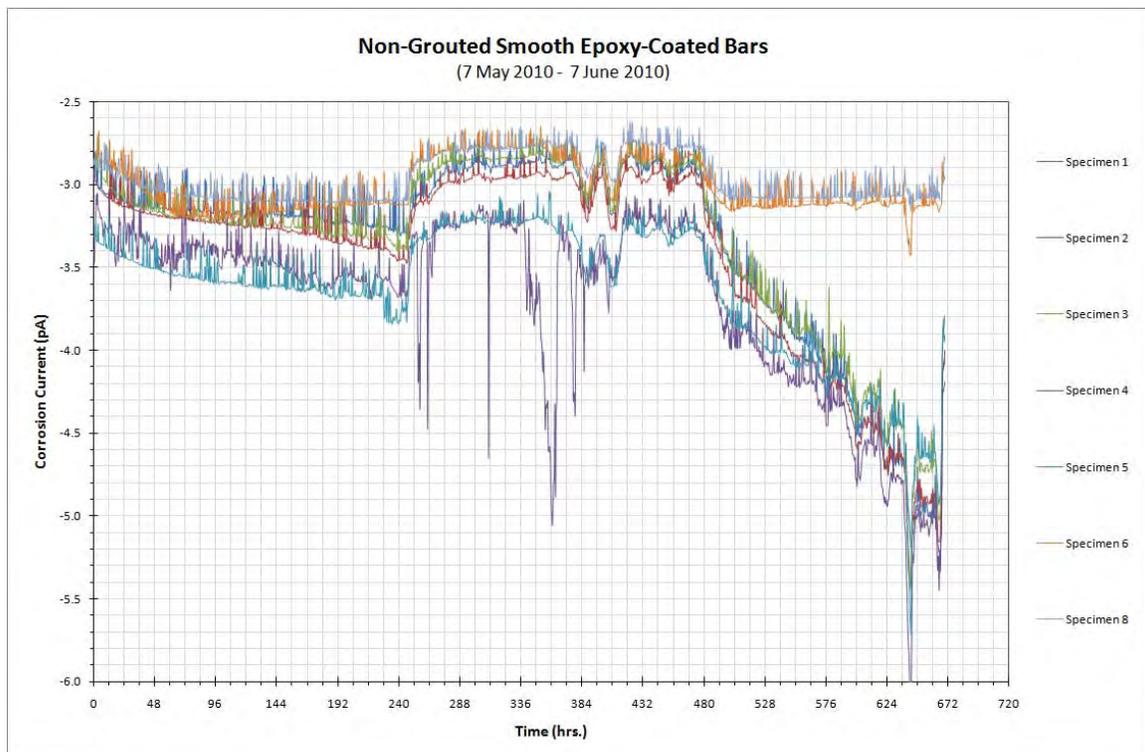
**Figure B - 7:** Corrosion current versus time plot for the non-grouted smooth epoxy-coated ACT specimens.

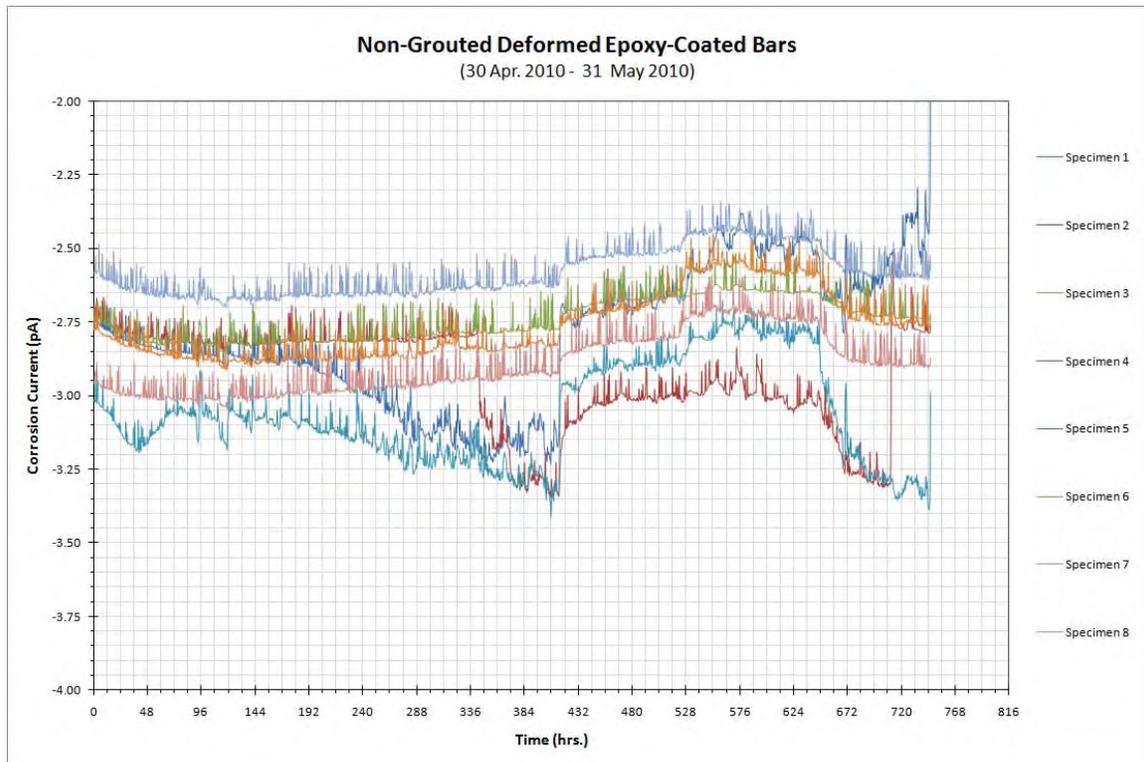
**Figure B - 8:** Corrosion current versus time plot for the non-grouted deformed epoxy-coated ACT specimens.

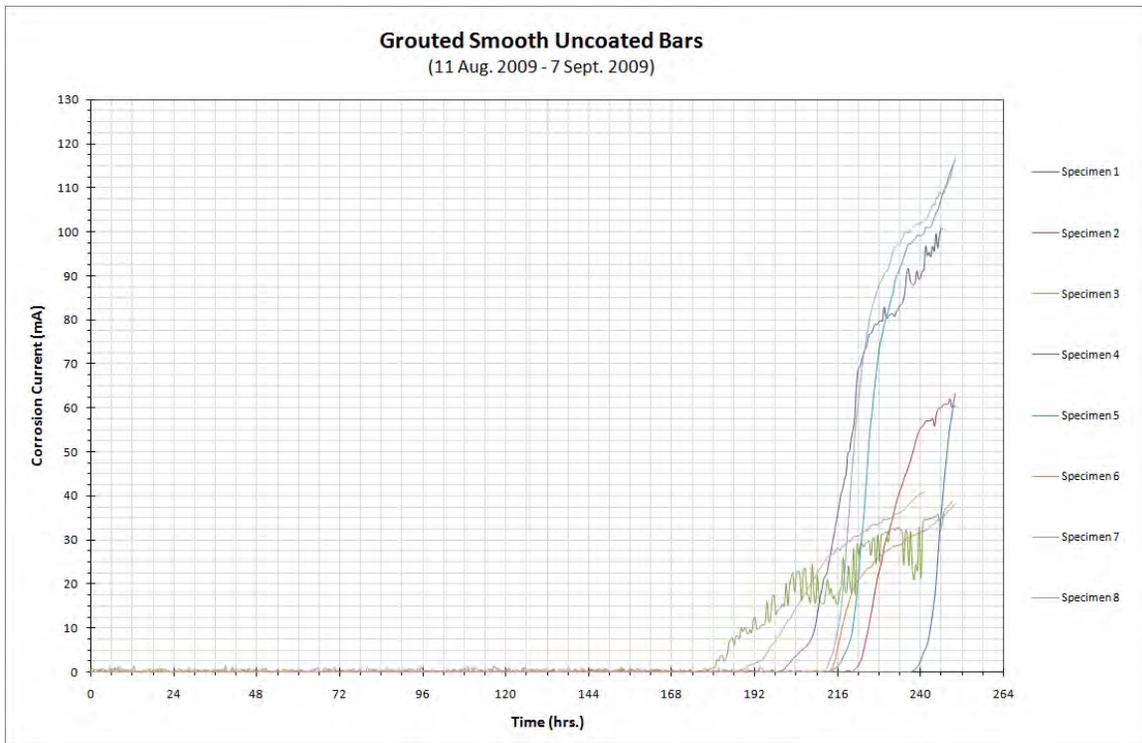
**Figure B - 9:** Corrosion current versus time plot for the grouted smooth uncoated ACT specimens.

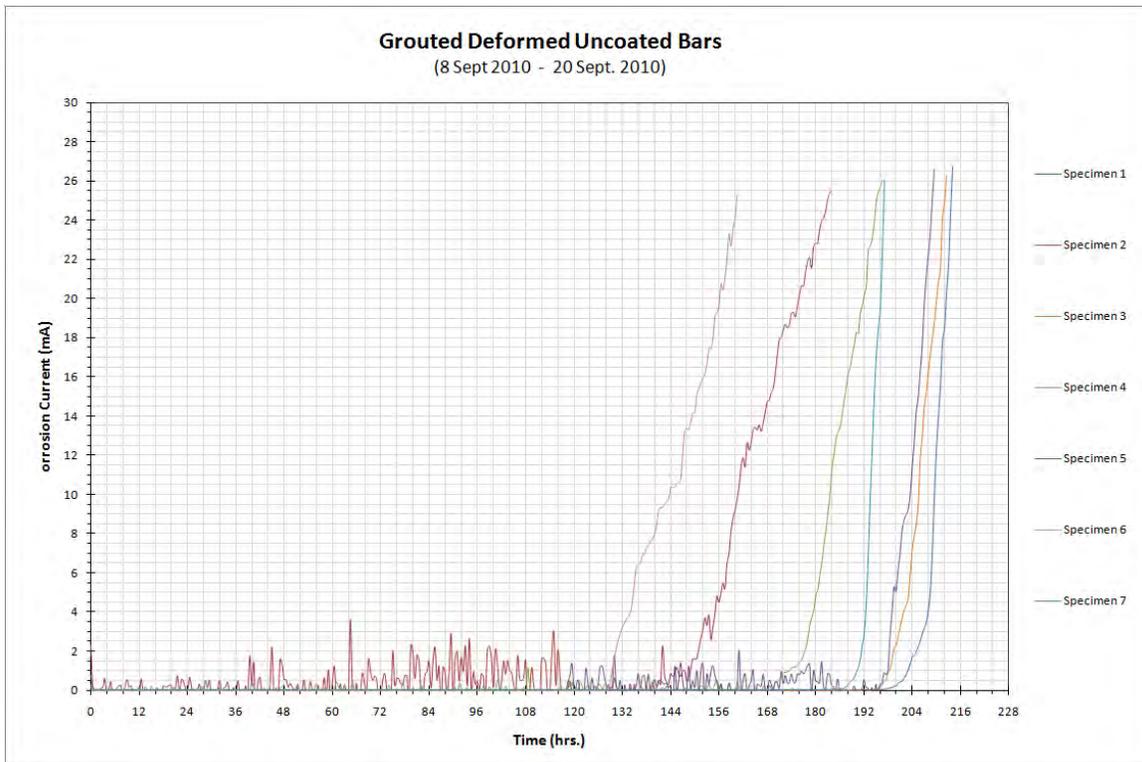
**Figure B - 10:** Corrosion current versus time plot for the grouted deformed uncoated ACT specimens.

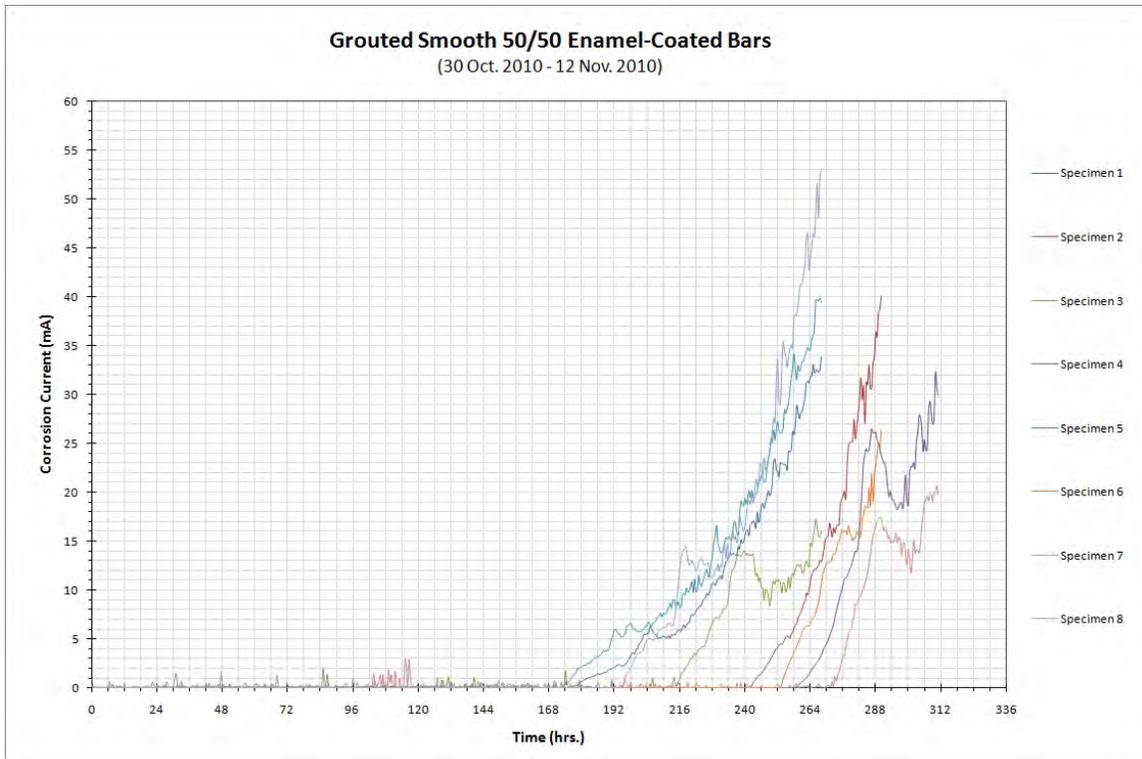
**Figure B - 11:** Corrosion current versus time plot for the grouted smooth 50/50 enamel-coated ACT specimens.

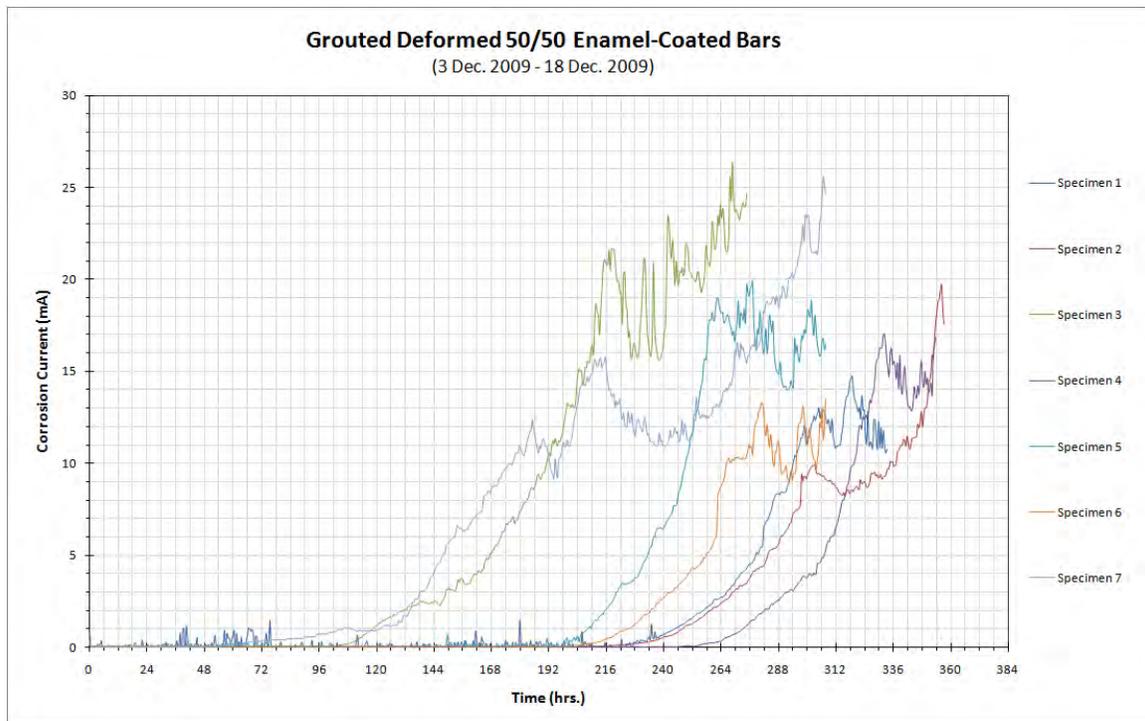
**Figure B - 12:** Corrosion current versus time plot for the grouted deformed 50/50 enamel-coated ACT specimens.

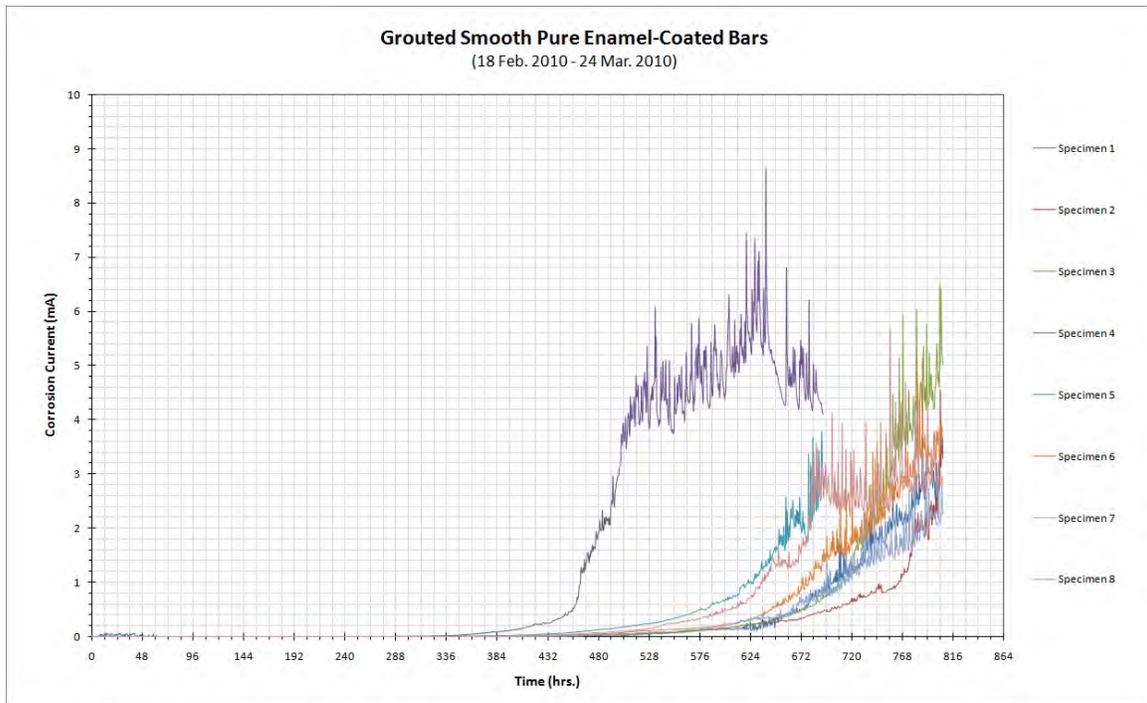
**Figure B - 13:** Corrosion current versus time plot for the grouted smooth pure enamel-coated ACT specimens.

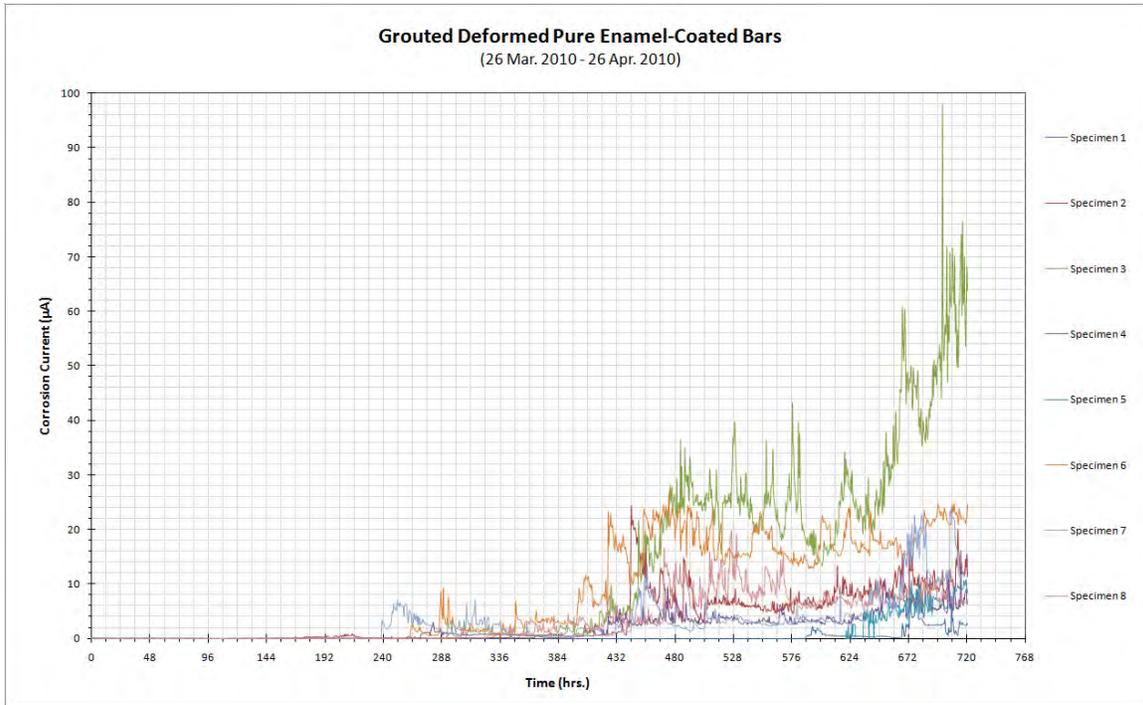
**Figure B - 14:** Corrosion current versus time plot for the grouted deformed pure enamel-coated ACT specimens.
