**Organizational Results Research Report**

# **Coated Steel Rebar for Enhanced Concrete-Steel Bond Strength and Corrosion Resistance**

**Final Report**

September 2010

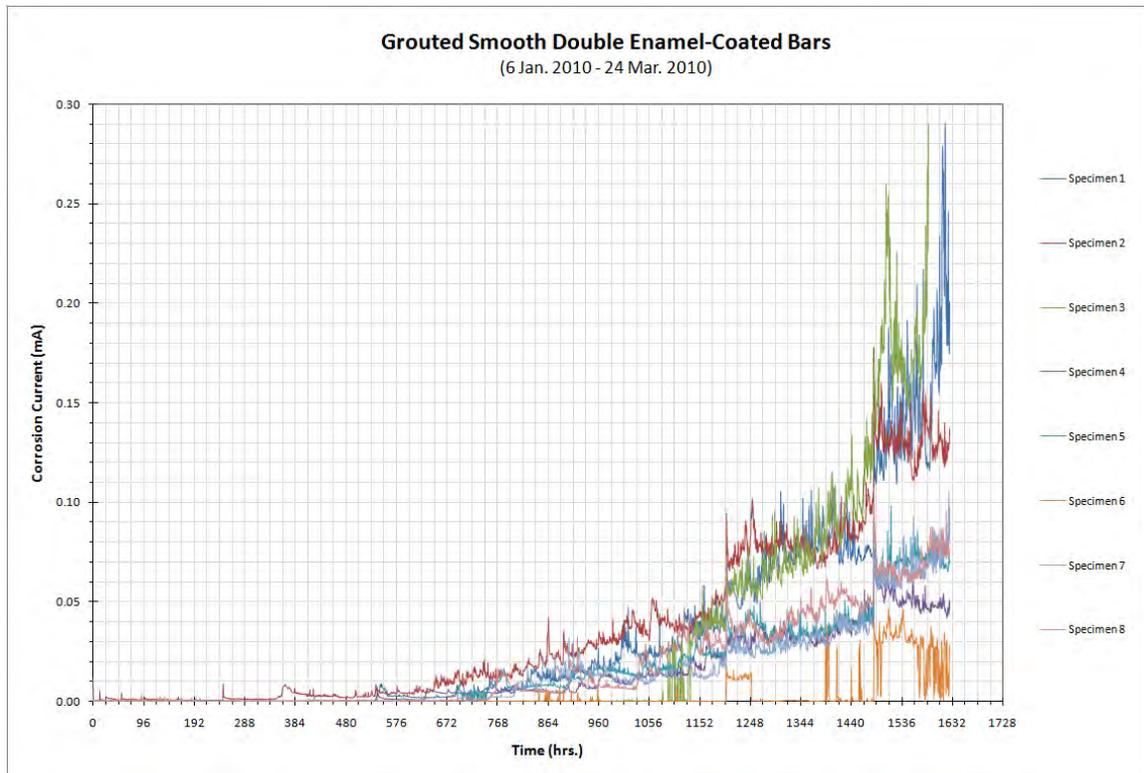
**Figure B - 15:** Corrosion current versus time plot for the grouted smooth double enamel-coated ACT specimens.

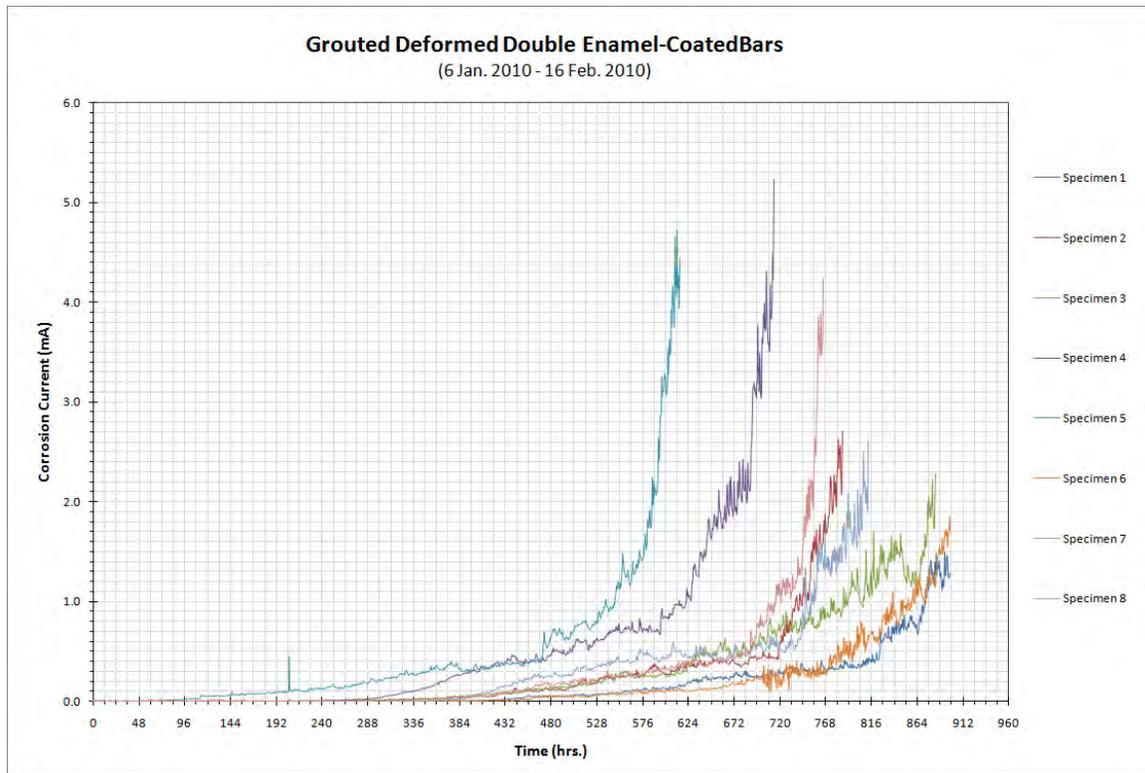
**Figure B - 16:** Corrosion current versus time plot for the grouted deformed double enamel-coated ACT specimens.

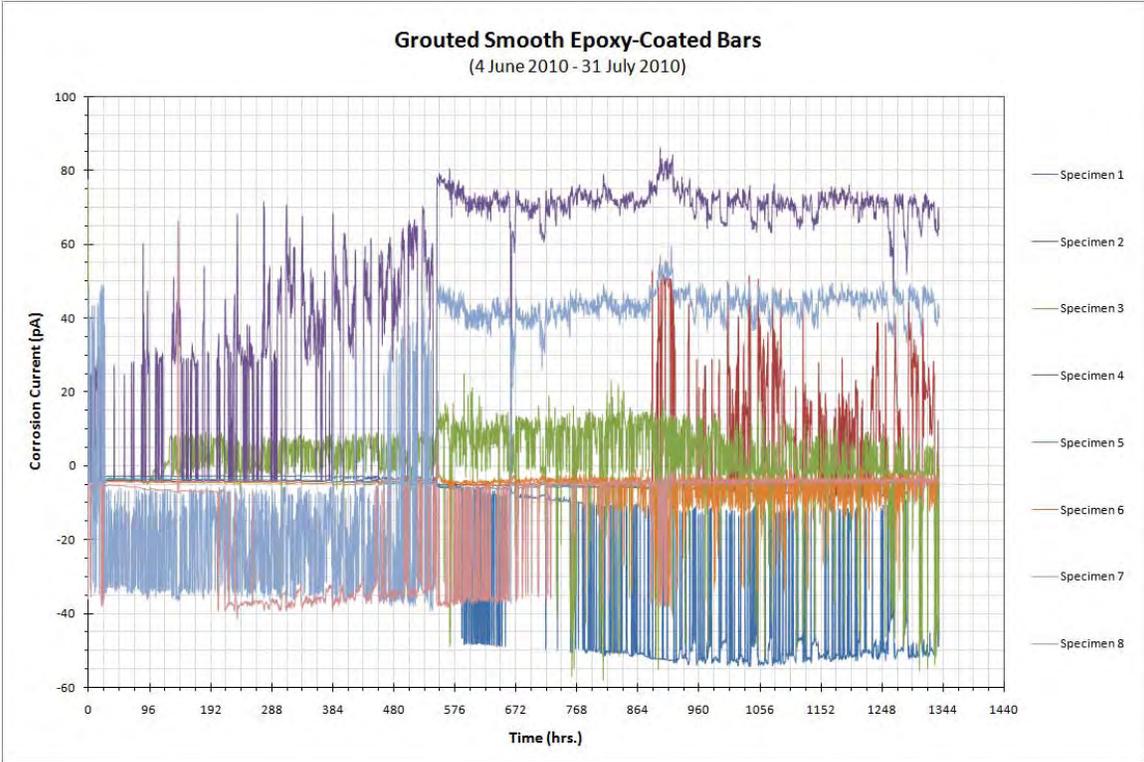
**Figure B - 17:** Corrosion current versus time plot for the grouted smooth epoxy-coated ACT specimens.

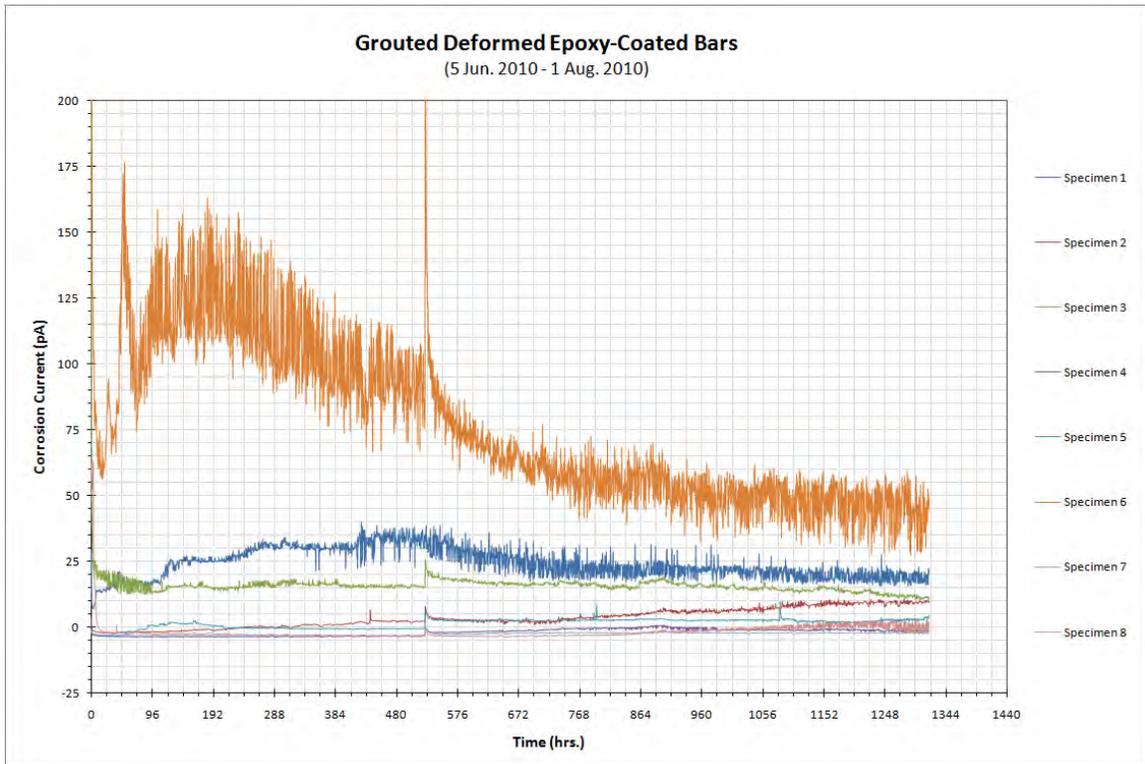
**Figure B - 18:** Corrosion current versus time plot for the grouted deformed epoxy-coated ACT specimens.

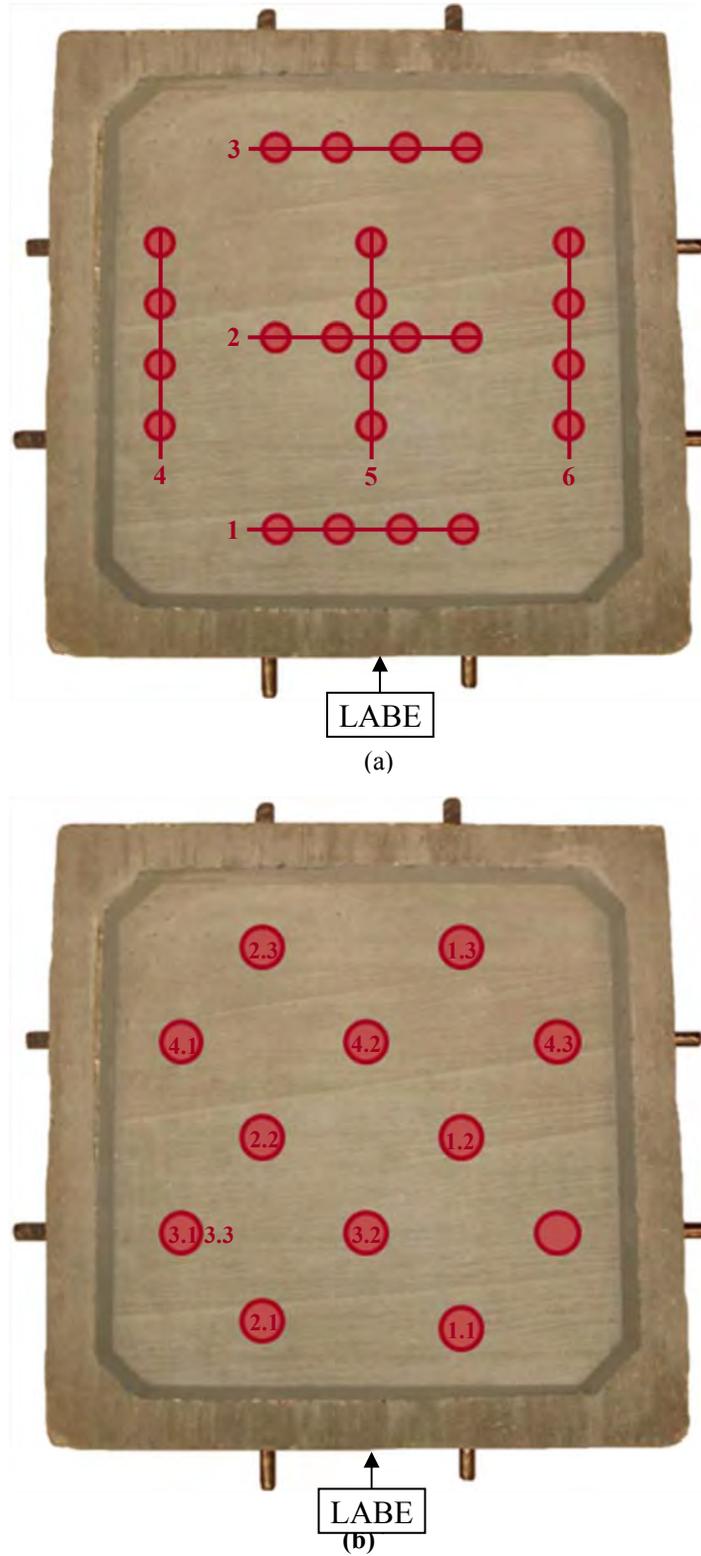
**Figure C - 4:** The locations of the (a) resistivity and (b) corrosion potential measurements with respect to a ponding specimen's label.

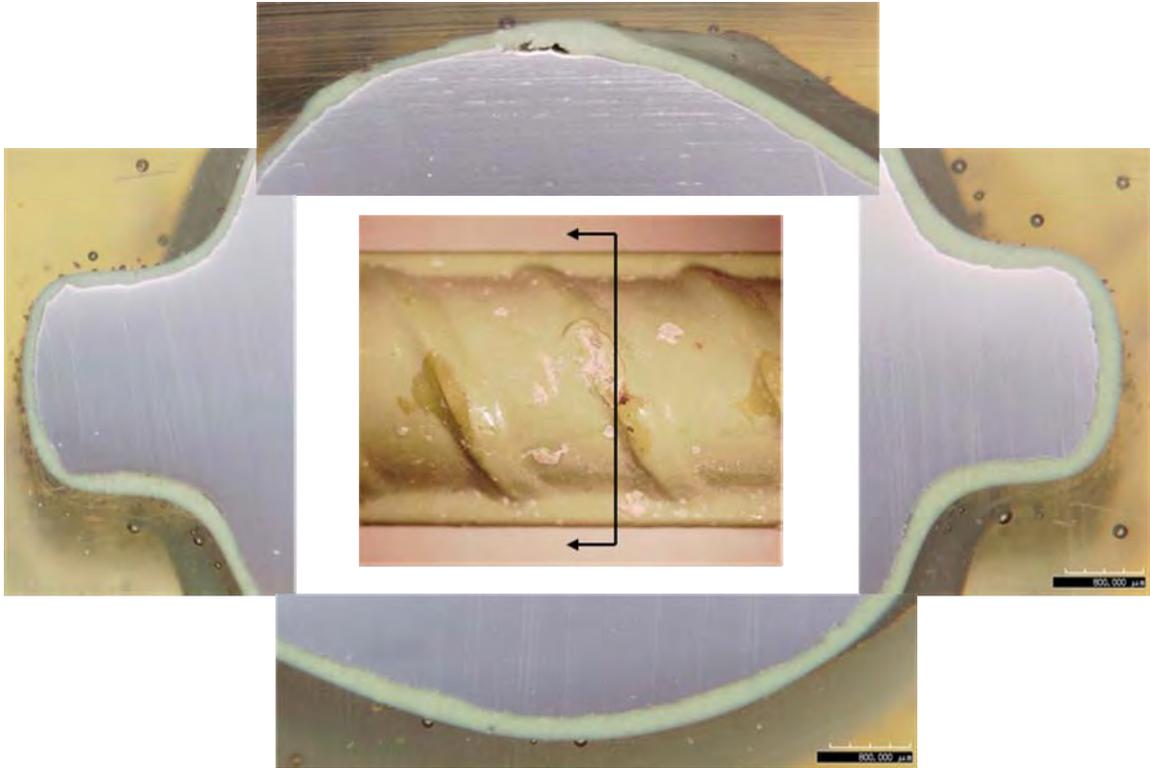
**Figure C - 33:** A cross-section through an intentionally damaged area along bar-1 of specimen EP-D-2.

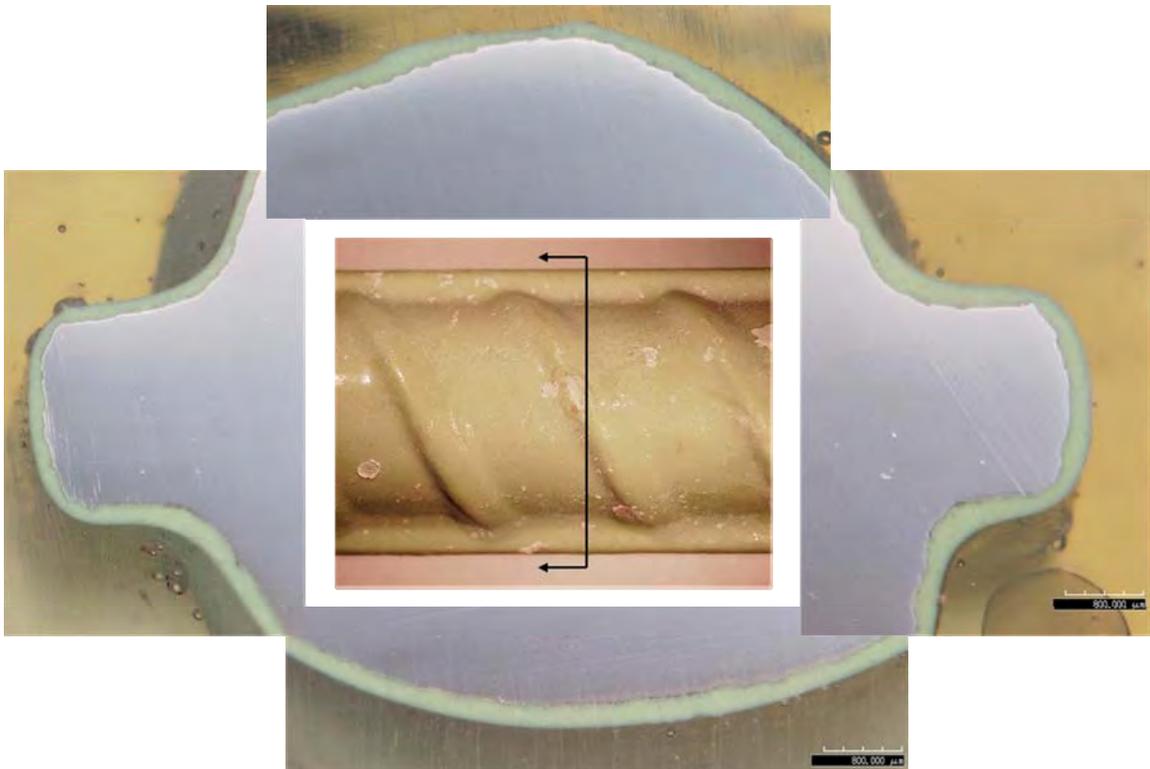
**Figure C - 34:** A cross-section through an intentionally damaged area along bar-1 of specimen EP-D-2.

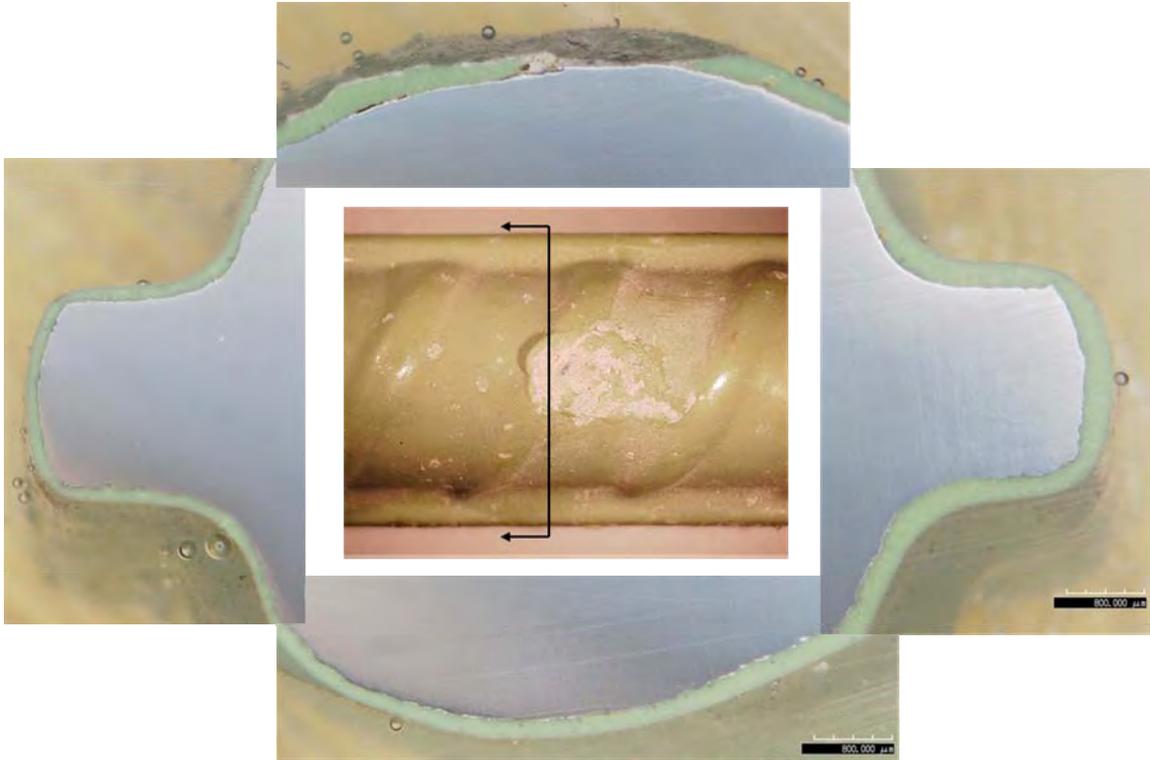
**Figure C - 35:** A cross-section through an intentionally damaged area along bar-2 of specimen EP-D-2.

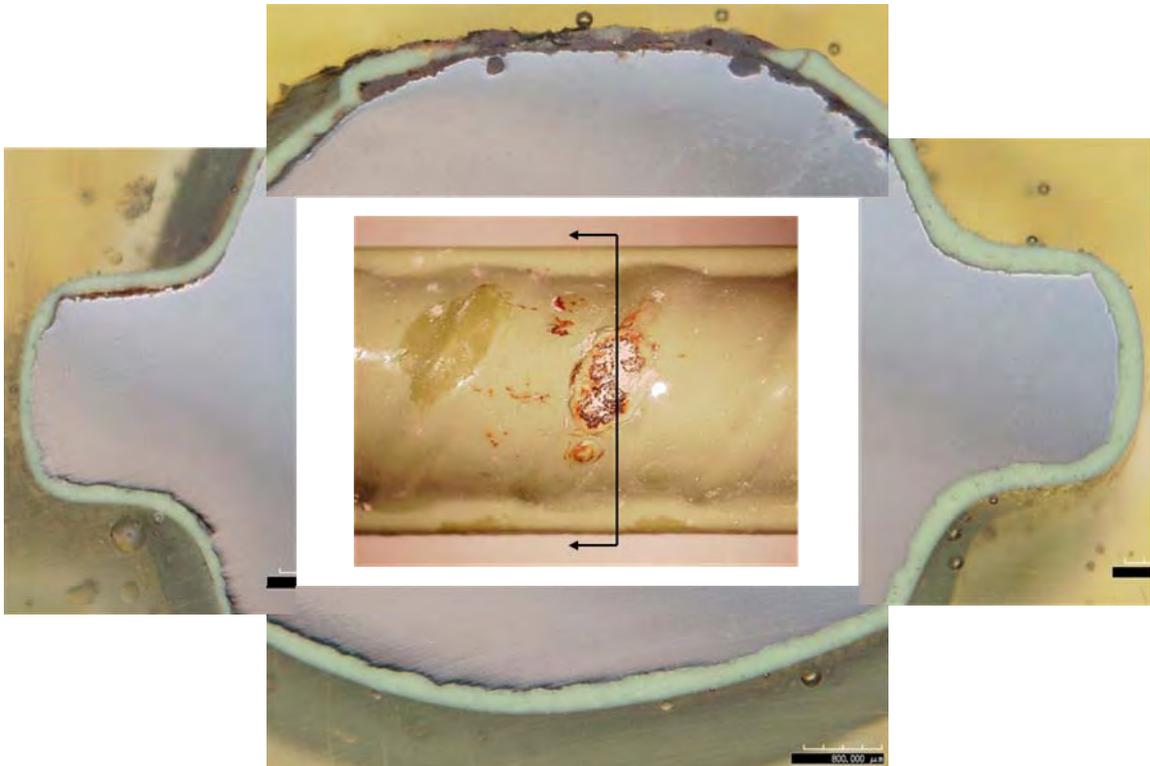
**Figure C - 36:** A cross-section through an intentionally damaged area along bar-2 of specimen EP-D-2.

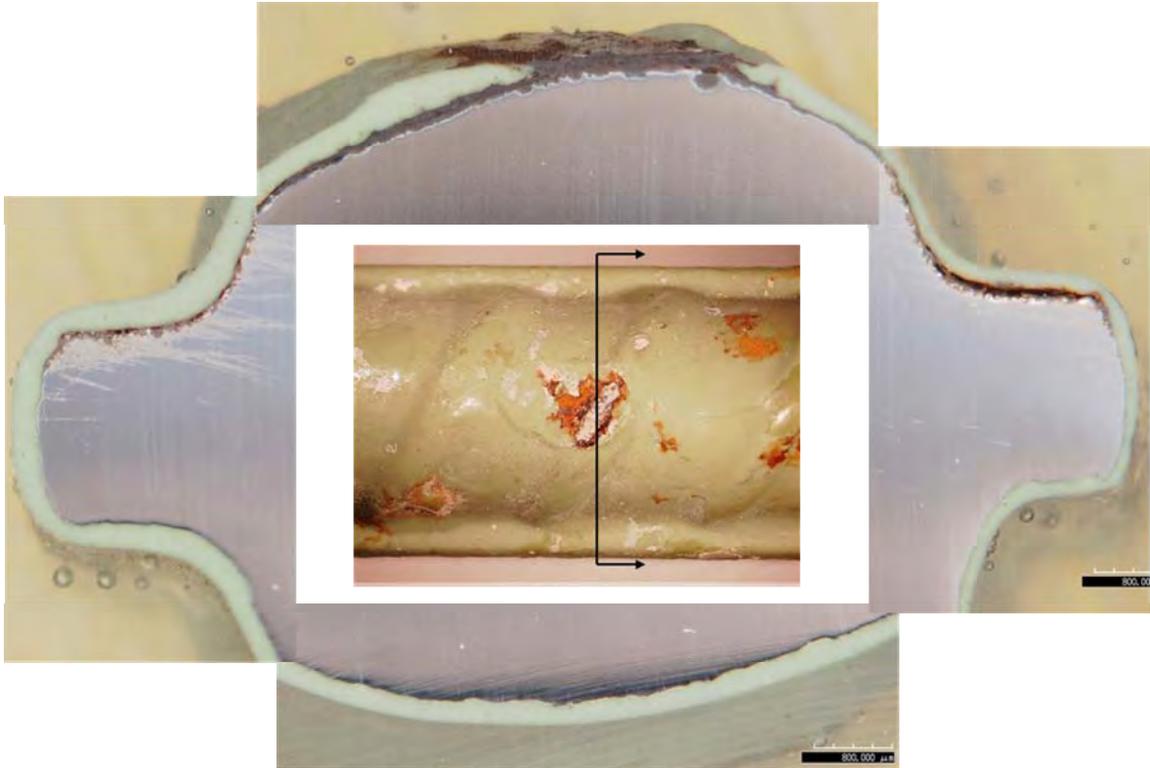
**Figure C - 37:** A cross-section through an intentionally damaged area along bar-3 of specimen EP-D-2.

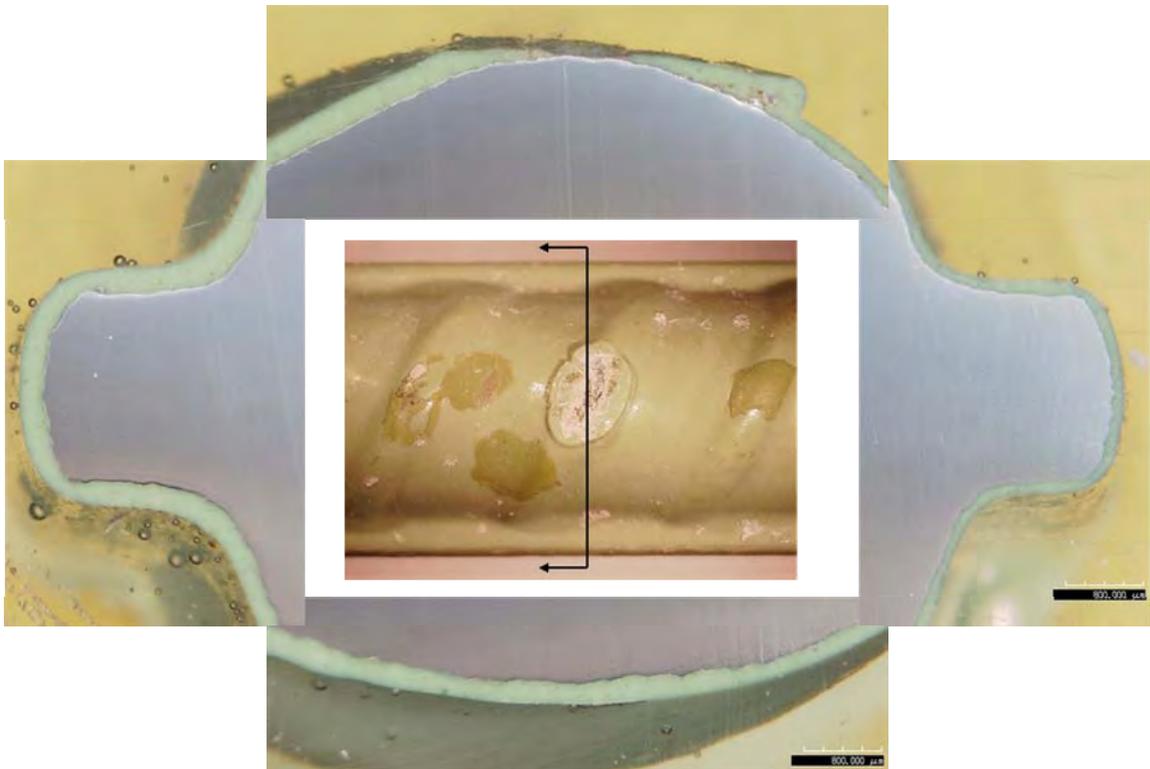
**Figure C - 38:** A cross-section through an intentionally damaged area along bar-3 of specimen EP-D-2.

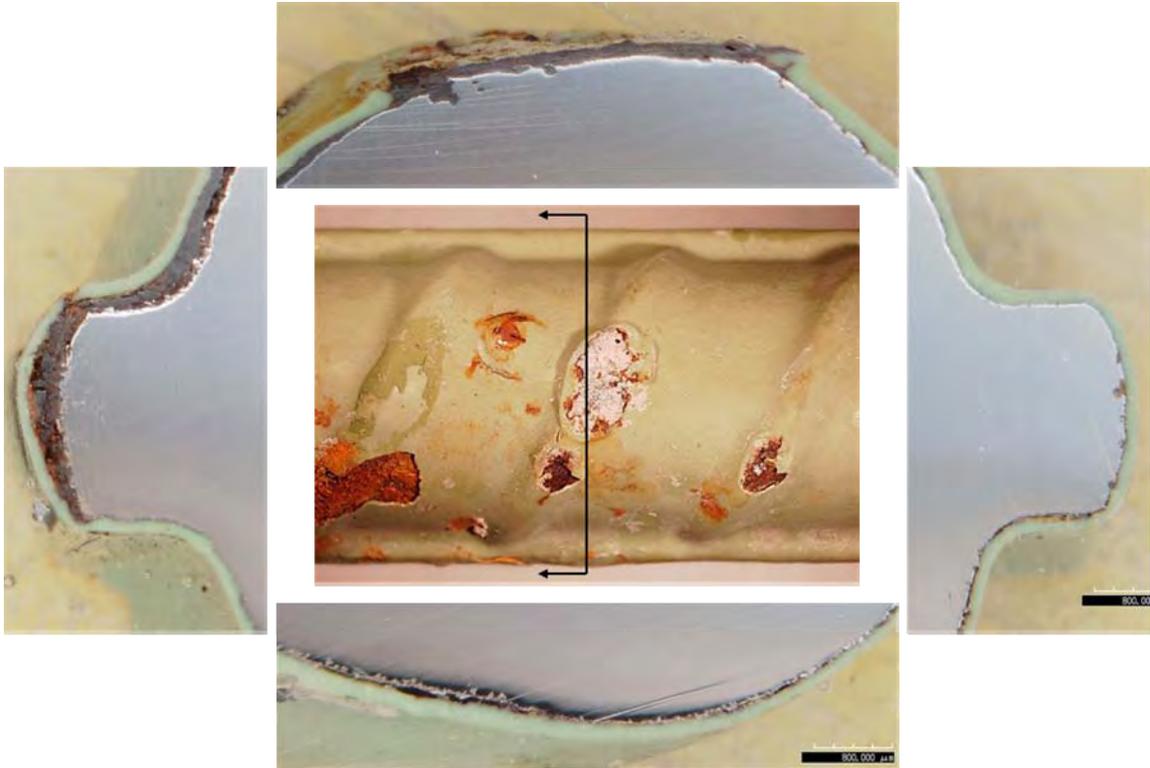
**Figure C - 39:** A cross-section through an intentionally damaged area along bar-4 of specimen EP-D-2.

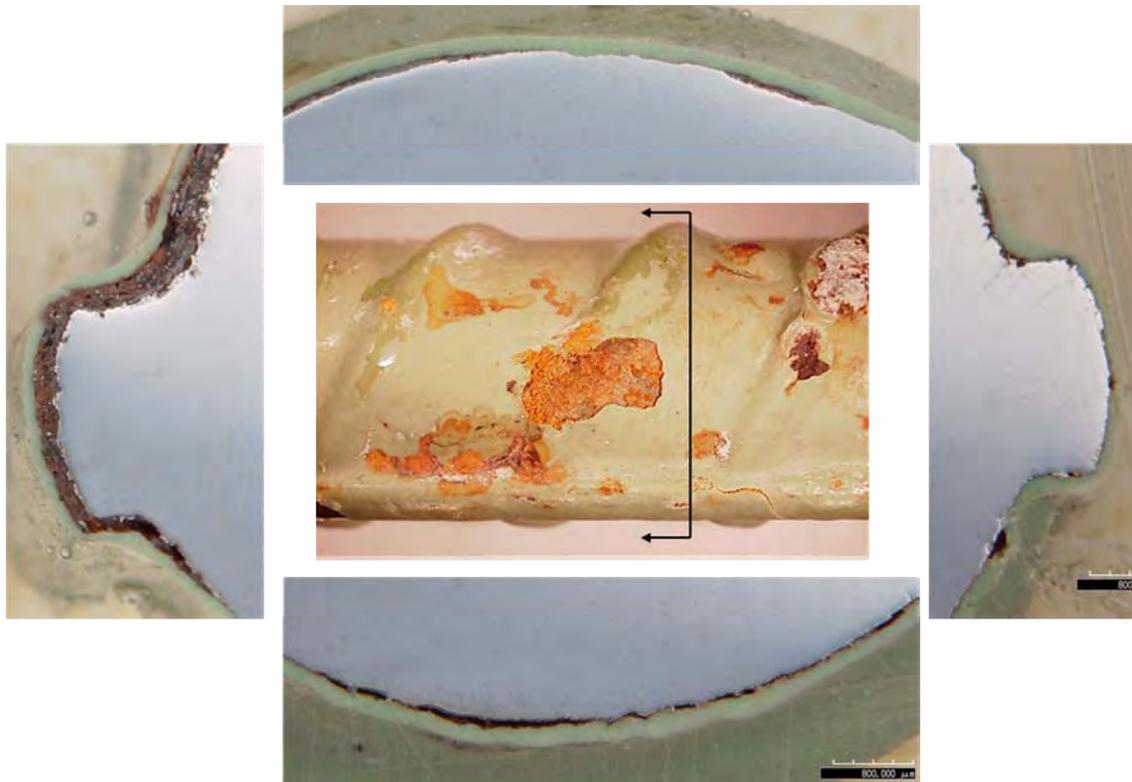
**Figure C - 40:** A cross-section through an unexplained area of damaged along bar-4 of specimen EP-D-2.

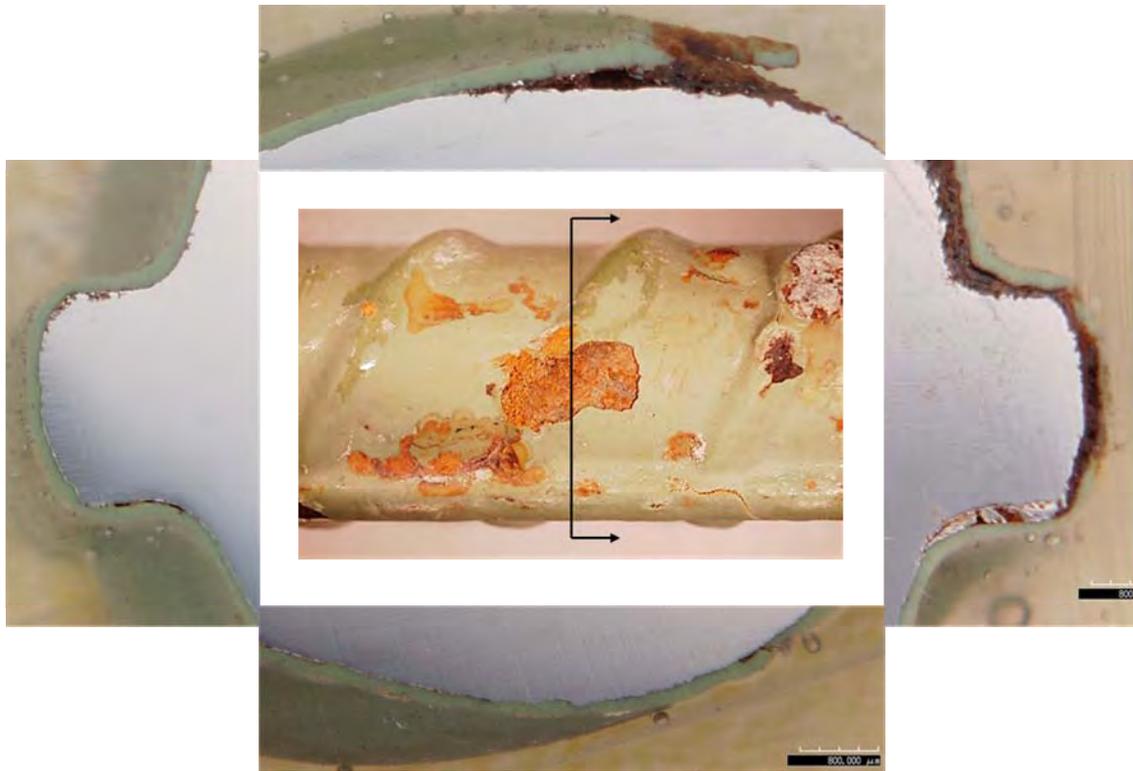
**Figure C - 41:** A cross-section through an unexplained area of damaged along bar-4 of specimen EP-D-2.

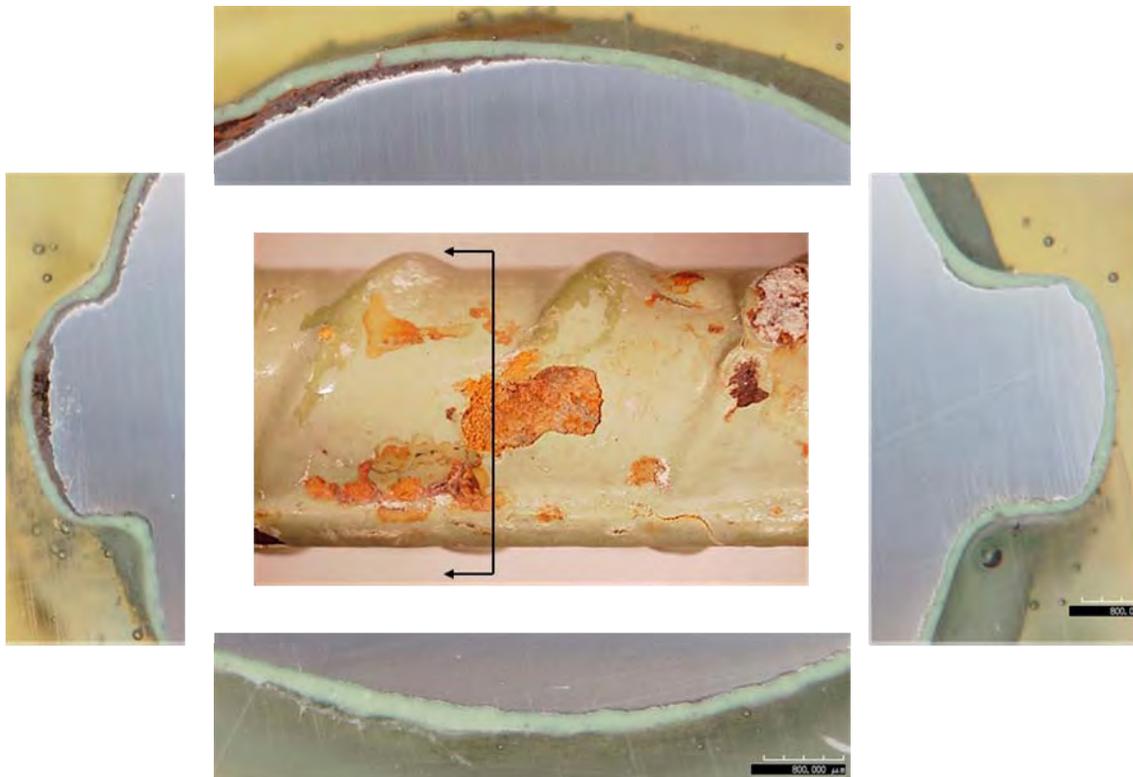
**Figure C - 42:** A cross-section through an unexplained area of damaged along bar-4 of specimen EP-D-2.
