# EVALUATING PERFORMANCE OF CONCRETE OVERLAYS FOR PAVEMENT REHABILITATION

November 2020
Final Report

Project number TR202003
MoDOT Research Report number cmr 20-012

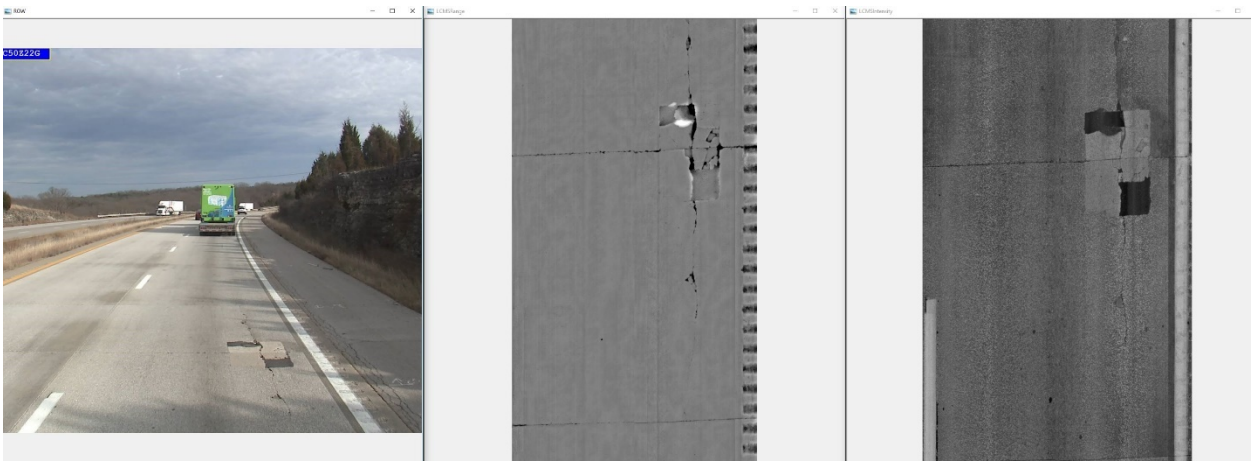
**Figure 2-5. ARAN display of forward camera (left panel), laser measured downward distance (center panel), and laser measure downward intensity (right panel) for project 12E, I-44 in Laclede County with corner patches and longitudinal cracks.**
