**MoDOT**

RDT 04-018

# Evaluation of Cutco Sawing and Sealing Method

RI 00-030

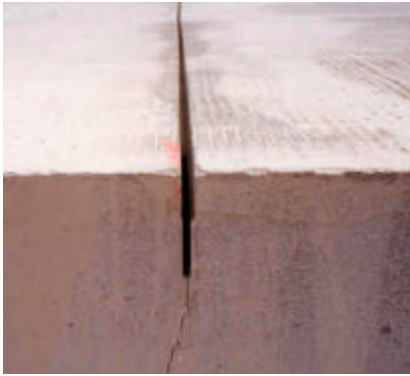
The 1/8" cut was completed prior to the diamond grinding operation. After the diamond grinding of the pavement, the 3/8" cut was made followed by the high pressure washing, light sand blasting, backer rod placement and sealing (See Figure 6 for the 2 passes cutting by Cutco method, Figure 7 shows the cut depth by MoDOT traditional method).

Figure 6. Cutco Transverse Joint 1<sup>st</sup> and 2<sup>nd</sup> wider Cut

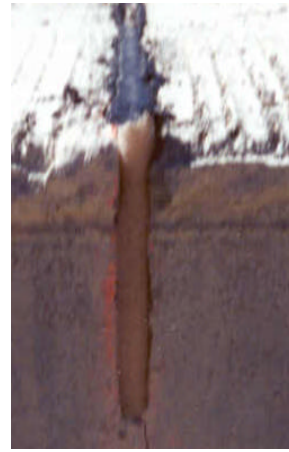
Figure 7. MoDOT Transverse Joint Depth

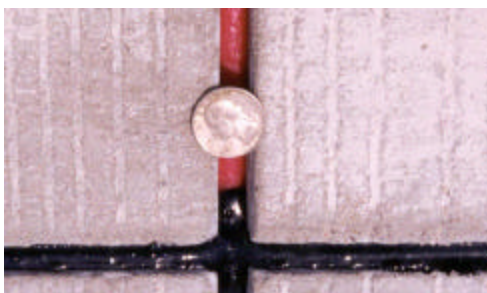
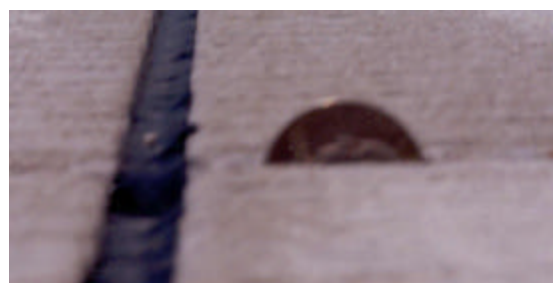
In the early stages of placing the foam backer rod on RT 71 bypass in Newton County, it was determined that the backer rod was not pliable toward the end of the spool. The foam material would not straighten out, it tended to curl and conform to the shape of the spool it came off of. Changing suppliers of the foam backer rod, which met the approval criteria, solved this problem. Placement of the joints sealant application presented no problems. Sealant installation was normal and the only problem that occurred was equipment breakdown, which was taken care of by the contractor on the job site with little or no loss of time (See Figure 9 and 10 for cut and seal dimensions by Cutco).

Figure 9. Joint Filler Installed in Longitudinal Joint      Figure 10. Quarter Showing Depth of Backer Rod Before Sealing
