# Investigations of Failures of Epoxy Polymer Overlays in Missouri

Prepared by  
Missouri Department  
of Transportation

RI06-020

**November 2007**

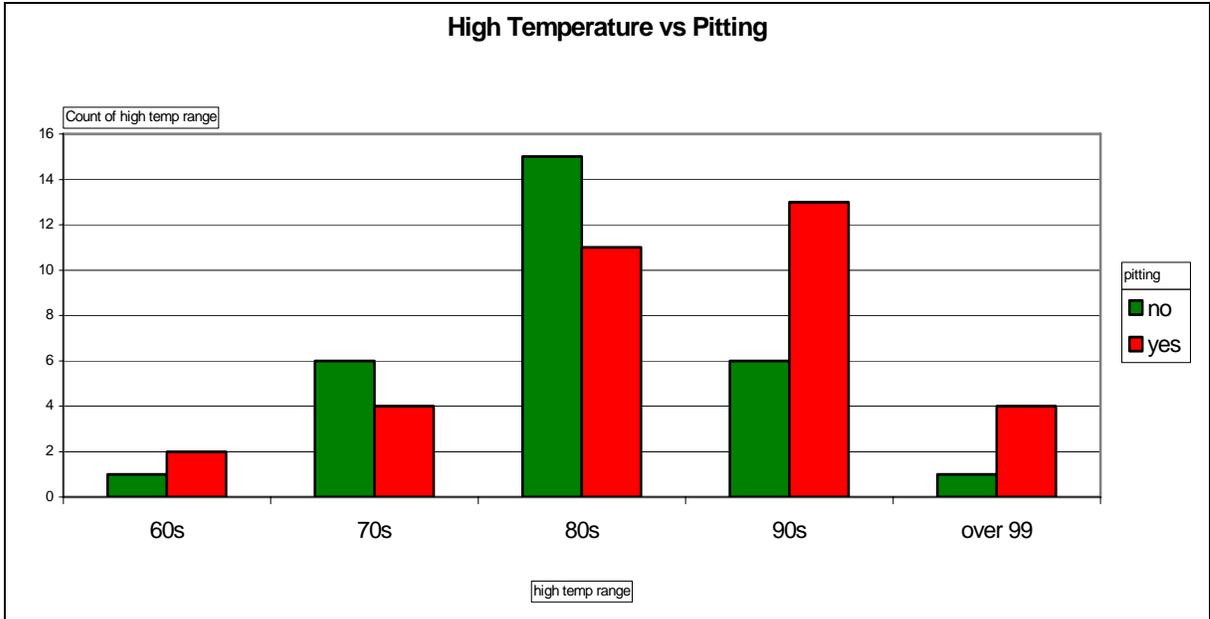
Figure 3. High Temperature at Placement vs. Pitting

An unexpected observation during the study was the presence of pitting on a majority of the bridge decks. Sixty-two out of ninety eight bridges had pitting of some degree. (The epoxy polymer overlay on two of the bridge decks, K108 placed in 1990 and A1944 placed in 1984, had worn to the point that determining failure mechanisms was impossible.) The degree of pitting ranged from pinprick sized pits to quarter inch sized pits. Pitting has been noted in many literature reports; however most sources claim that the pits will never line up between the two layers of overlay and should not be of concern. In the course of the investigation we found areas where the pits DID line up which create a funnel for water and chlorides to enter the deck. We also found that once the pitting became larger the EPO began to show signs of cracking between the pits, which eventually became block cracking. One source of pitting is the presence of air bubbles in the epoxy component of the overlay. In discussions with epoxy suppliers it was noted that the use of certain types of paddles for mixing can lead to air bubbles within the epoxy. The proper type of paddle to be used is called a “jiffy paddle” or a “Sika paddle.” Most epoxies have a maximum speed for the paddle, mixing any quicker can introduce air. Inspectors should verify that the contractor is using the correct type of paddle for mixing the epoxy and that the correct speed is being used. It was also noted that an increase in temperature leads to an increased chance of pitting. See Figure 3. During higher temperatures, extra care should be given to working out any remaining air bubbles during placement. The likelihood of pitting also increased with the number of freeze/thaw cycles. See Figure 4.

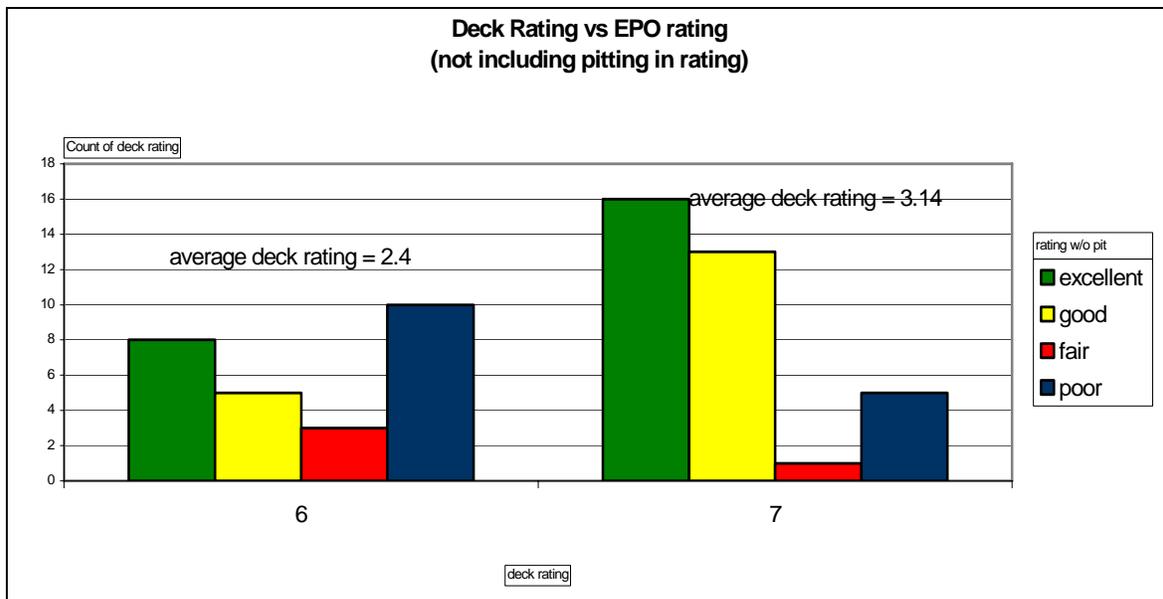
Figure 5. Previous Deck Rating vs. EPO Rating

For those bridges that we were able to gather background information, we collected the previous deck survey prior to placement. Most bridges had either a rating of 6 or 7. There were a few decks that were previously rated an 8 however there were only five. Four out of the five had overlays that ranged in age from 12-14 years old so there is not enough data to draw any conclusions for those bridges. In order to quantify the EPO rating, each bridge was given a number of the EPO rating of 4 for excellent down to 1 for poor. The average rating for the overlay on the bridges with a previous deck rating of 6 was a 2.4 whereas the average rating for the overlay on the bridges with a previous deck rating of 7 was a 3.14. See Figure 5. The bridge decks with a higher deck rating prior to placement are more likely to have an excellent or good rated overlay.

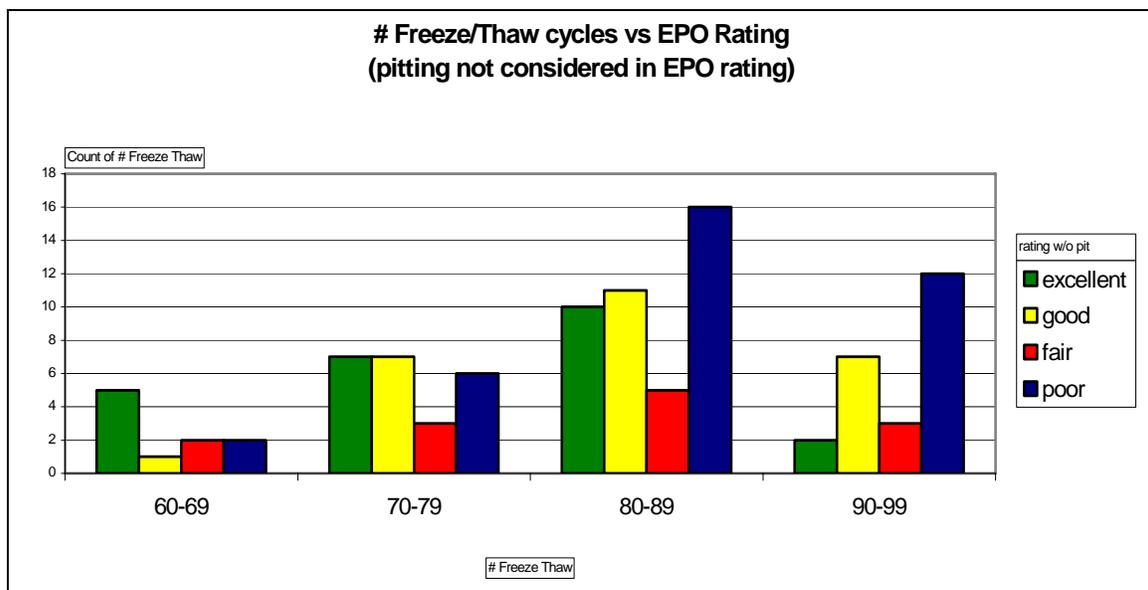
Figure 6. Freeze/Thaw Cycles vs. EPO rating

The number of freeze/thaw cycles greatly impacts a bridge deck. When water infiltrates the surface then freezes it can cause fractures in the concrete. The same can be said for epoxy polymer overlays, especially if the overlay has pitting. We gathered climatological data for each bridge deck. The Midwest Regional Climate Center provides the average values for temperatures from 1971 to 2000. By looking at the number of days below freezing and above freezing we estimated the number of freeze/thaw cycles at the nearest weather station to each bridge. As expected as the number of freeze/thaw cycles increases the average rating of the overlays decreased. See Figure 6.

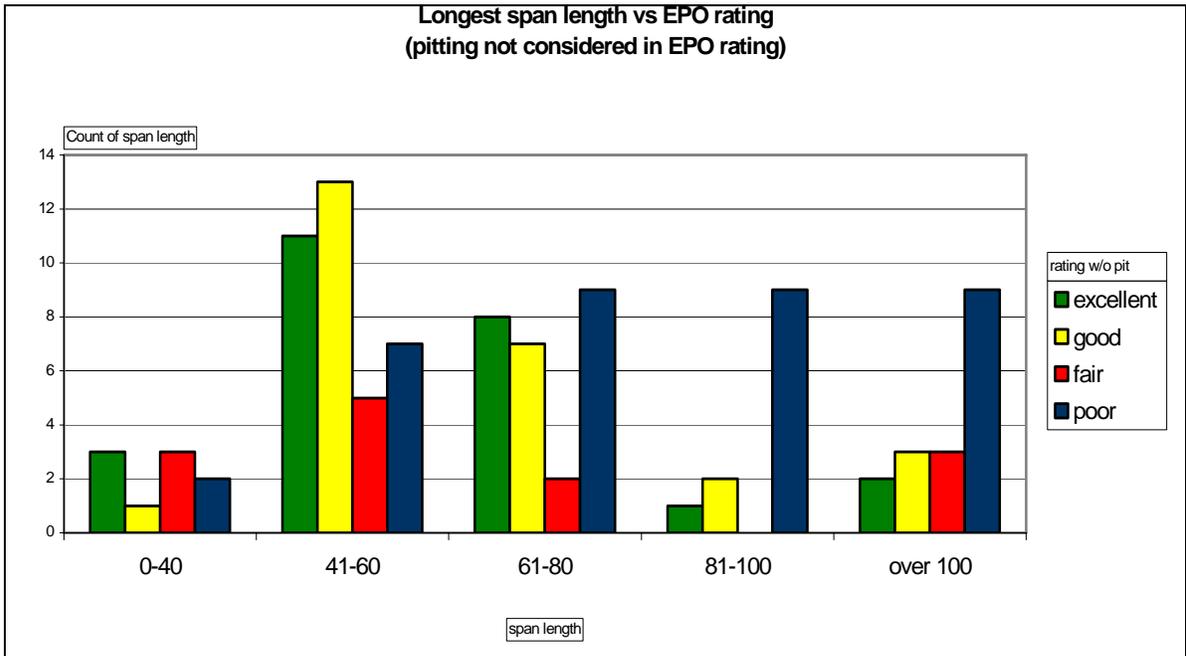
Figure 7. Longest Span vs. EPO rating

The span lengths of the bridge had an effect on the performance of the overlays. We compared the longest span length and overlay rating which indicated that the longer span bridges were more likely to have problems with their overlays. See Figure 7 and 8. This is not surprising since the longer spans will be more flexible, increasing the chance of the epoxy and/or deck cracking. Some of the newer epoxies are more flexible than the older epoxies, which should help with this problem. For bridges with long spans it would be more cost effective to look for an epoxy that is more flexible as opposed to going with the cheapest product. Transpo-T48 is a more flexible epoxy that might provide better protection on flexible decks. The girder type is related to the span length so the same pattern was found. Bridges with steel wide-flange sections and P/S I girders had higher EPO ratings than steel plate girders. See Figure 9.

- For bridges with long spans or flexible decks, require a flexible epoxy even if it is a little more expensive. A suggested brand is Transpo-T48.

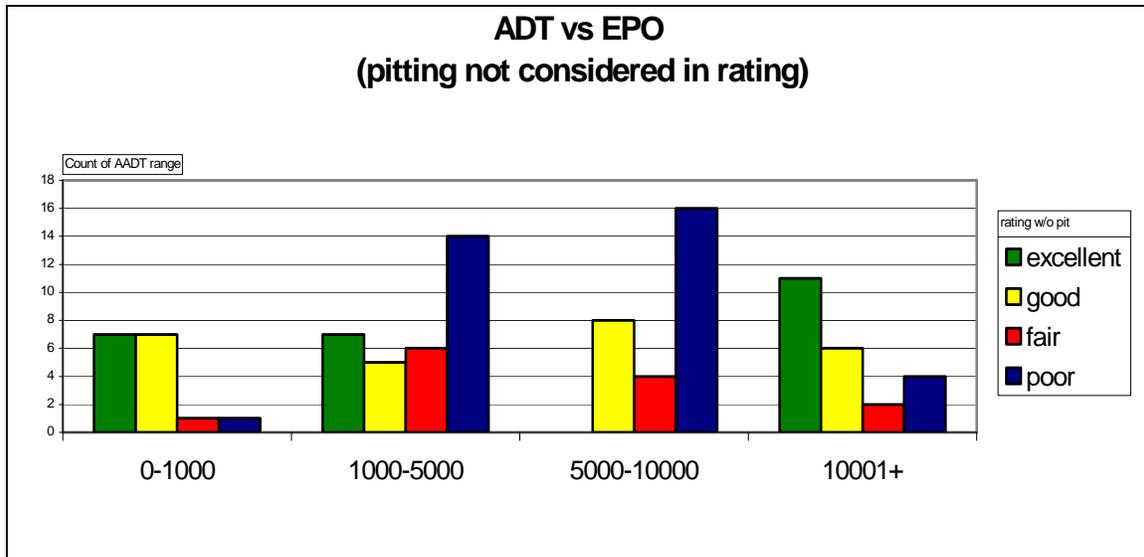
Figure 10. ADT vs. EPO

As expected when the number of cars and trucks that drive on an epoxy polymer overlay increases the overlay rating decreases. See Figure 10.
