# Preservation of Missouri Transportation Infrastructures: Validation of FRP Composite Technology

Volume 2 of 5

Life-Cycle Inspection and Monitoring Using  
Near-Field Microwave Nondestructive  
Testing Methods

Prepared by Missouri S&T  
and Missouri Department of  
Transportation

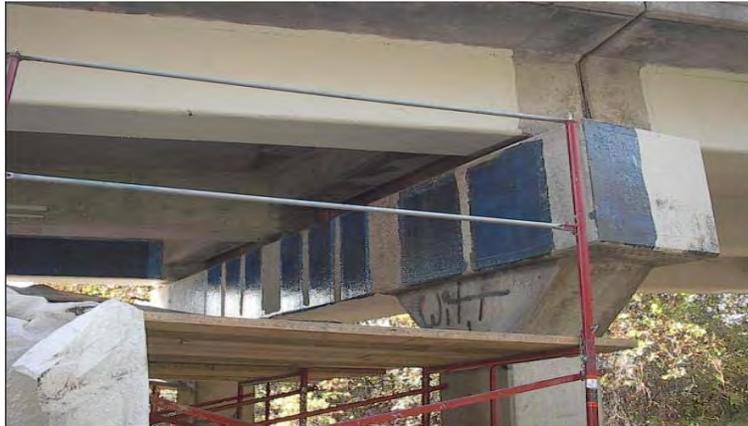
A number of artificial disbonds (intentional defects) were manufactured by injecting air between CFRP patches and concrete members at non-critical locations of the bonded CFRP patches when the epoxy adhesive was in its fresh state. The size and thickness (i.e. severity) of the disbonds were also varied using this process. The bonded CFRP patches in the abutment were used as reference since this part of the bridge is not usually strengthened by CFRP laminates. Moreover, the disbonds produced in the bent were thinner than the disbonds produced in the abutment. In addition, the bent with bonded CFRP patches were painted (Figure 4 shows the bent before it was painted).

Figure 4 - Picture of bent-A of the bridge P-0962 with FRP bonded patches before they were painted.

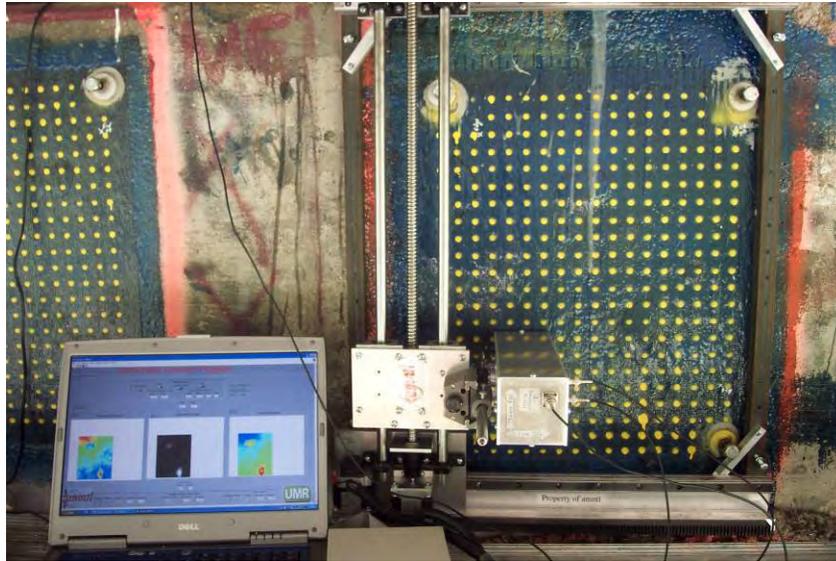
Figure 15 shows one of the abutment patches being tested by the reflectometer. The white spots on the surface of the abutment patch are paint spots used as a reference grid for another investigation. Figures 16a-b also show the three images produced by the system (shown on the laptop display). Figure 16 shows the microwave images of the 260 mm by 320 mm scanned area of the bonded CFRP patch in the abutment.

Figure 15 - A picture of the 2D scanning mechanism and the microwave reflectometer testing CFRP patch bonded to the abutment of a bridge.

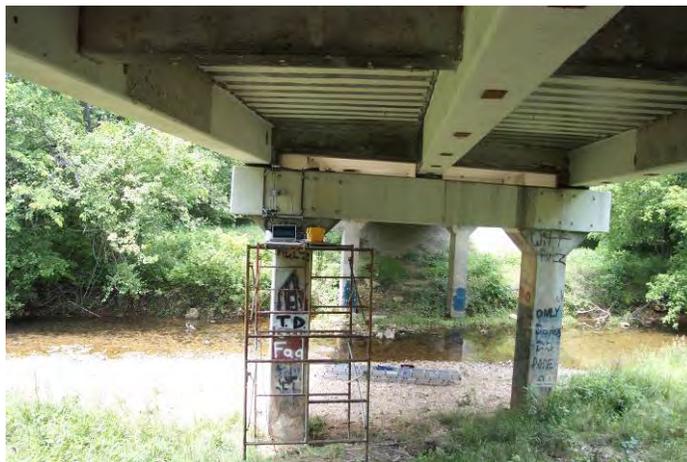
Figure 17 shows the picture of the bent of the bridge with the CFRP patches and the 2D scanning mechanism with the microwave reflectometer testing a CFRP patch.

Figure 17 - A picture of the bent with CFRP patches and 2D scanning mechanism with the microwave reflectometer testing CFRP patch #1.

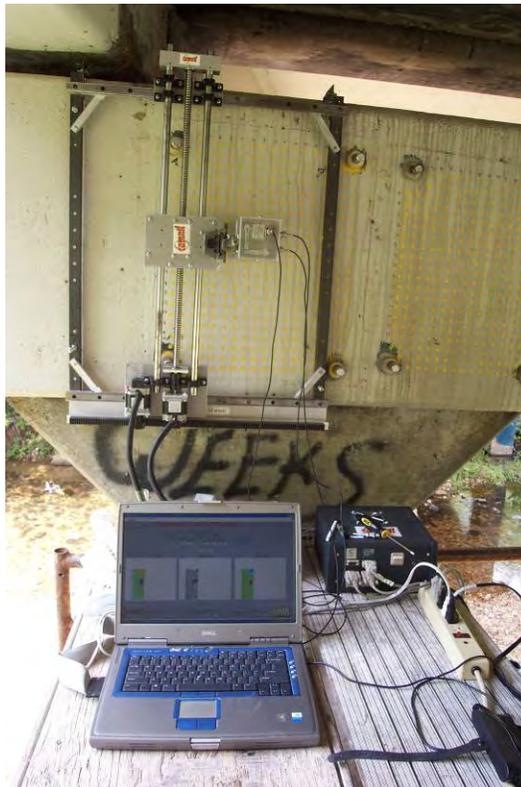
The bent patches were painted with white paint. As mentioned early, the disbonds produced in the bent were thinner than the disbonds produced in the abutment (i.e., not visible and difficult to detect). Close-up view of bent patch #1 while being tested by the dual-polarized reflectometer attached to a computer-controlled scanning platform is shown in Figure 18. Figure 18 also shows the three microwave images of the 270 mm by 330 mm scanned area of the CFRP patch in the laptop display.

Figure 18 - The dual-polarized microwave reflectometer attached to a scanning platform while inspecting a CFRP patch #1 bonded to the bent of a bridge.

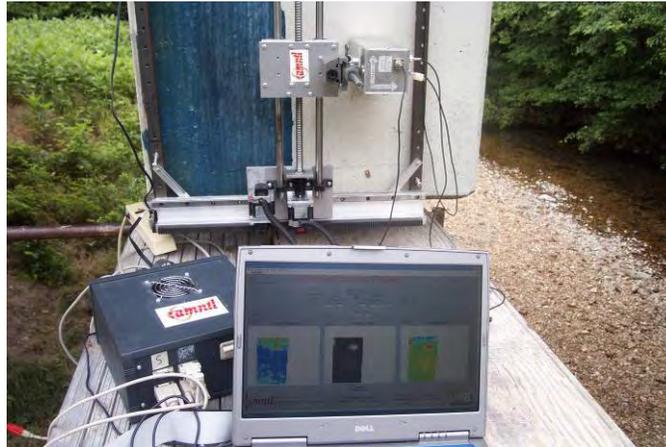
Figure 20 - A picture of the 2D scanning mechanism and the microwave reflectometer testing CFRP patch bonded to the side wall of the bent.

One of the CFRP patches was bonded on the side wall of the bent. Figure 20 shows this patch tested by the reflectometer. Half of the bent patch was painted as can be seen in Figure 20. This was done to visually blend in the presence of the patch into the natural color of concrete. Figure 21 shows the microwave images of the 260 mm by 360 mm scanned area of the bonded CFRP patch on the side wall of the bent. The results show that the image from the bent patch at perpendicular polarization is more non-uniform than the image of the abutment patch (Figure 16a). This is due to the fact that the disbands produced in the bent were thinner than the disbands produced in the abutment and the influence of standoff distance variation was also relatively more significant. It must be noted that there is indication of the boundary of paint in all three images. This fact once more confirms the ability of microwave signals to penetrate through low loss materials such as paint. The compensated image (shown in Figure 21c) clearly indicates the disbands as well as the local non-uniformity associated with them. The locations and sizes of the detected disbands, indicated by these compensated images, agreed well with their locations and sizes on the bonded CFRP patches and were corroborated by tap testing.

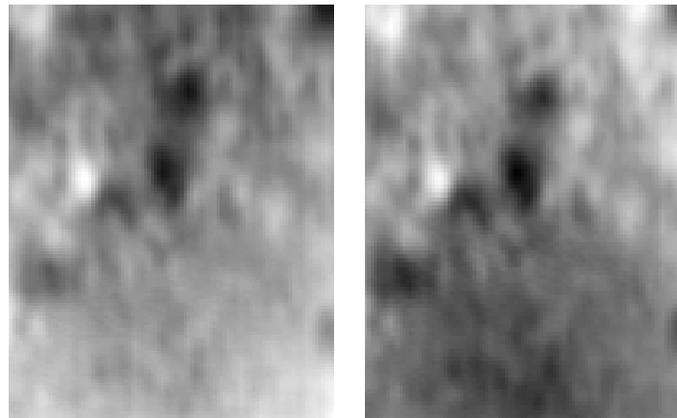
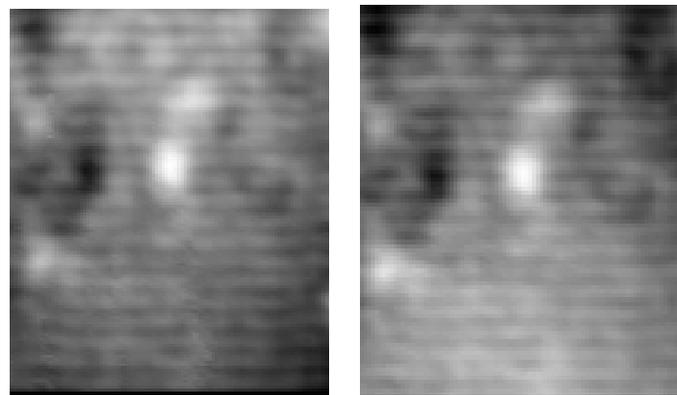
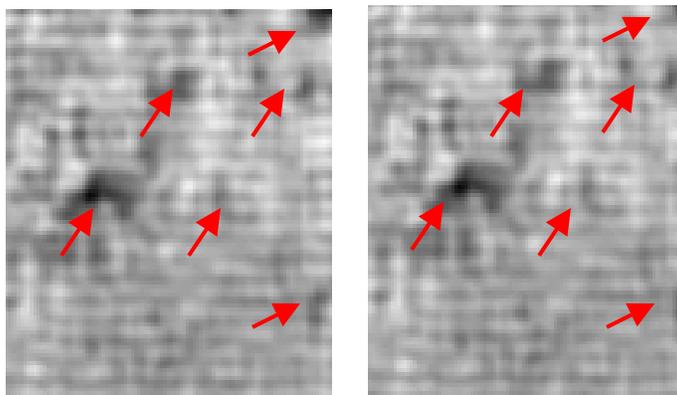
Figure 23 - Microwave images of a CFRP patch #2 at the bent: (a) at perpendicular polarization, (b) at parallel polarization, and (c) compensated image obtained in (left column) October 14, 2005 and (right column) May 26, 2006. Red arrows show disbonds.

Figures 22 - 23 show the microwave images of CFRP patch #1 and patch #2, respectively, at the bent at perpendicular and parallel polarizations, and compensated image obtained in 2005 (October 14) and in 2006 (May 26). Scanned areas were 270 mm by 330 mm and 250 mm by 300 mm for patch #1 and #2, respectively, and standoff distance was 8 mm for both patches. It can be seen from Figures 22 - 23 that all corresponding images for each patch are very similar.

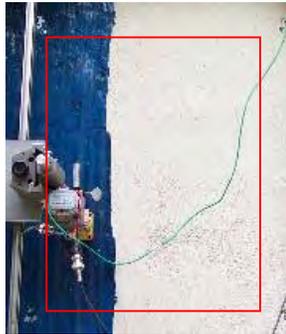
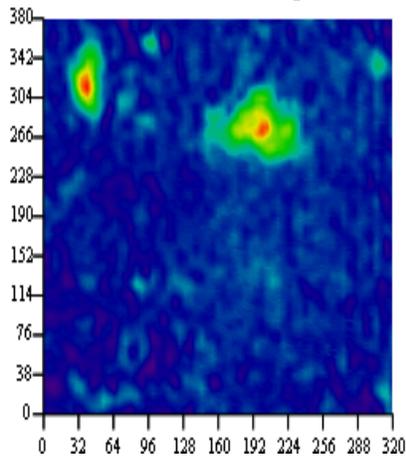
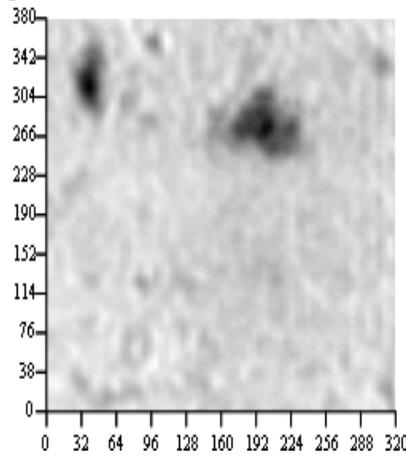
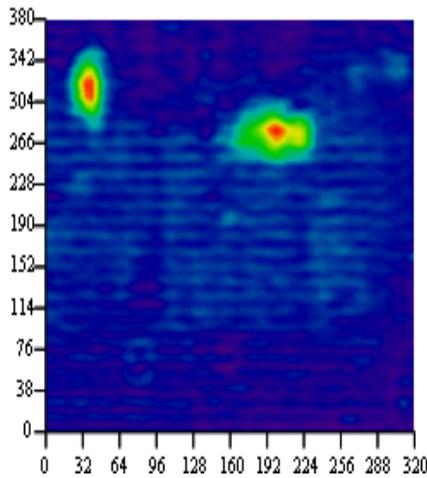
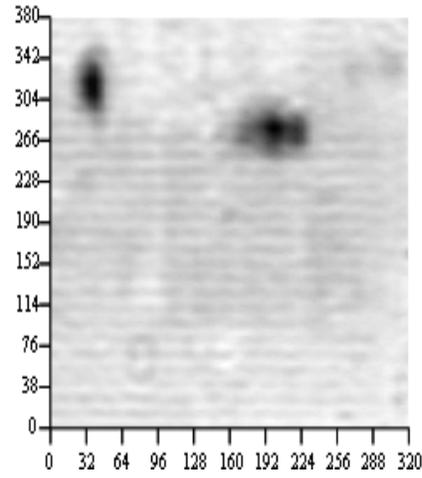
**Patch on east side of south bent (June 15/04)**

Picture of the patch with marked scanned area (320mm x 380 mm)

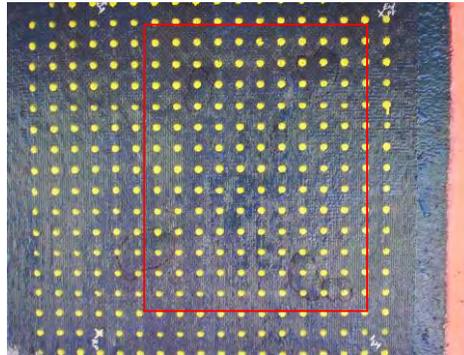
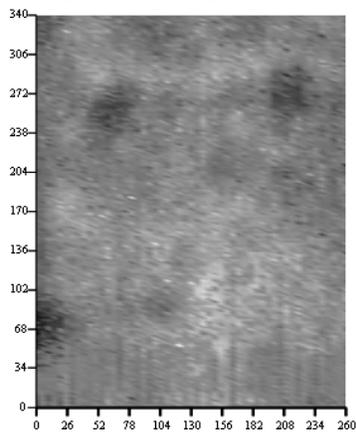
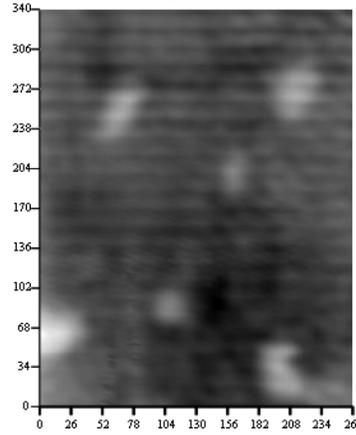
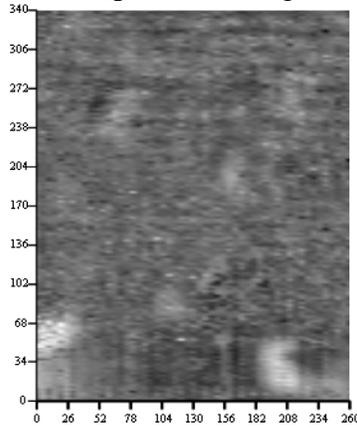
**Patch 2 (from left) on south abutment (November 11/05)**

Picture of the patch with marked scanned area (260mm x 340mm)

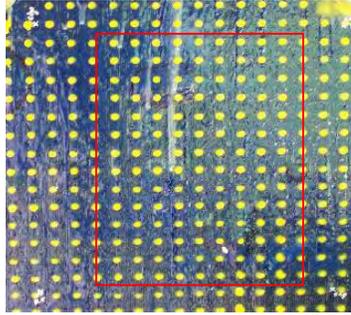
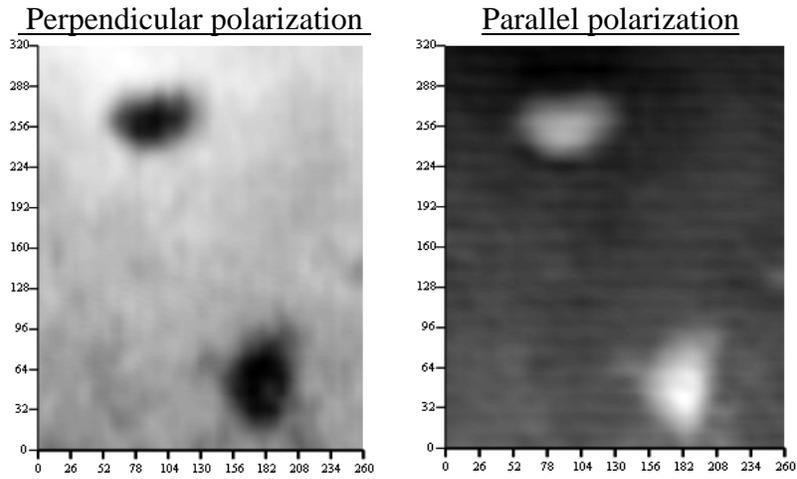
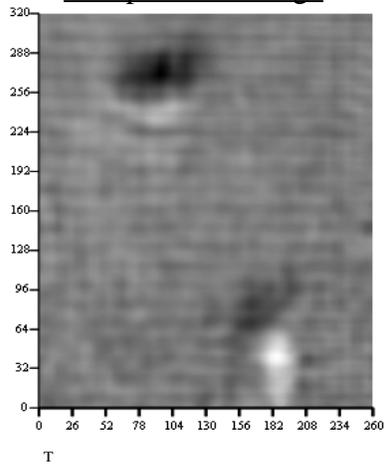
**Patch 3 (from left) on south abutment (November 11/05)**

Picture of the patch with marked scanned area (260mm x 320mm)

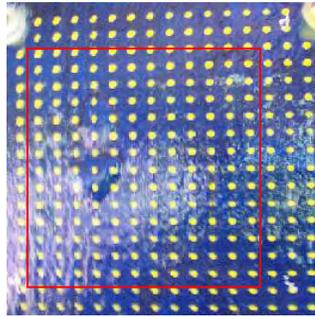
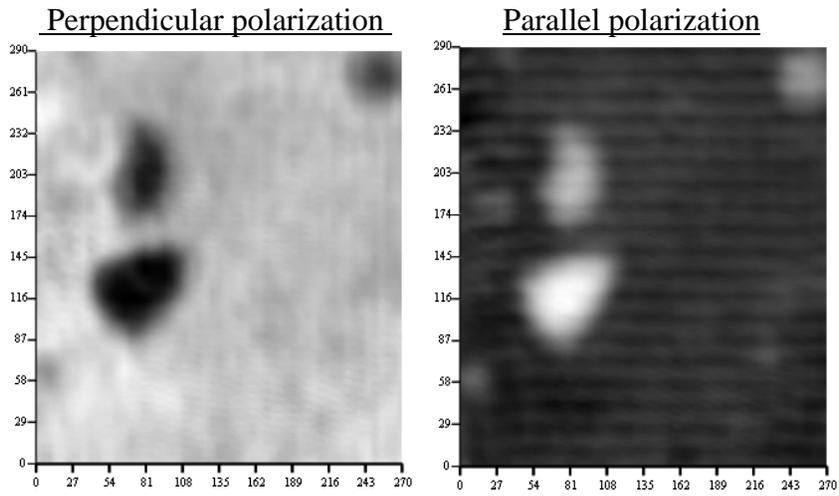
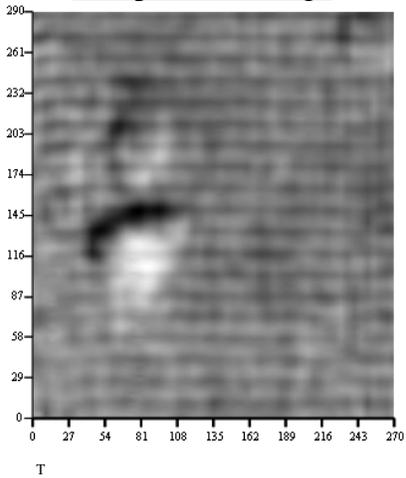
**Patch 4 (from left) on south abutment (November 11/05)**

Picture of the patch with marked scanned area (270mm x 290mm)

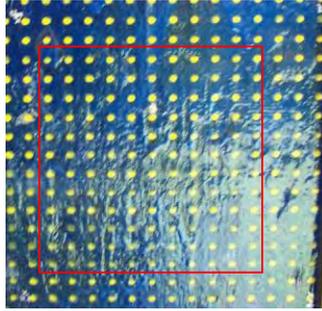
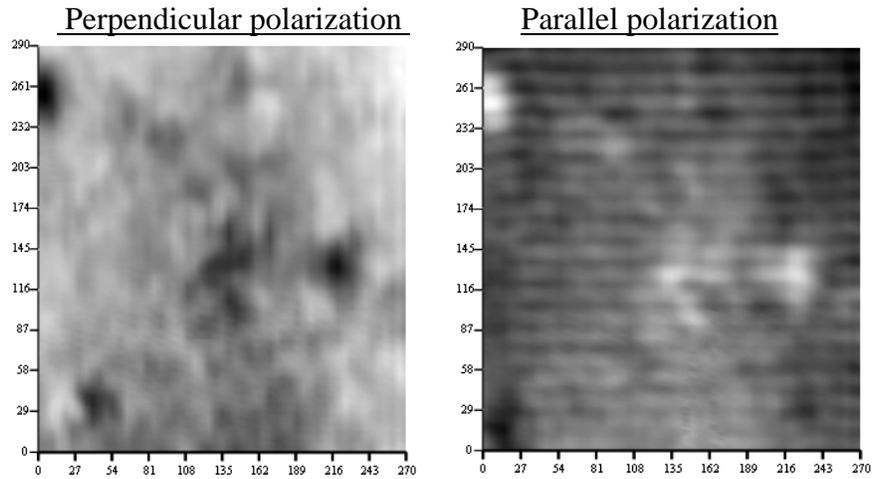
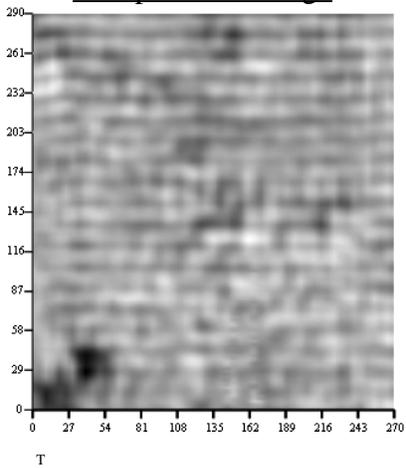
**Patch 5 (from left) on south abutment (November 11/05)**

Picture of the patch with marked scanned area (270mm x 290mm)

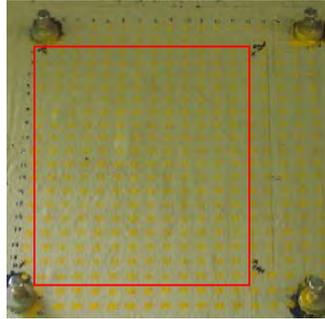
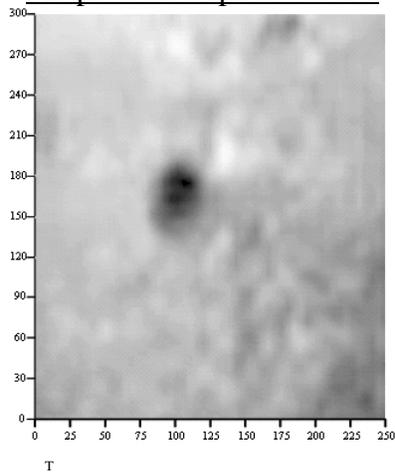
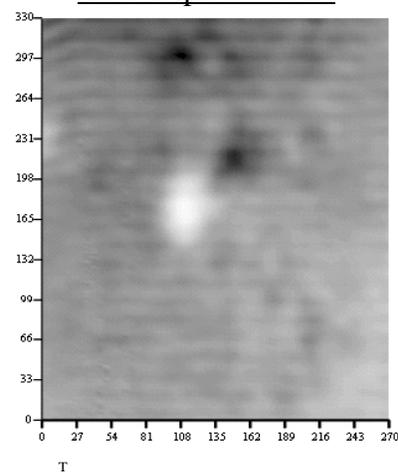
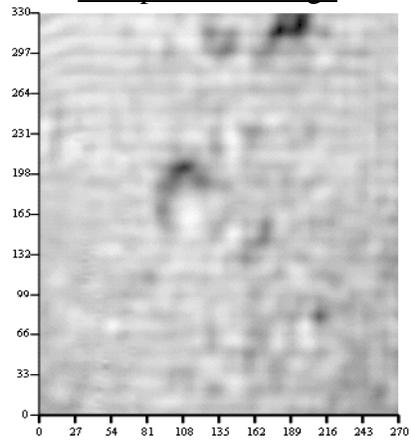
**Patch 1 (from left) on south bent (October 14/05)**

Picture of the patch with marked scanned area (270mm x 330mm)

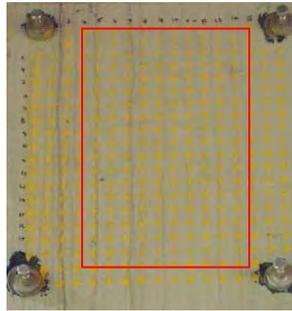
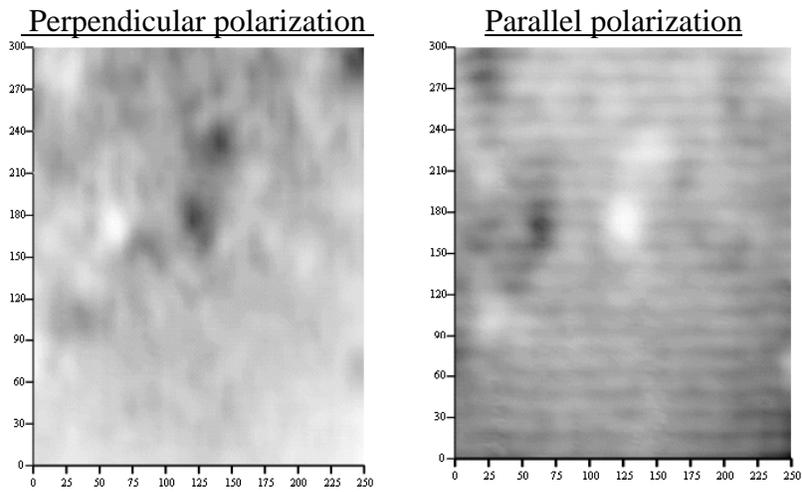
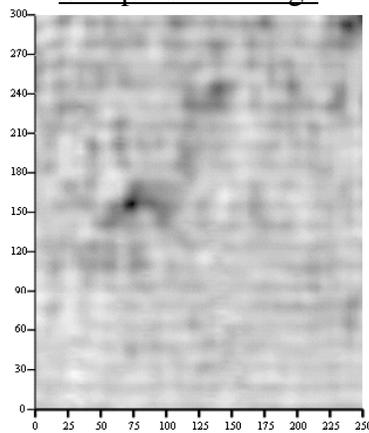
**Patch 2 (from left) on south bent (October 14/05)**

Picture of the patch with marked scanned area (250mm x 300 mm)

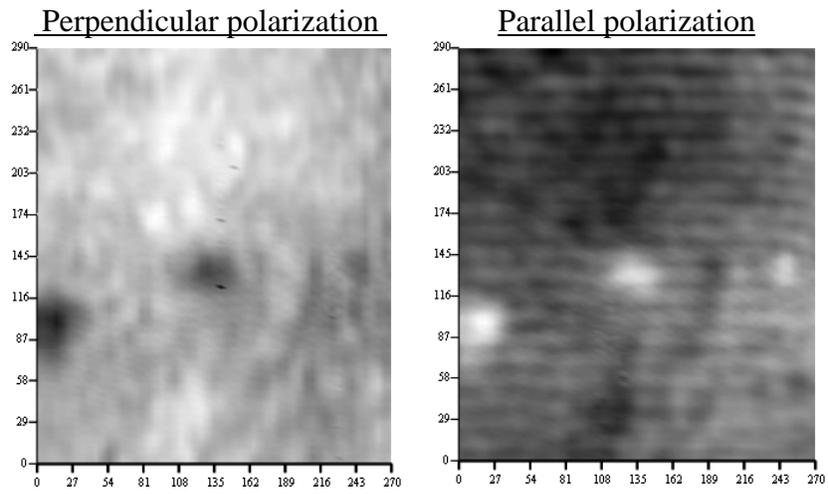
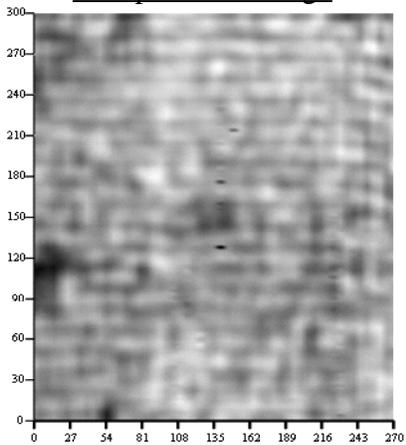
**Patch 3 (from left) on south bent (November 4/05)**

Picture of the patch with marked scanned area (270mm x 300 mm)

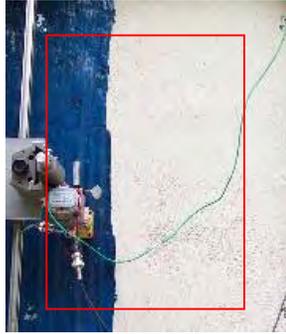
**Patch on east side of south bent (November 4/05)**

Picture of the patch with marked scanned area (260mm x 300 mm)
