# Dowel Bar Retrofit

## TECH BRIEF

*This document is a brief technical summary of the MoDOT case study **Dowel Bar Retrofit Case Study for Washington and Other Leading States** which is included in a larger report, **Concrete Repair Best Practices: A Series of Case Studies**, Publication no. cmr 17-013, November 2017.*

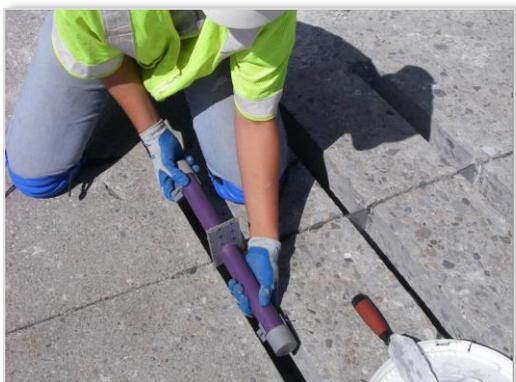
Figure 2. Inserting dowel bar assembly into slot (Photo courtesy of Jeff Uhlmeier, Washington State DOT).

**Dowel Bar Assembly.** The lubricated dowel bar assembly is placed into the slot, as shown in Figure 2. The dowel is lightly coated with a parting compound, foam core board is placed on the dowel to establish the existing concrete joint, and end caps/chairs are placed on the ends of the dowels that will provide a minimum of ½-inch clearance from the bottom of the slot. The assembly is placed in the center of the slot. Other States use a similar approach.
