**VIBRATION MONITORING  
AND  
CONTROL OF BLASTING  
ASSOCIATED WITH THE RELOCATION  
OF HIGHWAY H,  
GREEN COUNTY, MISSOURI.**

**Submitted to the Missouri Highway and Transportation Commission**

**Rock Mechanics and Explosives Research Center**

**Job No. J8S0331**

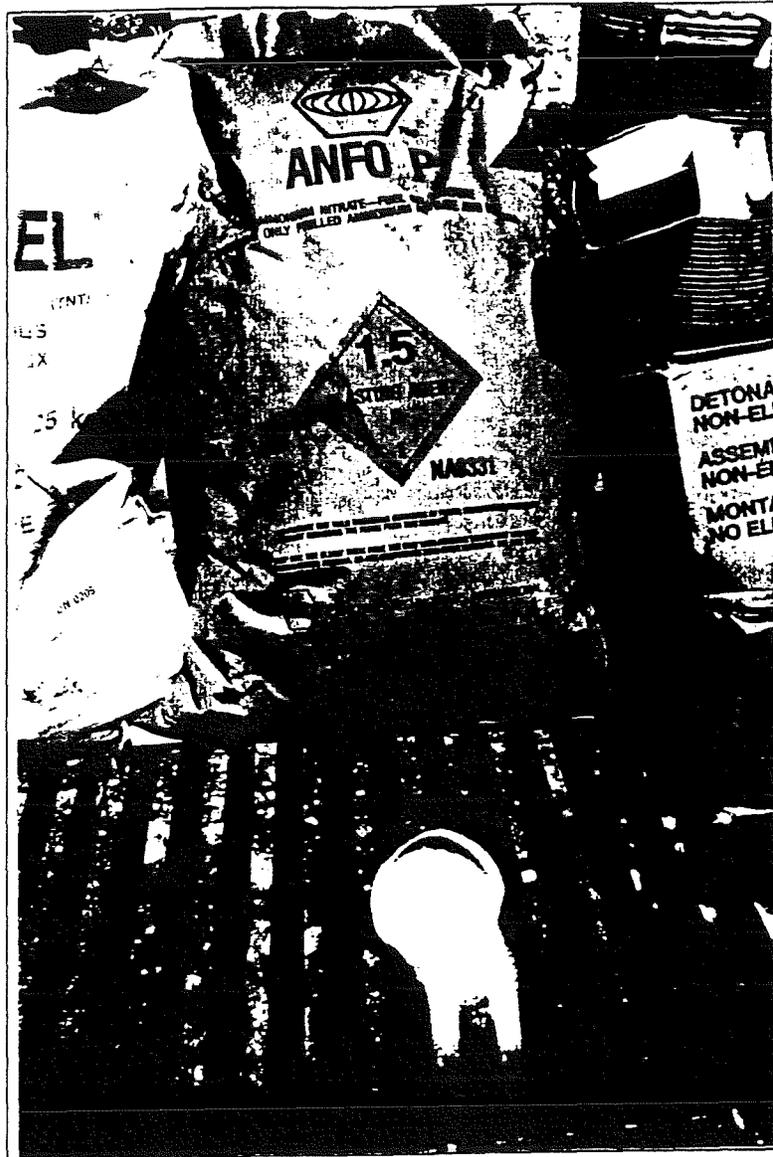
Figure 5: Nitropel prill

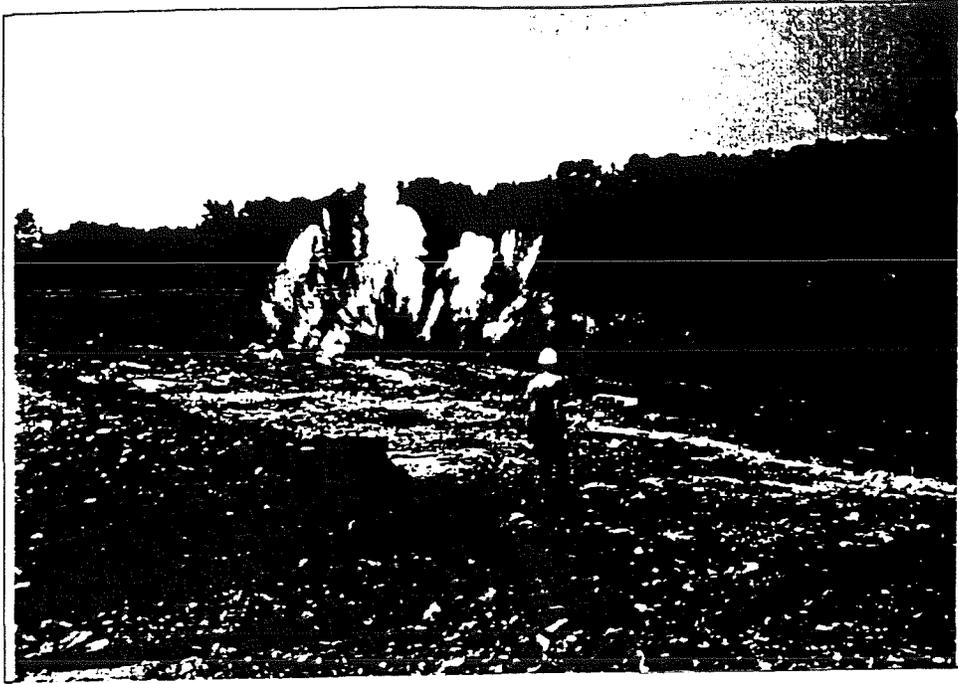
Figure 6: Typical shot across and approximately 1000 feet from cave.

The blasting was performed by Journagen Construction under the direct control and supervision of John Drake (Blaster in charge). The initial initiating system was millisecond (ms) period electric caps which were used only on the far north end of the contract no nearer than approximately 2,000 feet from the cave (Highway W and North). This was changed to a non-electric system for the remainder of the contract. This utilized EZ det nonelectric caps with 25 ms surface and 350 ms down the hole delays (Figure 1) and 42 ms surface row to row delays (Figure 2). Drill Holes of 3.0 inch diameter were drilled by crawler rigs up to approximately 25 ft. in depth. The holes were primed using single cartridges of Tovex Trenchrite 5 (Figure 3). Dry holes were then loaded with ETI ANFO P prill (Figure 4) and wet holes with ICI Nitropel, a TNT prill (Figure 5). Each hole was stemmed with drill cuttings. The holes were normally drilled on a rectangular pattern of 7 ft. spacing and 5 ft. burden and fired in a V pattern. Examples of shots are given in Figure 6 and Figure 7. Occasionally flyrock was experienced (Figure 8). A typical muck pile post blast is shown in Figure 9.

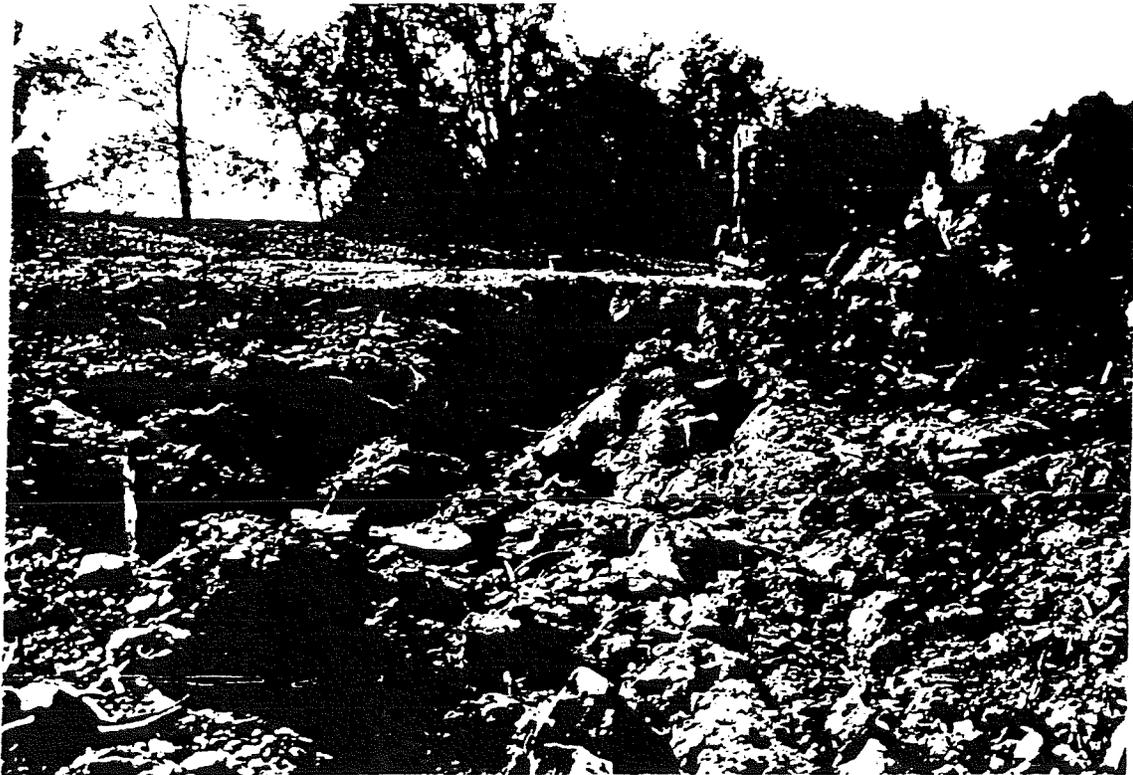
Figure 9: Typical shot muck pile against Williamsons' property line. Pre-split at perimeter just showing.

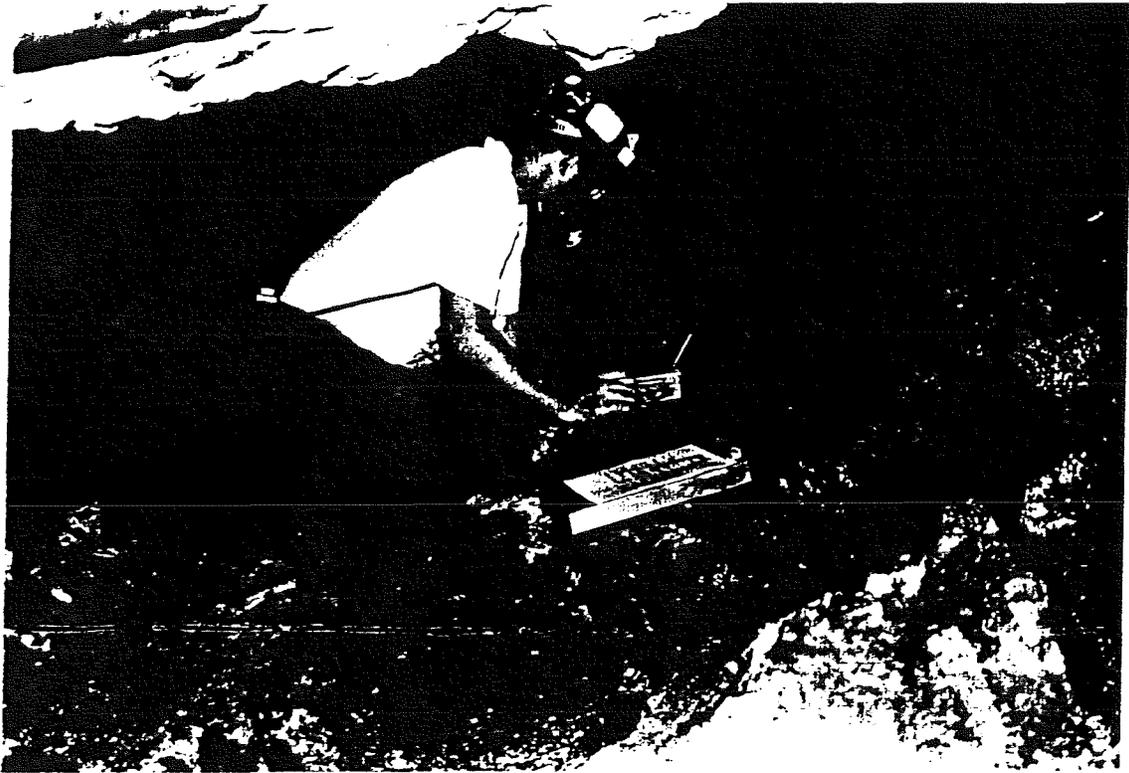
**Figure 13: Seismograph location in Indian Sleeping Chamber**

The Indian sleeping chamber ( INS in Appendices C and D ) is north of the Cathedral Room and is not part of the standard tour. Clay steps lead into the room. The instrument location was approximately 5 ft from the top of these steps. The mounting was on rock about 4.5 ft to the ceiling. See Figure 13. Conditions were dry. Instrument No. 19 was positioned at this location for the periods 11 May 95 to 12 May 95 and 21 June 95 to 17 July 95. Instrument No. 17 was substituted for the periods 13 May 95 - 20 June 95 and 18 July 95 to the end of the project. A third Instrument, No. 18, was positioned at this location during the period 17 June 95 to 22 June 95. This instrument location is No. 3 on Figure 10.

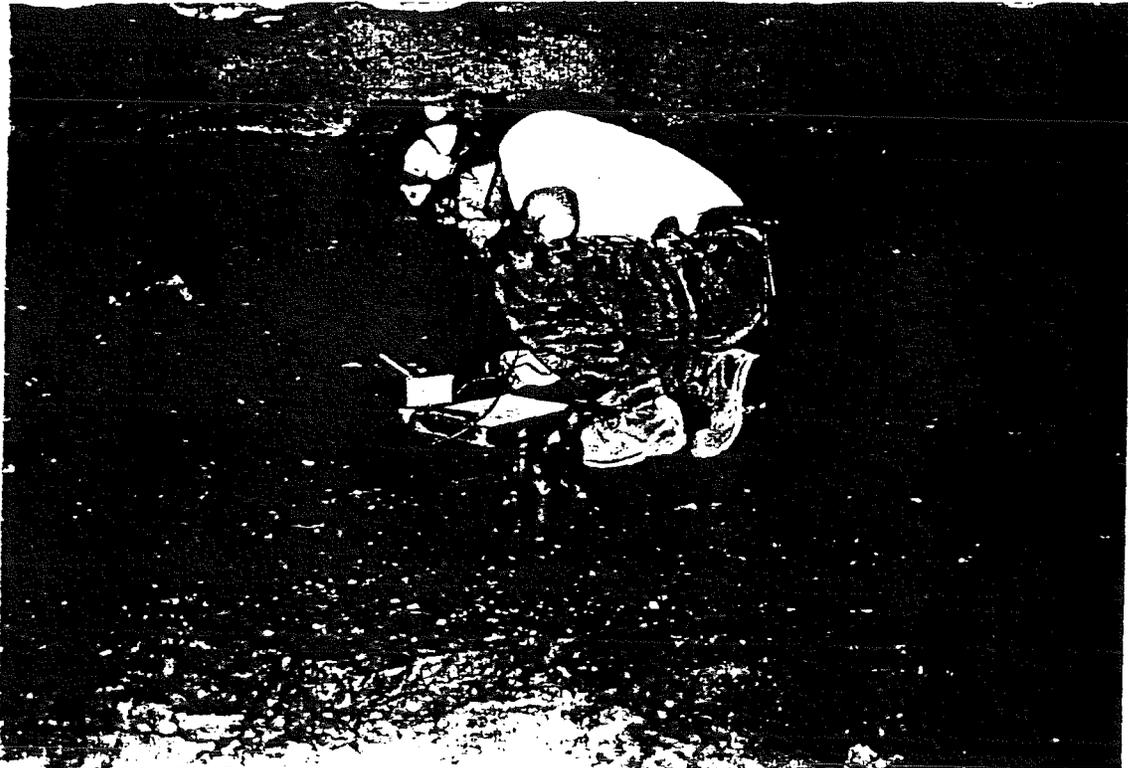
Figure 14: Seismograph location in Jacob's Room.

The instrument location was approximately 12 ft to the right of the railing immediately after entering Jacob's room. The mounting was on a rock slab resting on a layer of clay and having a distance of about 6 ft to the ceiling. See Figure 14. Station conditions were dry. Instrument No. 492 was positioned at this location during the period 11 May 95 to 17 July 95 and Instrument No. 18 was positioned at this location from 18 July 95 to the end of project. This is location No. 4 on Figure 10.

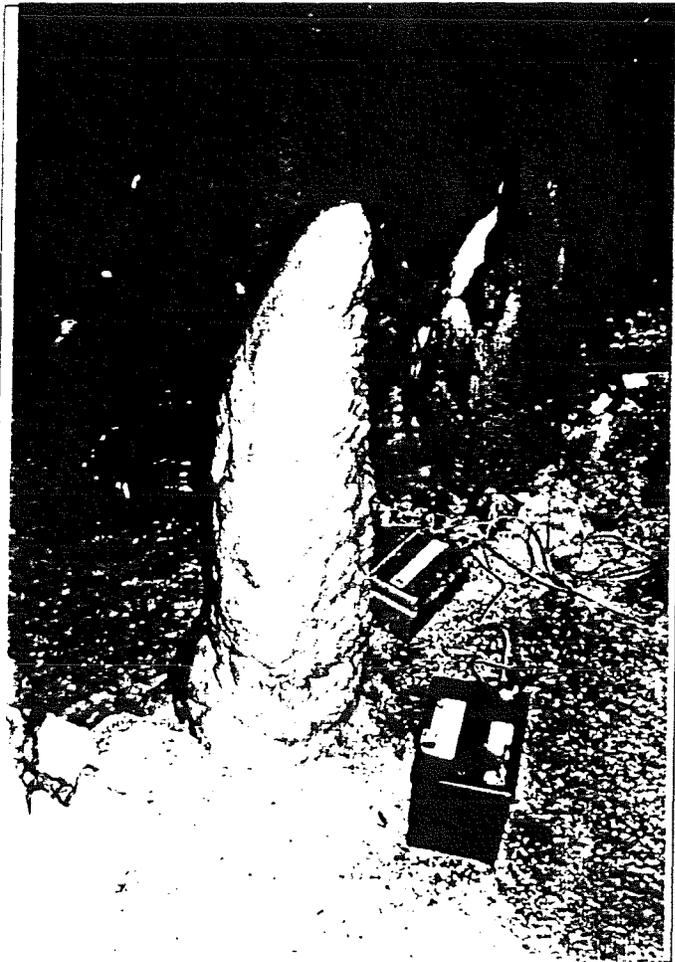
**Figure 15: Seismograph location  
in Helectite Room.**

MS-2D2G Seismograph with  
external geophone. Geophone  
under black sand bag.

Also illustrating external power  
source - 12 volt lead acid battery.

The MS-1D units (Figure 11) and the geophones of the MS-2D2G instruments (Figure 15) were mounted on metal plates for additional stability and weighted with sandbags to both improve coupling to the ground and to minimize extraneous vibrations. The seismic trigger level was set to 0.03 in/s on all instruments for most of the project. Two units were set to trigger at 0.05 in/s during the first few weeks of the project, but by 1 June '95 these were reduced to 0.03 in/s. The acoustic triggers were not used not only because overpressure inside the cave was minimal but also because of the possibility of accidental activation by tour groups.

The Helectite room is in actuality the rear portion of the chamber named the Chimes Room and is not part of the standard tour. This area is closed to the public because of the fragile nature and rarity of some of its Helectite formations. The instrument location was approximately 15 ft beyond a rope barrier at the end of the chat path and on the right side. The mounting was on a Gour Pool formation with a distance of about 7 ft to the ceiling. See Figure 15. Conditions were wet. Instrument No. 491 was positioned at this location during the dates 11 May 95 to 30 July 95 and was replaced with instrument No. 492 during the time 31 July 95 to the end of project. This is location No. 5 on Figure 10.

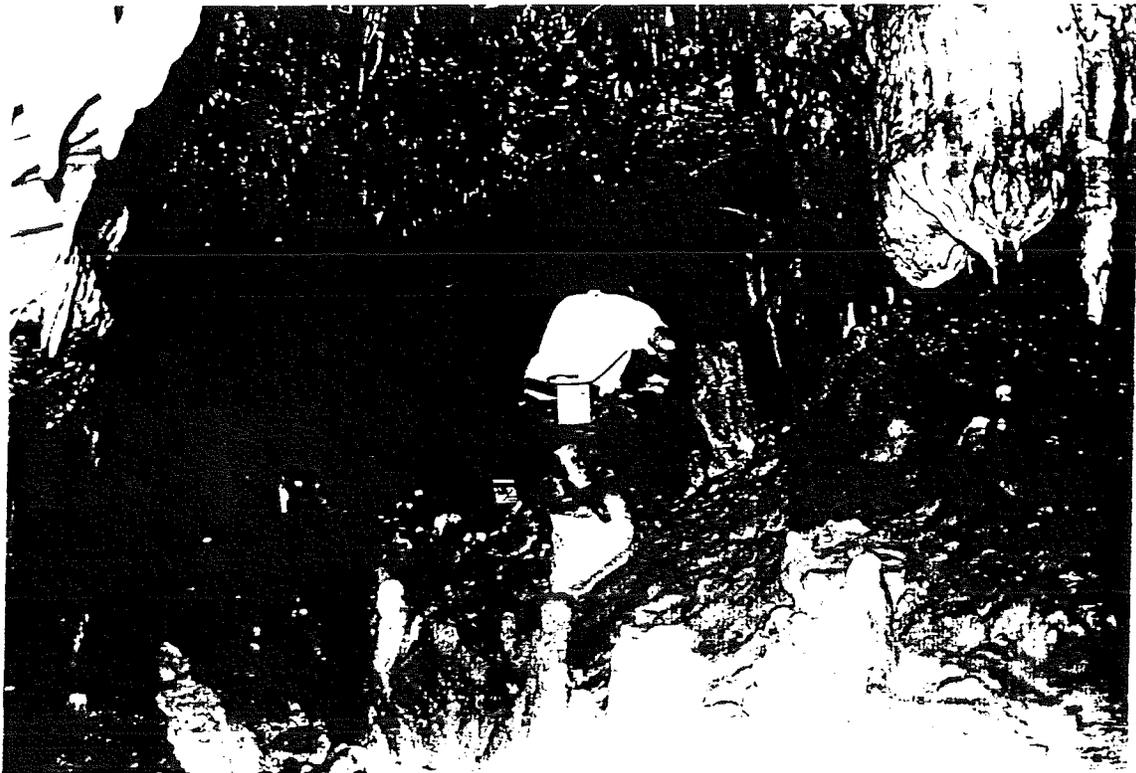
**Figure 16: Seismograph location in Lloyd's Room.**

The instrument was located approximately 15 ft beyond the end of the chat walk and on the right side near a column broken at the top end. The mounting was on clay with about 5 feet to the ceiling. See Figure 16. Conditions were damp. Instrument No. 20 was in place for the entire project. This location is designated No. 6 on Figure 10.

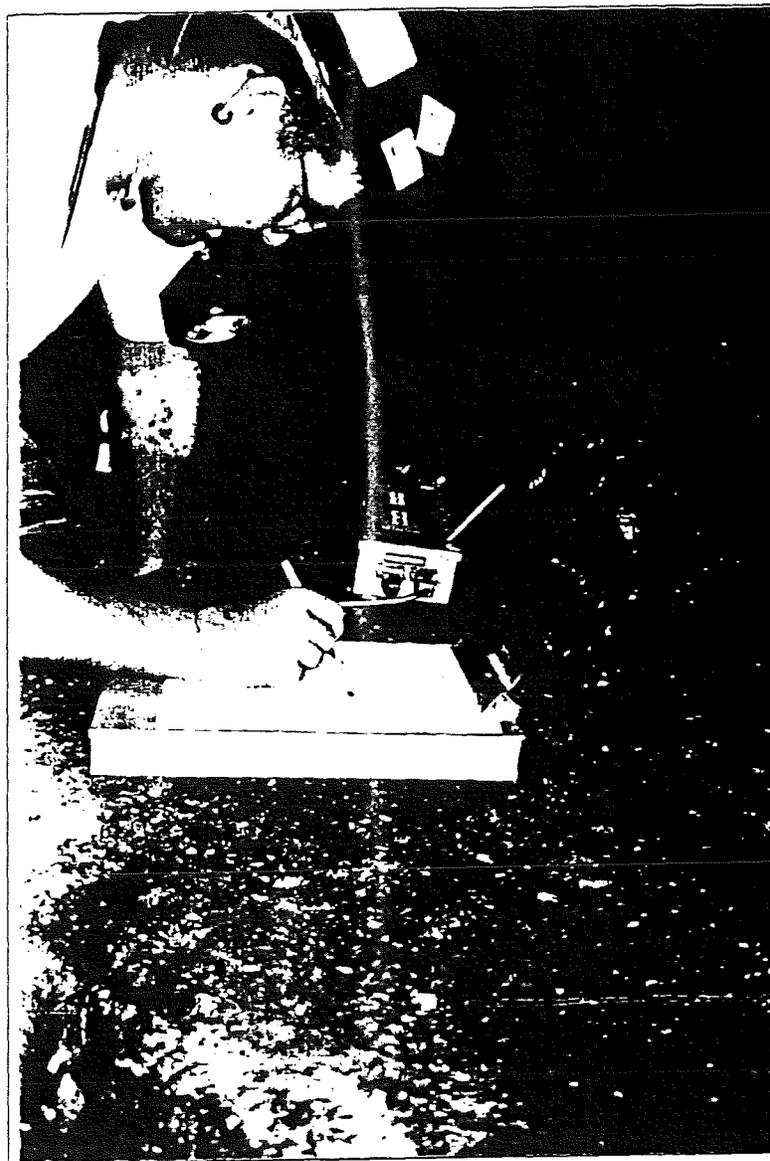
Figure 17: Taking blast readings after a blast.

After each shot was completed, the cave was entered and the associated summary data from each seismograph transferred to a log sheet. Figure 17. This data consisted of the date, time, event number, peak component velocity, and vector sum. The collection of this data permitted the daily upgrading of the peak particle velocity vs scaled distance plot. These data are summarized in Appendix C. Full waveform data were obtained by downloading weekly to a laptop PC ( Figure 18) via a RS232 serial port<sup>4</sup>. Copies are in Appendix E.
