# Research Summary

## PERFORMANCE OF WICKING GEOTEXTILE ON MITIGATING WATER PUMPING ISSUE ON I-44 HIGHWAY

<b><i>Project Information</i></b>	
<b>PROJECT NAME:</b>	TR201905 - Use of H2Ri to Mitigate Pumping in Concrete Pavement Shoulder
<b>PROJECT START/END DATE:</b>	September 2018 – February 2020
<b>PROJECT COST:</b>	\$37,403
<b>LEAD CONTRACTOR:</b>	Missouri University of Science & Technology
<b>PRINCIPAL INVESTIGATOR:</b>	Dr. Xiong Zhang
<b>REPORT NAME:</b>	Performance of Wicking Geotextile on Mitigating Water Pumping Issue on I-44 Highway
<b>REPORT NUMBER:</b>	cmr 20-003
<b>REPORT DATE:</b>	March 2020
<b><i>Project Manager</i></b>

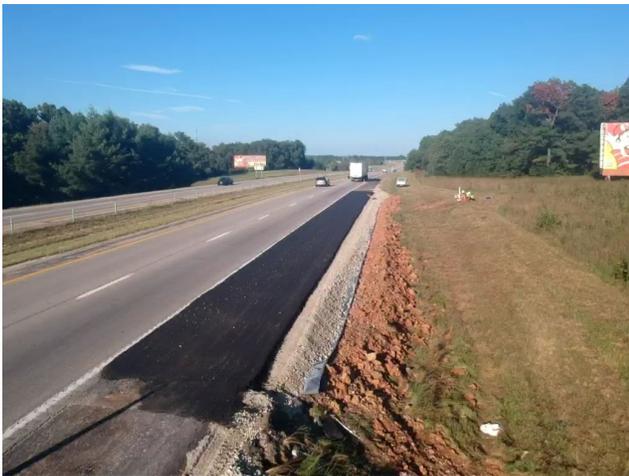
Figure 1: Section of shoulder along Interstate 44 after construction was completed.

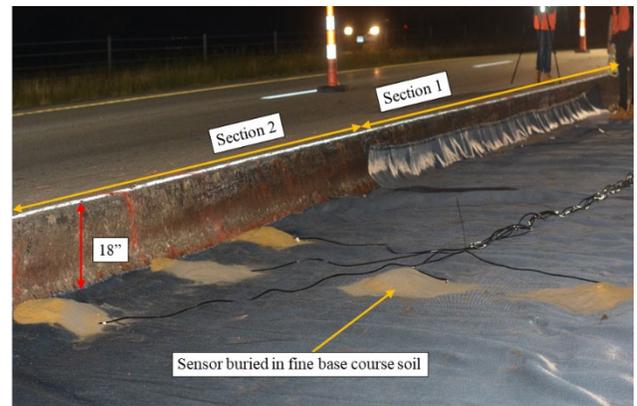
Figure 2: Sections 1 and 2 during construction, placement of wicking geotextile and instrumentation.

other sections were constructed by placing one layer of wicking geotextile on top of a clayey subgrade along the road shoulder, one with a vertical portion of geotextile just below the joint between the shoulder and pavement, and one without.

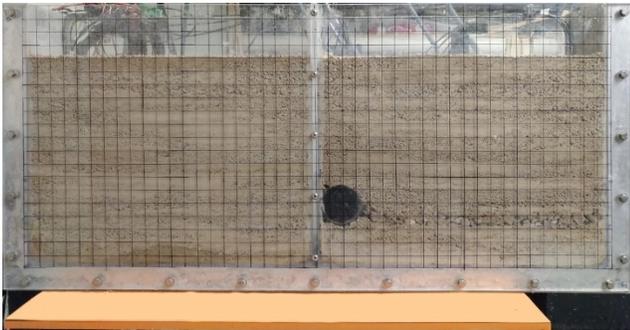
**Figure 3: Filled test box used to simulate field conditions and evaluate geotextile performance against French drain setup in laboratory.**

The average moisture content reduction was 5-10% at the improved sections compared to the control section. Some small-scale laboratory tests were also performed to investigate the drainage performance of wicking geotextile in a more controlled environment. The laboratory test results were consistent with the field monitoring results. It was also found that use of French drain was not as effective as the application of wicking geotextile in reducing moisture content in the pavement shoulder for pumping mitigation purposes.
